ASIA TURBOMACHINERY & PUMP SYMPOSIUM
MARCH 2018 | SUNTEC SINGAPORE

Technical Brief: Natural Frequency Whirl Instability in an Industrial Gas Turbine

Chris White, BSc, MEng
Principal Engineer, Rotating Equipment Reliability
Wood

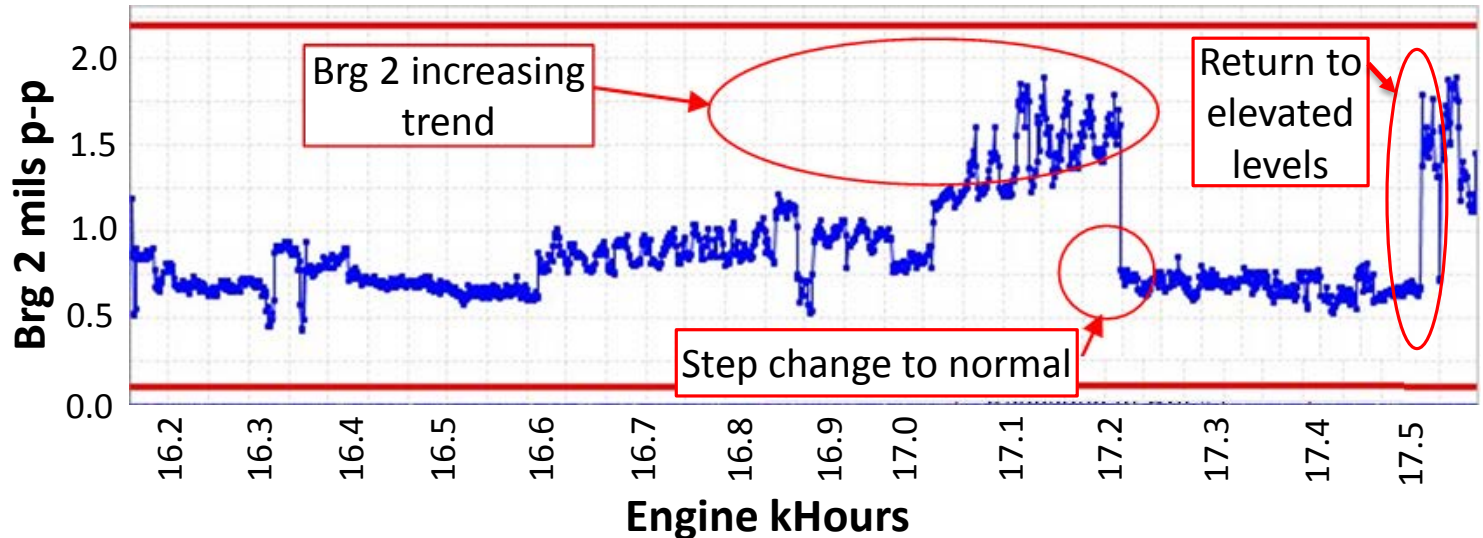
Human-machine interface display – Bearing 2 vibration amplitude trend

Shortly after Bearing 1 replacement, **Bearing 2** exhibited increasing vibration amplitude trend (from 16,600 – 17,200 hours), then:

- An unexplained step change back to normal without intervention
- At around 17,500 hrs, high vibration returned at Bearing 2

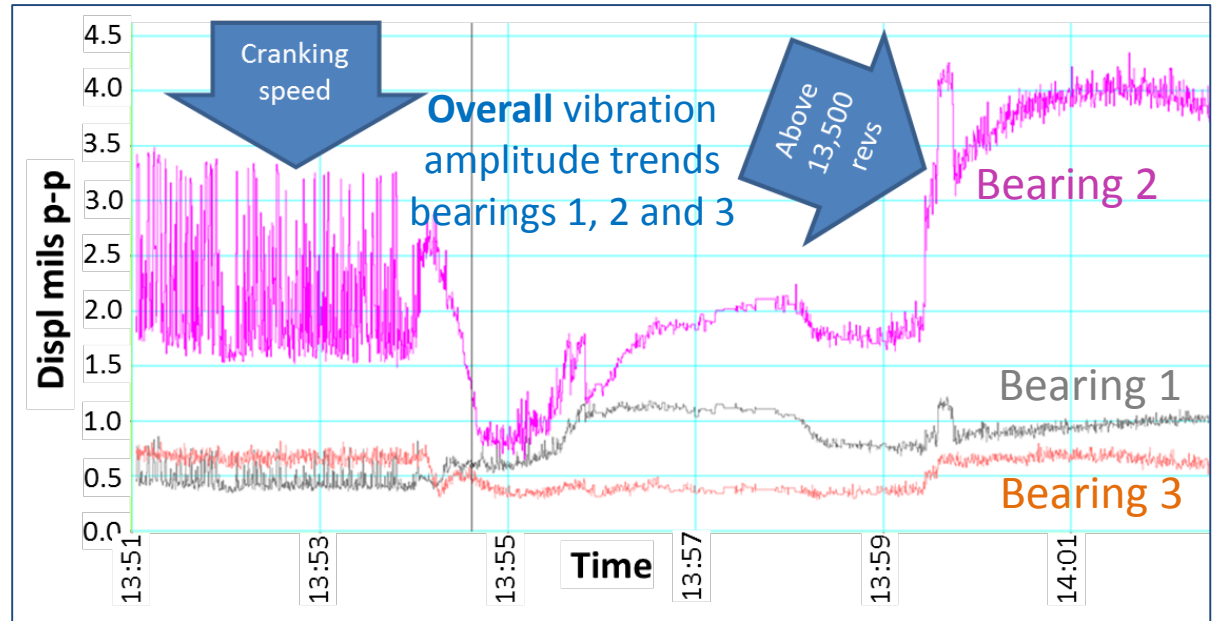
- At gas generator cranking speed of 3,300 RPM, large amplitude fluctuations observed at Bearing 2 to 90 μm / 3.5 mils pp
- Settles down as speed ramps up, however:
- At 13,500 RPM, a step increase to $\sim 100 \mu\text{m}$ / 4 mils pp at Brg 2 only
- No issues were noted on the power turbine

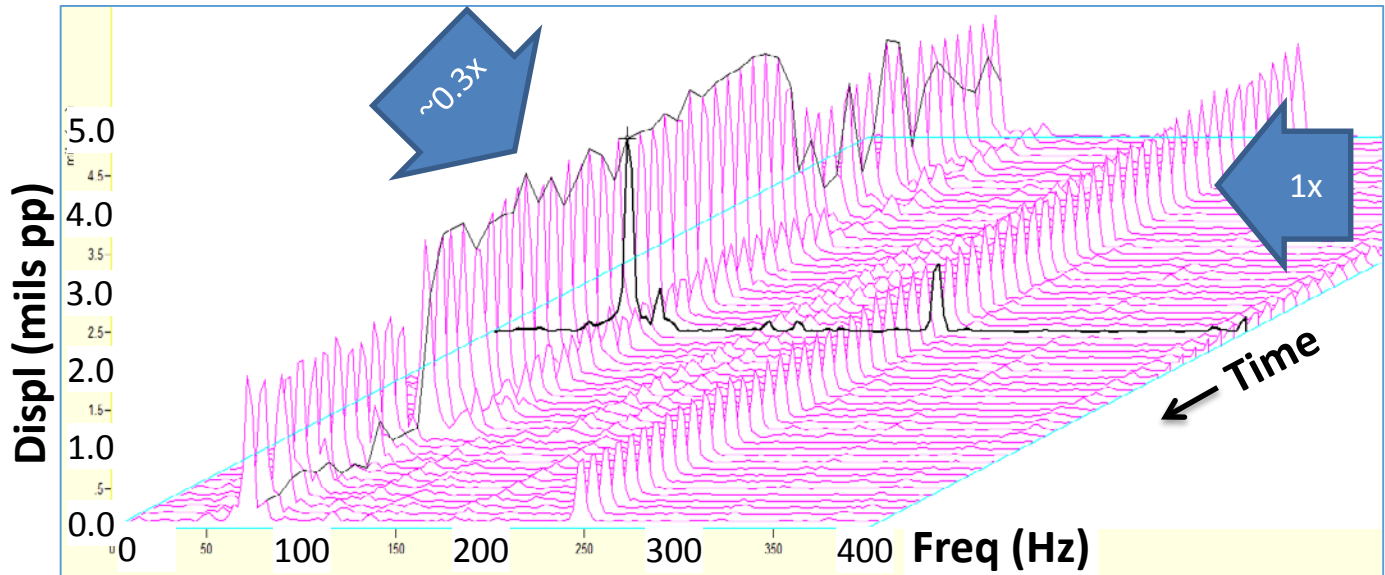
Bearing 2
start-up
waterfall at
onset

- High vibration amplitudes appear at around 13,500 RPM, reaching their worst at 14,200 RPM
- Main frequency component was at $\sim 0.27 - 0.3x$ turning speed (65.0 - 67.5 Hz), at over $75 \mu\text{m} / 3 \text{ mils p}$

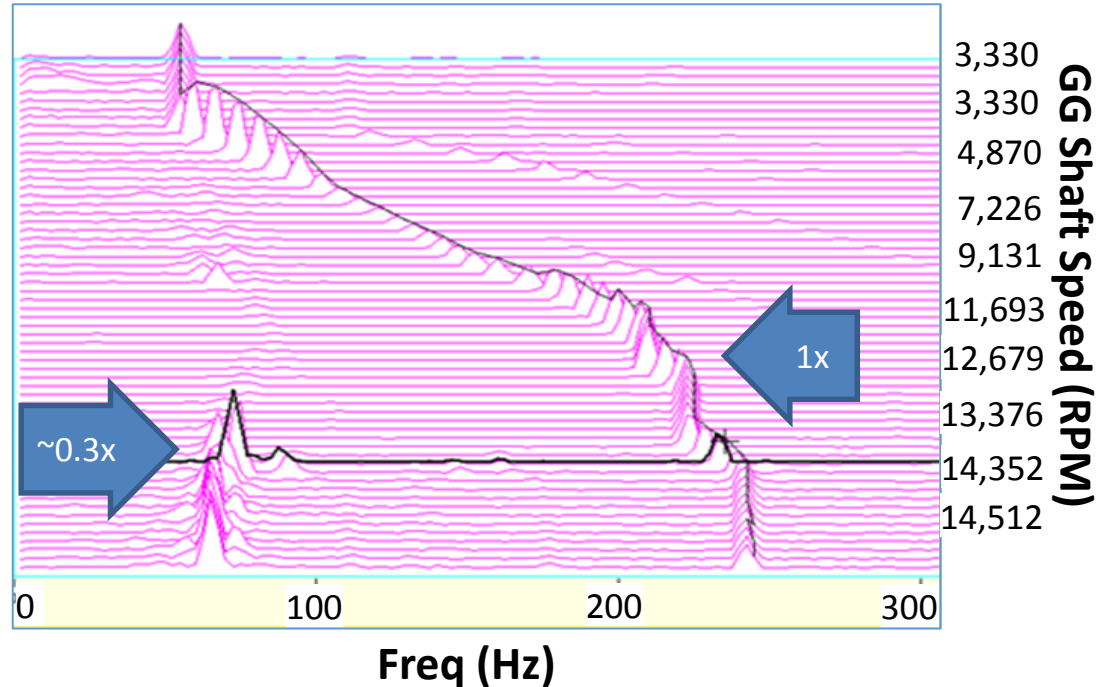
Bearing 2
start-up
waterfall

- Waterfall plot (read from rear to front) shows the high amplitude whilst cranking is at 1x, also suggests critical circa 4000 RPM
- At 13,500 RPM, we see onset of a large sub-synchronous frequency component – initially, around 0.3 orders of turning speed, but drops down a little

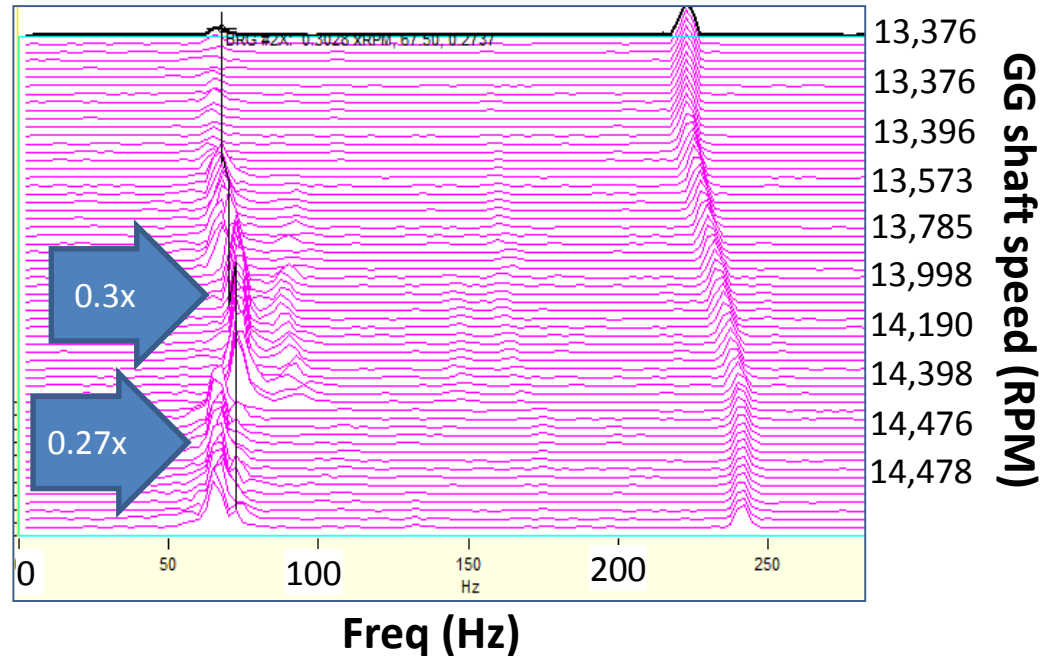
Zoom-in on bearing 2 start-up waterfall

- Closer examination of the onset of this sub-synchronous frequency component indicates it tracks with running speed during the final speed increase ($\sim 0.3x$)
- But then ‘locks on’ to a frequency of 65Hz, around 0.27 orders of turning speed

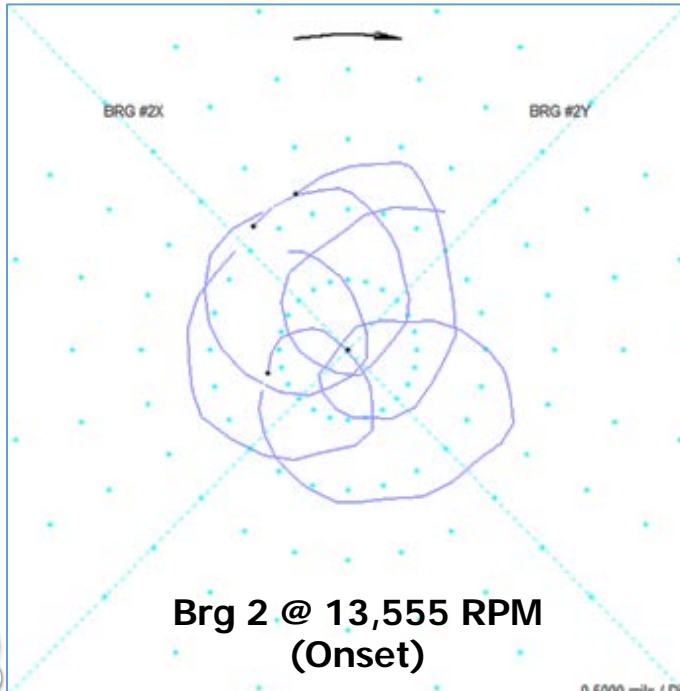
Bearing 2
orbit plot at
instability
onset

- Two inner loops (forward precession), 3 phase markers per cycle
- Not a closed cycle because not an integer fraction

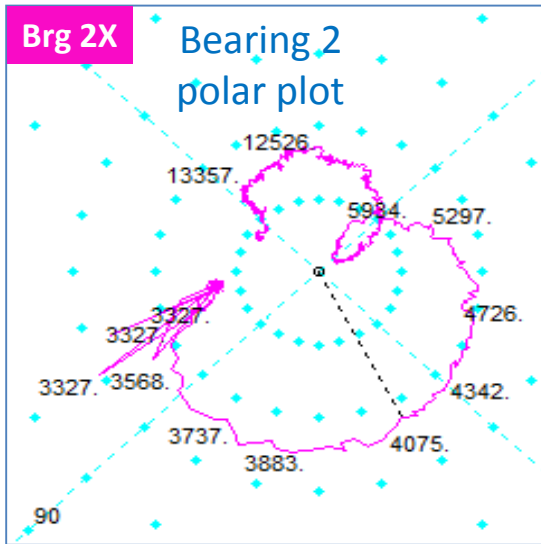
Indicate critical at around 4,100 RPM / = 68 Hz, good match for the 0.3 orders vibration which appears at 13,500 RPM

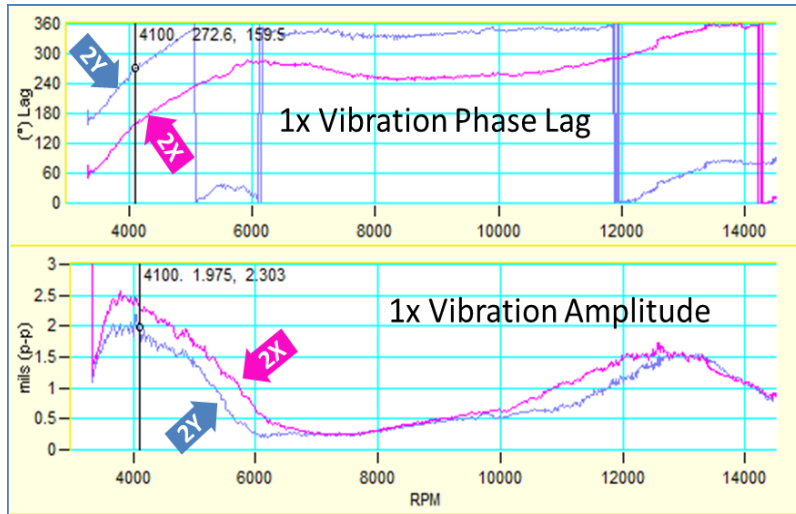
Problem machine Bearing 2 bode plots

When compared with a healthy example of the same model, 1st critical (as determined by phase change) similar but amplification factor appears much higher

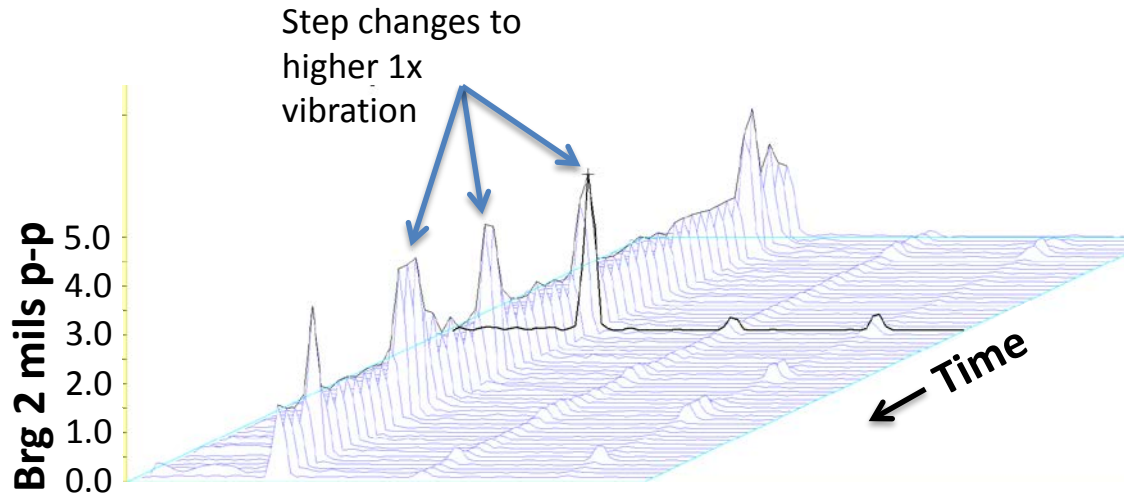
Bearing 2Y
cranking
speed
waterfall

At cranking speed of 3,300 RPM, turning speed vibration exhibits step changes between two clearly distinct 'states' at random intervals (bistable system)

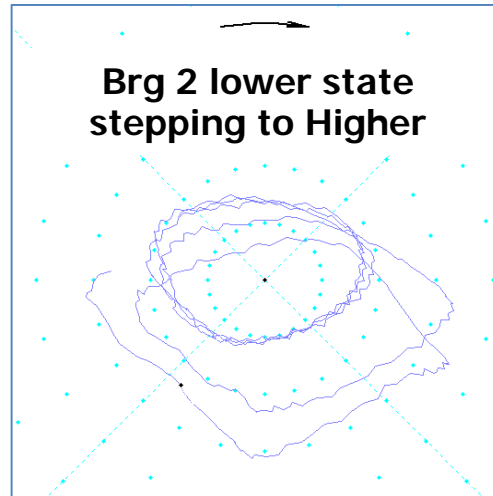
Bearing 2
orbit plot
during state
change

- Left orbit shows several rotations at lower stable state, followed by step to higher state
- Right orbit shows fully in higher vibration state, shape (abrupt trajectory changes) suggests low friction rub events
