Engine Driven Pumps - Vibration Problem Resolution Using Specialized Testing Techniques

A. Aziz Al-Qattan, Bahrain Petroleum Company

1st METS Turbomachinery Symposium
February, 2011

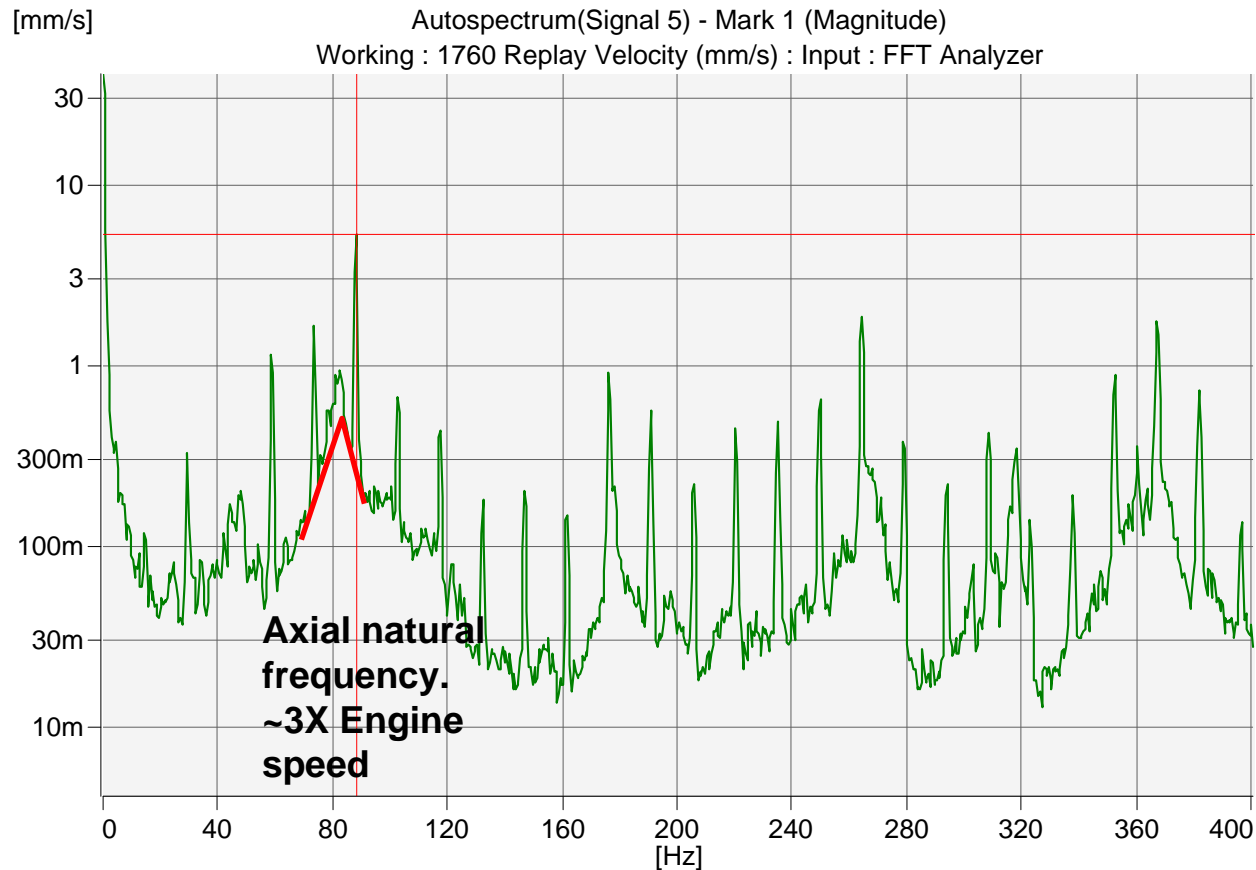
- Initial vibration testing used to identify potential issues to allow focusing on more specialized testing.
- Below: Typical vibration spectra of the P2952X engine inboard casing. Measurement in the axial direction. Note by plotting amplitude in the log scale a potential natural frequency is indicated.

Initial conclusion: Engine harmonics are exciting system natural frequencies.

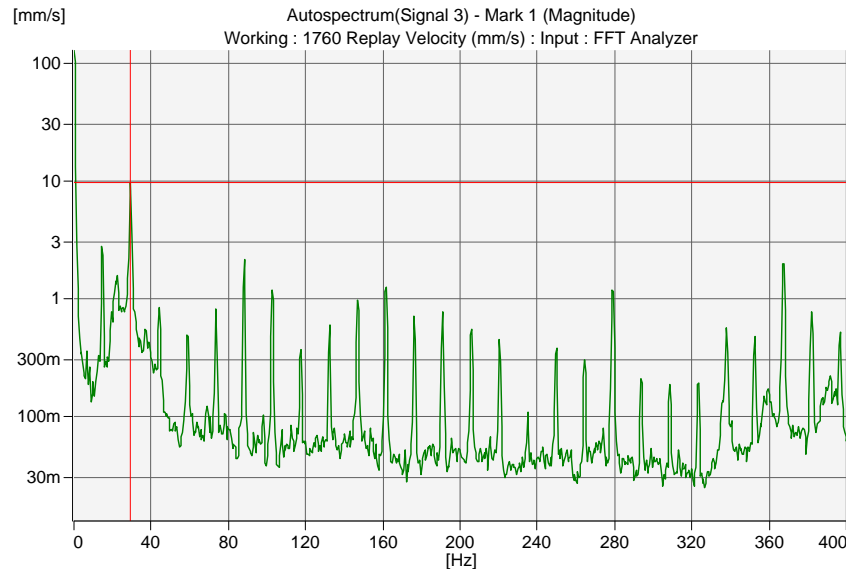
Left: Measured on the engine inboard casing in the vertical direction. Note the “picket fence” type response. Harmonics are $\frac{1}{2}$ engine speed.

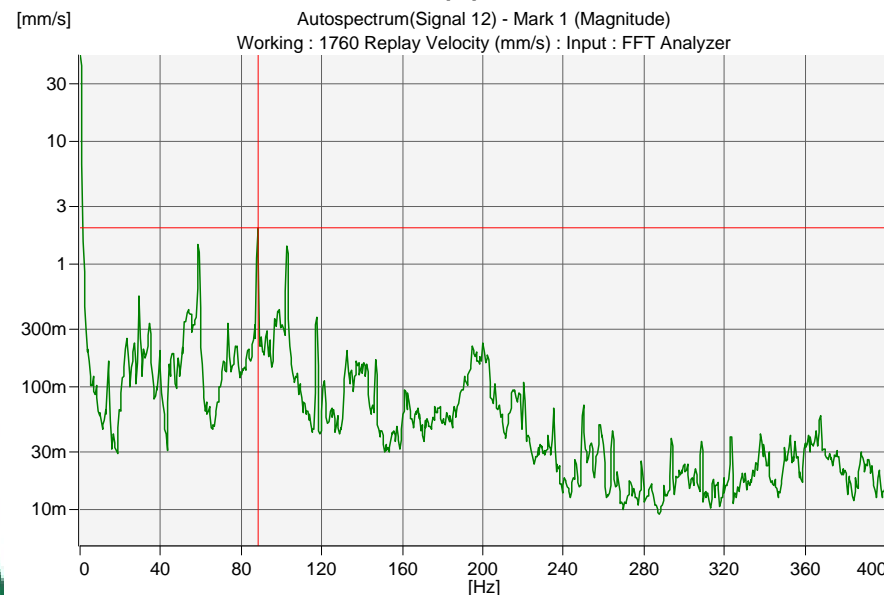
Below-left: Horizontal direction – Side to side mode near 96Hz (3.5Xengine speed).

- Highest vibration at intermediate bearing due to excitation of the pedestal mode in the axial direction (3x rpm, 84.5Hz) and side-to-side (3.5x rpm, 96Hz).
- The modes were being excited by the 3x and 3.5x rpm harmonics of 1/2 x rpm sourced engine excitation when the system was running at 1,722 rpm (28.7 Hz).

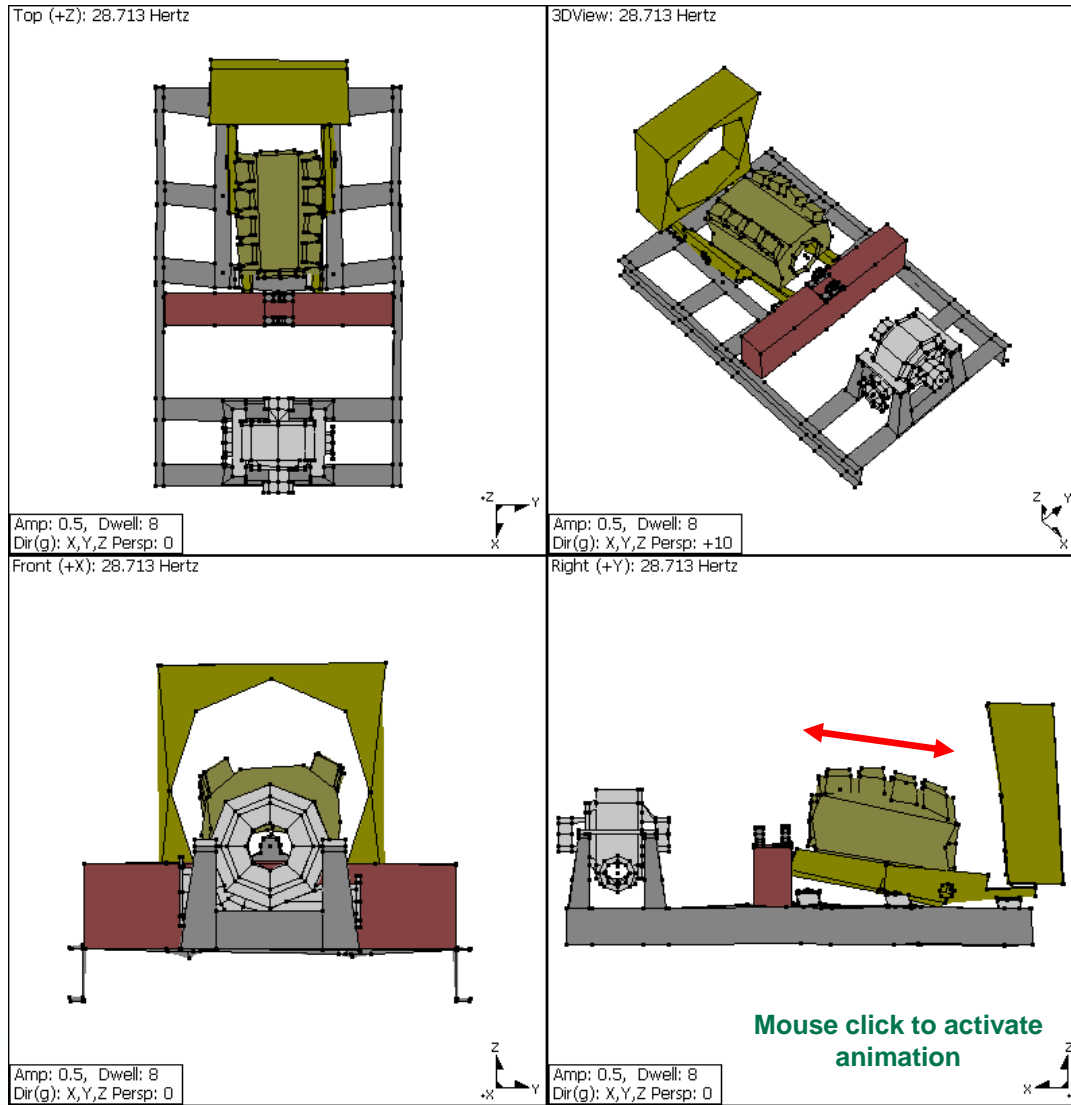
1x rpm (1722 cpm).

The animation shows flexibility of the diesel engine supports.

Pump remains stationary.

- Engines are moving considerably relative to the pumps due to flexible mounting pad support of engine feet.
- Transmitted motion through shaft to other system components including the P2952X steady bearings and their support beam, and the pump/pedestal.
- Vibration greatly amplified at select operating speeds leading to strong engine-driven harmonic response at multiples of $\frac{1}{2}$ x engine rpm.
- Engine mis-firing caused $\frac{1}{2}$ x rpm force response excitation (“picket fence”).
- Engine soft-mounting amplified the response levels.

- Replace flexible mounts with single or two-piece shim pack of equal height (no stacking of thin multiple thin shims). Retune engines to minimize mis-fire ($1/2 \times \text{rpm}$) excitation.

- Flexible rubber mounting pads replaced with appropriate metal shims.
- Engine tuning verified.
- Grout added under the engine.
- Engine rpm reduced.
- Impeller diameter increased to meet flow and head requirements at lower engine rpm

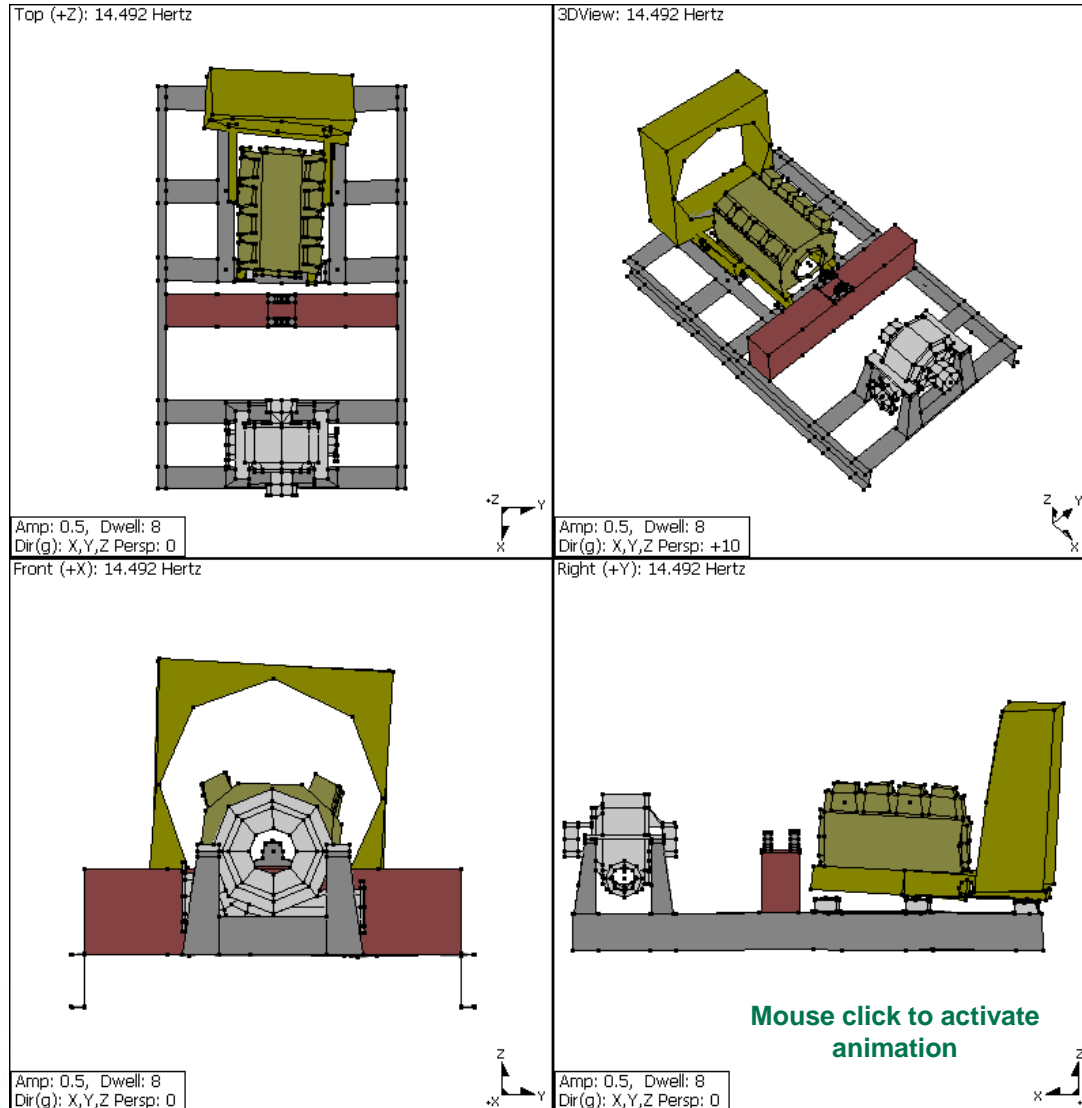
$\frac{1}{2}x$ rpm (890 cpm).

The animation shows the “swinging” of the engine supports

Pump remains stationary.

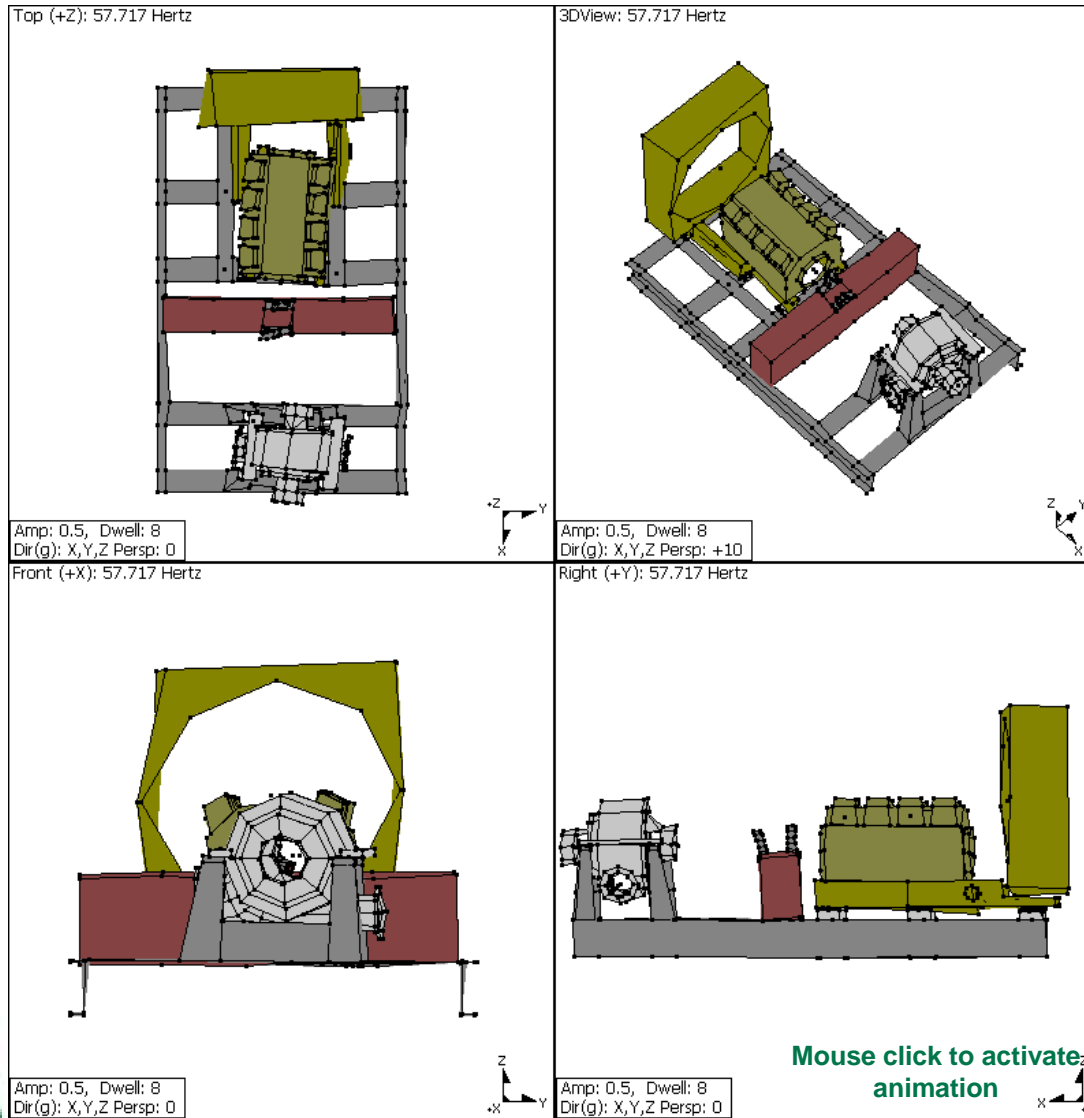
2x rpm

The animation shows horizontal side-to-side mode.

Pump and engine are out of phase.

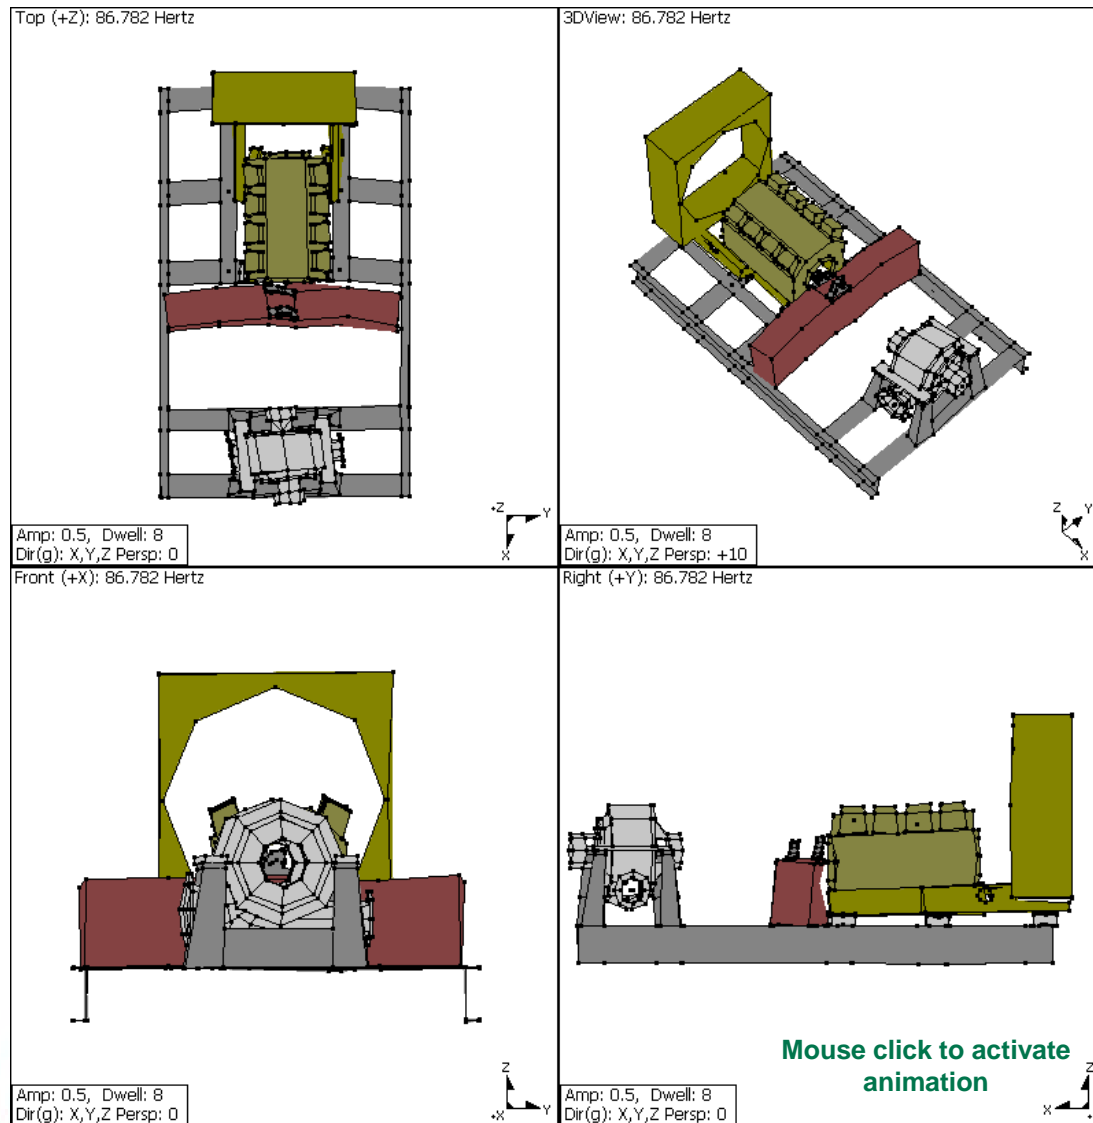
3x rpm (86.8Hz or 5,208 rpm)

The animation shows the intermediate pedestal rocking axially, and

A pump twist mode.

- Grout the baseplate for added stiffening and damping – may not be practical.
- Add piping shock absorbers/vibration dampeners to critically damp the 84.5Hz and 96Hz modes.

Lowering engine operating speed will reduce vibration by shifting the excitation frequency away from these natural frequencies. Lower engine rpm may require a larger impeller diameter to meet specified flow and head requirements.
