**Innovative Design in Expander Wheel-Shaft Attachment Replaces
Hirth Coupling
for
High Speed, High Temperature and High Power Applications**

Houman Shokraneh, Ph.D.
Director of Engineering
L.A. Turbine

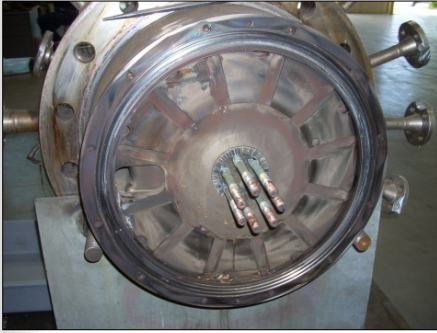
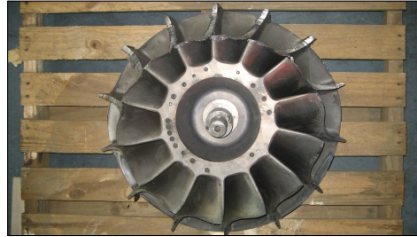
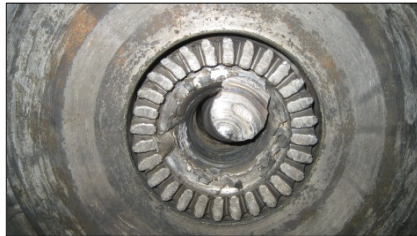
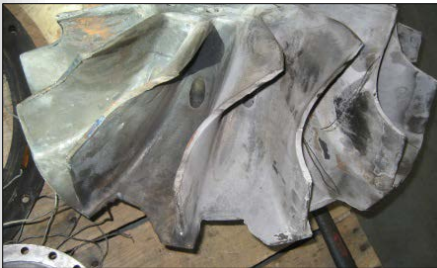
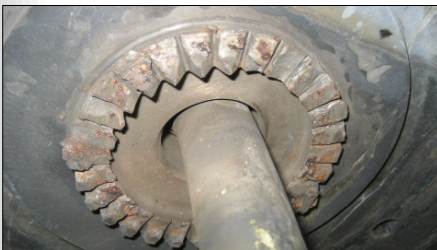
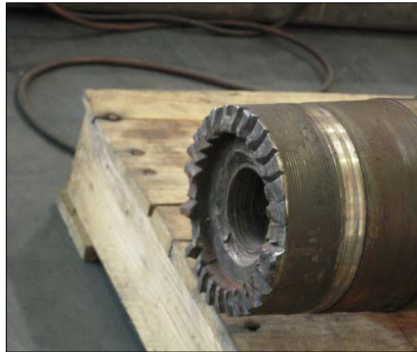
- Hirth coupling attachment was failing on all previous designs.
- Inconel 718 retaining bolt was also failing-either severely bent or completely sheared.
- Because of above reasons, in all failures the expander wheel was completely separated from the shaft, and it was rubbing to the follower and the housing, thus not much evidence was left for useful metallurgical analysis.

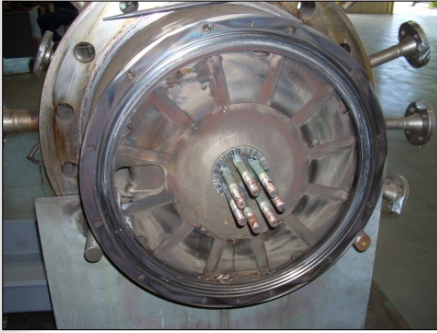
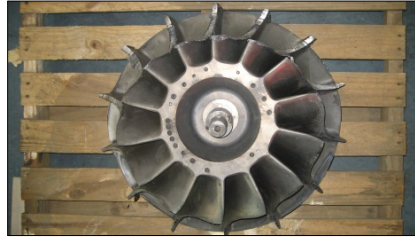
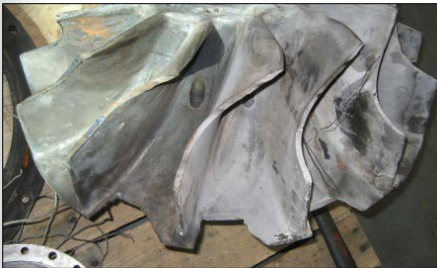
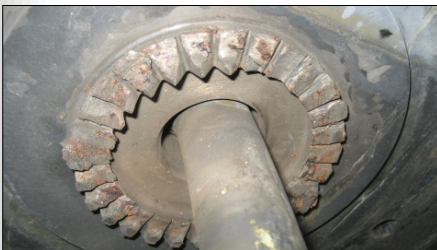
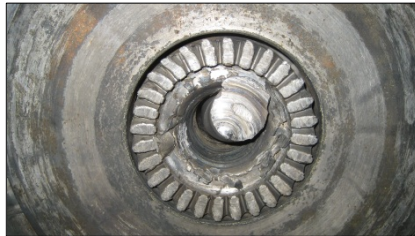
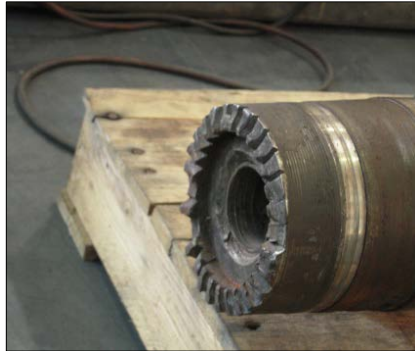
Possible causes for Hirth coupling failures:

- Wheel Weight (above 90 Kg)
- Hirth coupling size
(Re-designed 3 times)
- Hirth coupling teeth design
(Re-designed 4 times)
- Weak retaining bolt
(one single bolt, 7 bolts)
- Locating the wheel on the retaining bolt

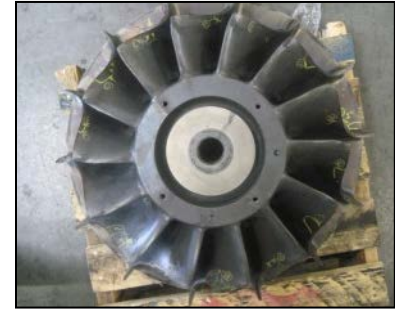
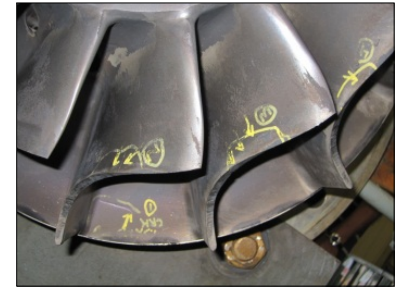
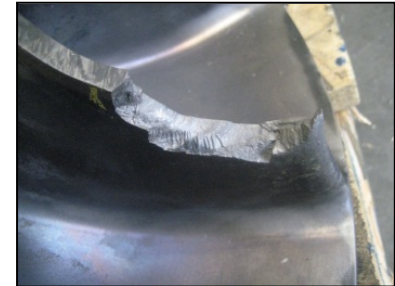
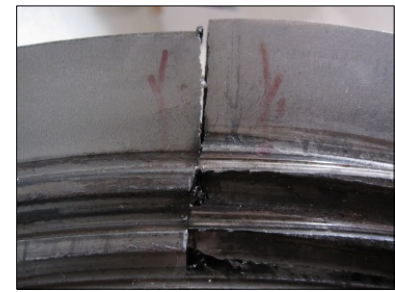
1. Expander wheel was attached to the shaft and retaining bolt was intact.
2. Build-up from the operating steam was firmly attached to the blades OD and was causing friction between the expander wheel blade and the follower.
3. Expander wheel blades were cut off in several locations, signs of high cycle fatigue observed.
4. Expander wheel disc had cracks in three locations on the OD.

- No change made to shaft-wheel attachment.
- Increased the clearance between the expander wheel and the follower to avoid rubbing on blade's outer edges.
- Wheel resonance re-evaluated on complete rotor assembly and with the maximum stretch on the retaining stud. Few blade frequencies observed to be close to the operating speed. By cutting blades in front and on the OD, safety margin increased on these frequencies.
- Back wheel seal design changed to increase the clearances and consider the wheel expansion by centrifugal forces and temperature.

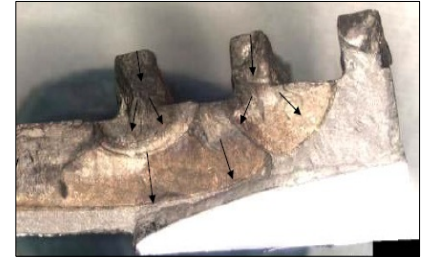
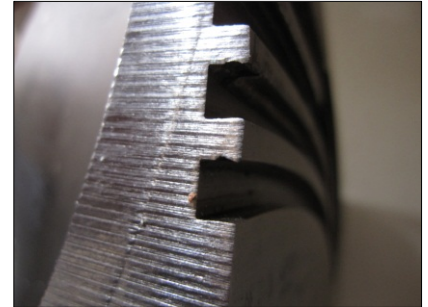
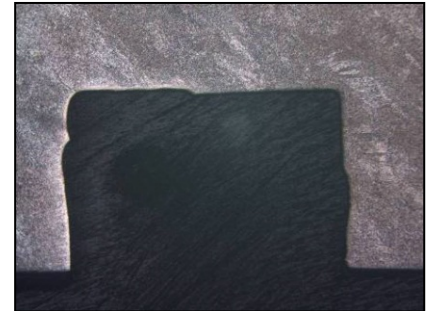
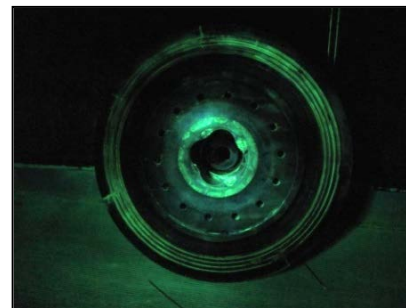
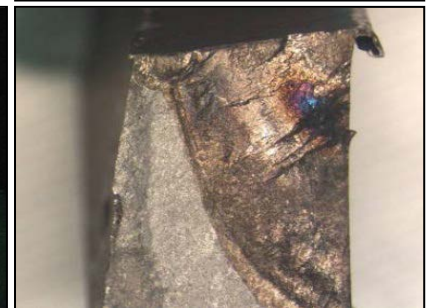
5. Disc cracks were initiating from the third stage of the back wheel seal on all three locations.
6. Signs of severe rubbing were observed between the wheel and back wheel seal inside all four stages of the back wheel seal. Material property changed locally and became brittle.
7. Discovered electrical current was passing through the unit. Signs observed on blades between each crack and between shaft and wheel shoulder surface.

- New grounding system implemented on all casings on four different locations, and on two places on the shaft with higher capacity brushes to eliminate current migration through the unit.
- Moved sphere pivot to 55% position under each pad to improve the bearing stability based on the data collected during three months of operation and new rotor dynamic analysis.
- Used new Cr-Cu material for bearing casings to transfer heat faster to the bearing housing.
- Study on high temperature marks on both bearings with no thrust force indicated that oil pumps were failing to provide sufficient oil to keep these bearings cold. Repaired both oil pumps to ensure the maximum capacity of oil flow is reachable.
- Changed oil and cleaned oil piping and filters as some blockage appeared on the piping over time.

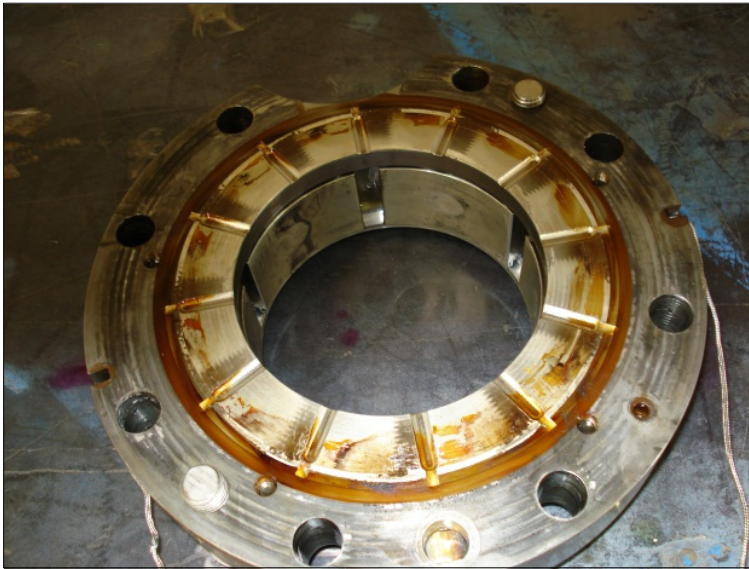
8. Serious instability observed during operation after the start-up but the vibration limit was steady and less than 0.05 mm.

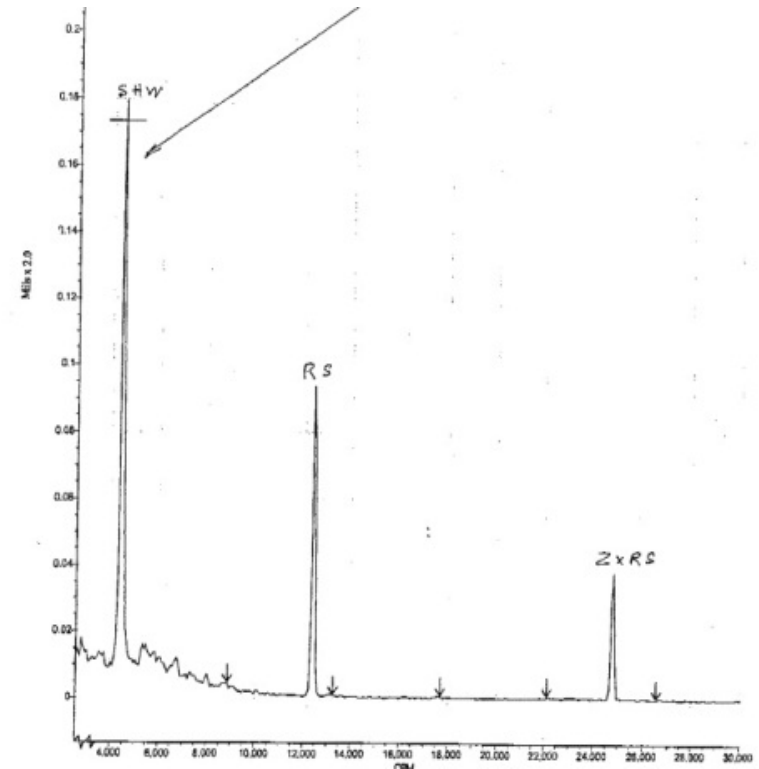
9. On both bearings, journal pads and thrust faces were showing signs of high temperature exposure.
