# Premature Dry Gas Seal Failure on a Sales Gas Centrifugal Compressor

Sergio Vidal  
(Saudi Aramco, Hawiyah Gas Plant - Reliability Unit)

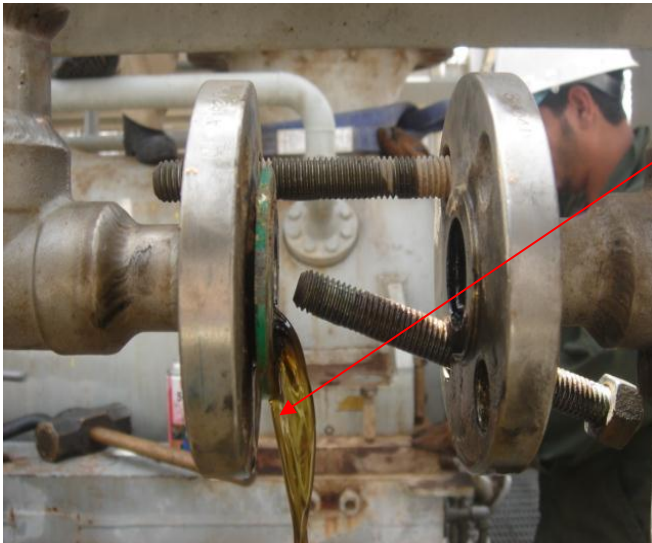
- **Lube oil spread all around the machine surroundings,** through the secondary seal leak line discharge to the atmosphere (3<sup>rd</sup> floor compressor bay).
- **Compressor shaft was found to be stuck/not rotating.**
- **Inboard dry gas seal 2nd leak drain** to sewage (1<sup>st</sup> floor): Some traces of lube oil.
- **Inboard dry gas seal 1st leak drain** to sewage (1<sup>st</sup> floor): Without any liquid.
- **Outboard dry gas seal 2nd leak drain** to sewage (1<sup>st</sup> floor): **Lube oil.**
- **Outboard dry gas seal 1st leak drain** to sewage (1<sup>st</sup> floor): **Lube oil and hydrocarbons liquid.**
- **Outboard dry gas seal 1st and 2nd leak lines** (1<sup>st</sup> floor): **Completely filled with lube oil.**

Outboard dry gas seal 1st and 2nd leak lines were completely filled with lube oil.

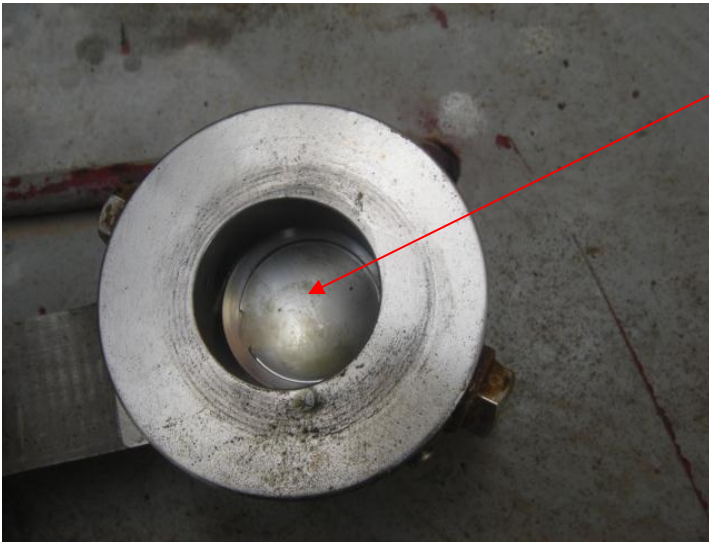
Inboard dry gas seal 1st leak line rupture disk was intact.

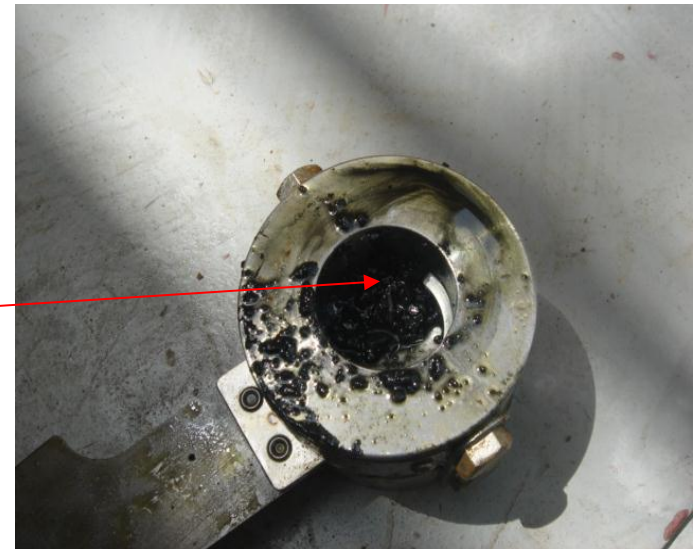
- **Outboard dry gas seal 1st leak line rupture disk on 1<sup>st</sup> floor: rupture and full of debris (metal and other particles).** This debris appears to belong to dry gas seal internal components (rotating and static rings, springs, etc.).
- **Inboard dry gas seal 1st leak line rupture disk on 1<sup>st</sup> floor: Not damaged.** Lube oil only on the vent side of this rupture disc (no lube oil coming from the inboard dry gas seal 1st leak line).
- **Filter for N<sub>2</sub> supply to the dry gas seal on 1<sup>st</sup> floor: Not plugged and in good condition.** There were no moisture or liquid traces on this filter.
- **Dry gas seal buffer gas filters on 1<sup>st</sup> floor (in service and standby): Liquid inside both of them.**

Outboard dry gas seal 1st leak line rupture disk was found ruptured and full of debris.

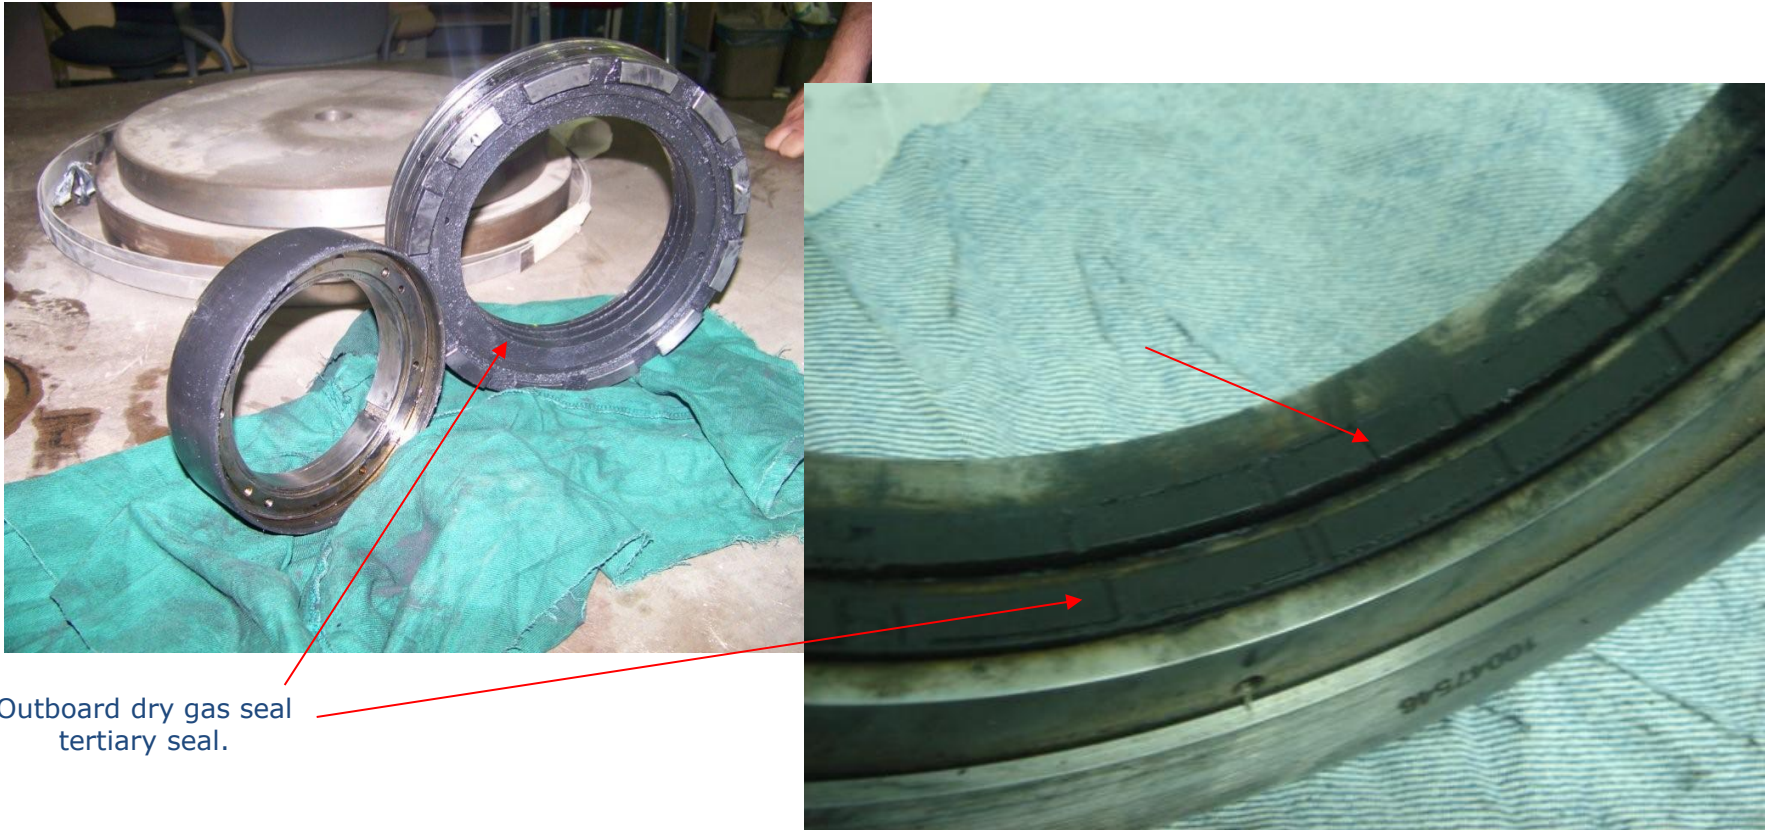
- **Inboard dry gas seal:** Not seriously damaged (just some medium scratches in seal journal area), a very little amount of lube oil was found on the tertiary seal area.
- **Outboard dry gas seal tertiary seal:** Oil contaminated and with black deposit but no visible wear or scratches.

Outboard dry gas seal  
tertiary seal.

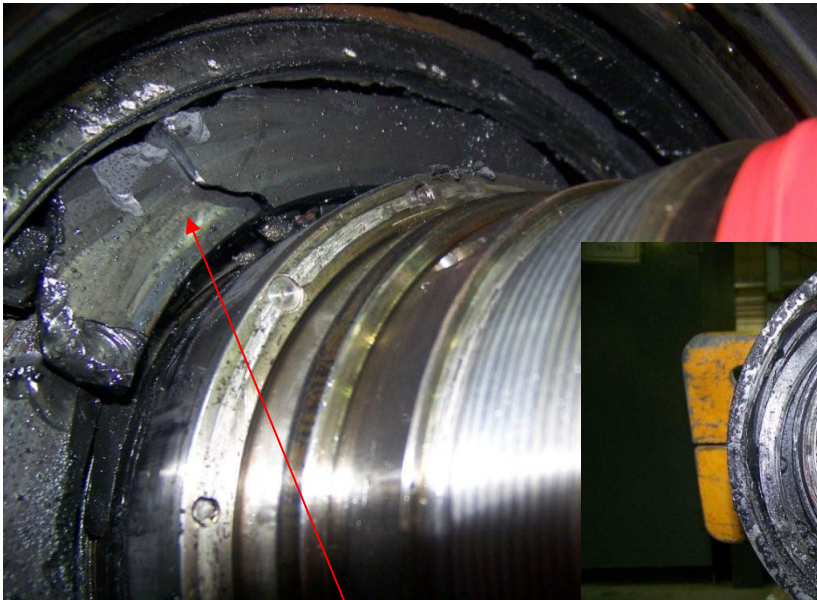
- **Outboard dry gas seal 2nd seal: Springs had disappeared, the rotating ring (tungsten carbide) and the stationary ring (carbon) were found broken in pieces.**
- **Rotating ring (tungsten carbide) and stationary ring (carbon) of the outboard dry gas seal 1st seal were not broken.** The seal faces have scratches, on the stationary ring (carbon) a little piece was missing. The spring was in good conditions and in place.
- The process side labyrinth/shaft clearance on both inboard and outboard dry gas seal has found be **around 0.017" (design values: 0.012" to 0.15"), value acceptable.**

Outboard DGS 2nd seal, broken rotating ring.

- The DGS manufacturer investigation report states the cause for this seal failure was due to **reverse pressurization of the dry gas seal 2nd seal, outboard side.**
- Reverse pressurization occurs when the **pressure on the ID of the seal is higher than the OD of the seal** (normally the seal operated with the pressure on the OD higher than on the ID of the seal).

- **Reverse pressurization tends to close the faces at the outside diameter producing a divergent gap**, which can cause thermal stress at the OD of the tungsten carbide seat due to localized high temperature.
- The localized **thermal stress create and propagated axial cracks** through the seat which can cause a catastrophic DGS failure.

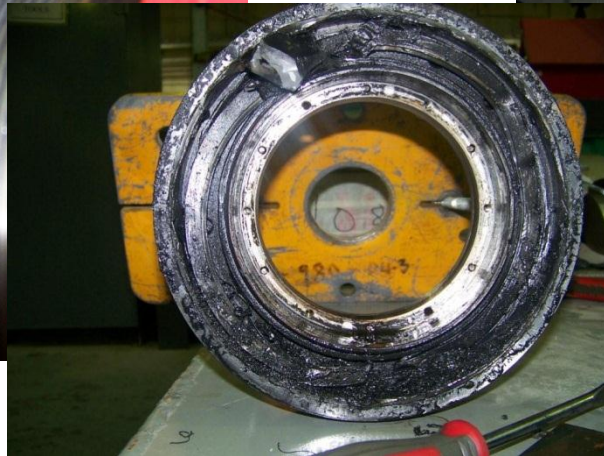
Outboard DGS 2nd seal, broken tungsten carbide pieces.

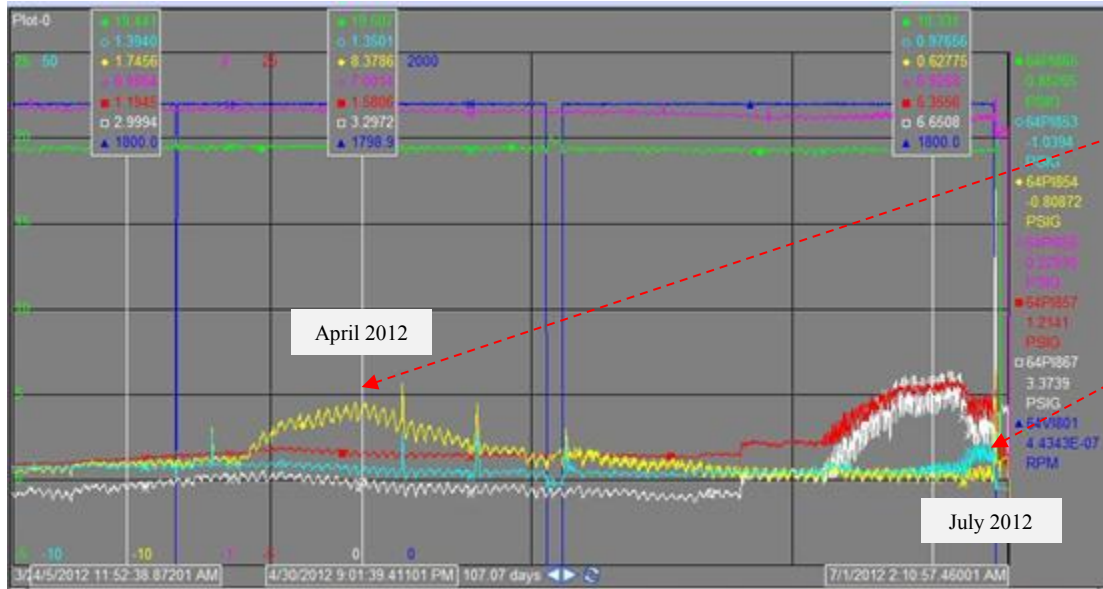
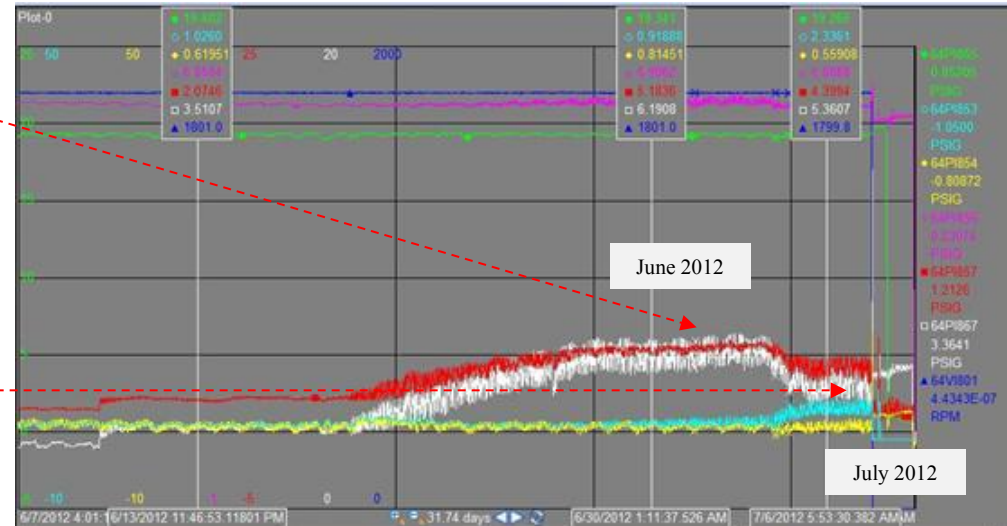
- DGS 1st leak pressure outboard side (tag PI854) **reached 8.3 psig on 30-04-2012** and for around 2 weeks had higher values than the normal values of 0-2 psig.
- DGS 1st leak pressure inboard board side (tag PI853) on **04-07-2012 start increasing to 4 psig until the trip on 07-07-2012**, normal values 0-2 psig.

- 2nd leak pressure inboard and outboard side (tags PI857/PI867) **started to rise around 20-06-2012 and reach 7/6 psig on 30-06-2012 then dropped to 5/4 psig until the trip on 07-07-2012**, normal values 0-1 psig.
- 6 days before the failure, around 01-07-2012 several DGS parameters start **showing more fluctuations than normal**.

- Change the **current DGS secondary leak pressure (PIT857/PIT 867) alarm from 12 psig to 4 psig** – DGS manufacturer recommendation accepted by compressor OEM.
- **Don't run the compressor lube oil system without having N2 supply to the DGS tertiary seal** – DCS interlock to prevent this situation.
- Change the **current time delay** setting for the vibration protection systems shutdown values **from 3 seconds to 1 second**, which is the standard value recommended by API 670.
- DGS instrumentation (pressure and flow transmitters) should be **replaced/sent to calibration every 5 years**.

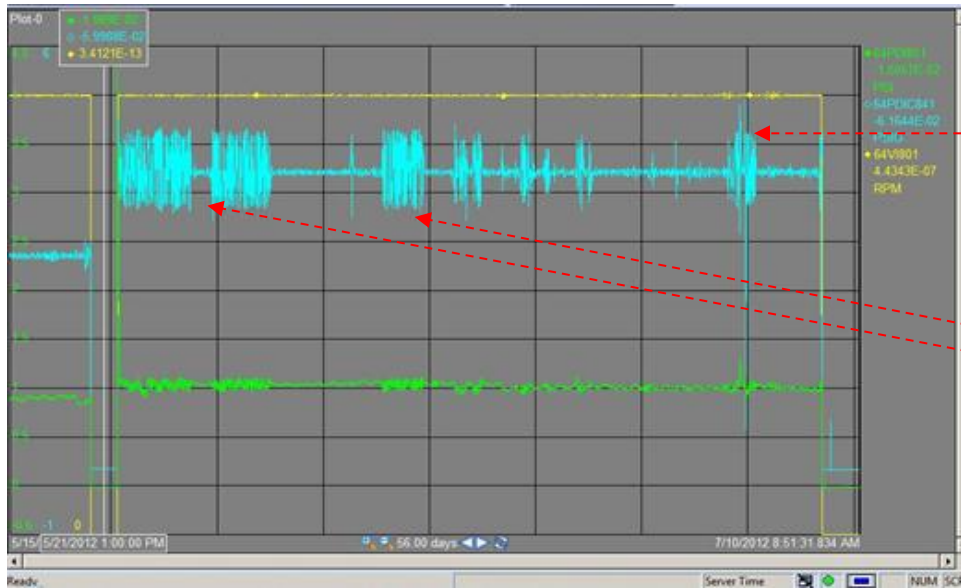
- The **DGS buffer gas ΔP (tag PDIT841) values start fluctuating** around 2:30 h before the trip on 07-07-2012.
- Between 02-07-2012 to 03-07-2012 (5-6 days before the failure), the **DGS buffer gas ΔP showed several times unusual fluctuations.**

- The tertiary seal N2 gas supply flow (Tag FI853) **increase to 168 SCFH on 14-06-2012 and drop again** to normal values of 80-90 SCFH. It increase back to around 150-160 SCFH on 04-07-2012 and maintain this values until the trip on 07-07-2012.

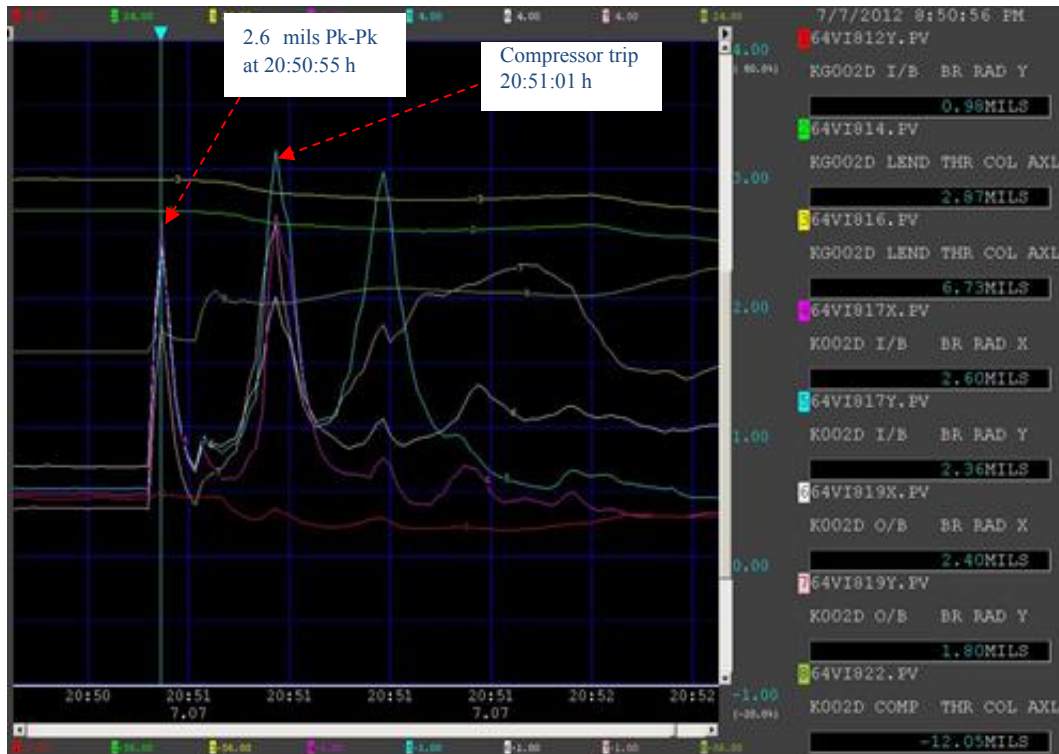
- The vibration monitoring system (VMS) is **configured with 3 seconds filter time delay** for the danger alarm (i.e., HH vibration) to avoid trips on vibration spikes.
- As per API 670 Machinery Protection System section 5.4.1.5:

*"With exception of electronic over speed detection, fixed time delays for shutdown (danger) relay activation that are field changeable (via controlled access) to require from 1 to 3 seconds sustained violation. **A delay of 1 second shall be standard.**"*

- Before the trip of 07-07-2012 20:51:01 h due to the DGS 1st seal leak outboard, there was a **vibration peak 2.36-2.6 mils Pk-Pk** at 20:50:55 h (compressors bearings) above the shutdown value (2.26 mils Pk-Pk) that lasted no more than 1 second.
- As **vibration peak at 07-07-2012 20:50:55 h of 2.36-2.6 mils Pk-Pk** lasted less than the current 3 second time delay it didn't cause a trip.
