47TH TURBOMACHINERY & 34TH PUMP SYMPOSIA
HOUSTON, TEXAS | SEPTEMBER 17-20, 2018
GEORGE R. BROWN CONVENTION CENTER

Up-thrust and Seal Failures on a Vertical Can Pump

Pine Bend, MN, 12x10, 9 stage vertical can pump, 600 hp, 1780 rpm

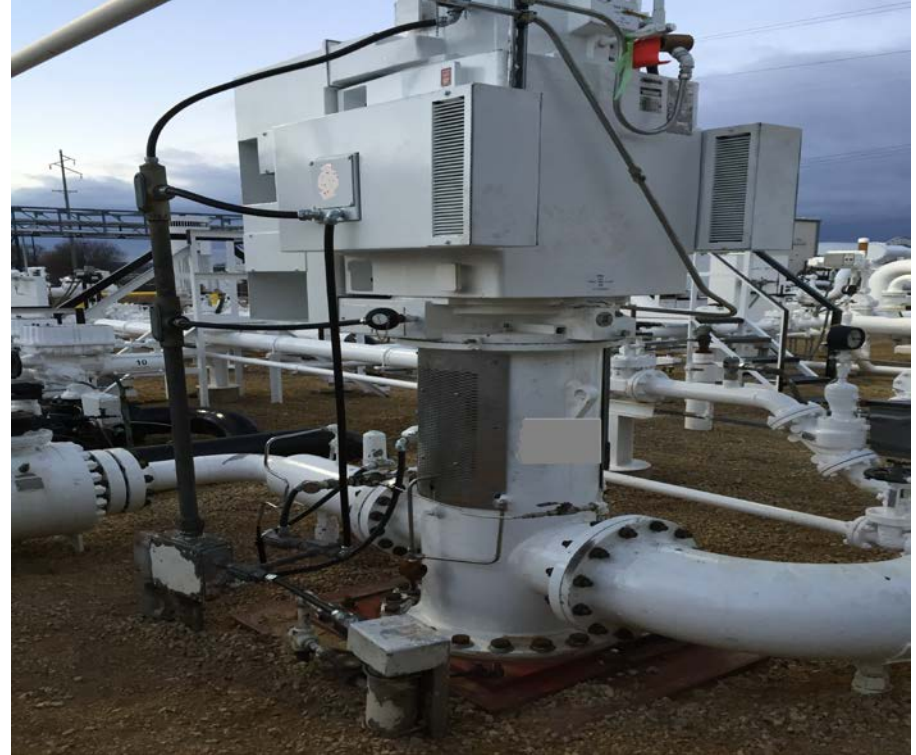
New Motor

A new smaller, higher efficiency motor was installed to replace the old motor and shortly after numerous mechanical seal failures occurred. The motor is a solid shaft motor that is connected to the pump with a rigid coupling.

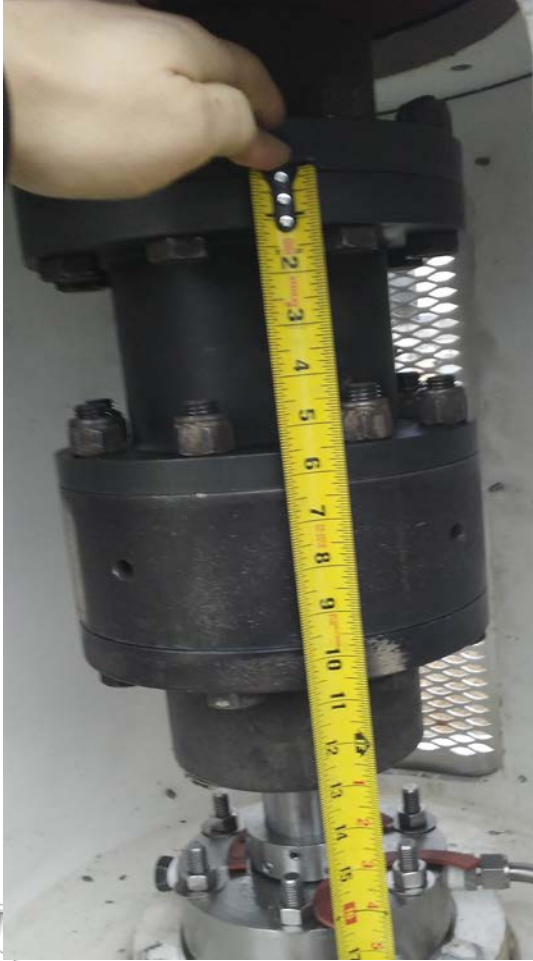
Upward
Movement

When the suction valve was opened it was noticed that the pump shaft and 4 piece rigid coupling moved about $3/8$ inch upward before the pump was started since flow through the pump pushed the components upward.

It was difficult to determine that the motor shaft did not move so it was difficult to trouble shoot and resolve the problem.

After the pump was started and flow was established the components moved back down to the normal position and the pump was in down thrust.

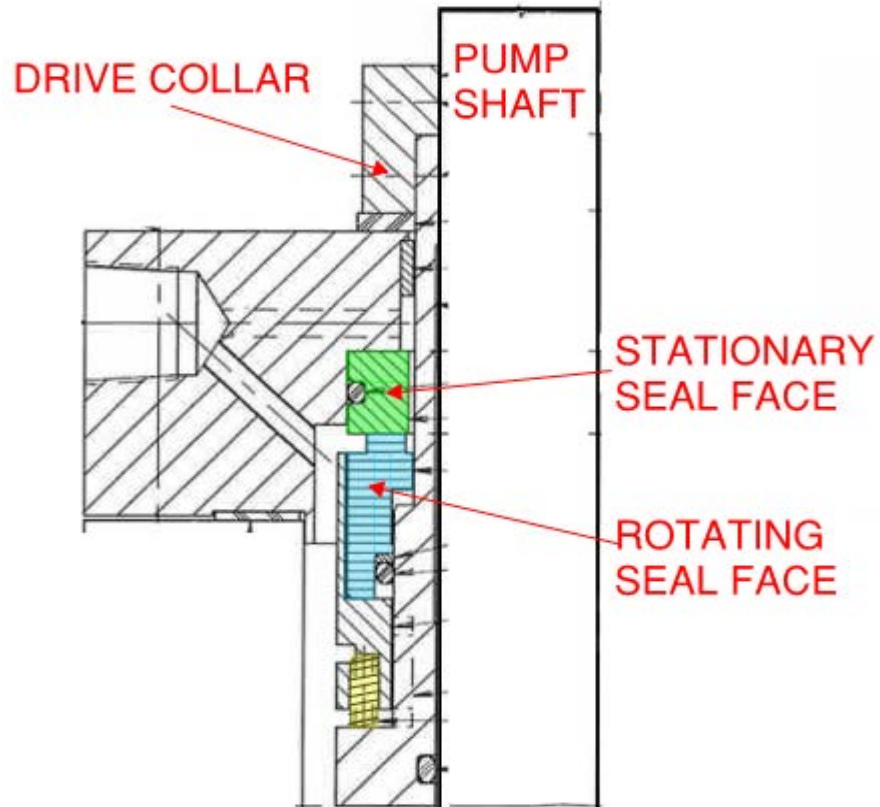
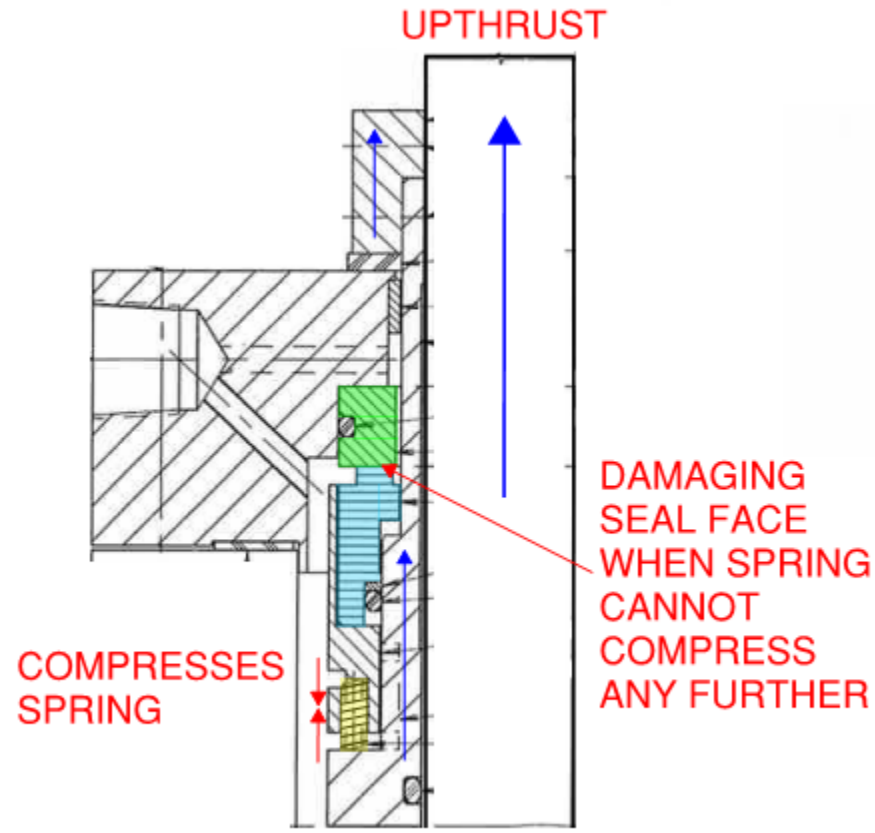
Mechanical Seal

The motor hub is connected to the motor shaft with a split ring. On startup it was observed that the pump shaft would move about 3/8 inch upward and the mechanical seal would leak.

- It was noticed that when the pump shaft moved upward the motor shaft did not move upward so the motor was not providing any force to stop the upward movement of the pump shaft.
- The pump was started and shortly after the pump shaft went back down and stayed down. It was noticed that the seal was dripping product after the start up.
- After further investigation it was determined that the set screws had slid on the pump shaft even when properly tightened.

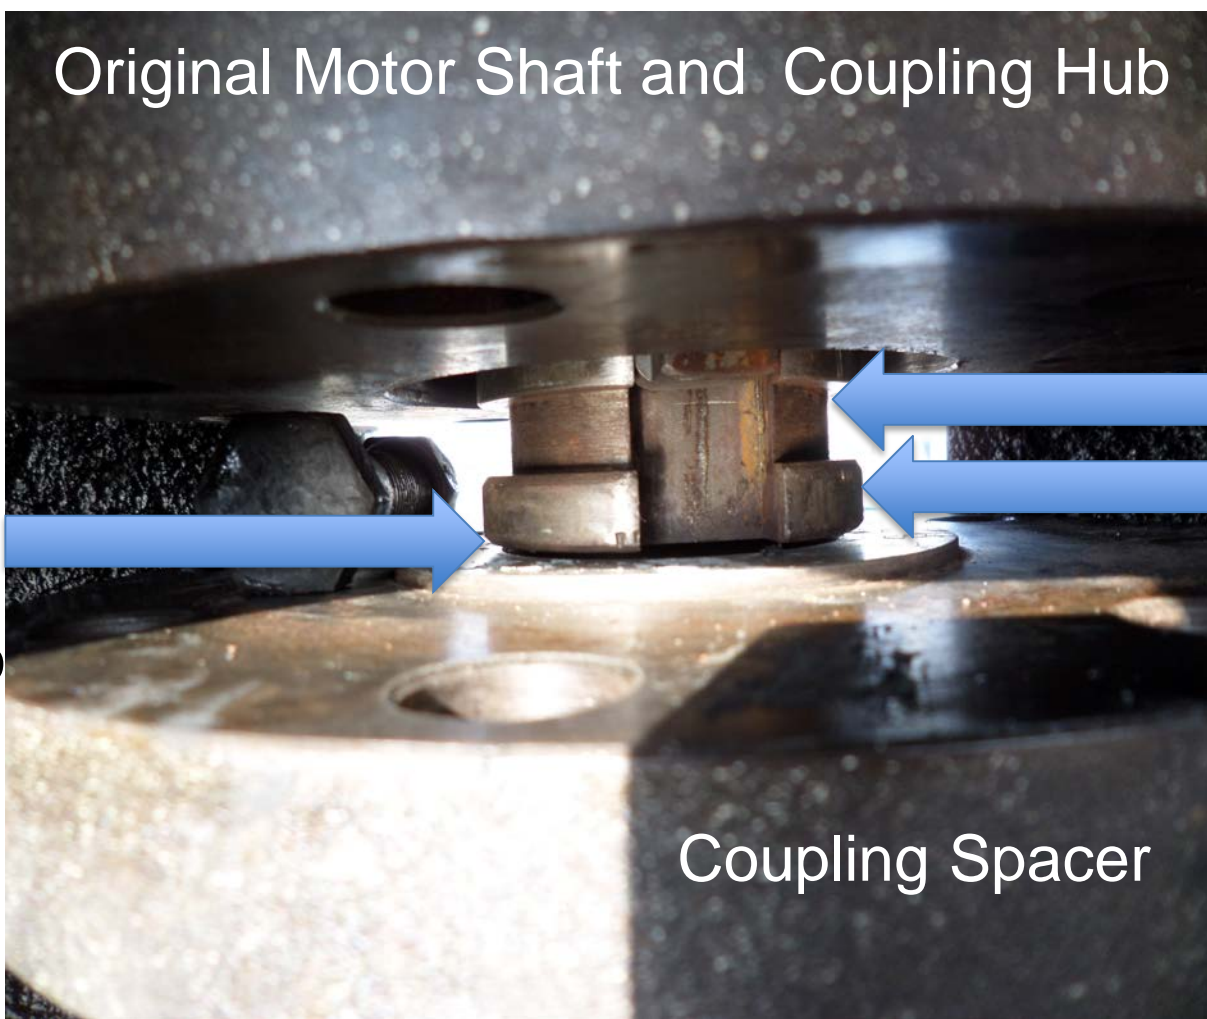
Original Motor Shaft and Coupling Hub

ID and OD
difference
transfers
up thrust to
motor

Location for
Split Ring
Motor Shaft
