47TH TURBOMACHINERY & 34TH PUMP SYMPOSIA
HOUSTON, TEXAS | SEPTEMBER 17-20, 2018
GEORGE R. BROWN CONVENTION CENTER

Investigation and Resolution of Governing Valve Linkage Failure for Compressor Drive Steam Turbine

Kenichi Nishiyama – MCO
Mayank Jain – MCO
Elumalai Subramani – ExxonMobil

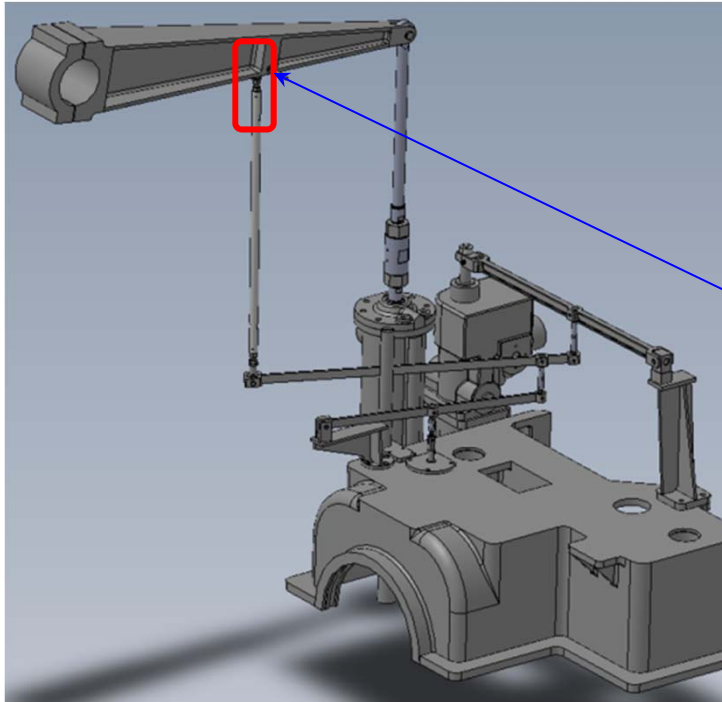
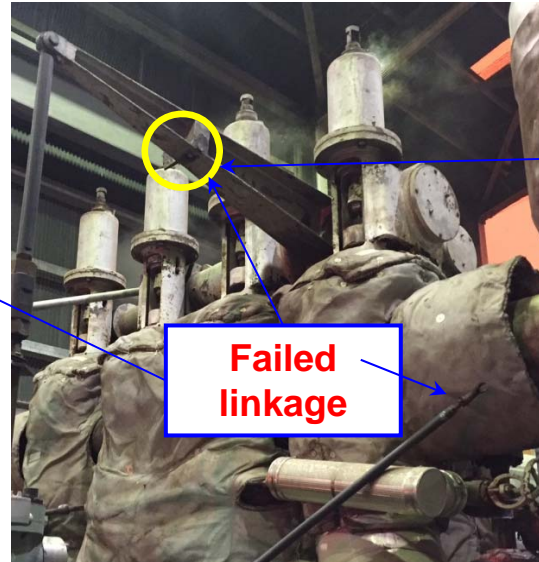
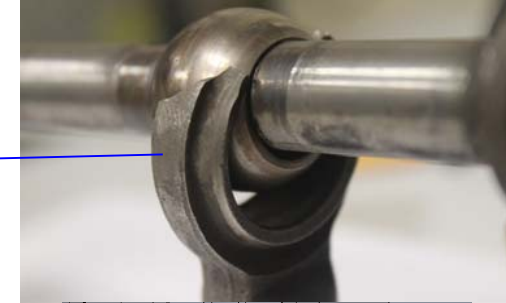
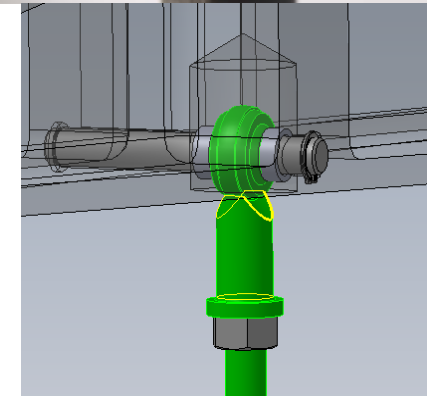
The rod end bearing failure occurred in 2017 after the Turbine had been in operation for 9 years.

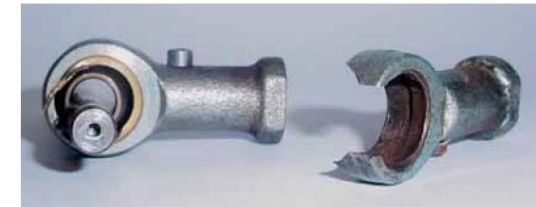
Similar trouble had happened around 2006 in other plants. Countermeasure → Bearing size up from M8 to M16

This turbine reconfigured the bearing size to M16 in 2008.
→ The M16 bearing failed in 2017 after 9 years of operation.

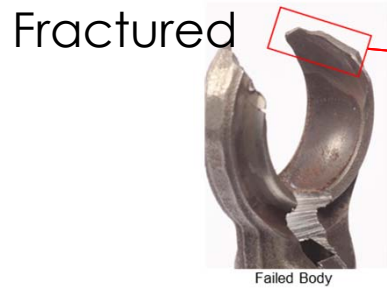
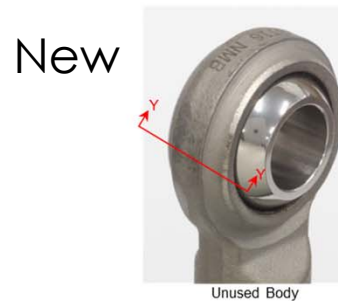
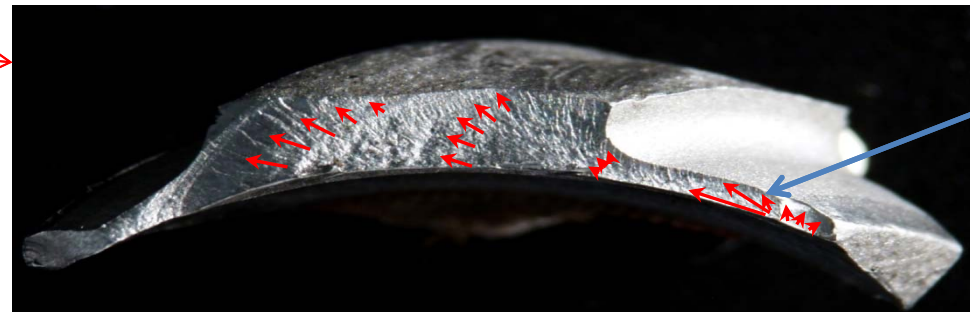
1mm
remains

Worn out thickness was roughly 2mm and striation pattern was observed which helped us identify high cycle fatigue fracture .

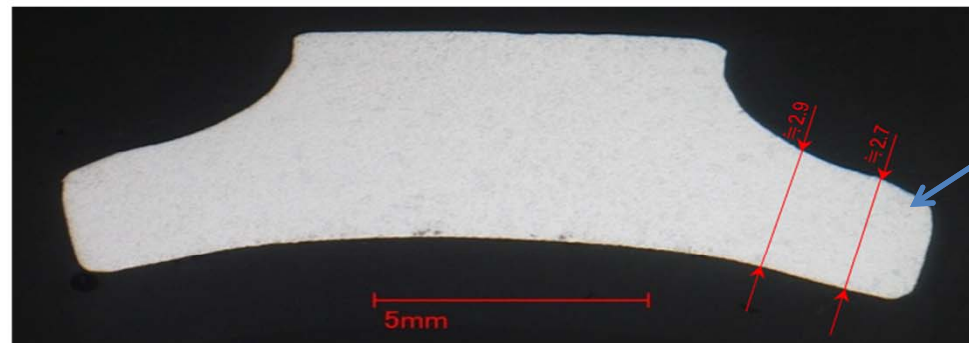
Y-Y cross section

Approx.
3mm

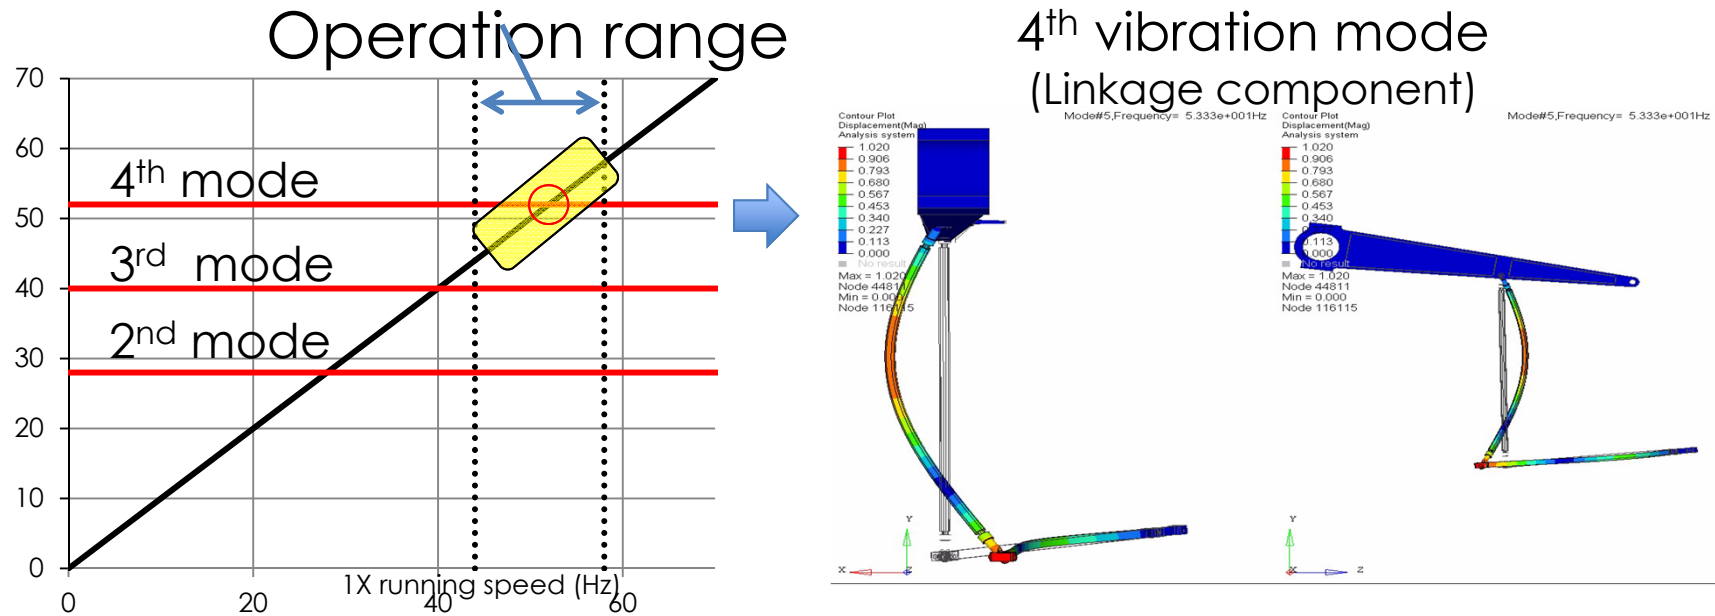
Fatigue fracture pattern and vibration analysis indicated that the 4th resonance mode falls in the Turbine operation range.

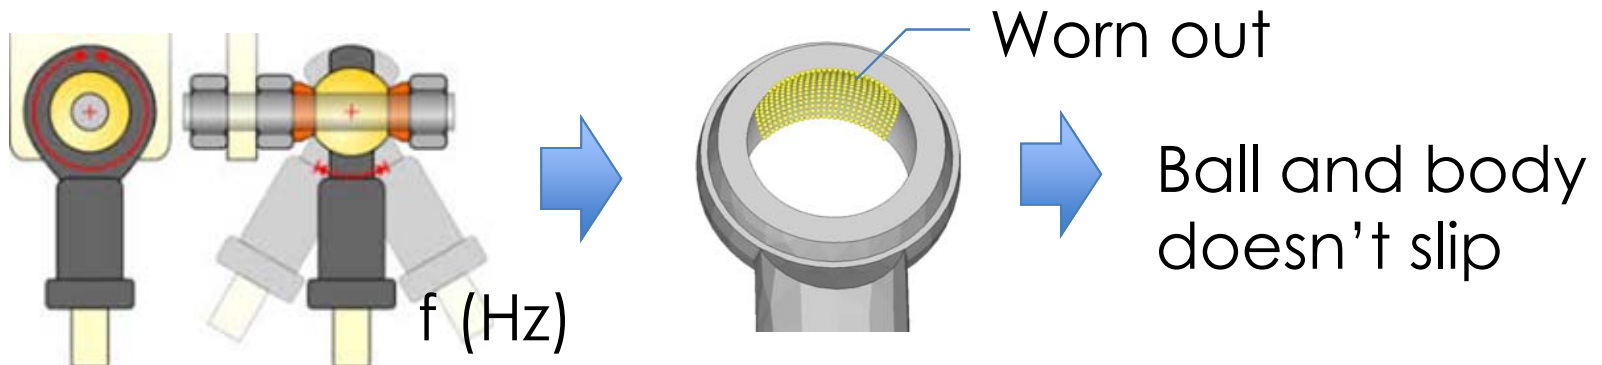
- PTFE liner wore out due to resonance vibration (4th mode).

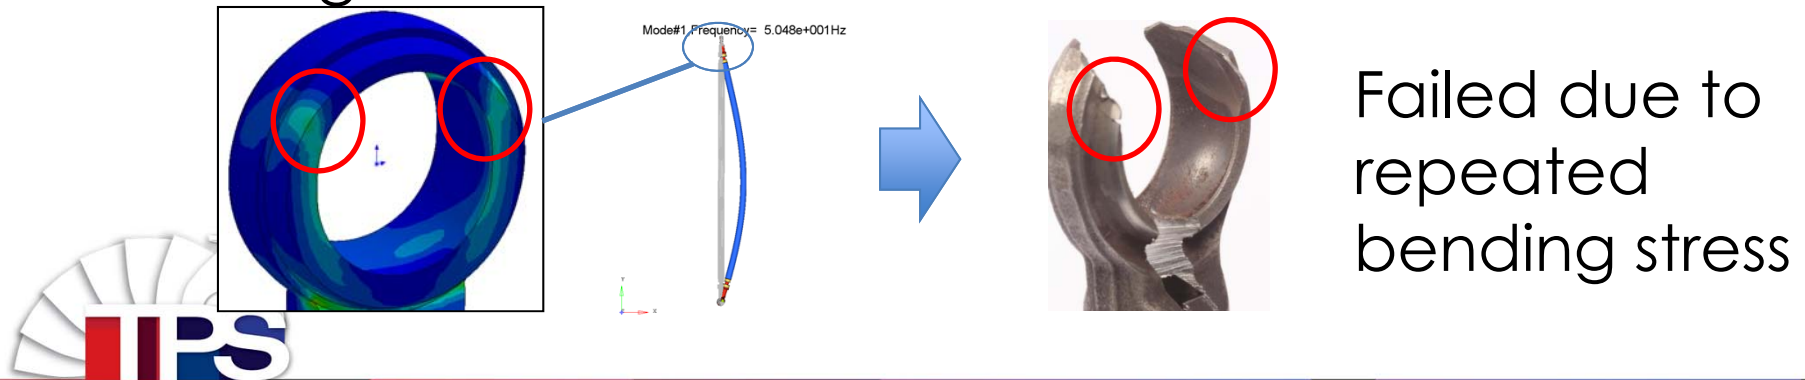
- Bending stress occurred due to resonance vibration.

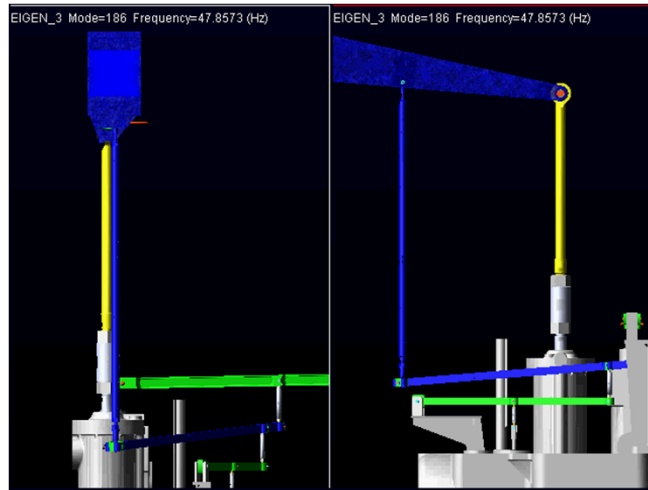
(4th mode : 51.6Hz)
Resonance mode

MAX.	3498 r.p.m
NOR.	3331 r.p.m
MIN.	2665 r.p.m

Slip velocity (5.6 mm/sec),
Lh = 16,644 hr (1.9 years)

Under resonance condition, PTFE liner will wear out within 1.9 years of operation.

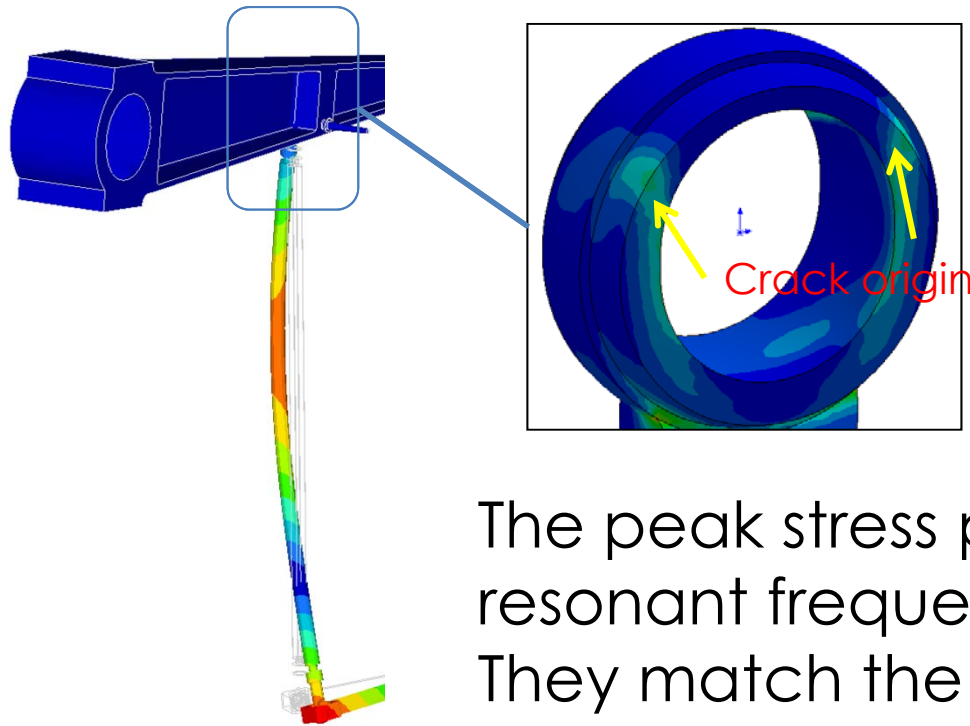
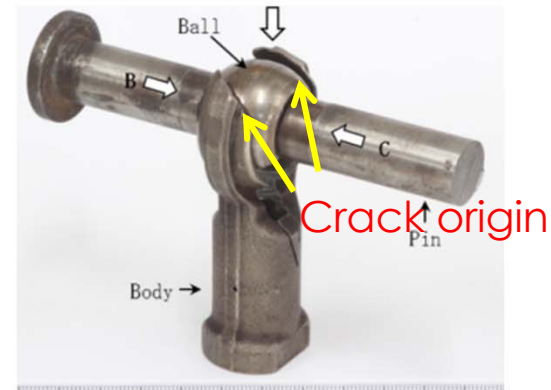
The peak stress points due to vibration at resonant frequency was found using FEA. They match the crack origin point of the failed bearing.

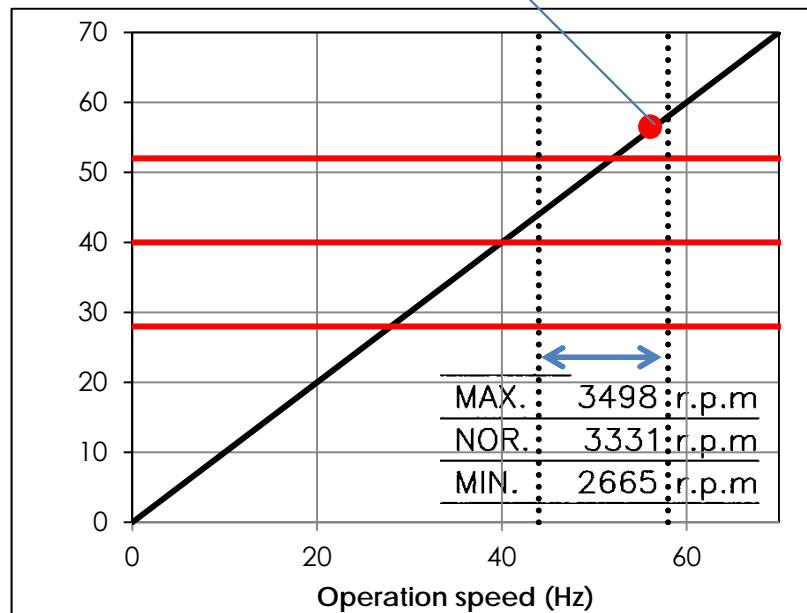
Current operation

As a result of modification (Plan 1), turbine operation speed is far away from the resonance frequency. No issues experienced after the maintenance.
