TURBOMACHINERY
& PUMP SYMPOSIA

Analysis and troubleshooting of a piston rod failure of RC

Sanghun Lee / Jinseok Yang

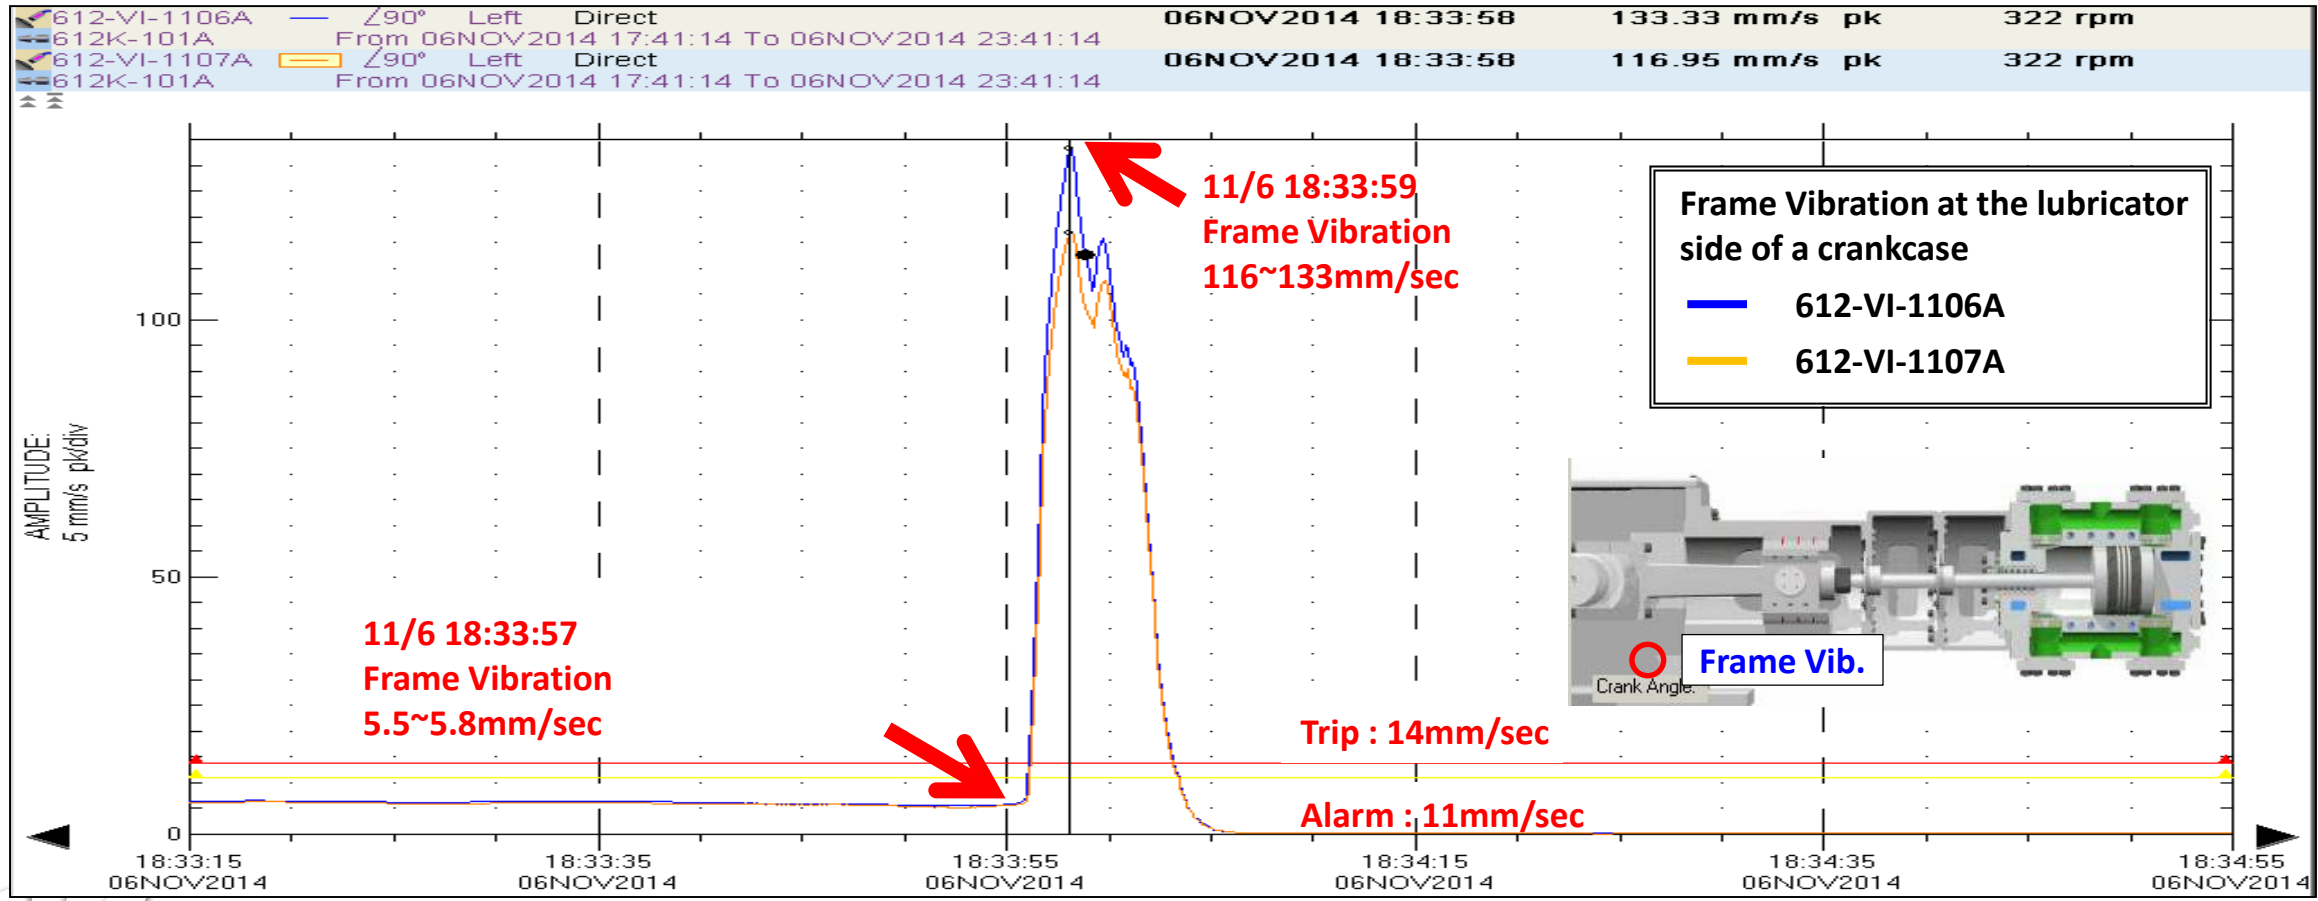
The compressor tripped due to high vibration(133mm/s) in 128 days after overhaul. It normally operated at about 5.5m/s of frame vibration and there was no indication just before the event. * Alarm : 11mm/s, Trip : 14mm/s

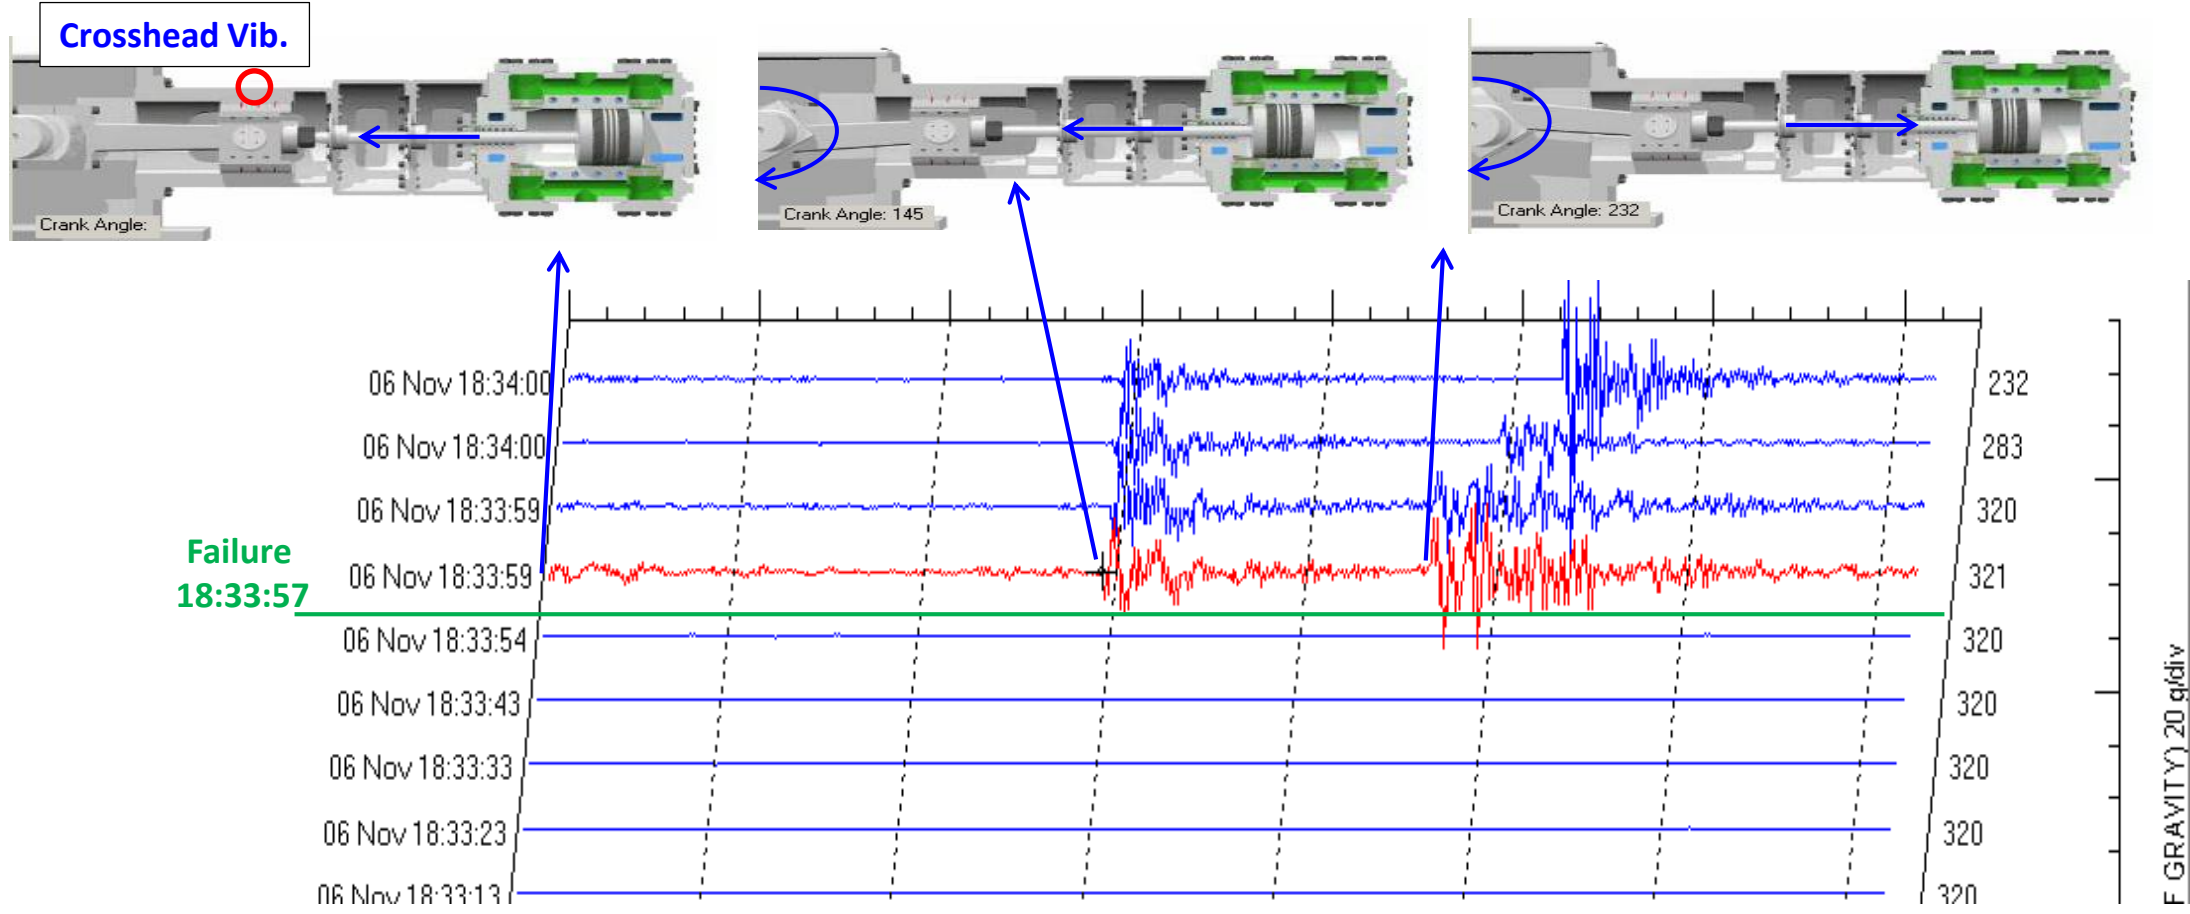
A crosshead vibration also increased suddenly from normal 0.5G to 56G after failure.

* Alarm : 1.5G, Trip : null

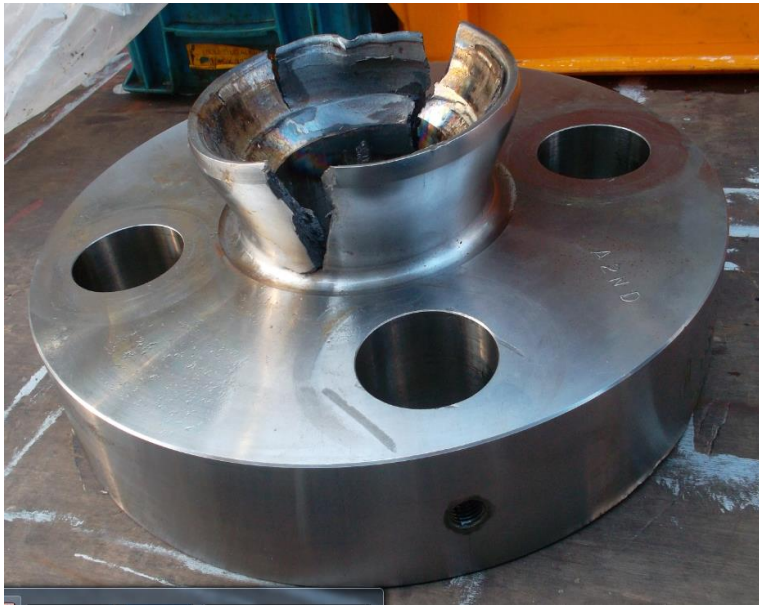
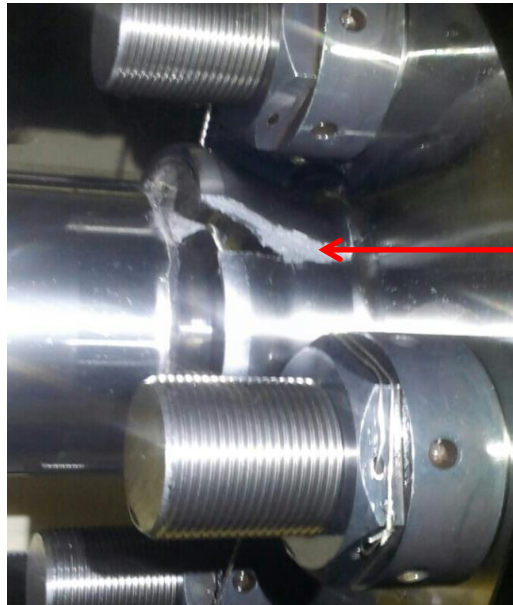
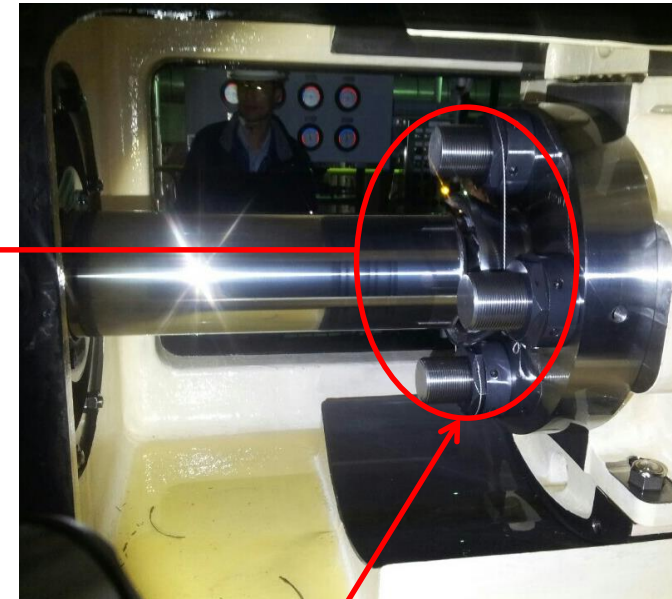
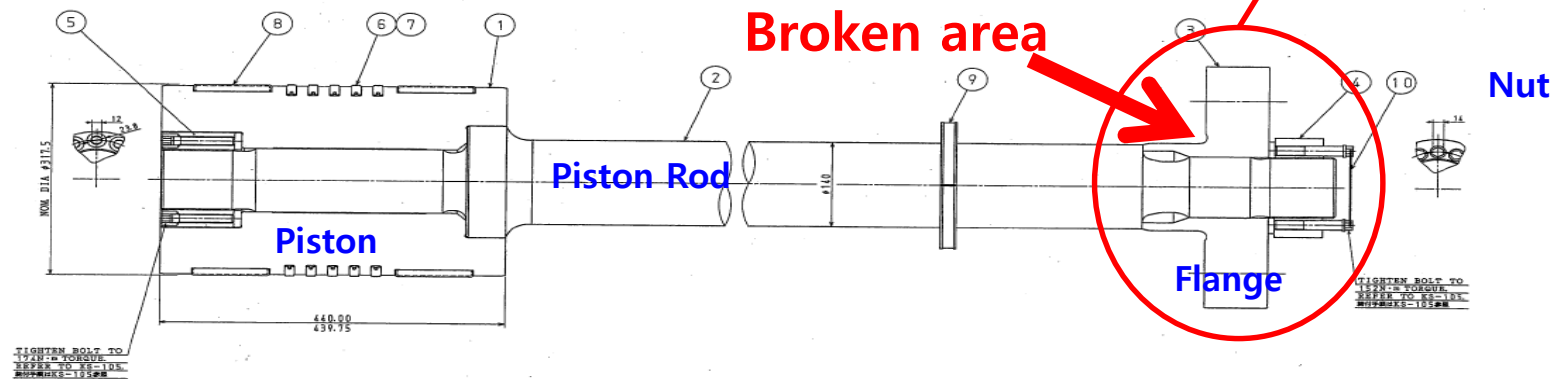
Severely damaged piston rod connecting flange

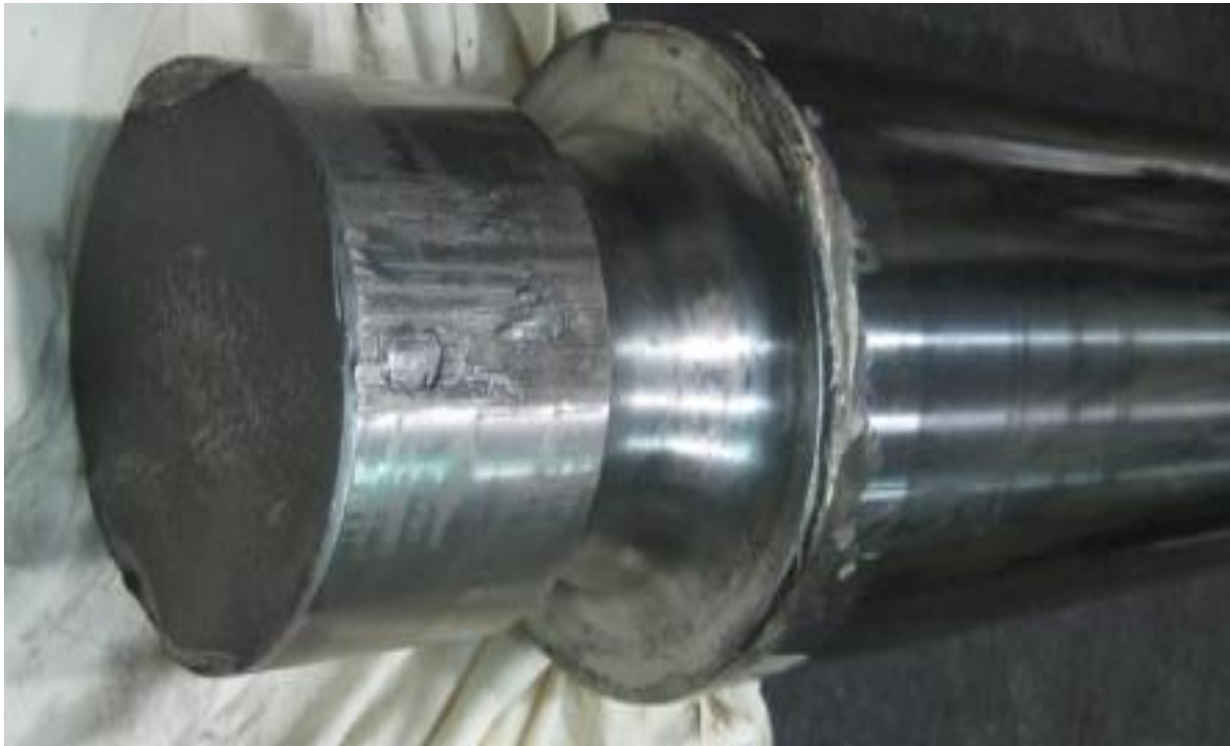
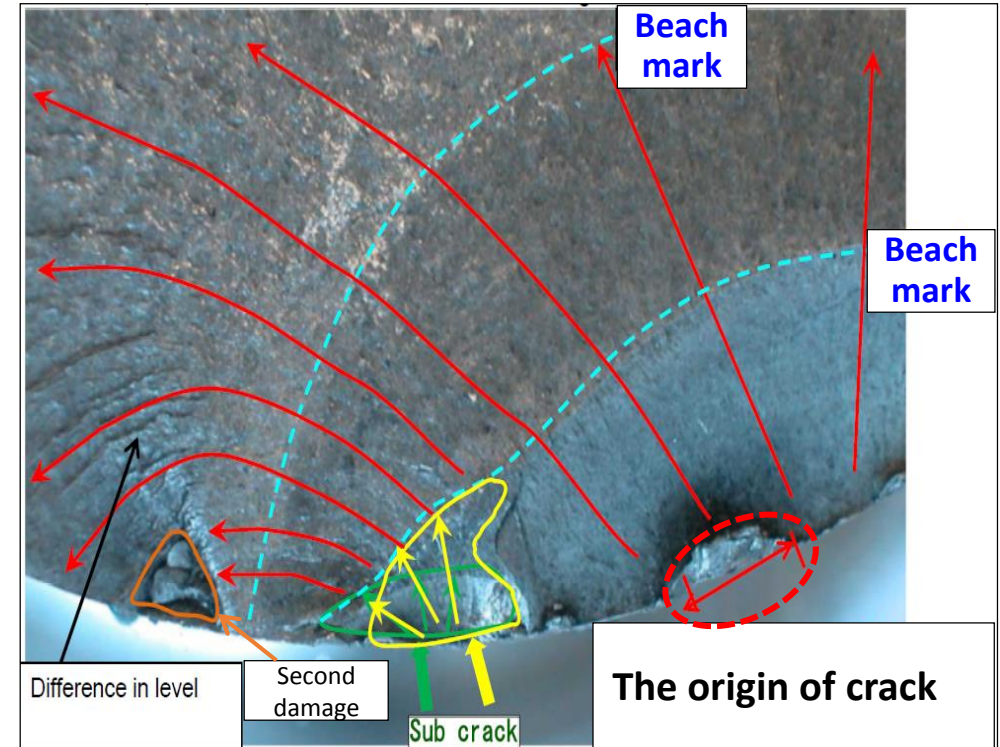
Piston rod broke due to excessive stress and fatigue. There is a beach mark which is the typical fatigue failure on fracture surface. The origin of the crack is located in the center of the arc.

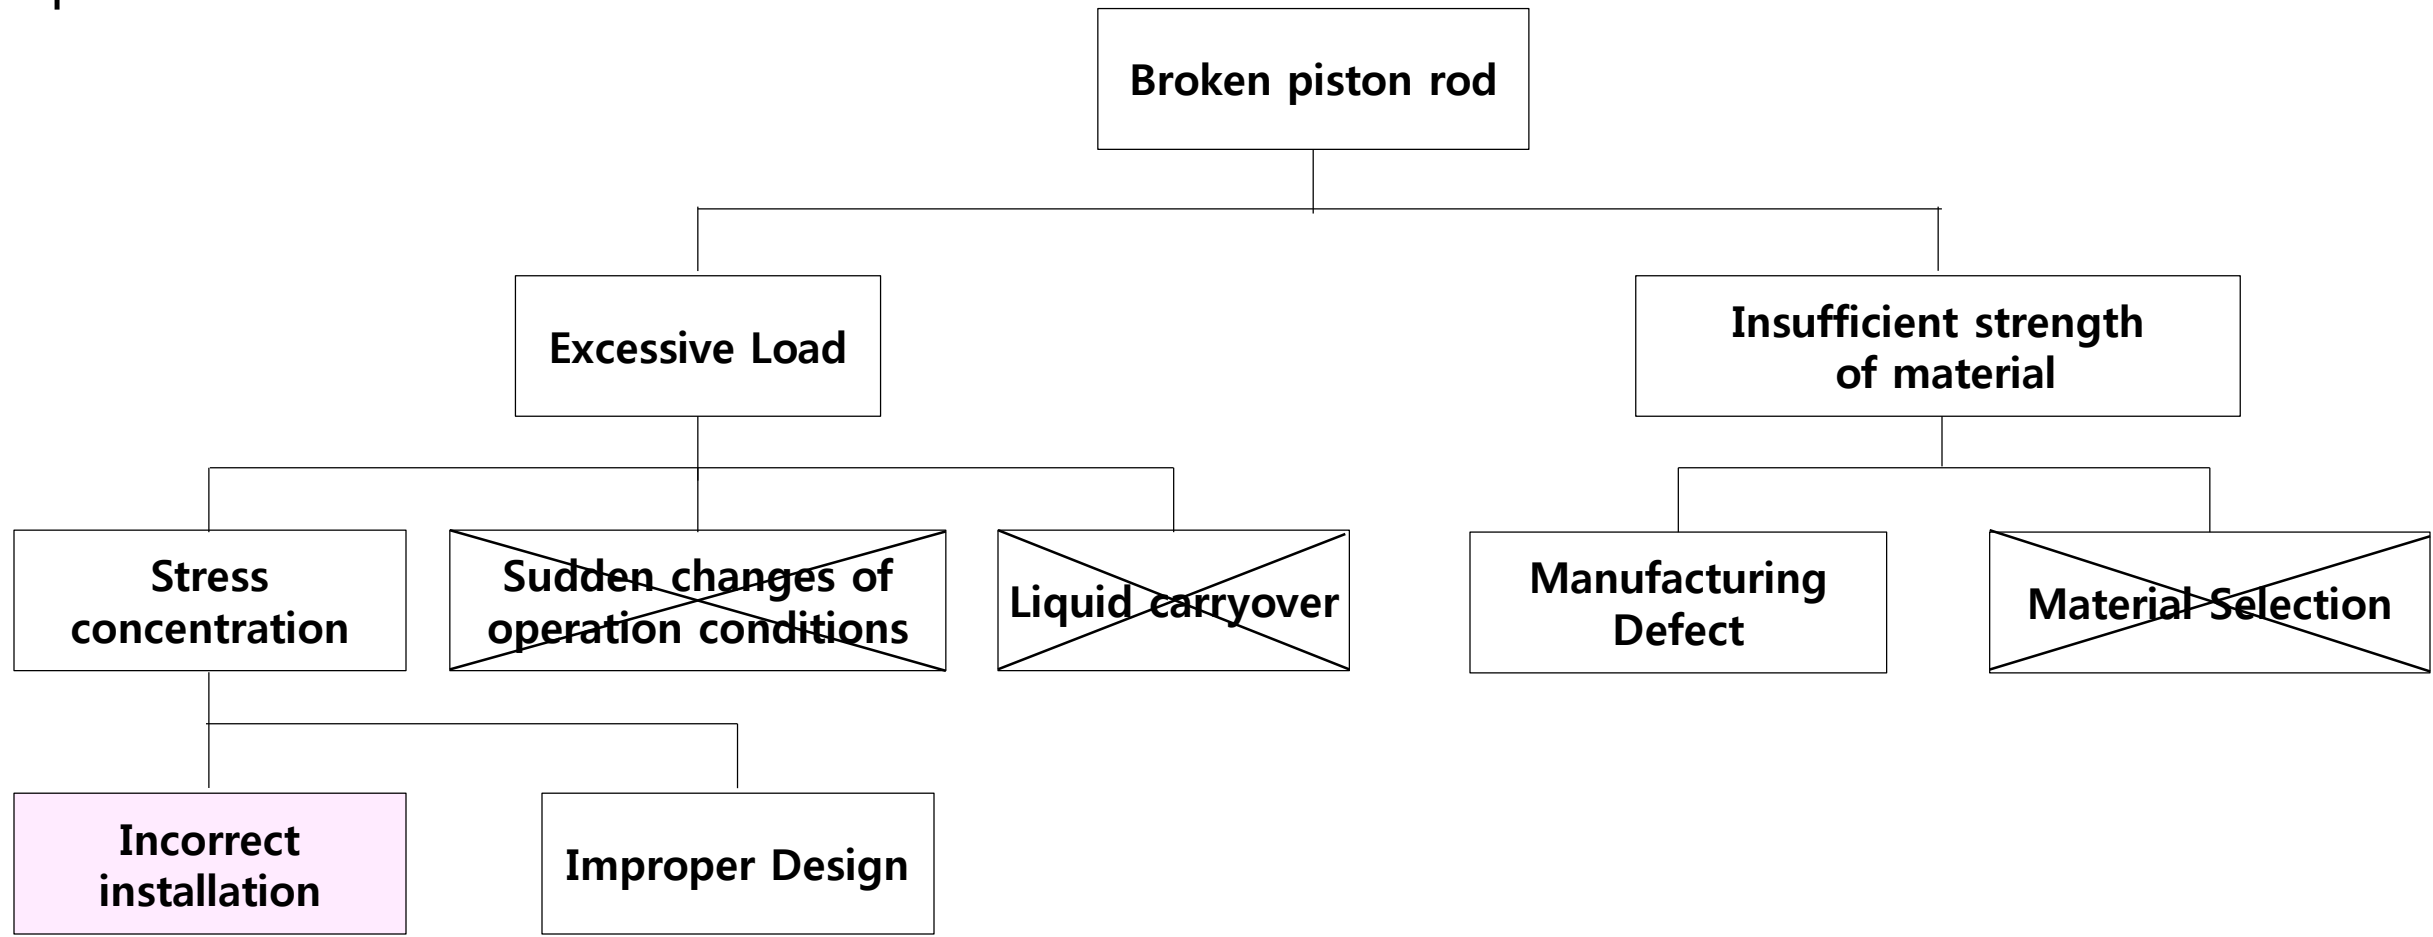
Performed RCA with OEM through "Why trees" and derived and validated all possible root causes

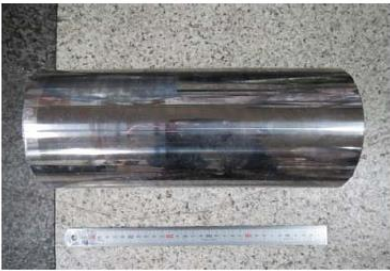
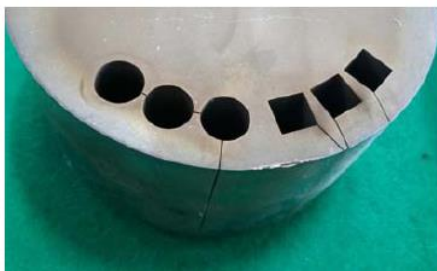
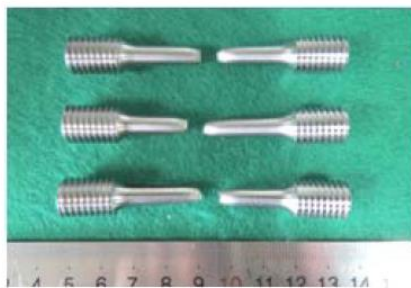
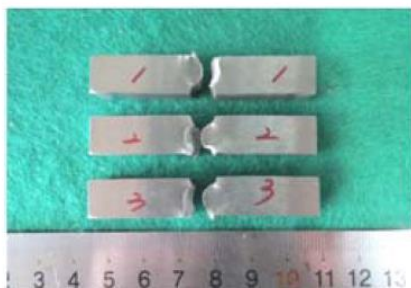
Destructive testing performed to verify the mechanical properties of the material, and to confirm that all samples met the ASTM standard.

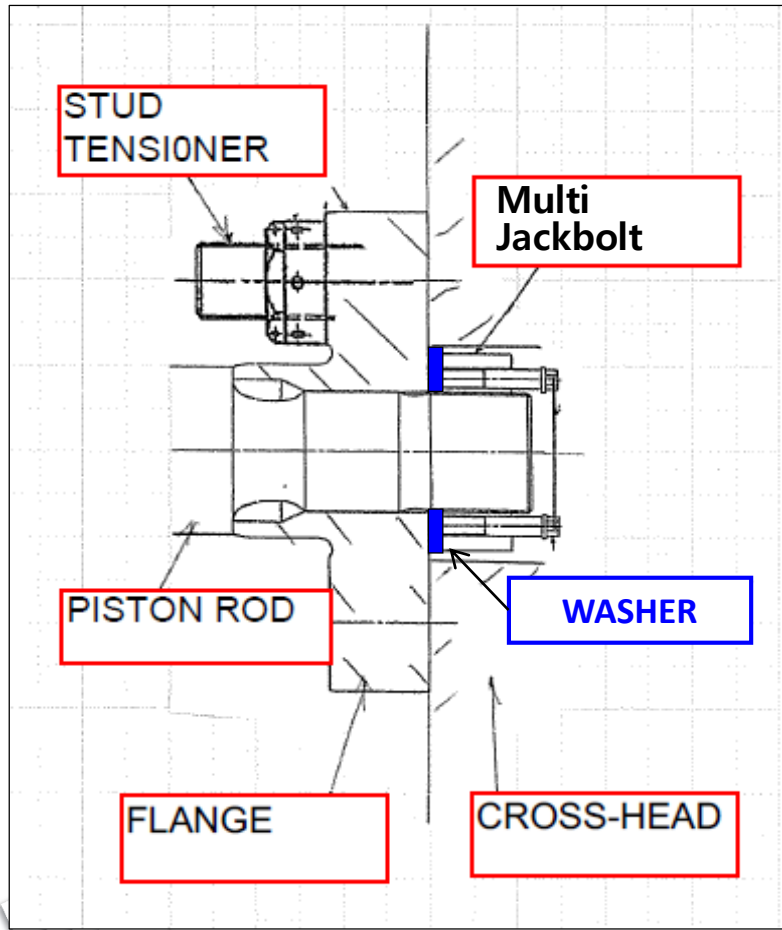
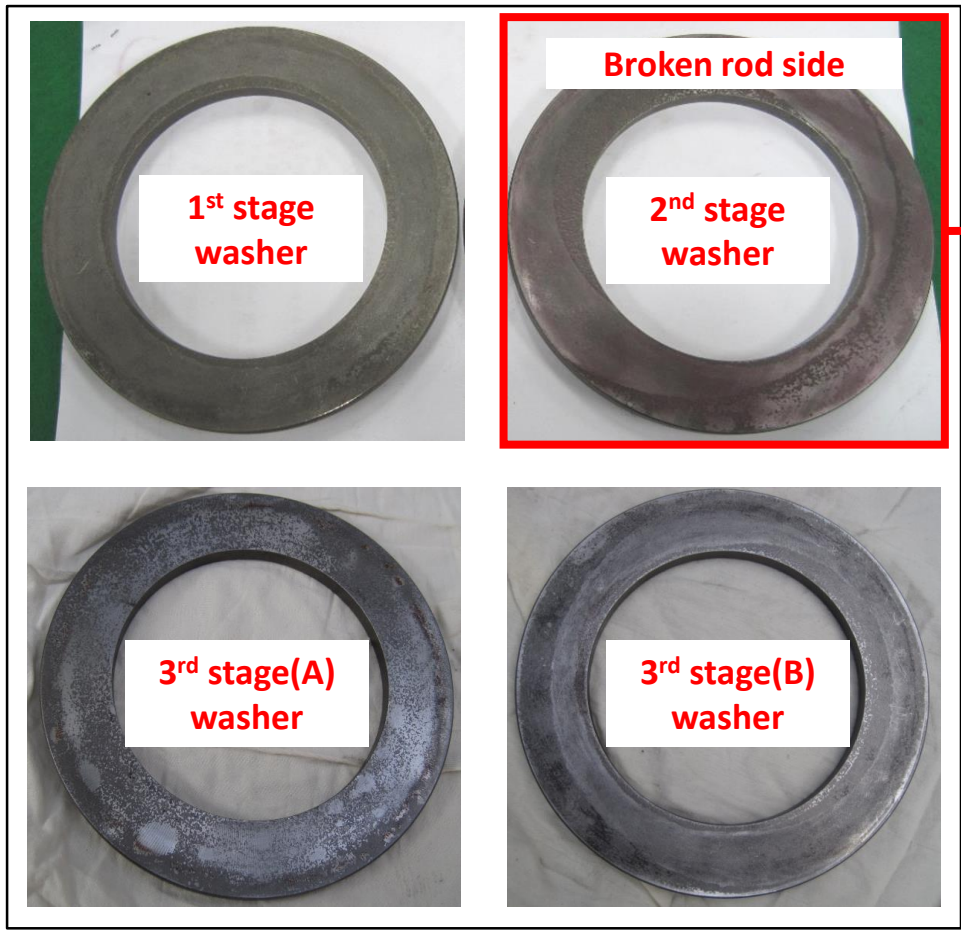
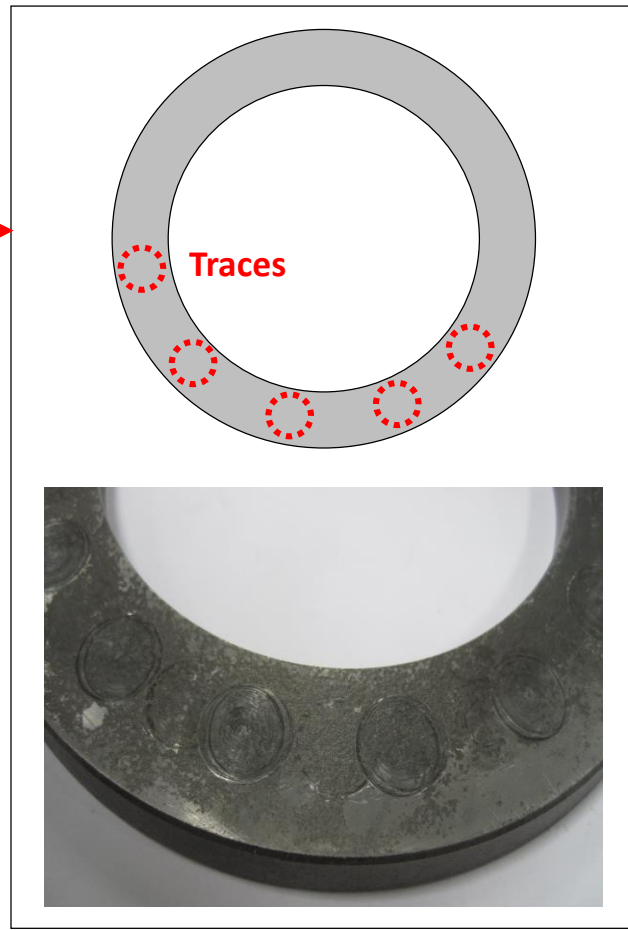
The investigation team found traces of non-uniform force applied to the washer of the 2nd cylinder. Fortunately, there were no traces in other cylinders except the broken one. Did further investigation to determine the cause of the non-uniform forces.

For assembling the piston nut with the same torque, the maintenance procedure improved as follows.

- 1) When assembling the piston rod nut, tighten the multi jackbolts 4 times by increasing the torque sequentially.(5%, 30%, 60%, 100%)
- 2) Check the clearance between flange and piston rod nut at every step, and adjust so that it is less than 0.1mm.
- 3) Train maintenance workers on the proper procedure to assemble the multi jackbolt tensioner.

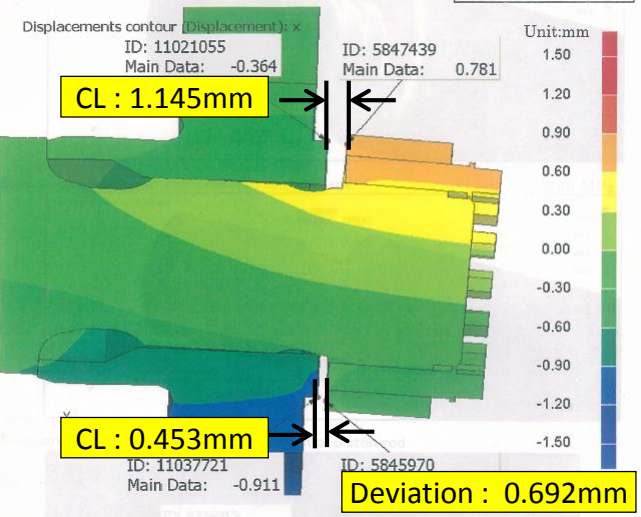
Case 2 : 0.7mm inclination

Confirmed through FEM analysis that if there is a 0.7mm of inclination between a flange and a washer, the stress concentration(68.3MPa) above the allowable stress occurs at the piston rod. (Maximum allowable stress: 68.1 MPa)

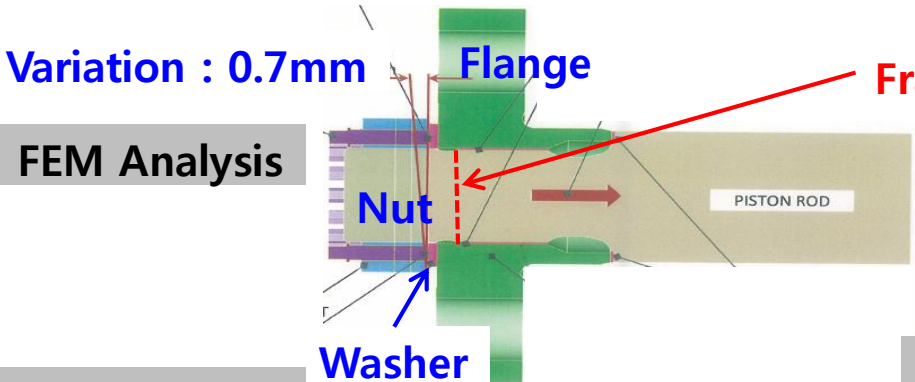
It means the rod may break if the inclination is greater than 0.7mm during assembly.
