Measured Seepage Losses of Canal 6.0 La Feria Irrigation District – Cameron County No. 3

April 2011

Texas Water Resources Institute Technical Report No. 373
Texas A&M University System
College Station, Texas 77843-2118

**MEASURED SEEPAGE LOSSES OF CANAL 6.0
LA FERIA IRRIGATION DISTRICT-CAMERON
COUNTY NO.3**

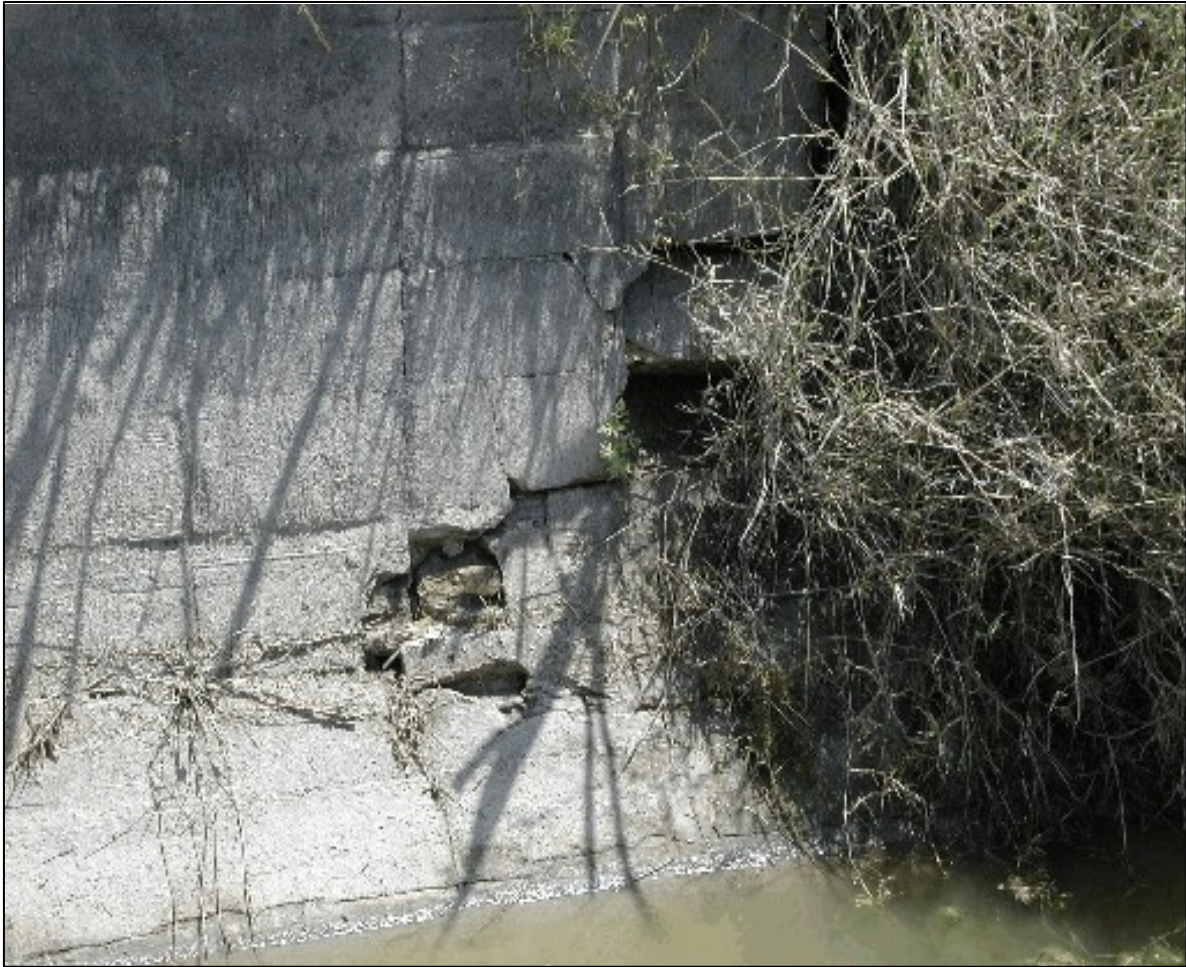
The south segment had approximately six large holes in the canal similar to the one shown in Figure 2. This is likely the reason that the south segments seepage rate is over twice that of the north segment.

Figure 2. One of six large holes observed in the brick/concrete lining of the south test segment of Canal 6.0.

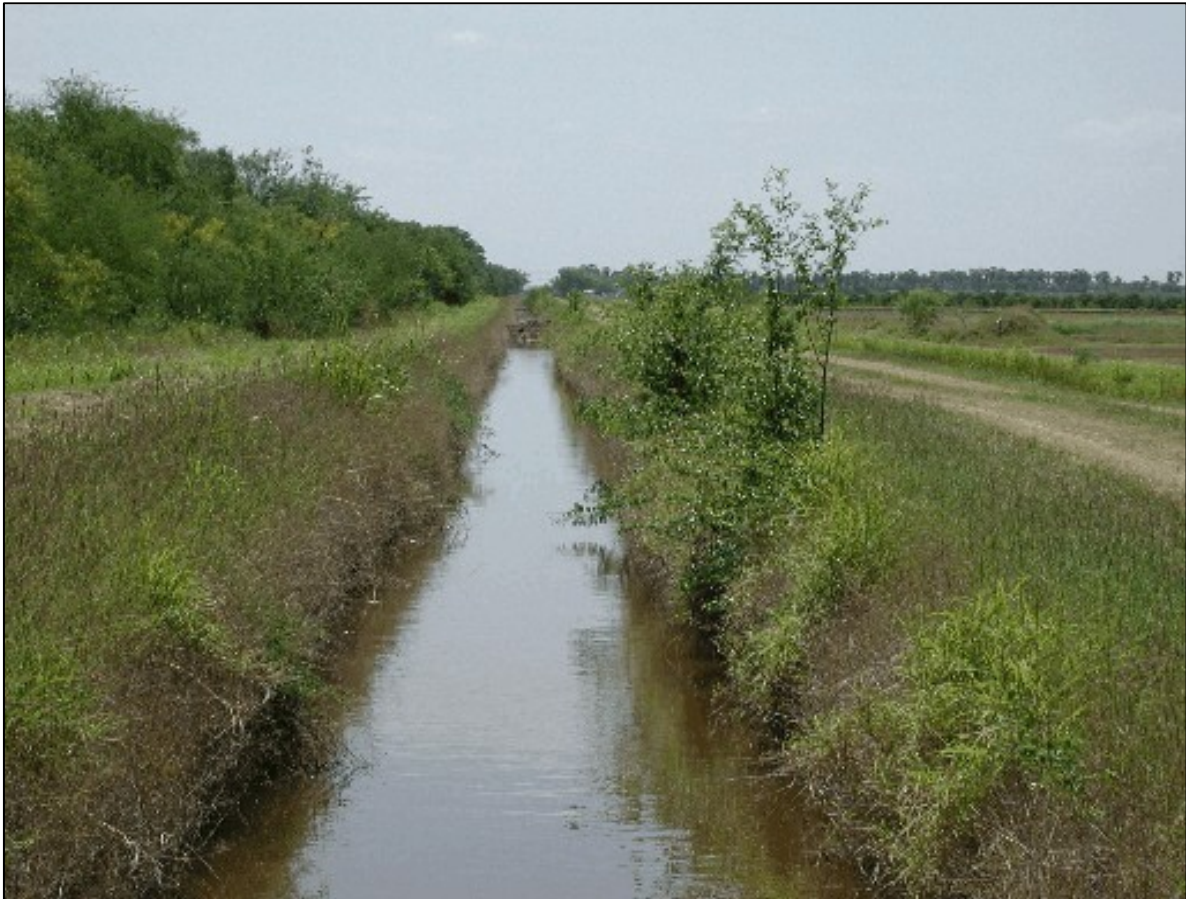
Figure 3. Canal 6.0 - North

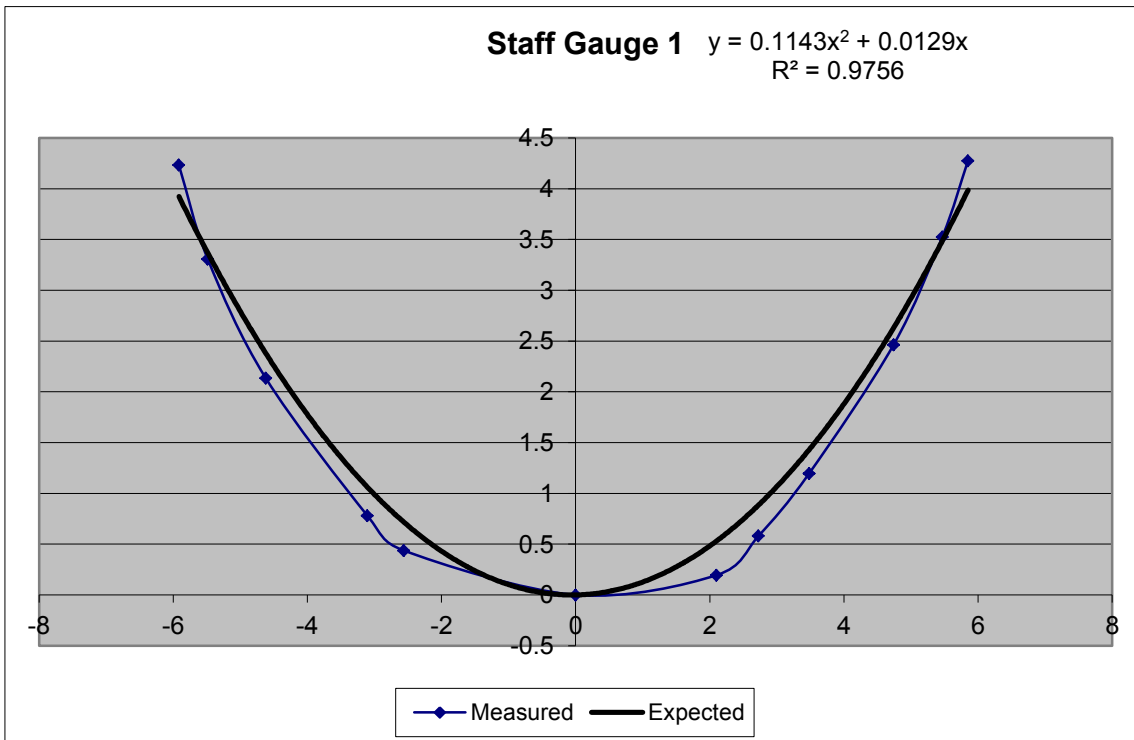
Figure 4. Cross-section of Staff Gauge 1 of Canal 6.0 - North.

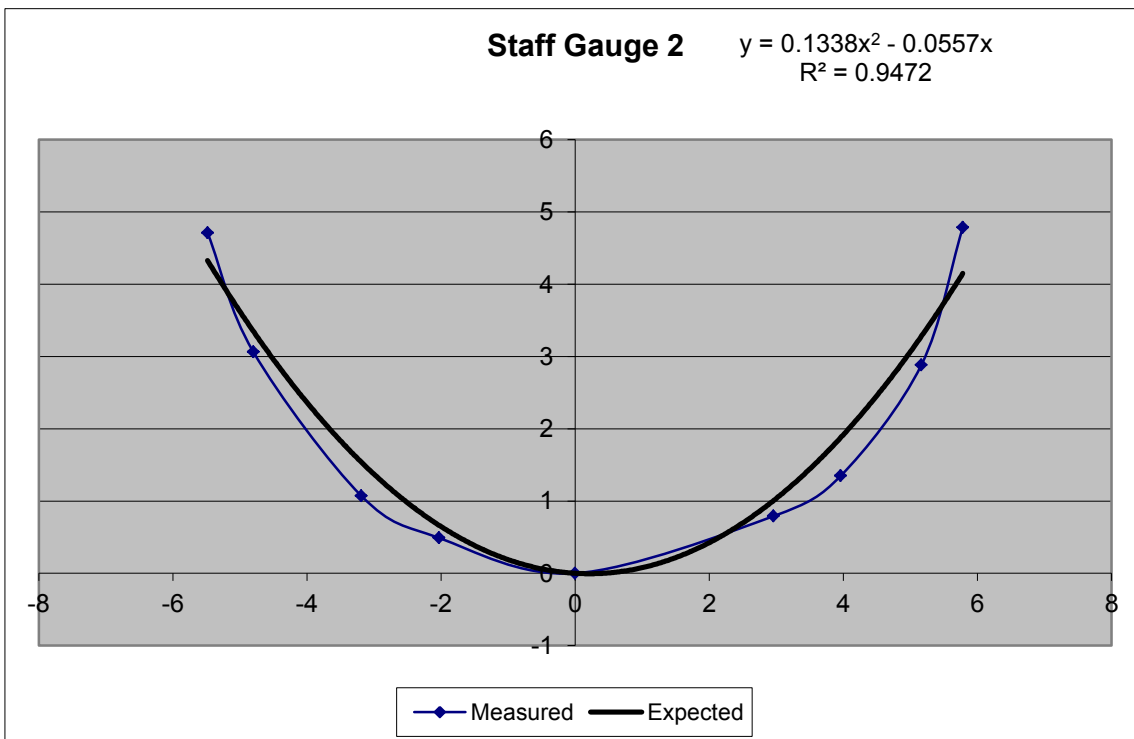
Figure 5. Cross-section of Staff Gauge 2 of Canal 6.0 - North.

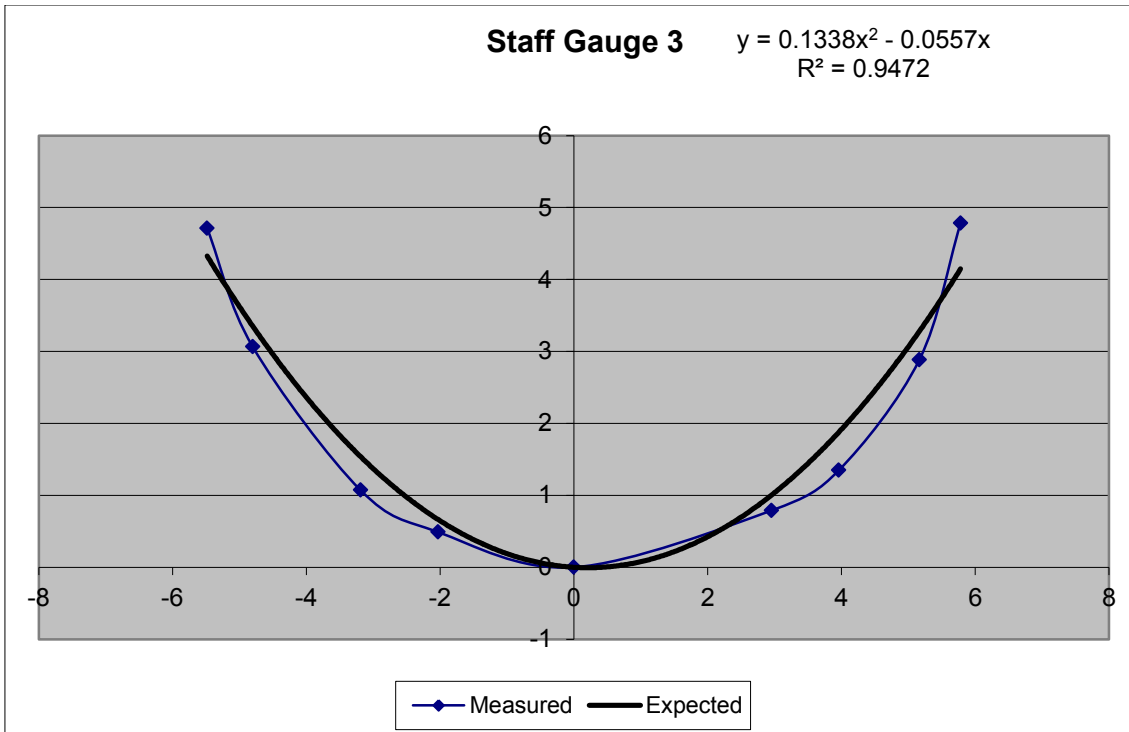
Figure 6. Cross-section of Staff Gauge 3 of Canal 6.0 - South.

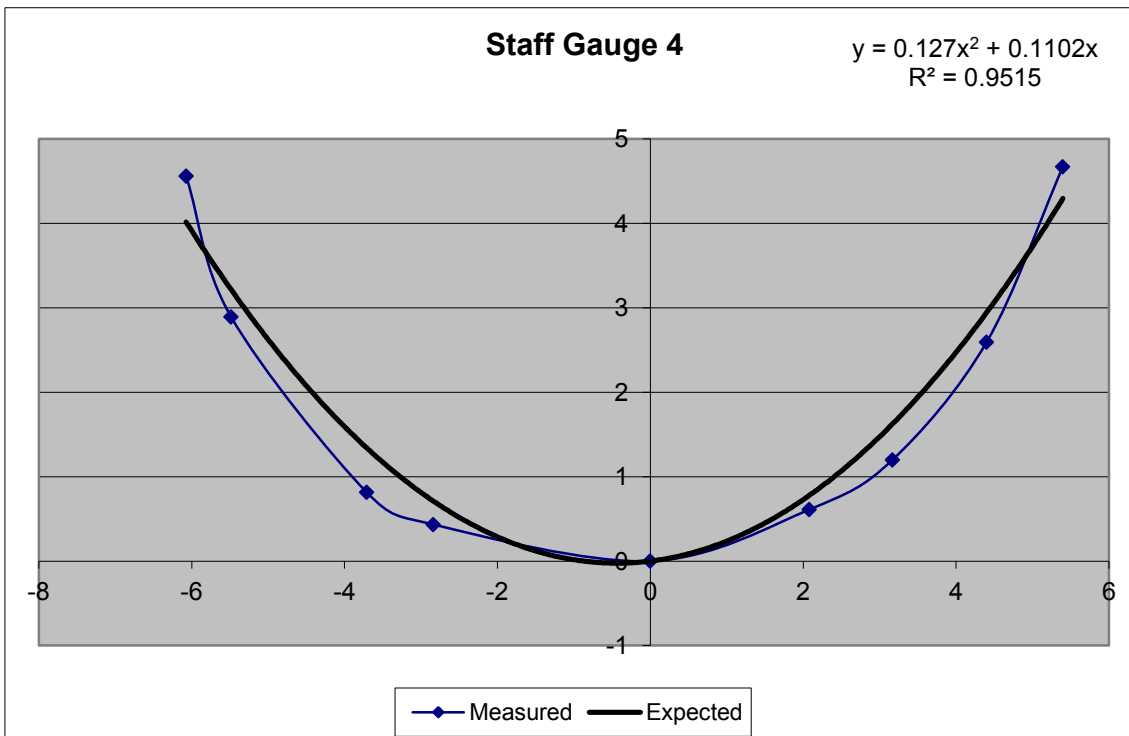
Figure 7. Cross-section of Staff Gauge 4 of Canal 6.0 - South.

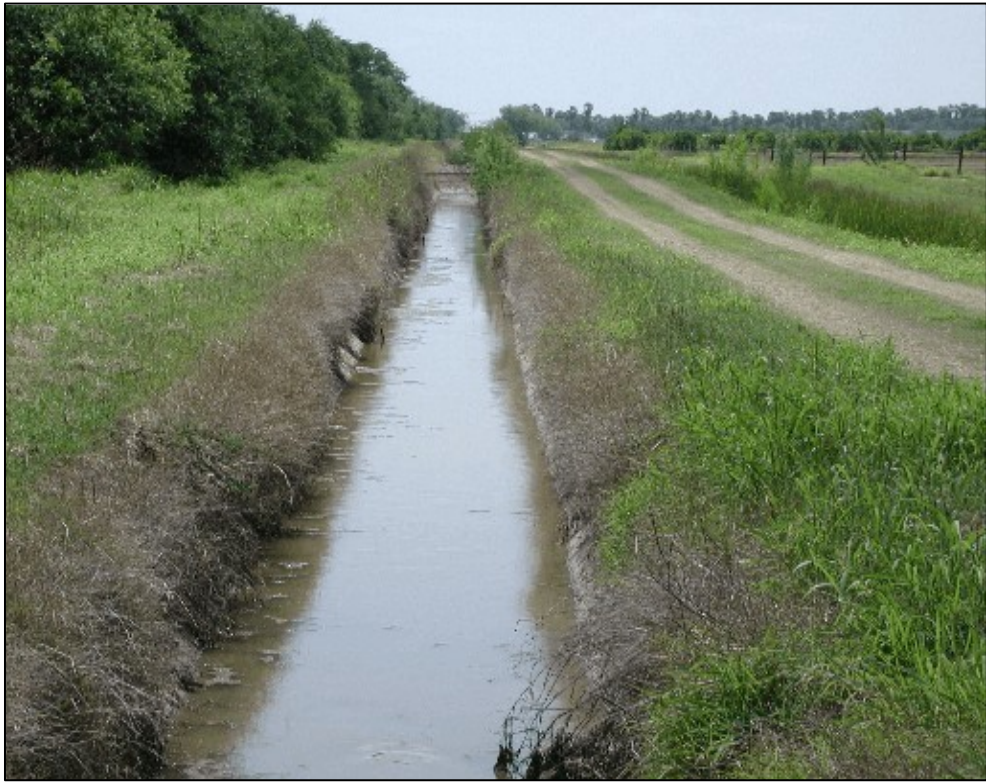
Figure 8. Canal 6.0 - South

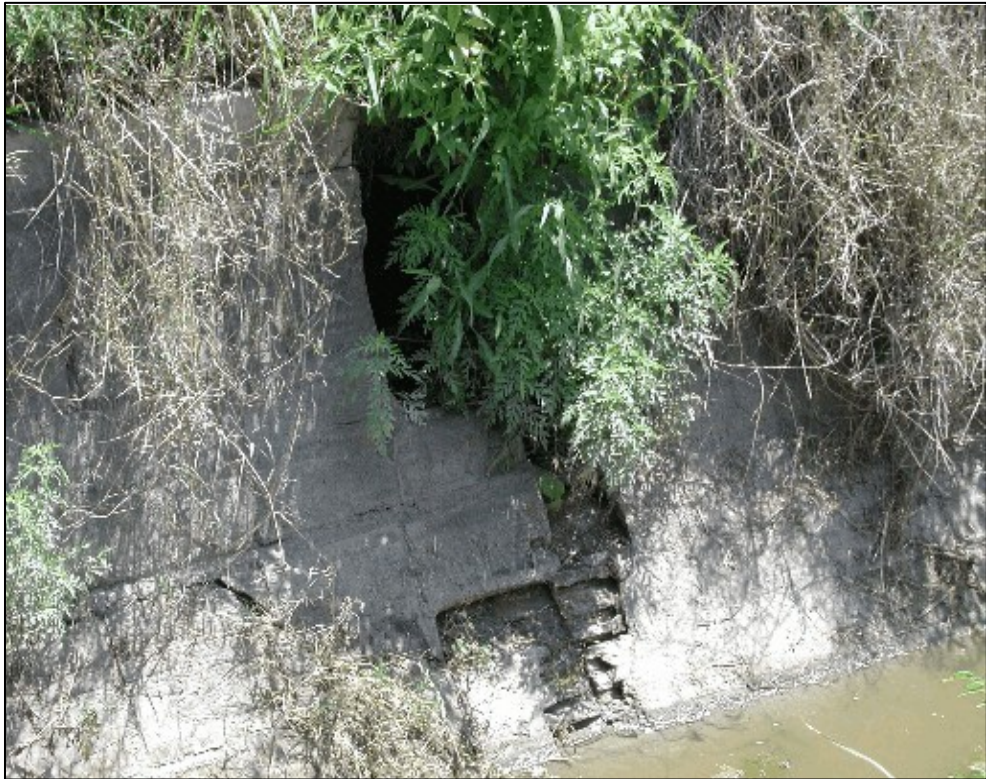
Figure 9. Large hole in the canal lining of Canal 6.0 - South1
