Documentation and Conditions Assessment of High Knoll Fort, St. Helena (CHC-2020-01-01)

**Report prepared for the British Napoleonic Bicentenary
Trust and St. Helena Government**

**Brent R. Fortenberry, Associate Director, Center for Heritage Conservation
Jane Ashburn, Architectural Conservator**

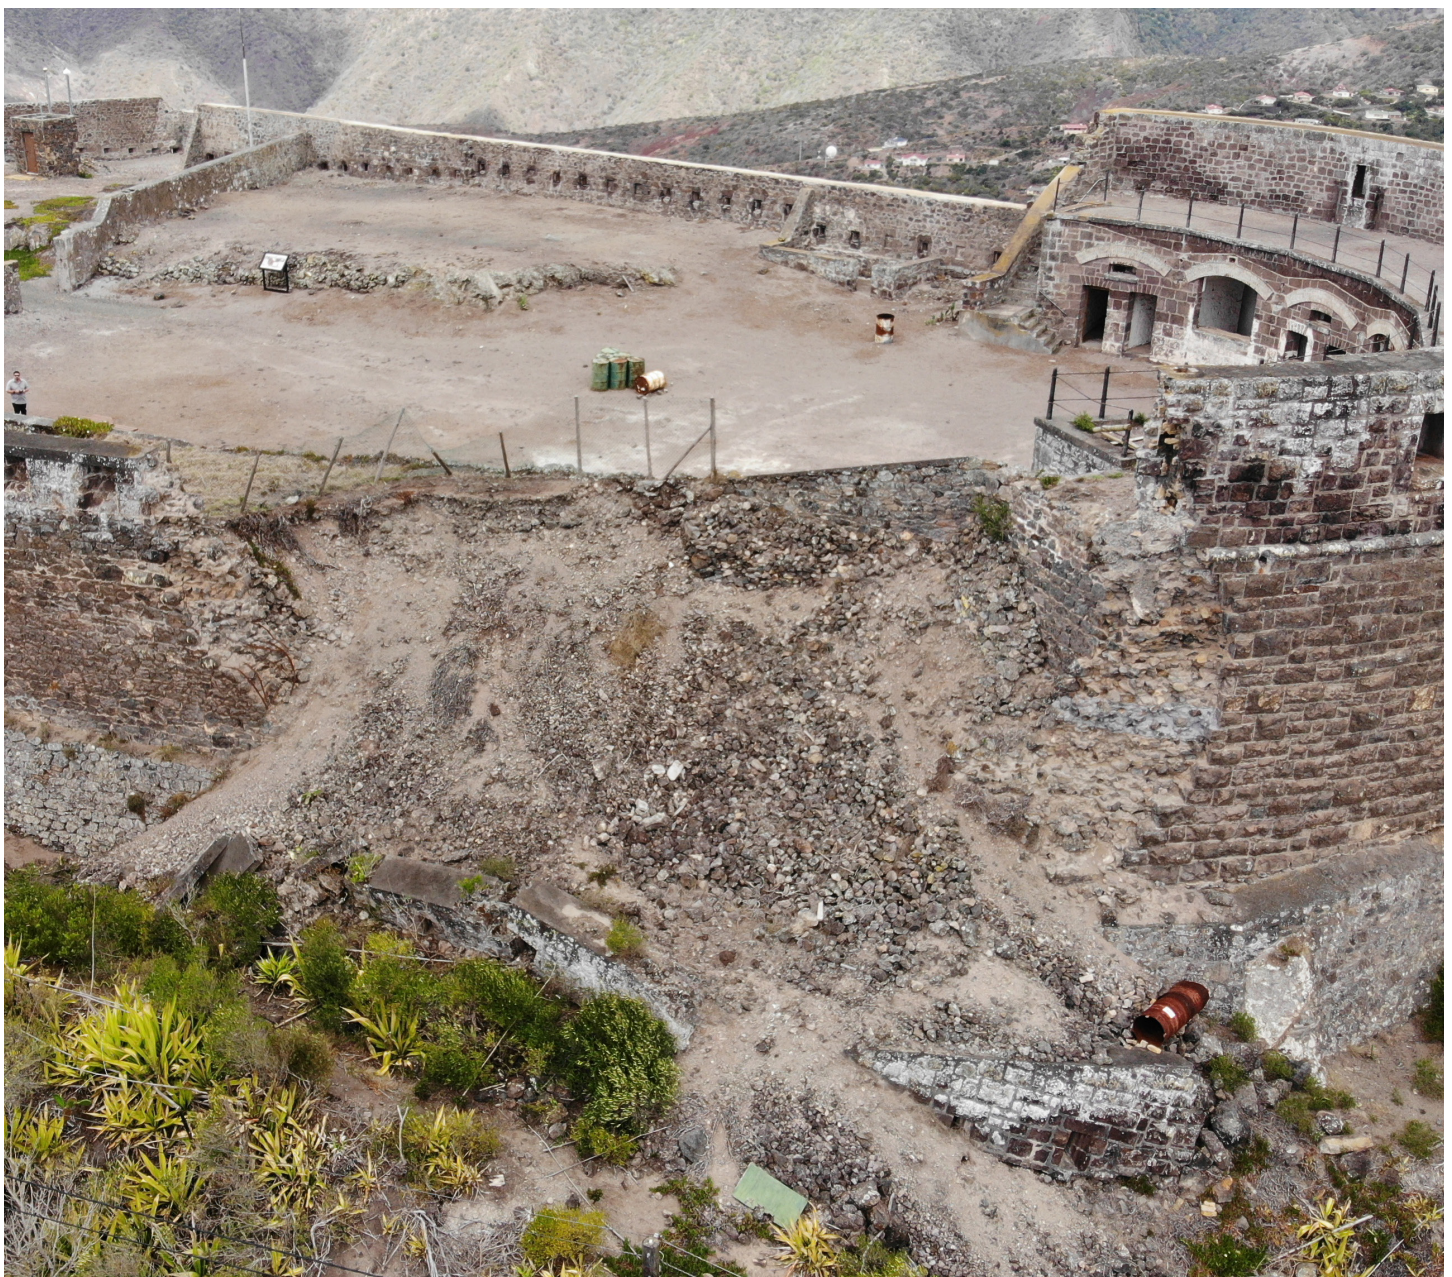
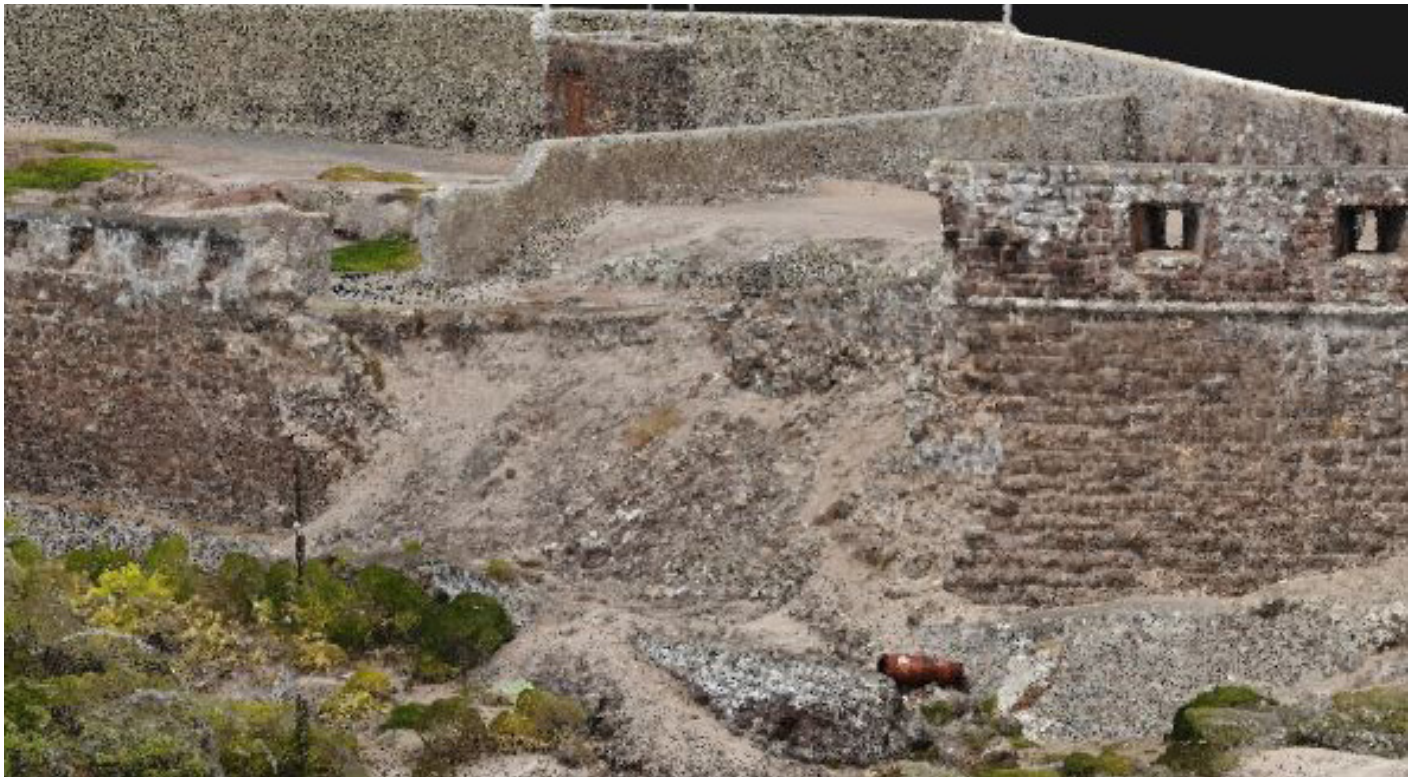
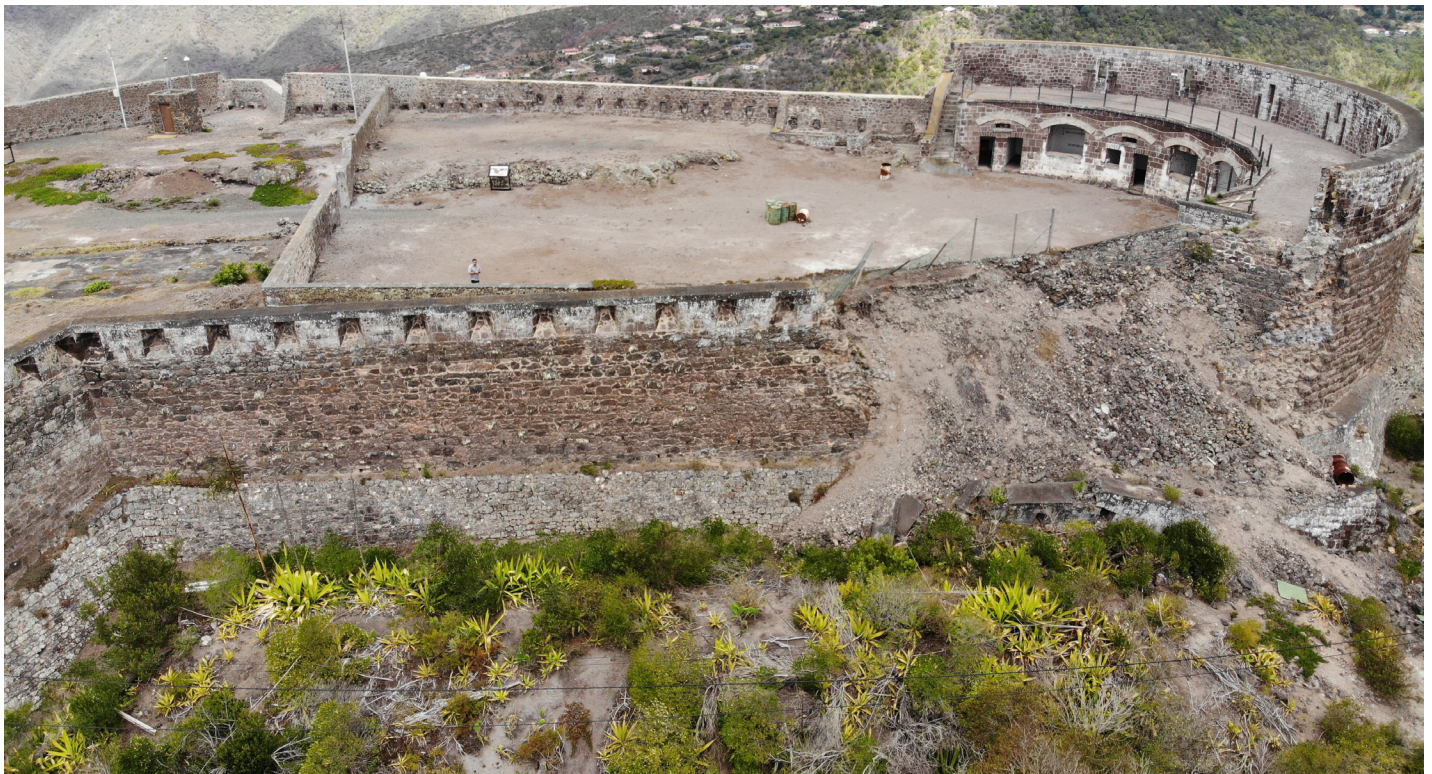
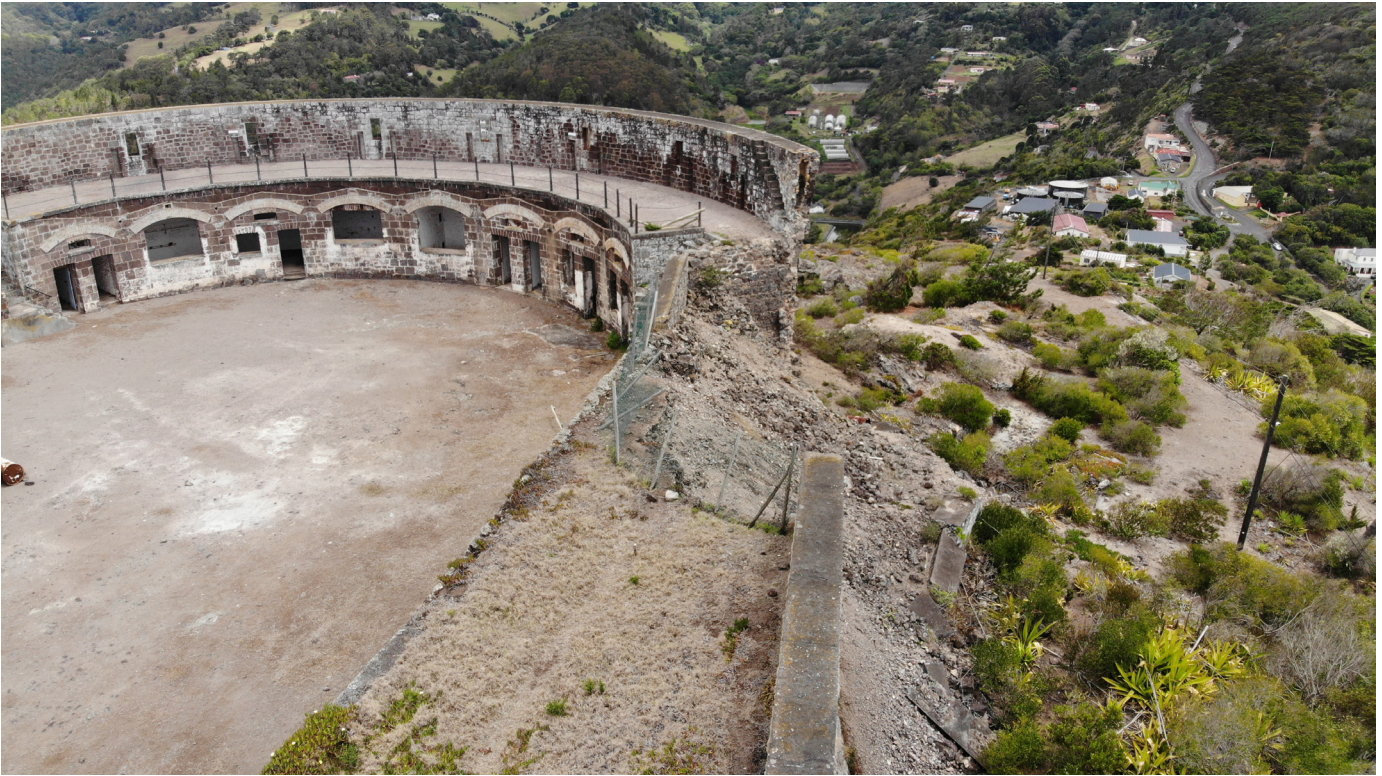
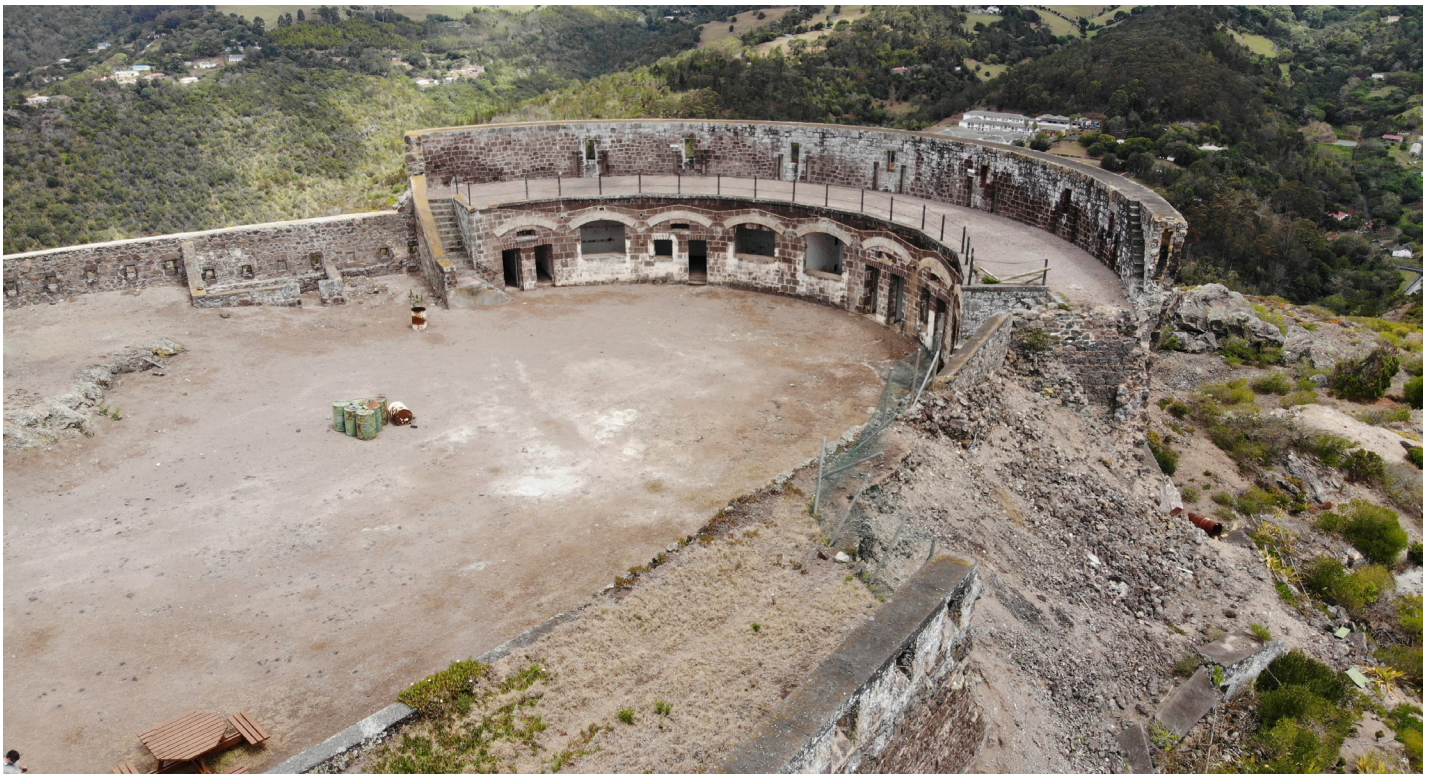
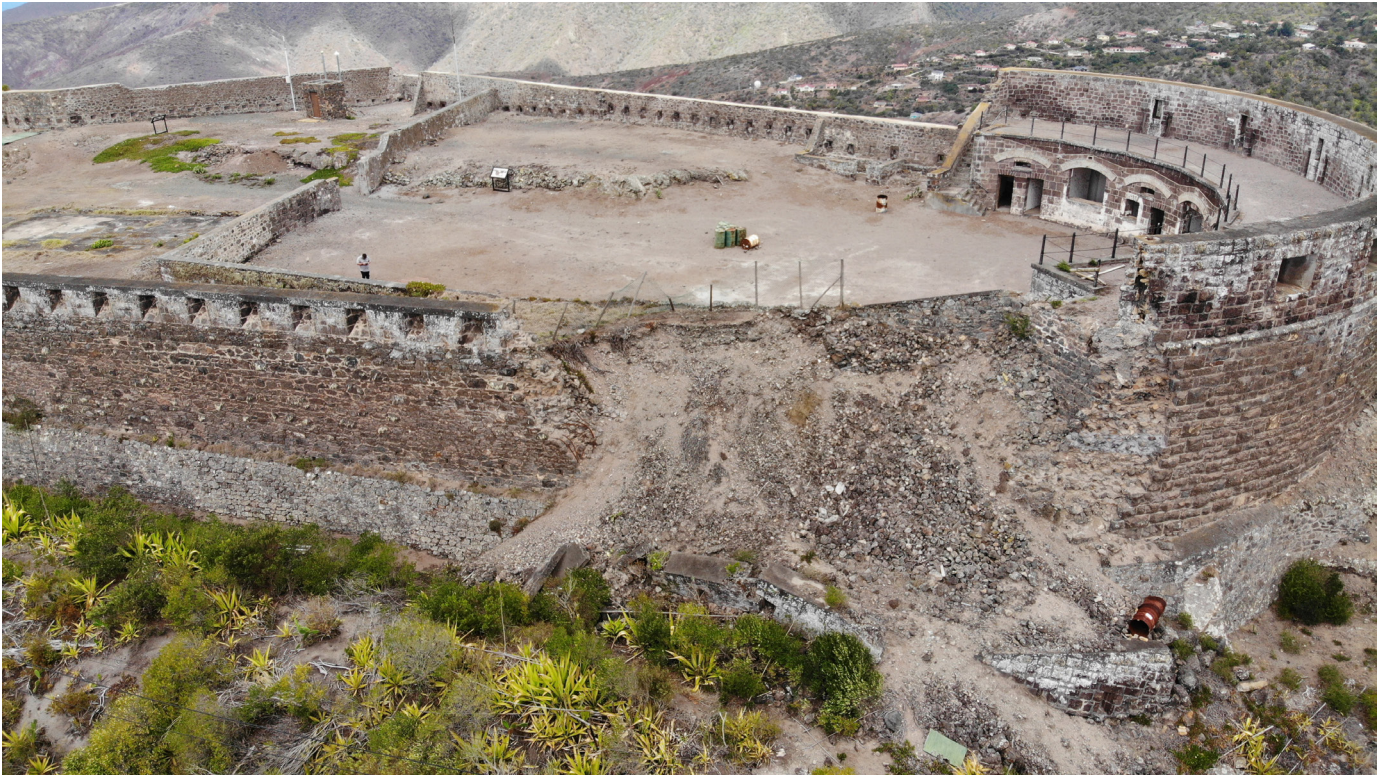
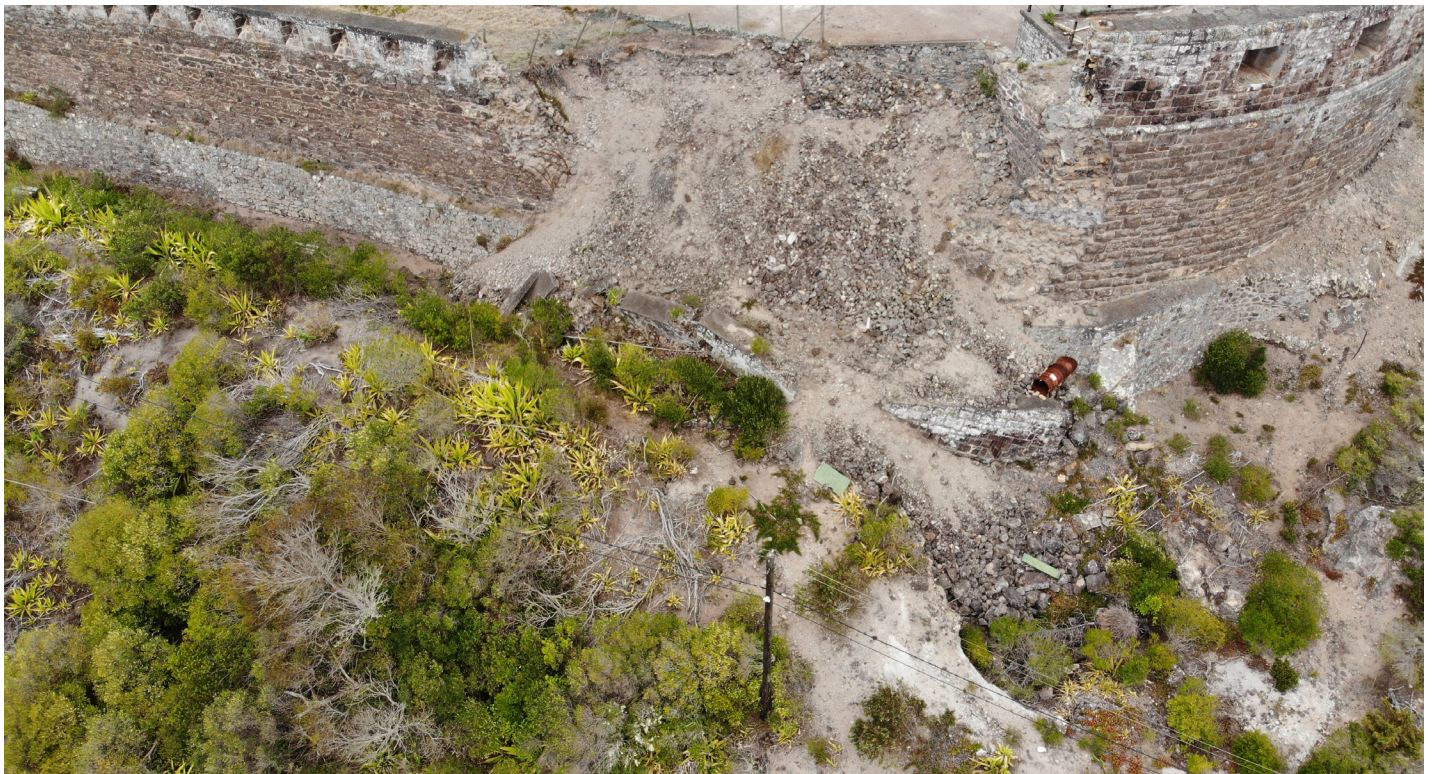
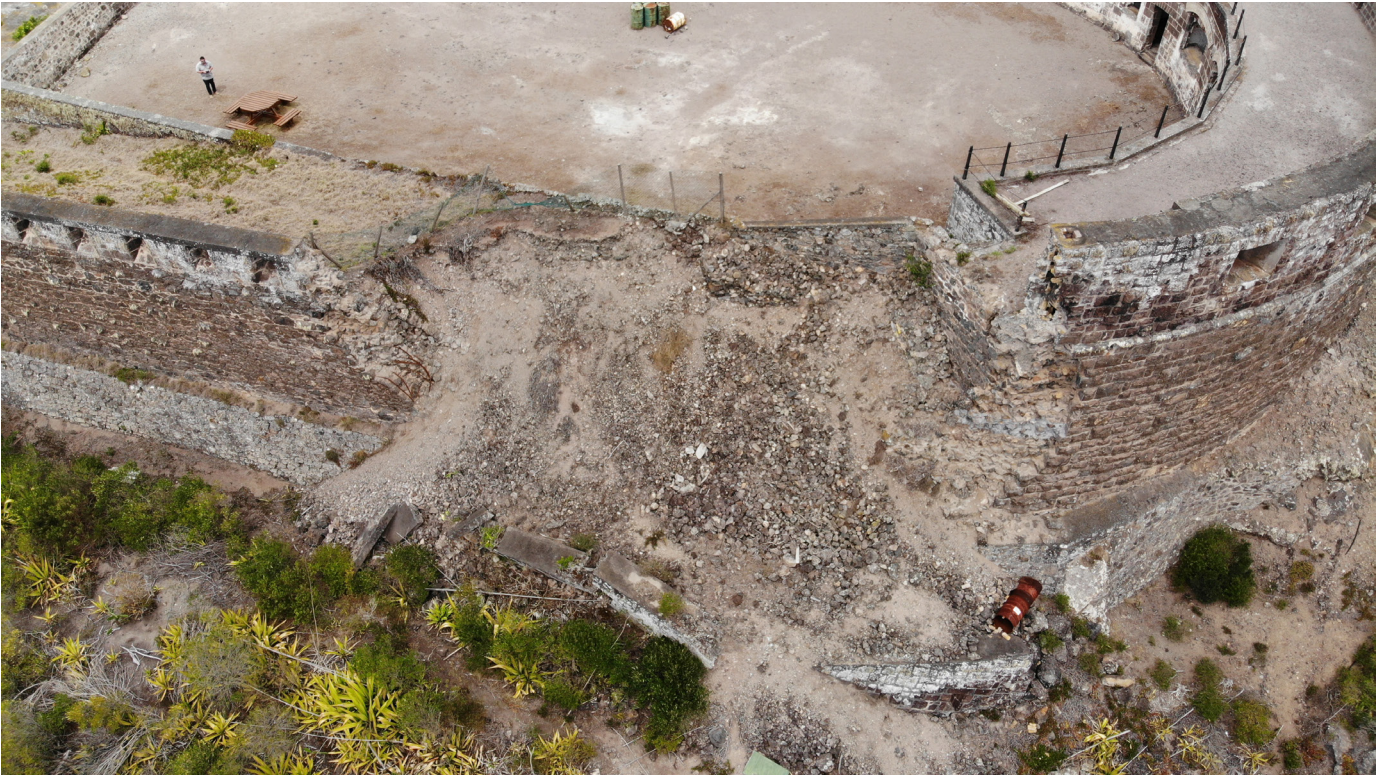
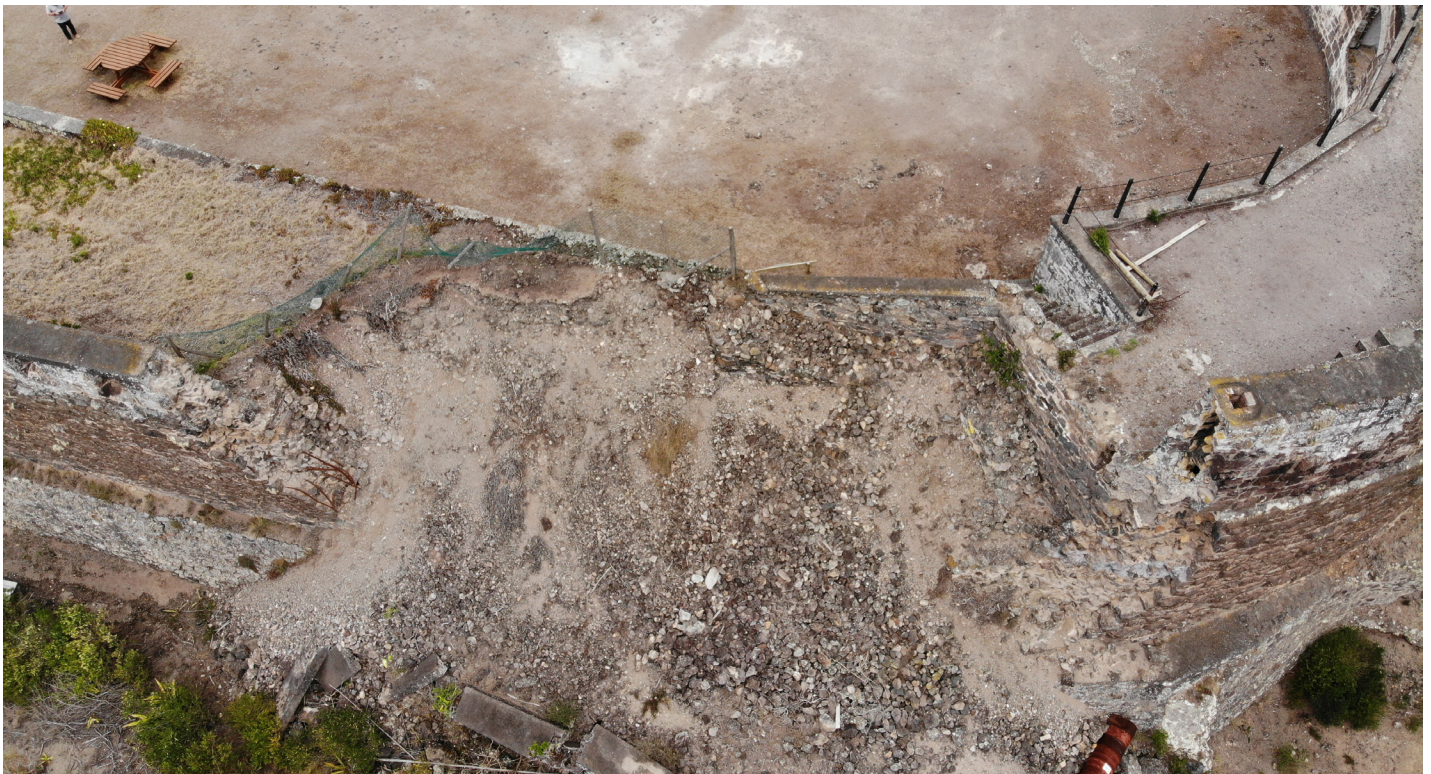
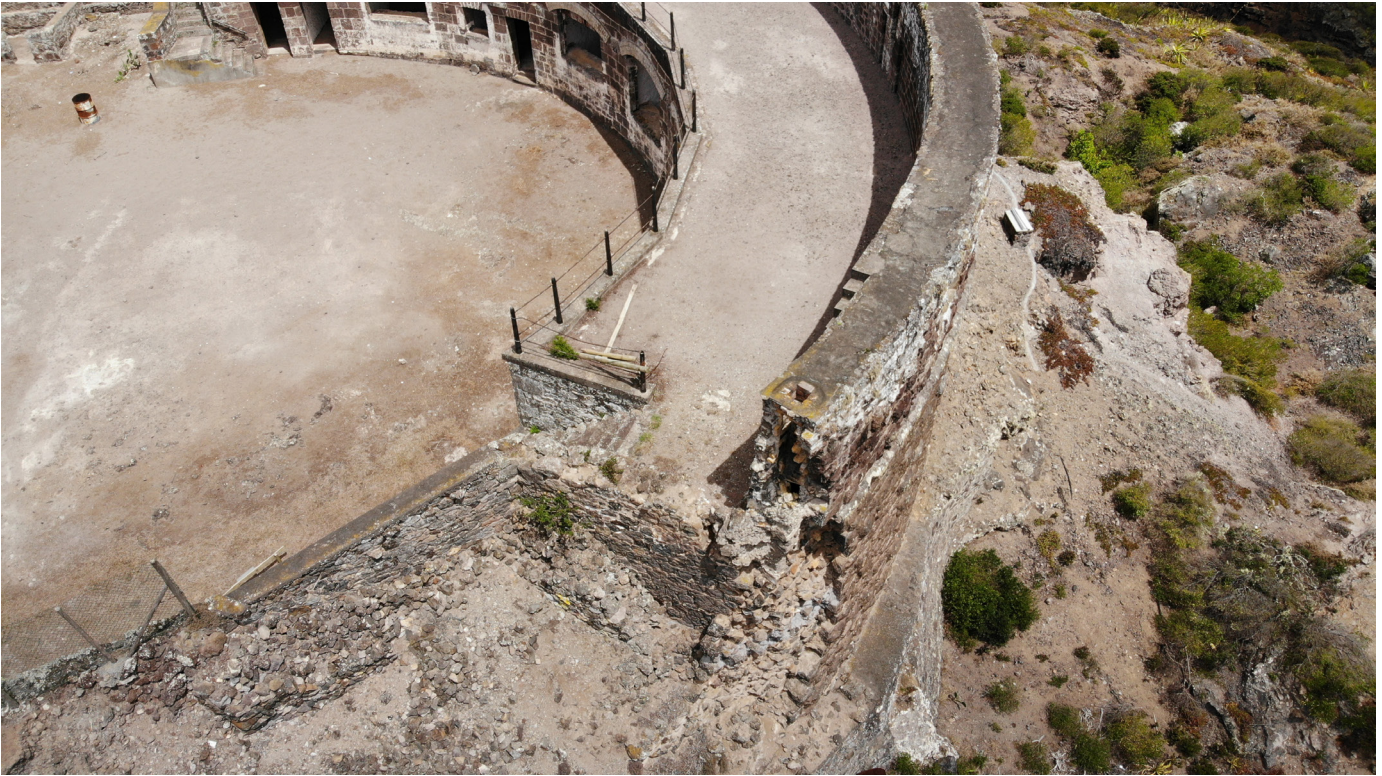
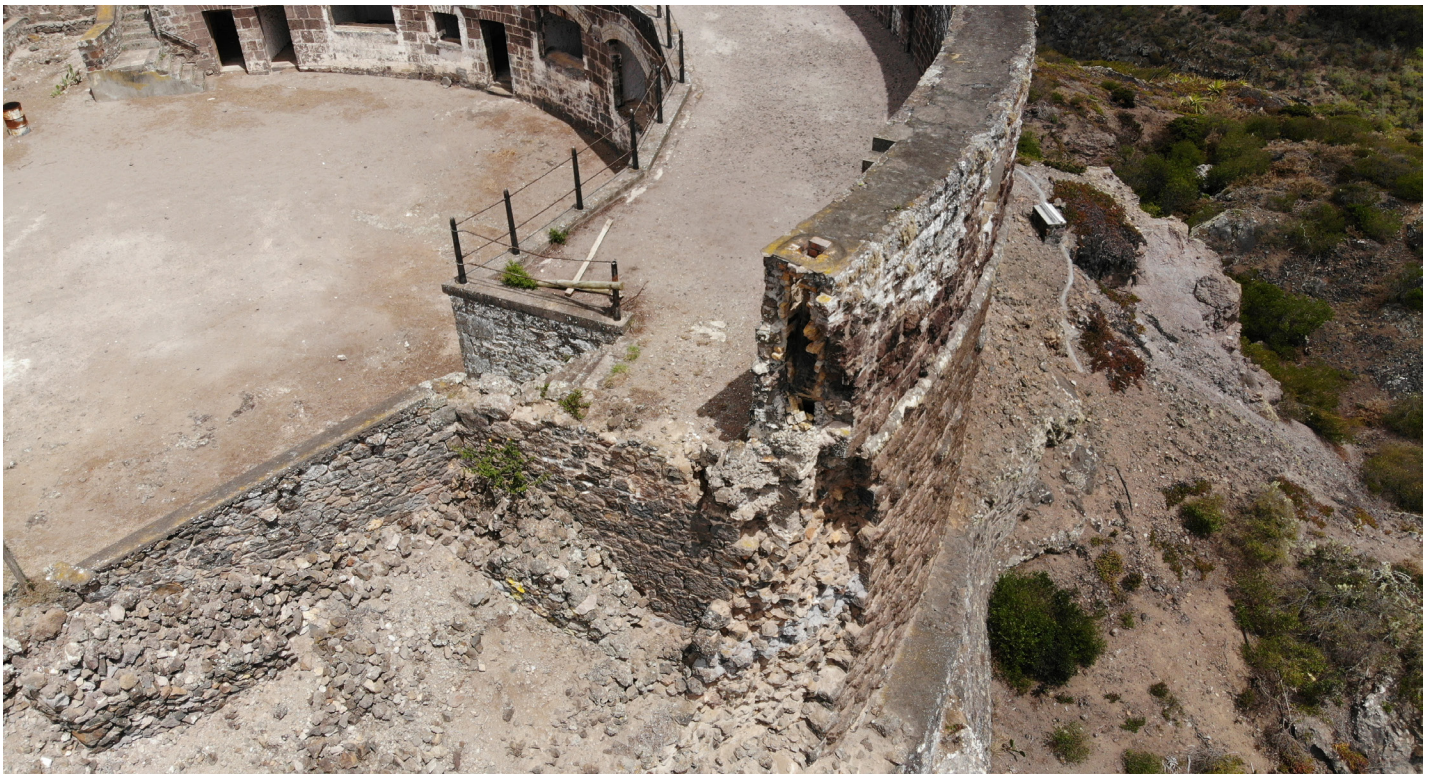
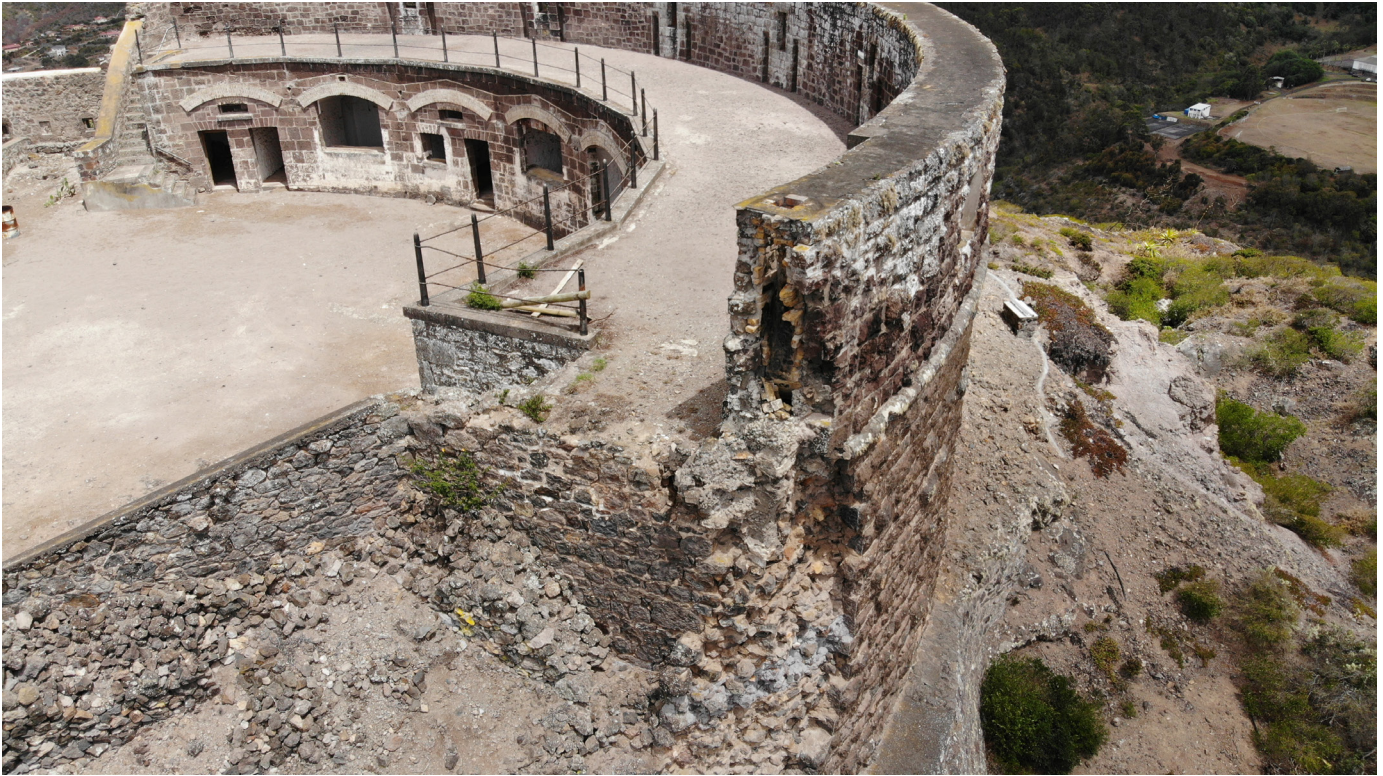
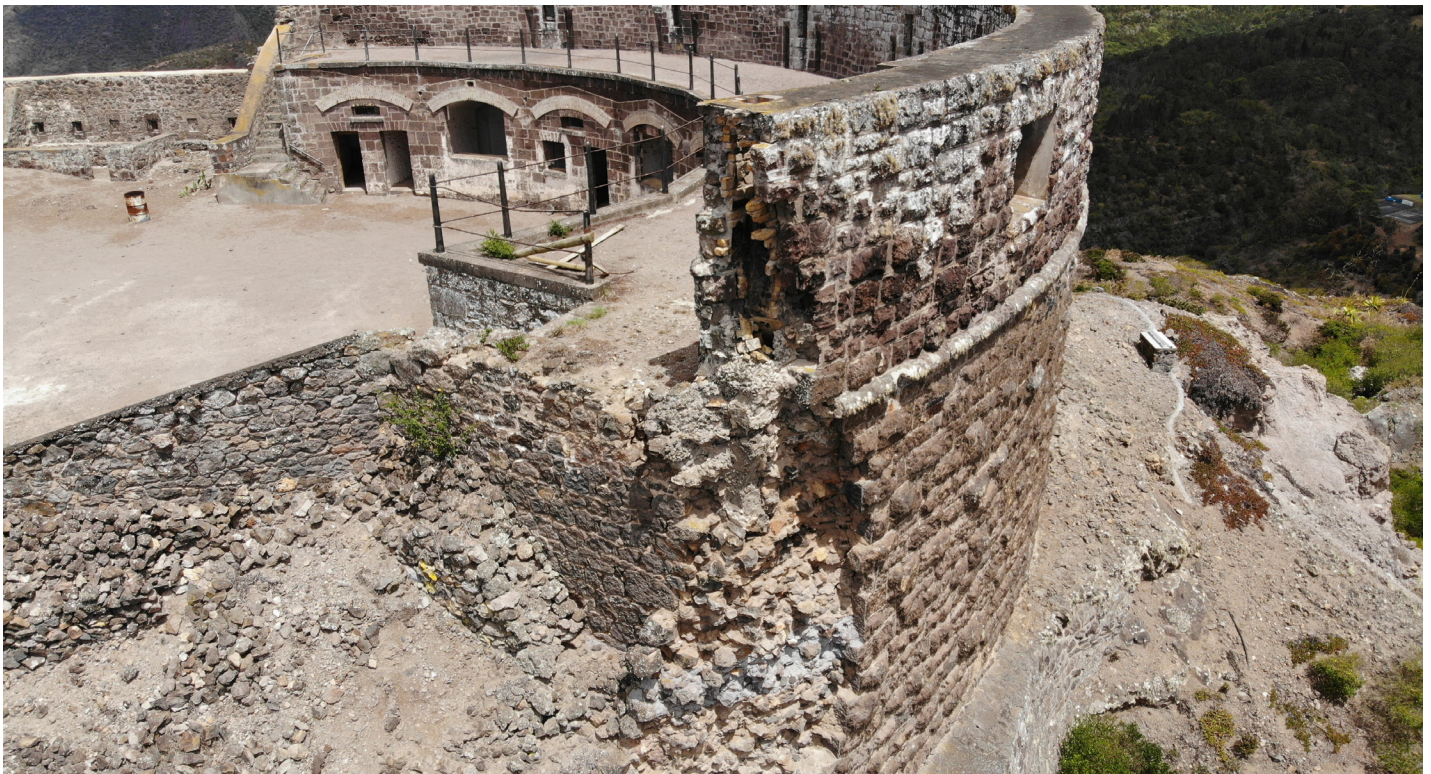
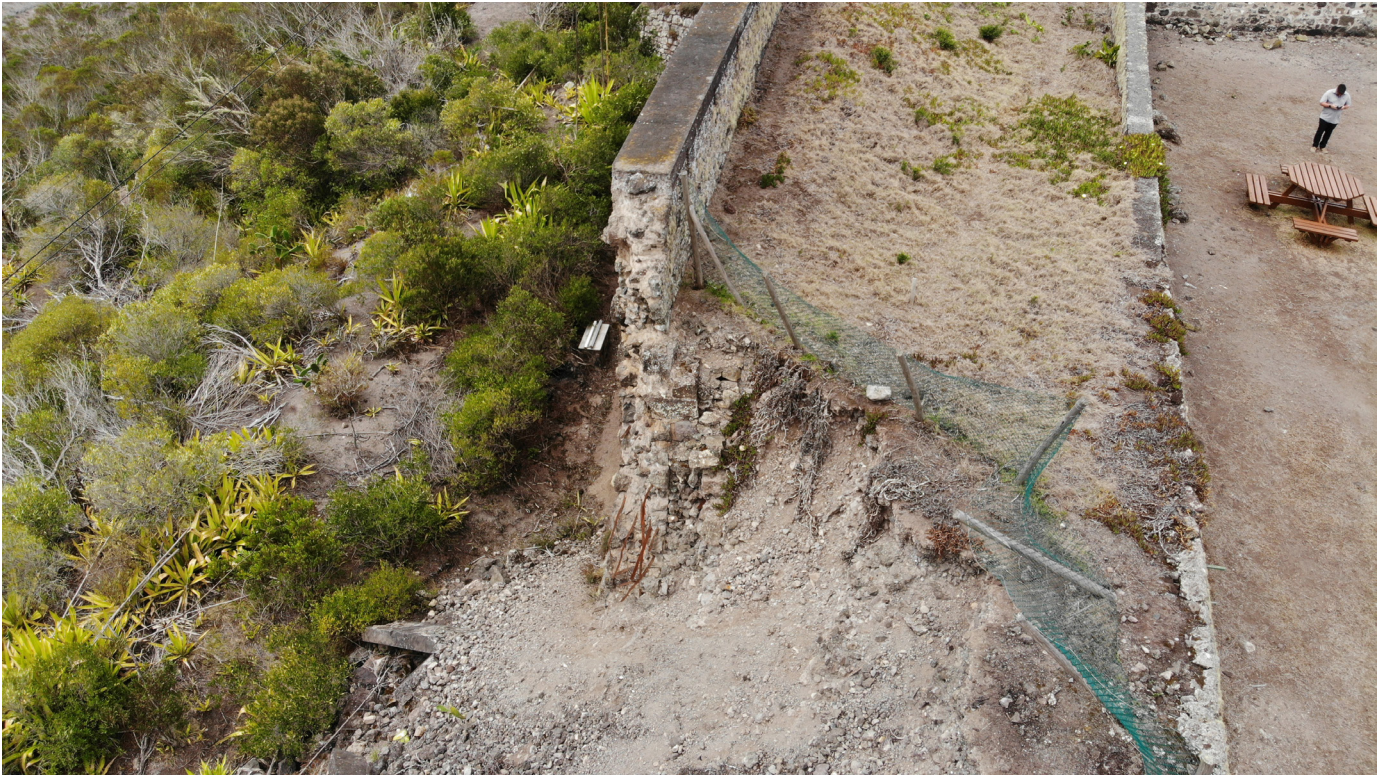
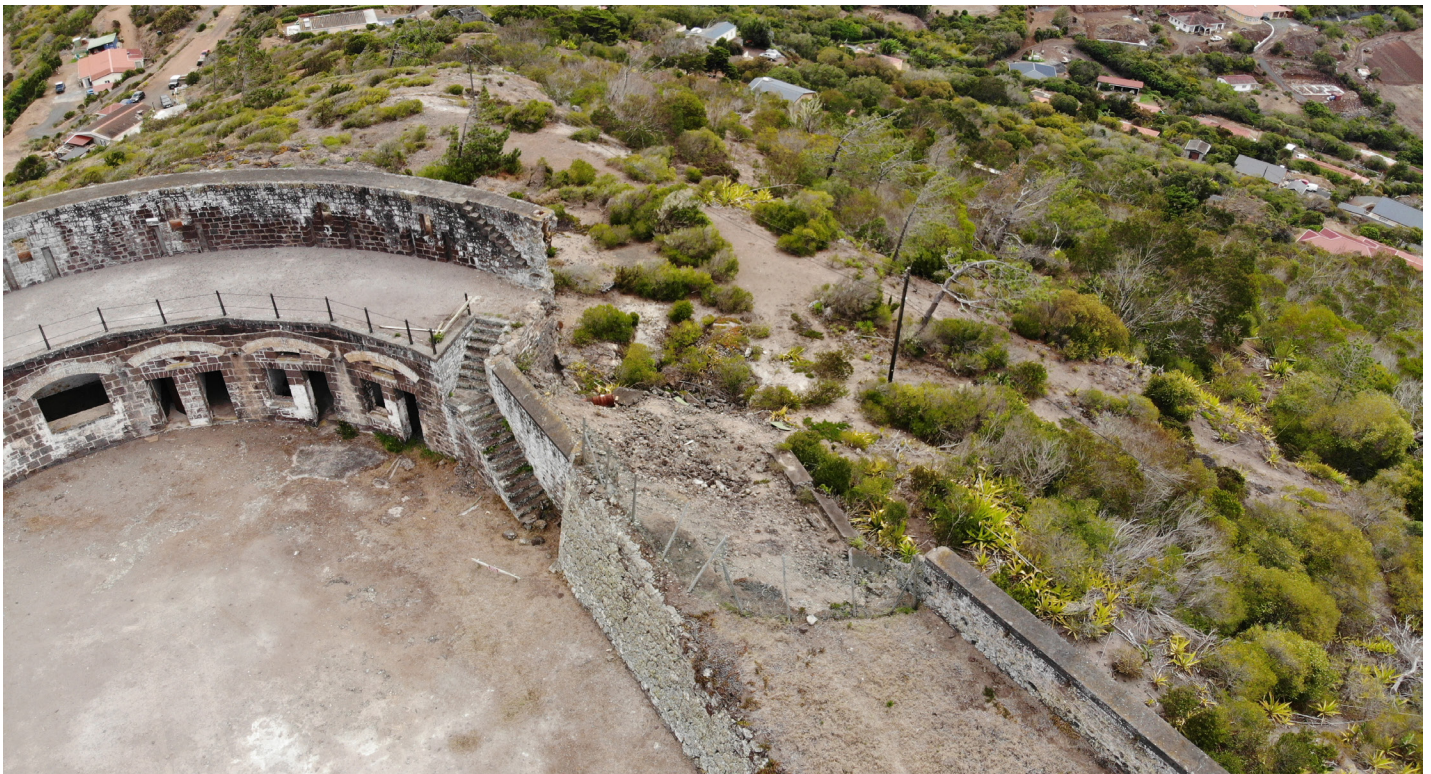
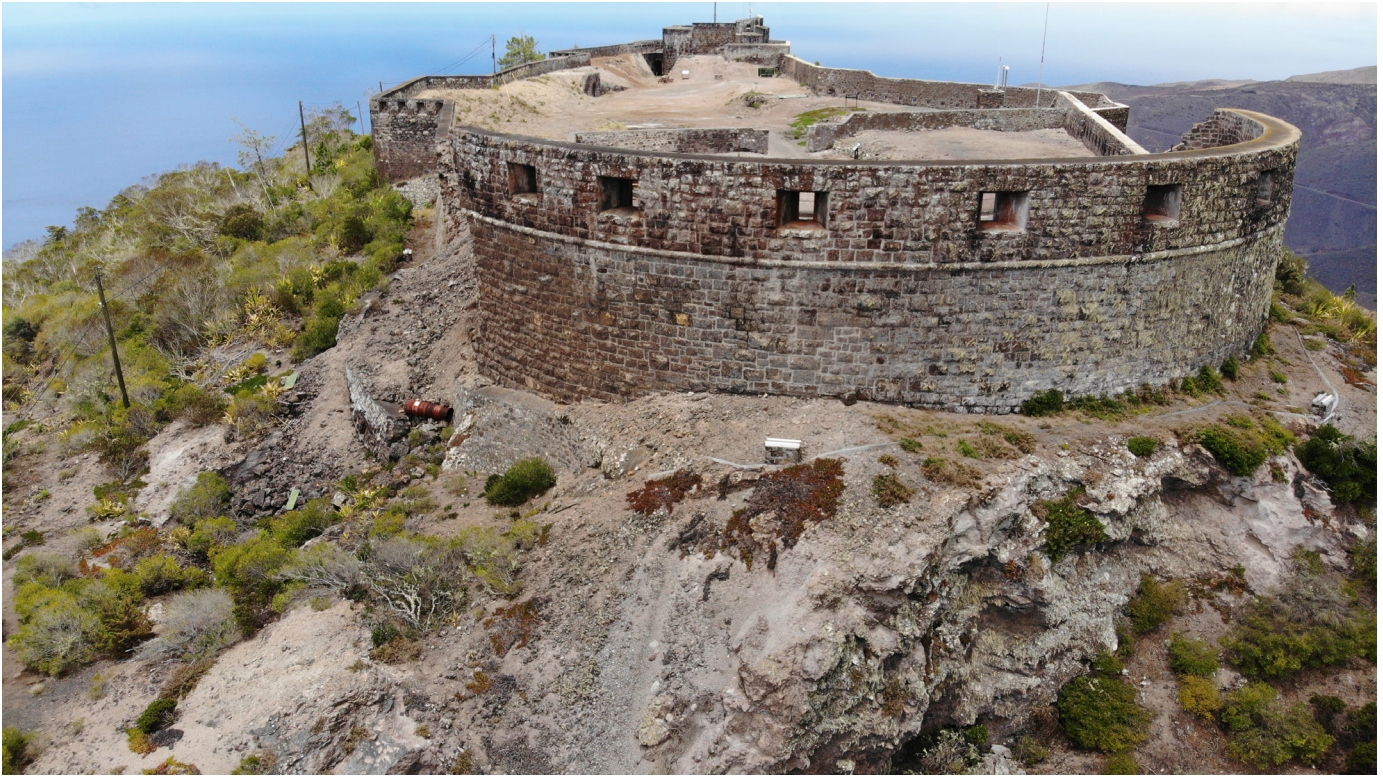
A roughly 40-foot section of the western wall collapsed near to its junction with the southern barracks and firing platform. The cause of this collapse was likely a combination of hill erosion to the west and south as well as related deferred maintenance on the wall, for example, if large amounts of bio growth were left unchecked that could have led to the stone destabilization.

For the overall integrity of the south and west wall, this collapse, if not repaired, will cause further detriment to the standing historic fabric. Particularly along the south portion of the collapse where sections of the firing platform are now hanging in the air without support. It is only a matter of time before further wall collapse takes place.

Figure 15: Oblique aerial view of wall collapse from southwest corner of fort (Image: B. Fortenberry).

Figure 16: Photogrammetric detail of wall collapse (Model: B. Fortenberry).

Figure 17: Oblique aerial view of wall collapse from southwest corner of fort with adjoining western wall in view (Image: B. Fortenberry).

Figure 18: Aerial view of wall collapse from southwest corner of fort looking south (Image: B. Fortenberry).

Figure 19: Oblique Aerial view of wall collapse from southwest corner of fort looking southeast (Image: B. Fortenberry).

Figure 20: Oblique Aerial view of wall collapse from southwest corner of fort looking east (Image: B. Fortenberry).

Figure 21: Nadir aerial view of wall collapse from southwest corner with base of collapse in detail (Image: B. Fortenberry).

Figure 22: Nadir aerial view of wall collapse from southwest corner with base of collapse in detail (Image: B. Fortenberry).

Figure 23: Nadir aerial view of wall collapse from southwest corner with top of collapse in detail (Image: B. Fortenberry).

Figure 24: Aerial view of wall collapse from southwest corner with wall section in detail (Image: B. Fortenberry).

Figure 25: Aerial view of wall collapse from southwest corner with wall section and firing platform in detail (Image: B. Fortenberry).

Figure 26: Aerial view of wall collapse from southwest corner with wall section in detail (Image: B. Fortenberry).

Figure 27: Aerial view of wall collapse from southwest corner with wall section elevation in detail (Image: B. Fortenberry).

Figure 28: Aerial view of wall collapse in southwest corner looking north, western failed wall section in detail (Image: B. Fortenberry).

Figure 29: Aerial view of wall collapse in southwest corner looking southwest, interior walls and fence in detail (Image: B. Fortenberry).

Figure 30: Aerial view of wall collapse in southwest corner from the southern exterior of the fort (Image: B. Fortenberry).

Figure 31: Aerial view of wall collapse from the northern edge of the fort complex, image looks south (Image: B. Fortenberry).

1. The wall collapse is the most pressing condition that needs to be addressed at High Knoll Fort, and a structural engineer specializing in historic buildings should be consulted prior to any conservation work taking place. The engineer should examine the photographs, drone images, 3D models, and drawings to make preliminary determinations of the scope of rehabilitation and repair. An on-site visit is preferable for detailed inspection.

2. Concurrent with the engineer's inspection, all surviving wall fragments from the collapse should be recorded and documented in situ, and recovered from being used a part of the reconstruction of the wall.

3. While the structural engineer will address the historic fabric, a geologist or environmental engineer should also be consulted to discuss how current erosion conditions contributed to the collapse and how they might be mitigated as a part of site rehabilitation. For example, could additional vegetation in the area be used to reduce soil erosion?

4. Immediate action should be taken to segregate this area from the public areas of the site. A chain-link fence is draped over the small hill to the east of the collapse that does not adequately isolate this dangerous area from visitors, still too, on the exterior of the fort complex, there is no barrier, permitting individuals potential access to hazardous areas in and around the collapse. The area needs to be marked using health and safety guidelines.

1. **IMMEDIATE:** Install signage and barriers that conform to UK Health and Safety Guidelines. Areas of concern are detailed in the Wall Collapse and Signage and Visitor Experience sections.
2. **SHORT TERM:** Address the wall collapse on the southwest corner of the exterior fort wall. This item is a priority both in terms of the continued structural integrity of the fort and the health and safety of visitors.
