Documentation and Conditions Assessment of High Knoll Fort, St. Helena (CHC-2020-01-01)

**Report prepared for the British Napoleonic Bicentenary
Trust and St. Helena Government**

**Brent R. Fortenberry, Associate Director, Center for Heritage Conservation
Jane Ashburn, Architectural Conservator**

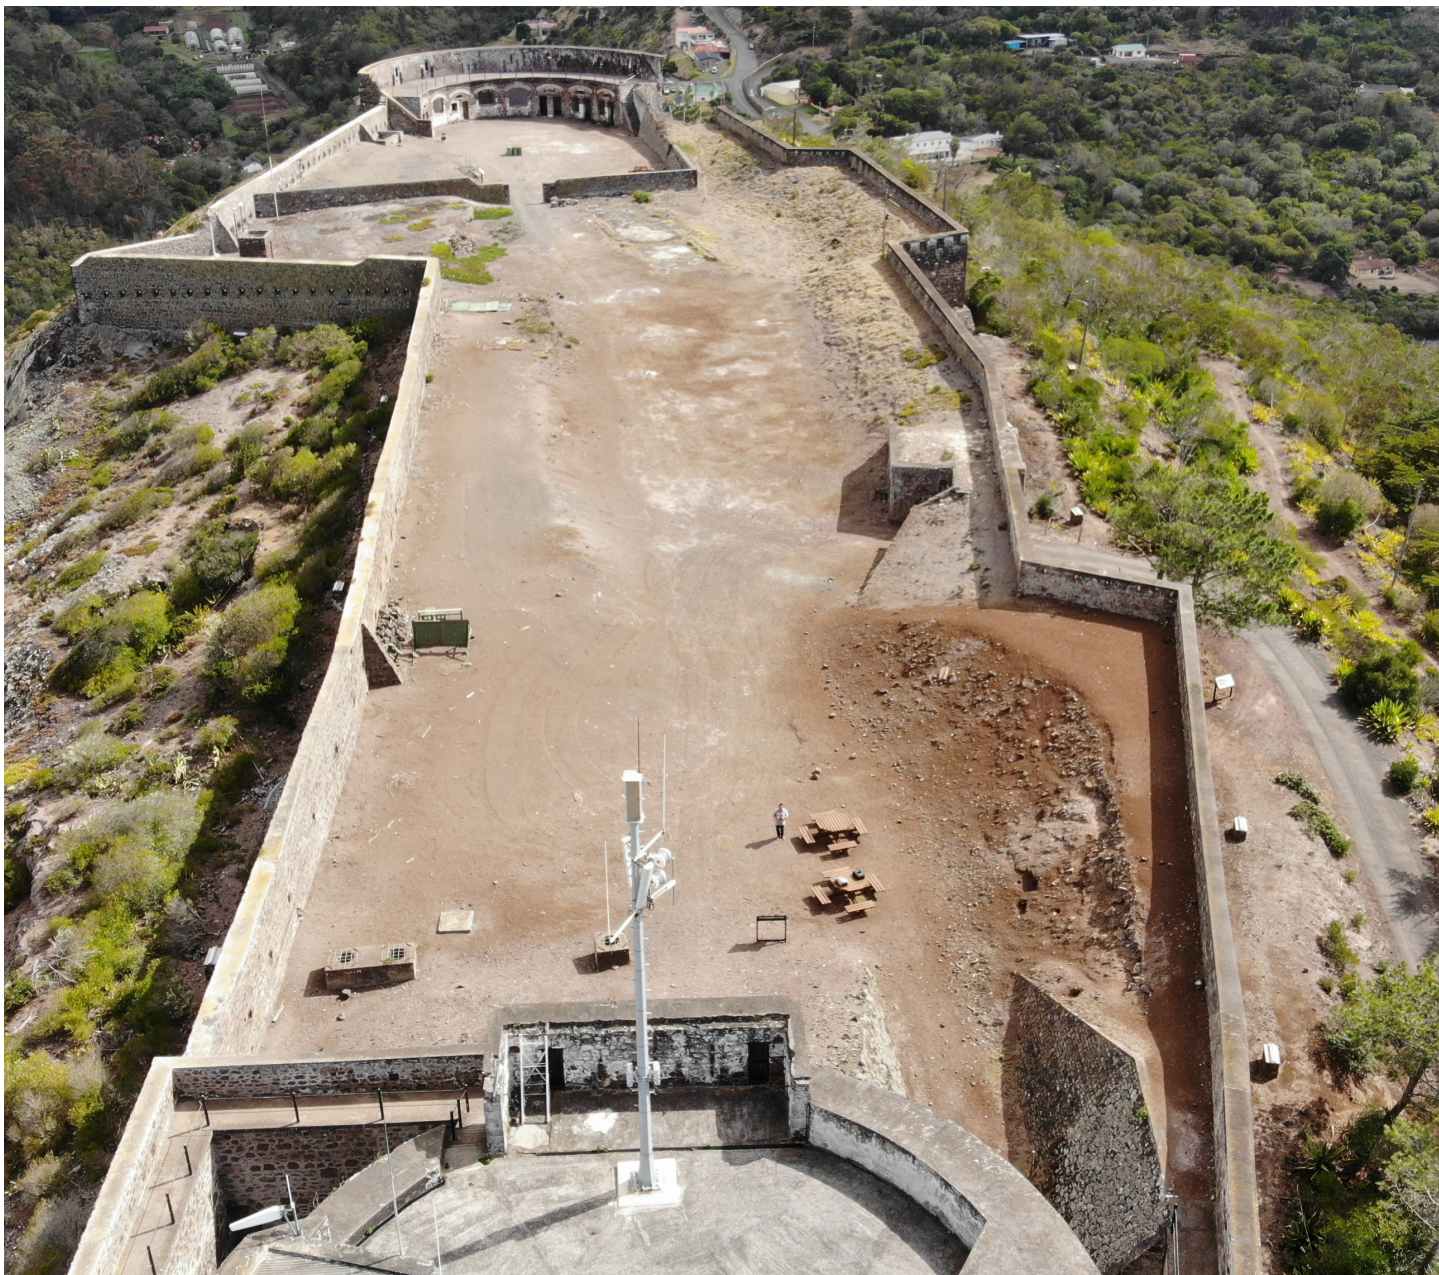
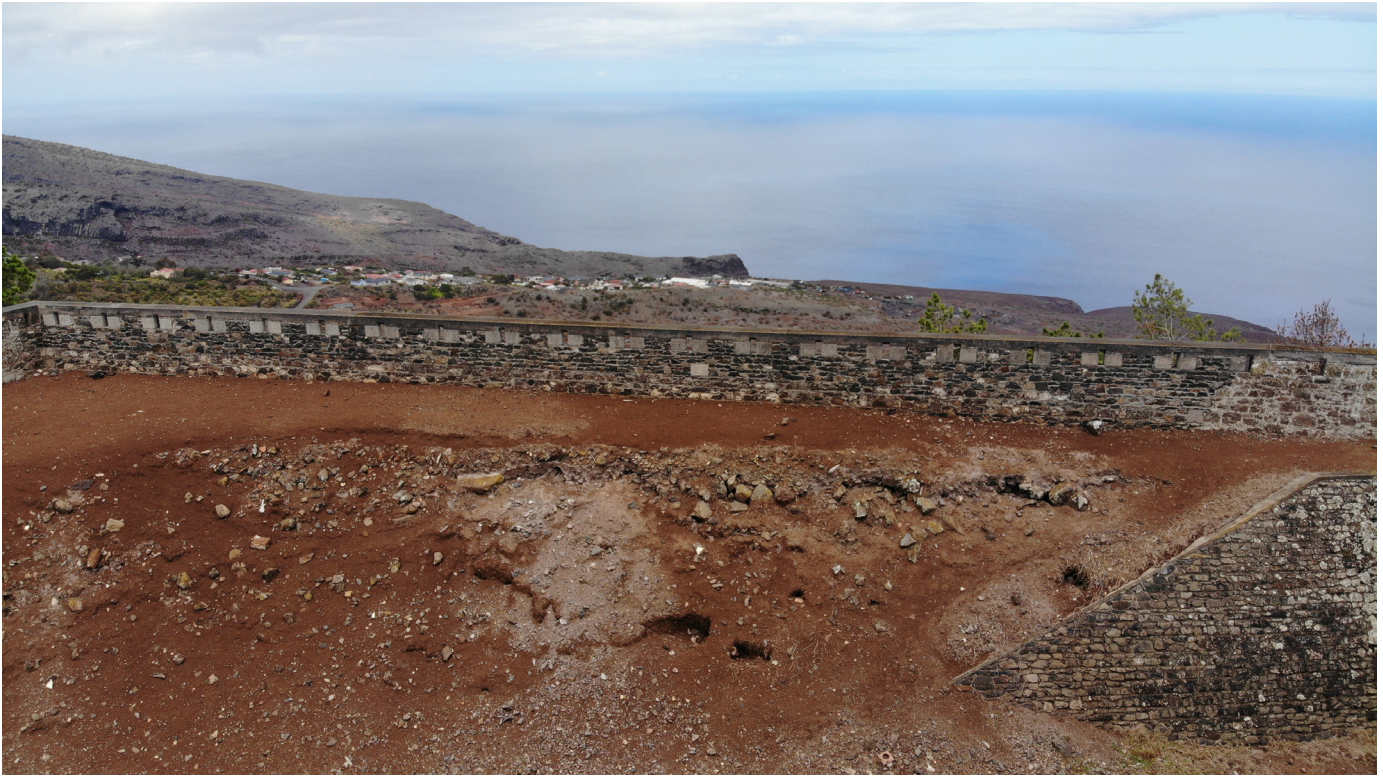
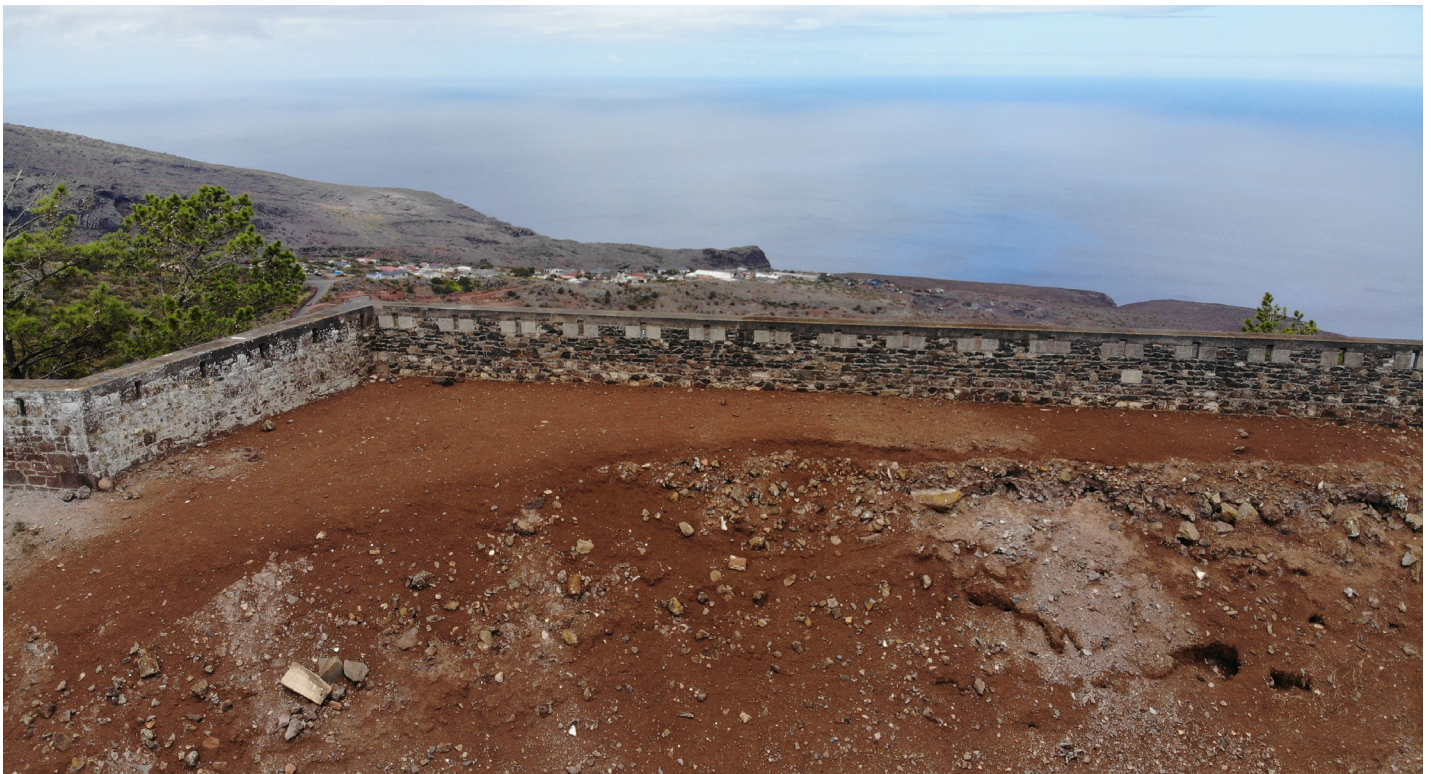
To the north of the guard house along the western wall the interior soil which forms a ramp to the top of the western wall, is eroding. This is likely a product of inappropriate infilling after the wall collapse in 1994 and subsequent repair in 2001 (see history section above). When repairs took place, the soil was not adequately compacted to hold the hillside; additionally, the heterogeneous rock infill coupled with water intrusion has caused the hill to erode. If this continues unabated, the structural integrity of this wall section will be undermined, perhaps causing further collapse. This area of recent fill can be identified from its red-brown color.

Figure 32: Aerial view of northern terminus of fort interior, erosion in detail in the right portion of image (Image: B. Fortenberry).

Figure 33: Aerial view of western interior wall section with erosion of 21st century infill in detail (Image: B. Fortenberry).

Figure 34: Aerial view of western interior wall section with southern extreme of erosion of 21st century infill, in detail (Image: B. Fortenberry).

1. Consult an environmental engineer to discuss appropriate mitigation measures. These might include a replacement of the heterogeneous infill with homogeneous fill that is compacted, a retaining wall at the base of the hill to add further integrity, or vegetation to abate erosion.

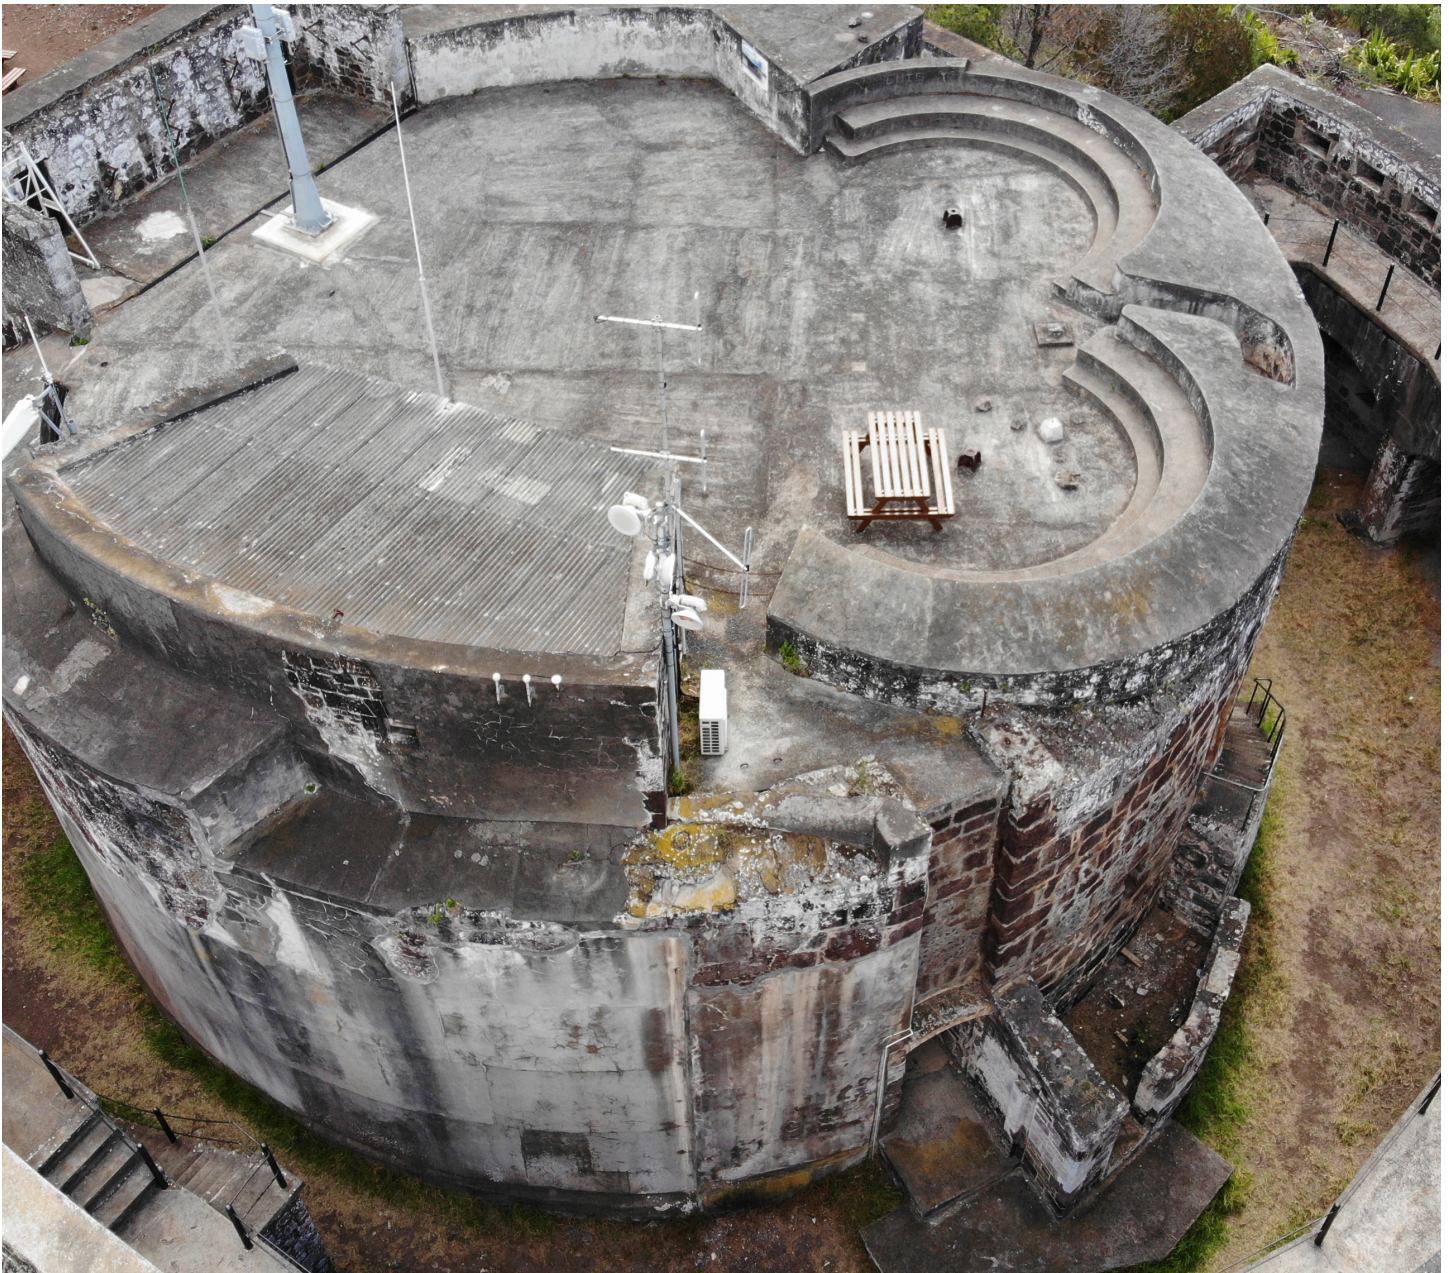
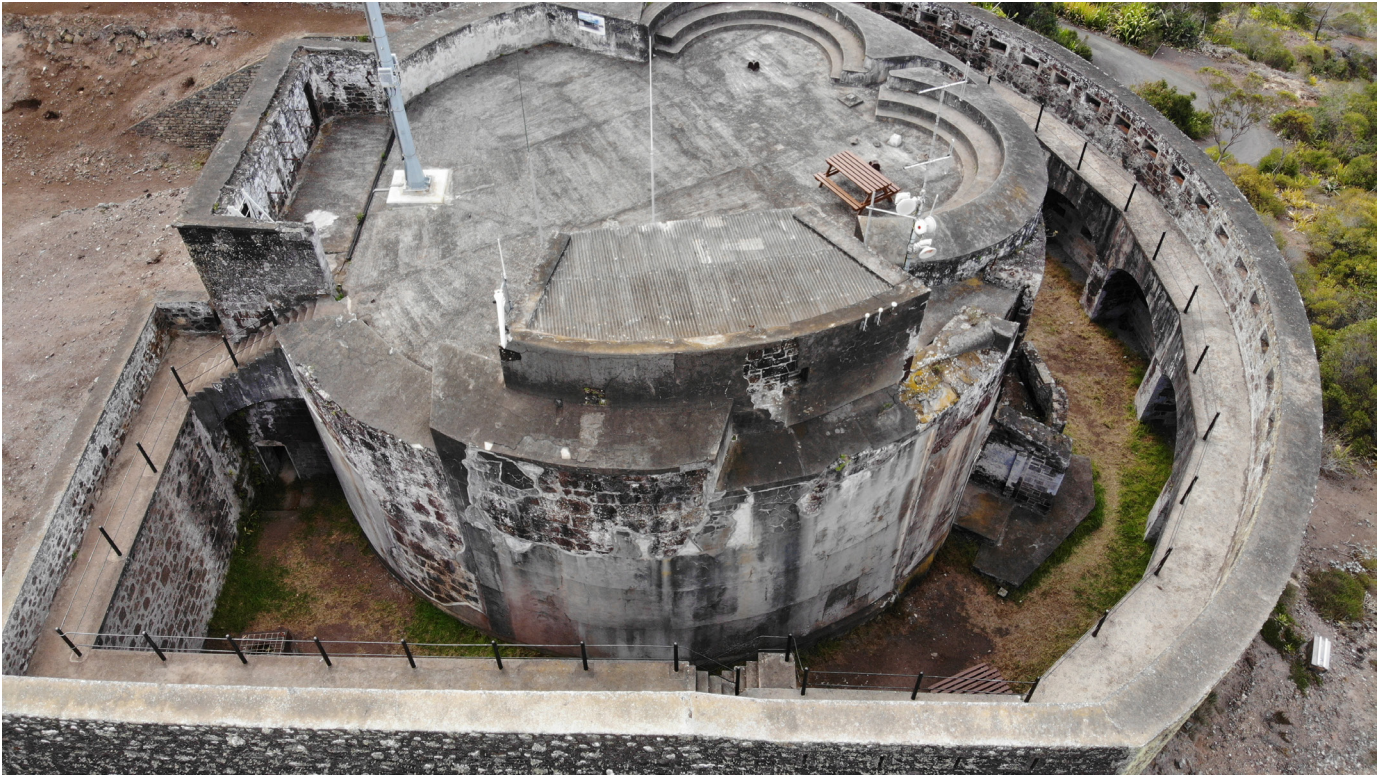
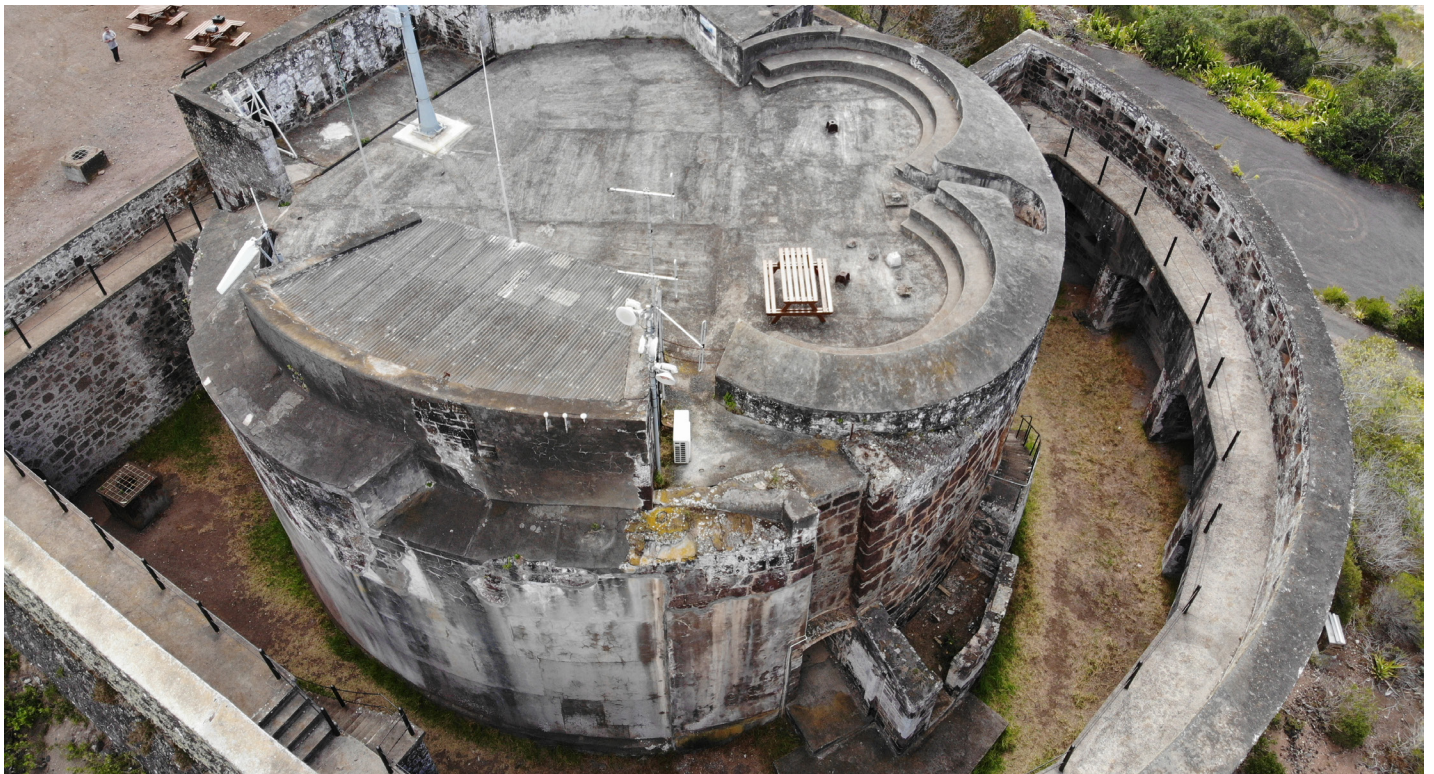
Failing stucco is also present in a small section of the northern tower complex.

Figure 35: Aerial view of stucco from northern tower complex, stucco campaigns in detail (Image: B. Fortenberry).

Figure 44: Aerial image of stucco present on the north tower complex (Image: B. Fortenberry).

Figure 45: Aerial image of stucco present on the north tower complex (Image: B. Fortenberry).

4. Care should be taken to preserve the surviving stucco on the site.

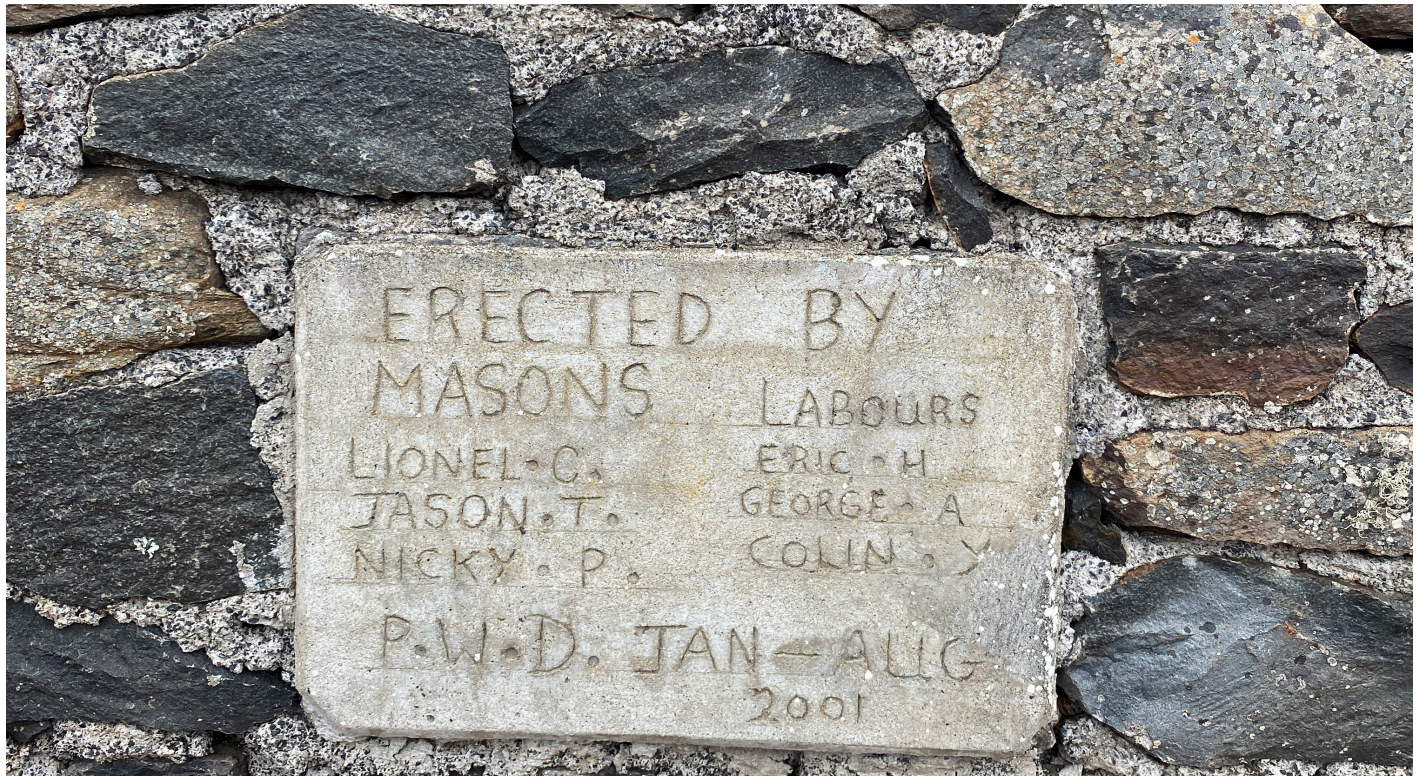
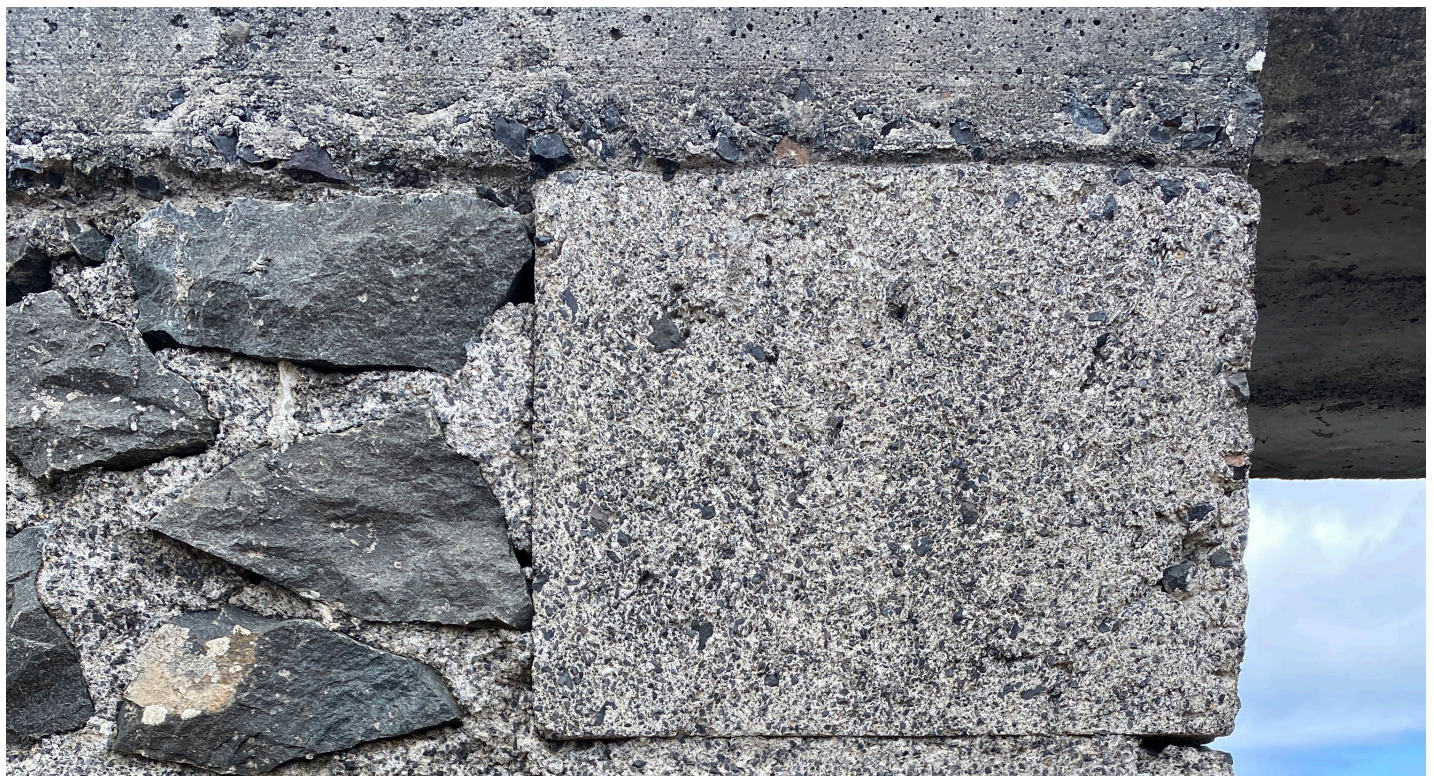
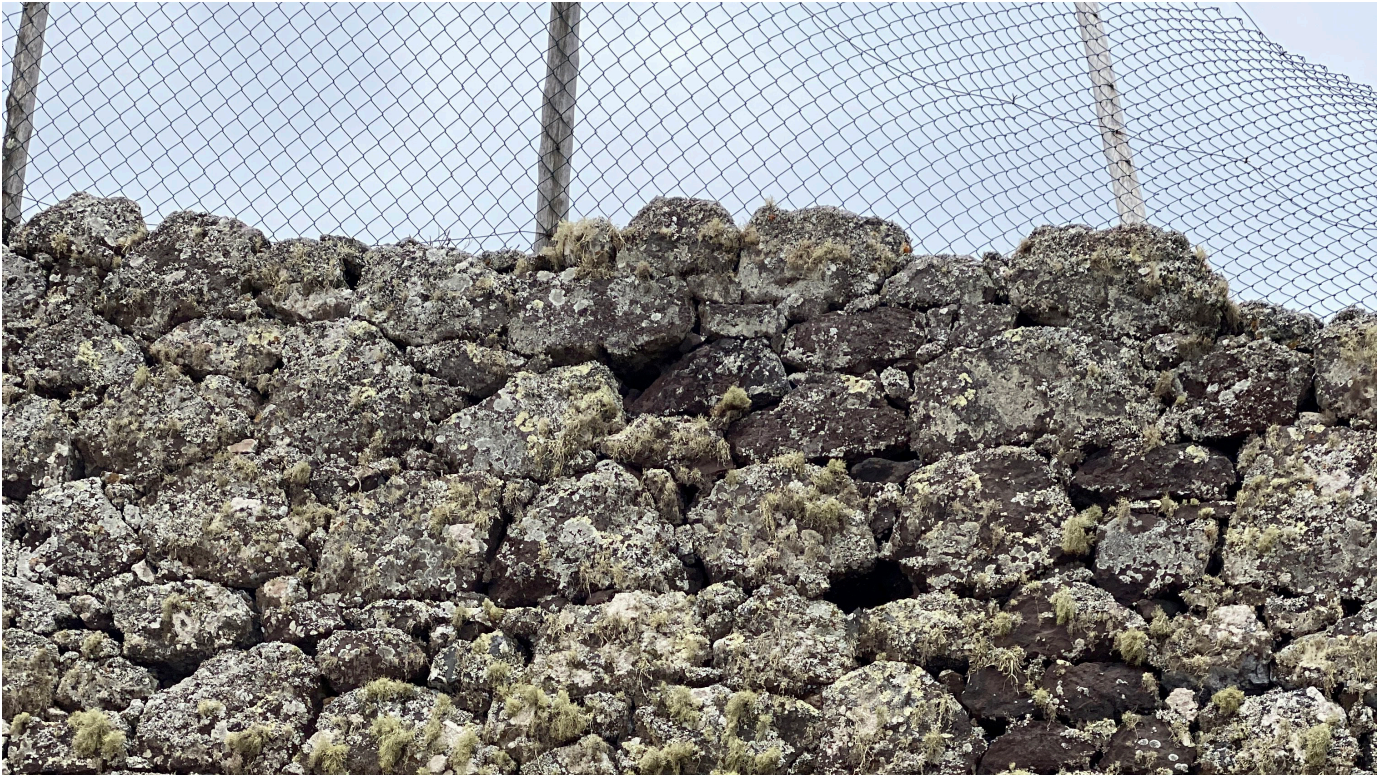
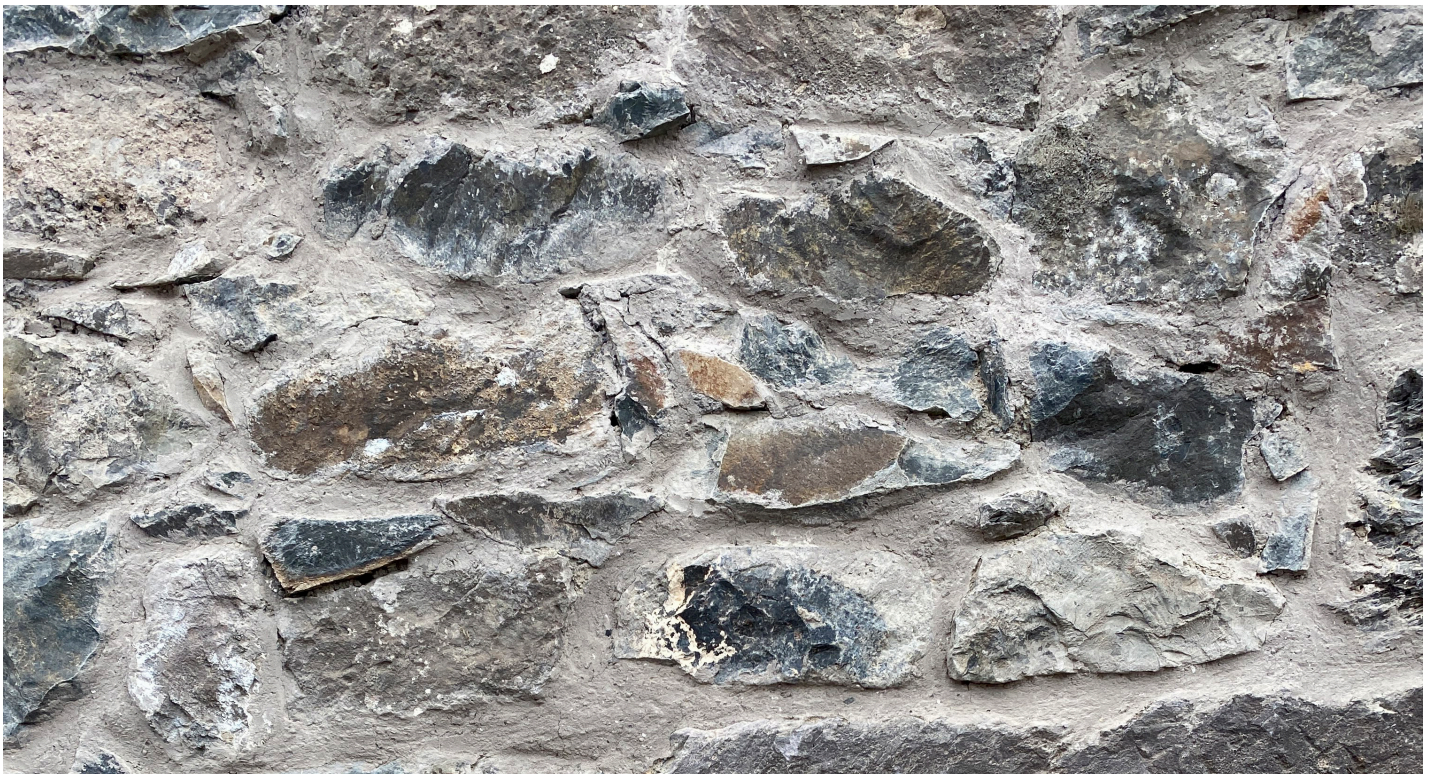
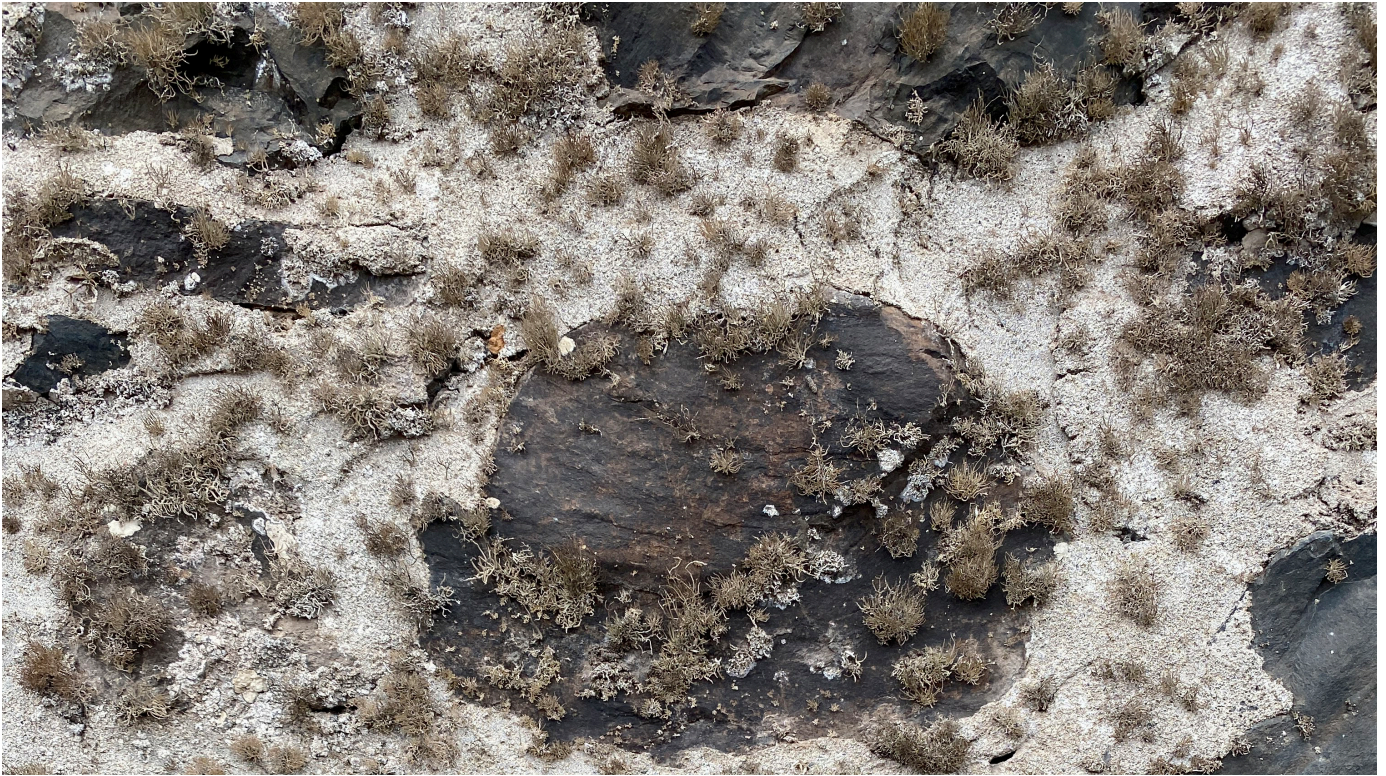
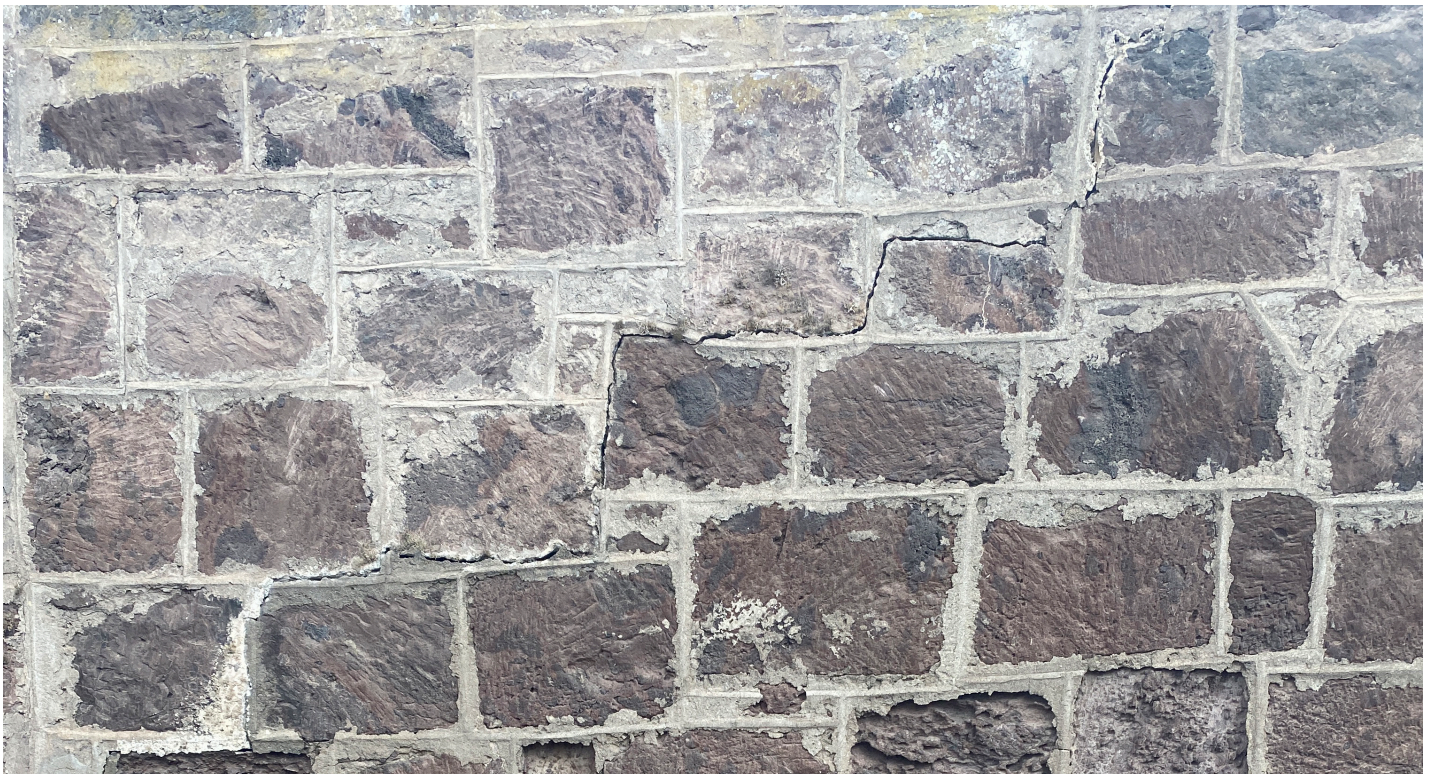
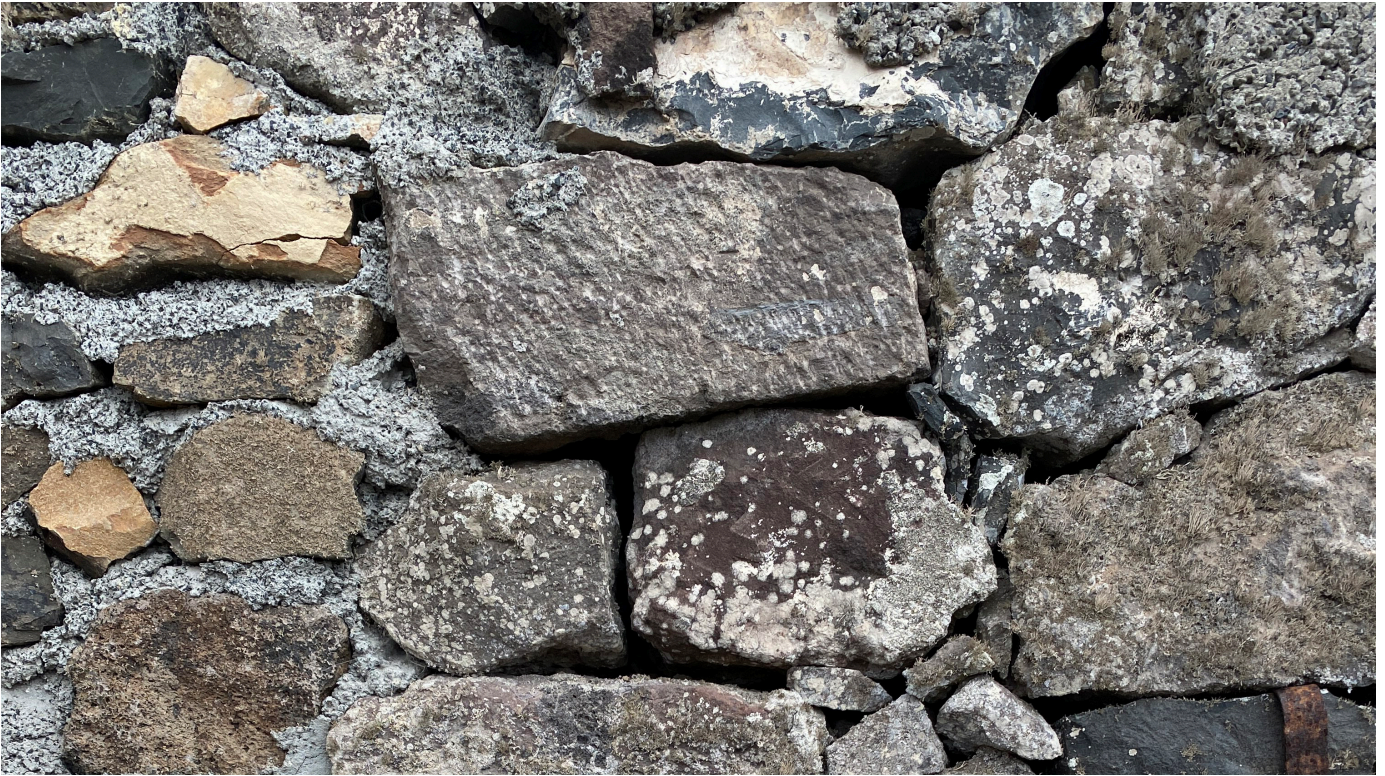
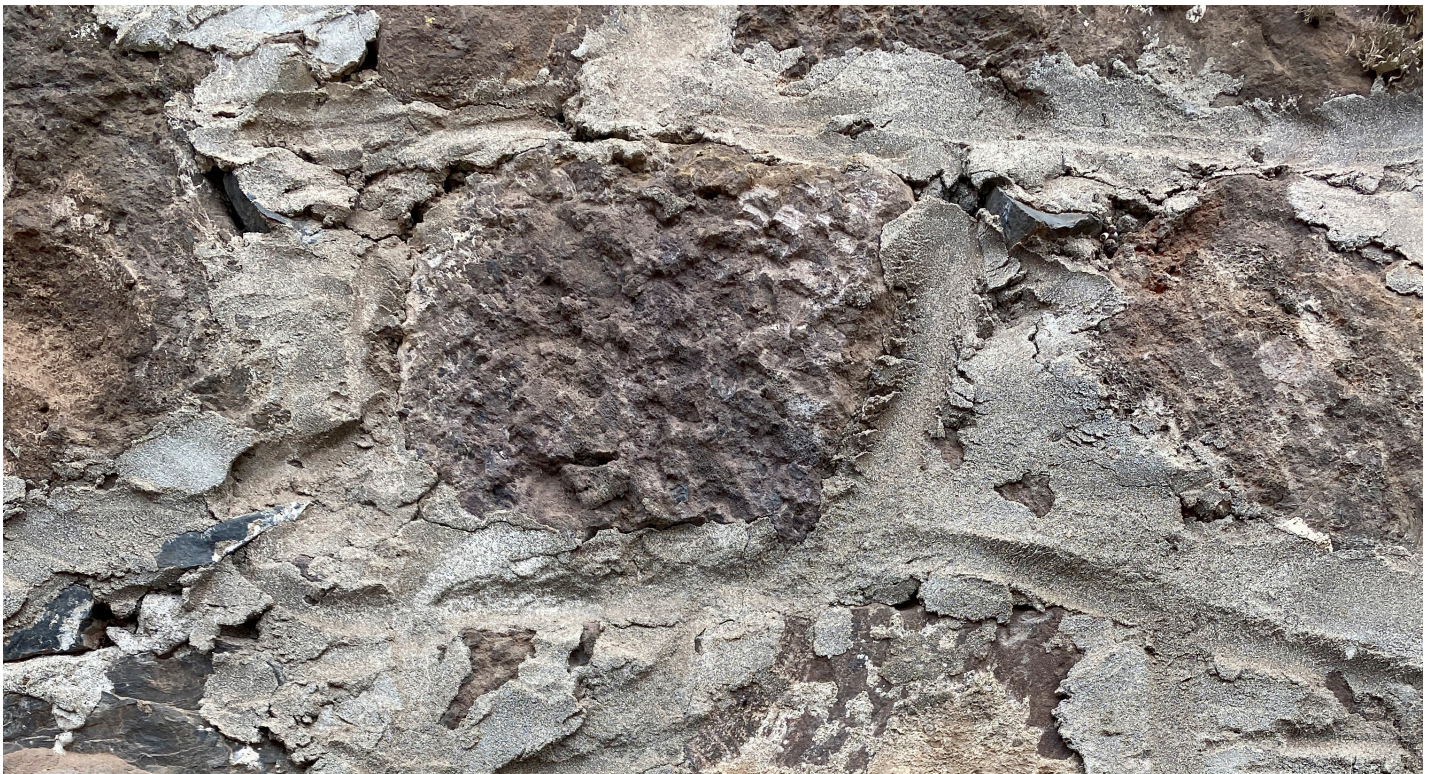
Mortar is present as a bonding medium throughout the stone structure. Inappropriate replacement mortars (incompatible with historic mortar composition) are used throughout the fort stone walls. At least seven different mortars were identified with varied compositions ranging from those with high levels of modern concrete to those without aggregate and Portland cement. Additionally, several of the mortar mixes were not properly composed and contained organic inclusions allowing bio growth to take root. Several areas of dry-laid stone were also identified.

Figure 36: Detail of Portland based mortar with date plate from 2001 (Image: B. Fortenberry).

Figure 37: Detail of Portland based mortar in detail (Image: B. Fortenberry).

Figure 38: Detail of dry-laid stone wall with bio-growth present (Image: B. Fortenberry).

Figure 39: Detail of Portland based mortar without aggregates in detail (Image: B. Fortenberry).

Figure 40: Detail of Portland based mortar without aggregates and bio-growth present in detail (Image: B. Fortenberry).

Figure 41: Detail of Portland based mortar with raised joints in detail (Image: B. Fortenberry).

Figure 42: Detail of Portland based mortar and dry-laid stone in detail, bio-growth also present (Image: B. Fortenberry).

1. Identify and test in-context, identified historic mortars. Samples should be taken from the south and north exterior walls and tested through aggregate analysis and acid digestion to identify appropriate historic composition. This should be done by an architectural conservator.

2. In consultation with an architectural conservator, the dry-laid sections of the wall on the fort's interior should be monitored to ensure their long-term integrity, consultation with a conservator and historic building contractor should a dry-laid wall collapse is recommended. Consider isolating these walls from the public areas of the site with appropriate health and safety barriers and signage.

3. Do not remove inappropriate mortars without oversight from an architectural conservator. Monitor these areas for mortar failure and repair with historically appropriate mortar composition derived from mortar analysis (Recommendation 1). Mortar replacement should be completed in consultation with an architectural conservator.
