Documentation and Conditions Assessment of High Knoll Fort, St. Helena (CHC-2020-01-01)

**Report prepared for the British Napoleonic Bicentenary
Trust and St. Helena Government**

**Brent R. Fortenberry, Associate Director, Center for Heritage Conservation
Jane Ashburn, Architectural Conservator**

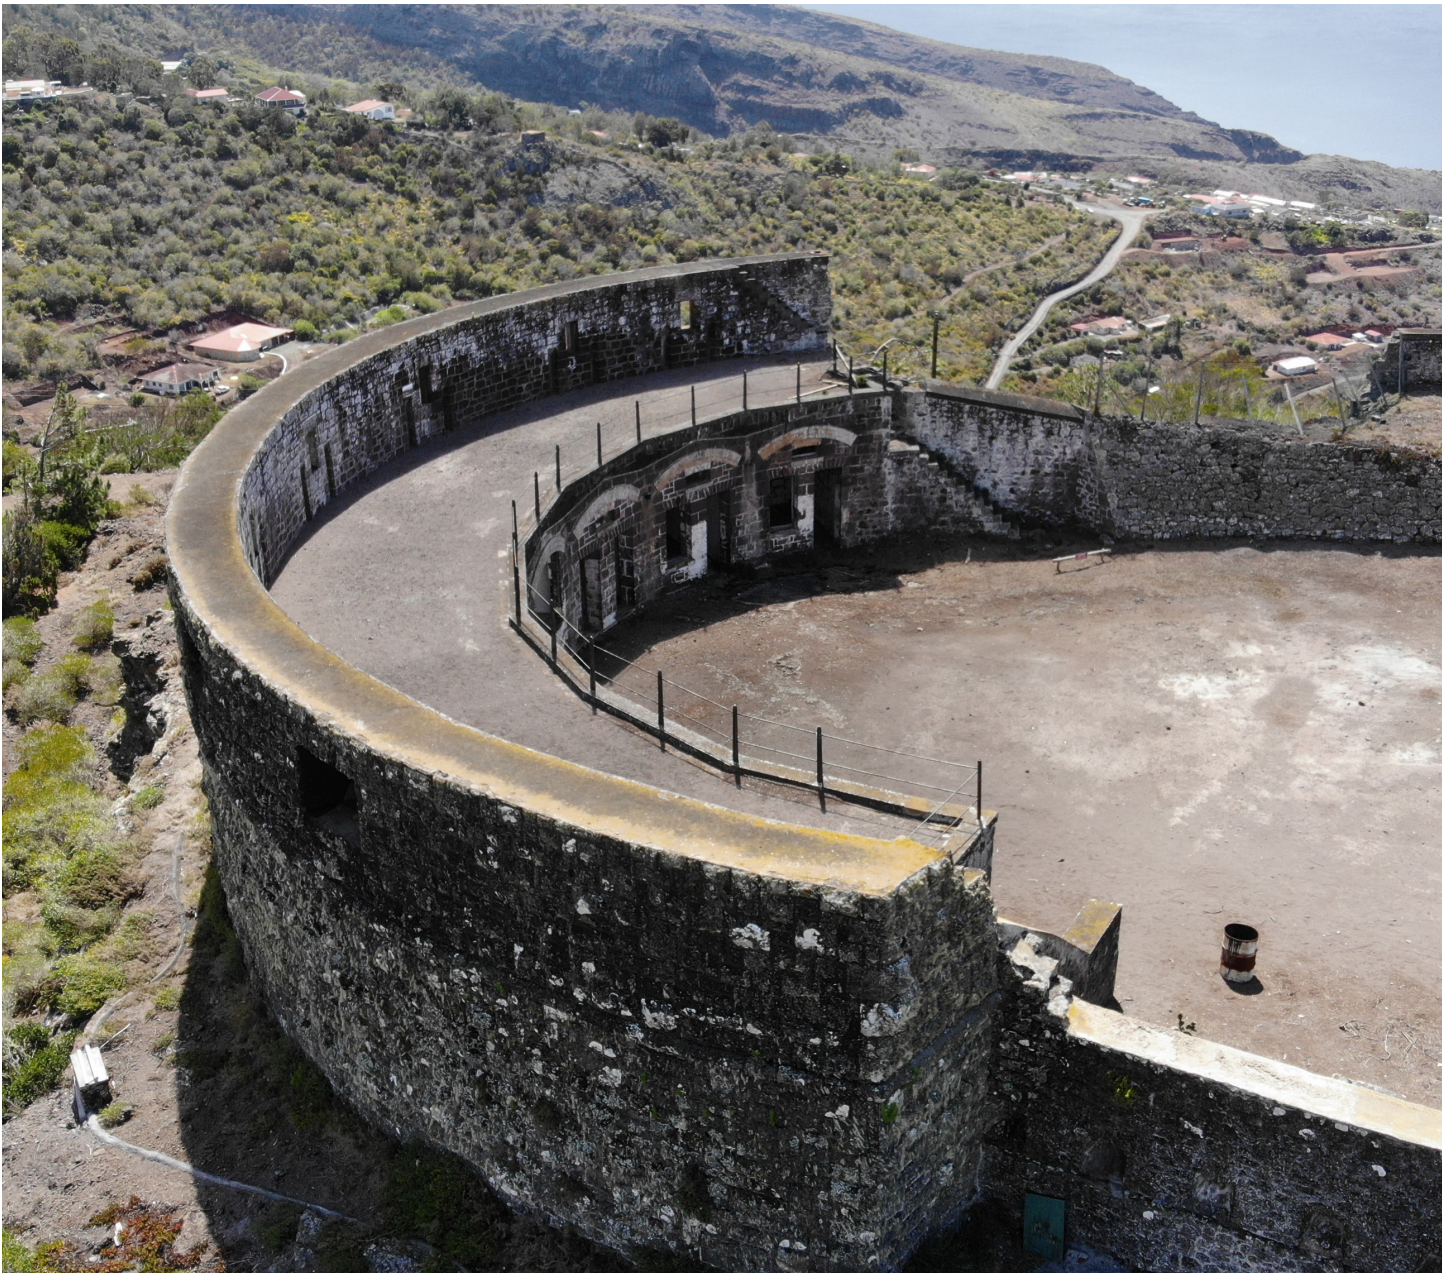
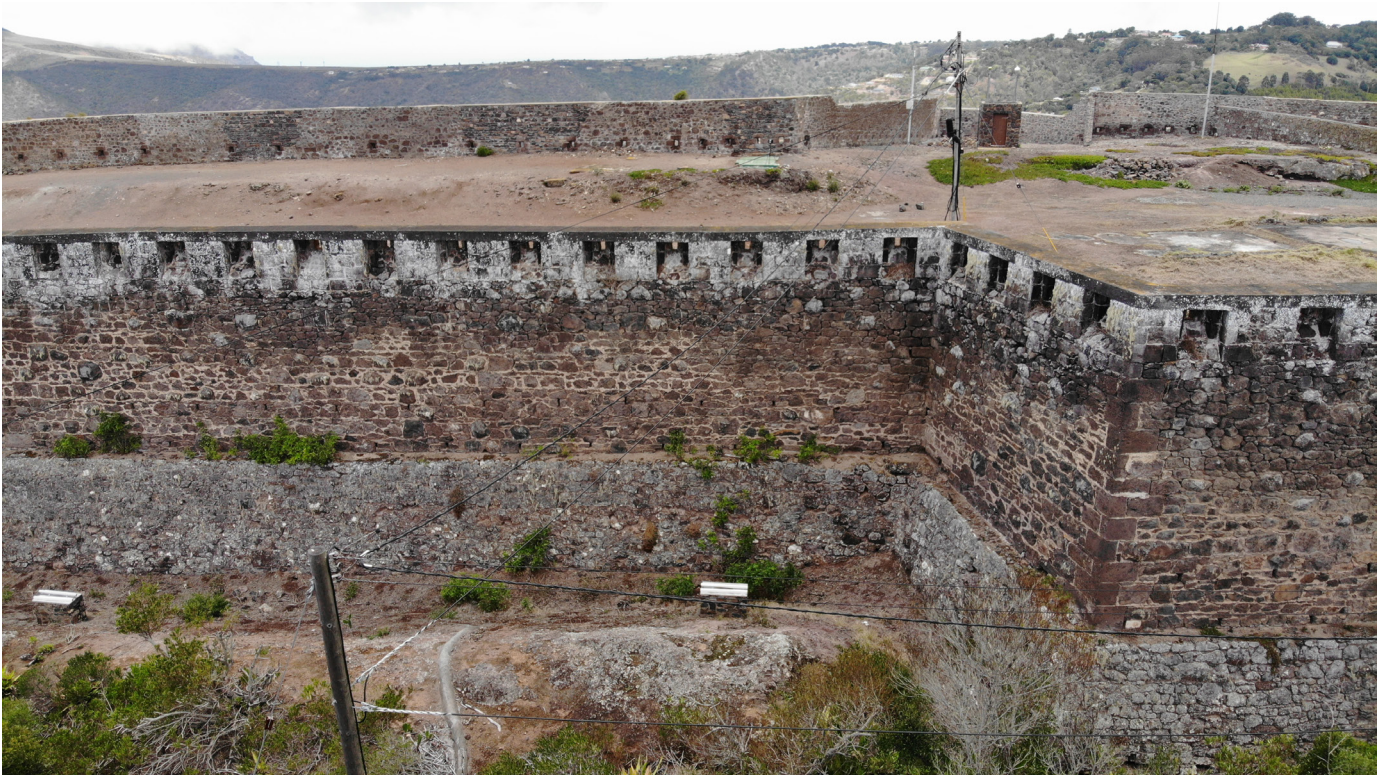
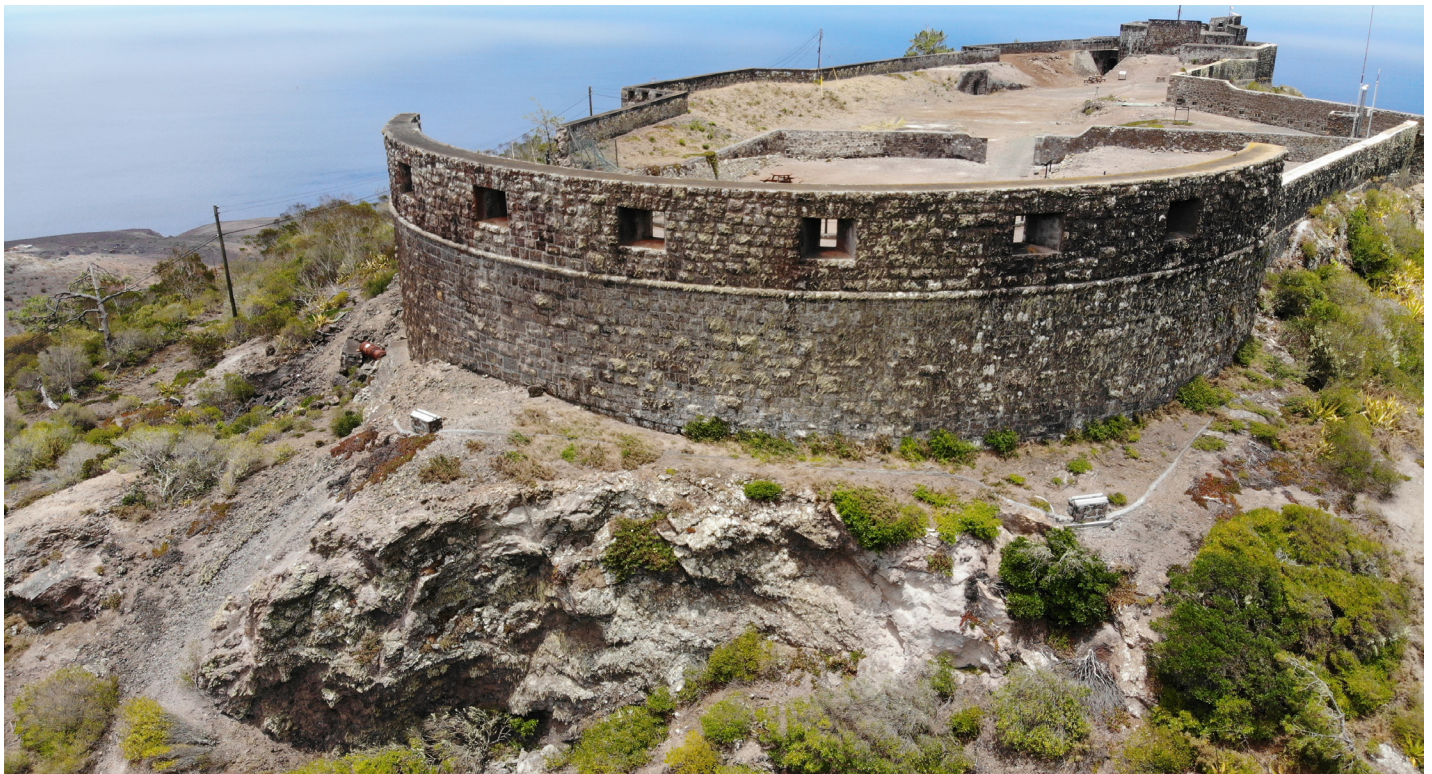
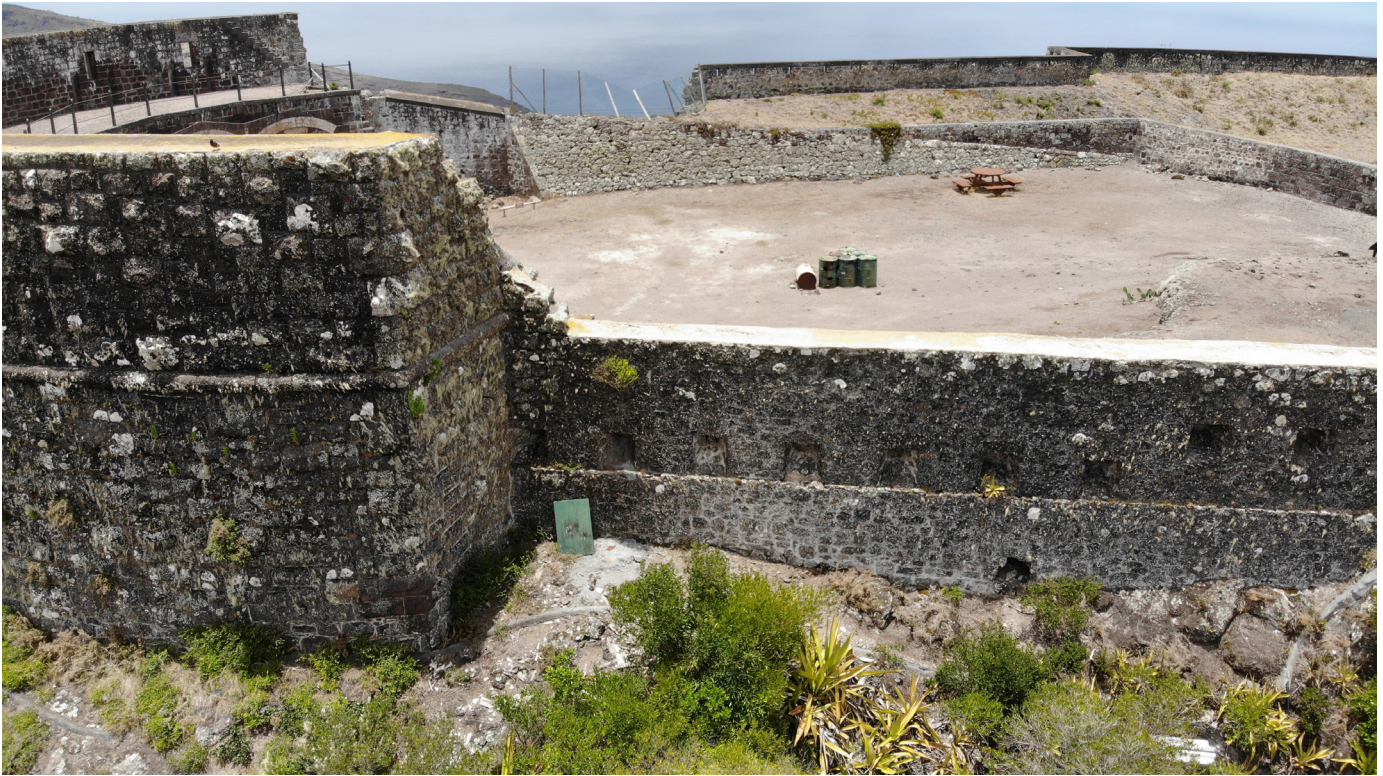
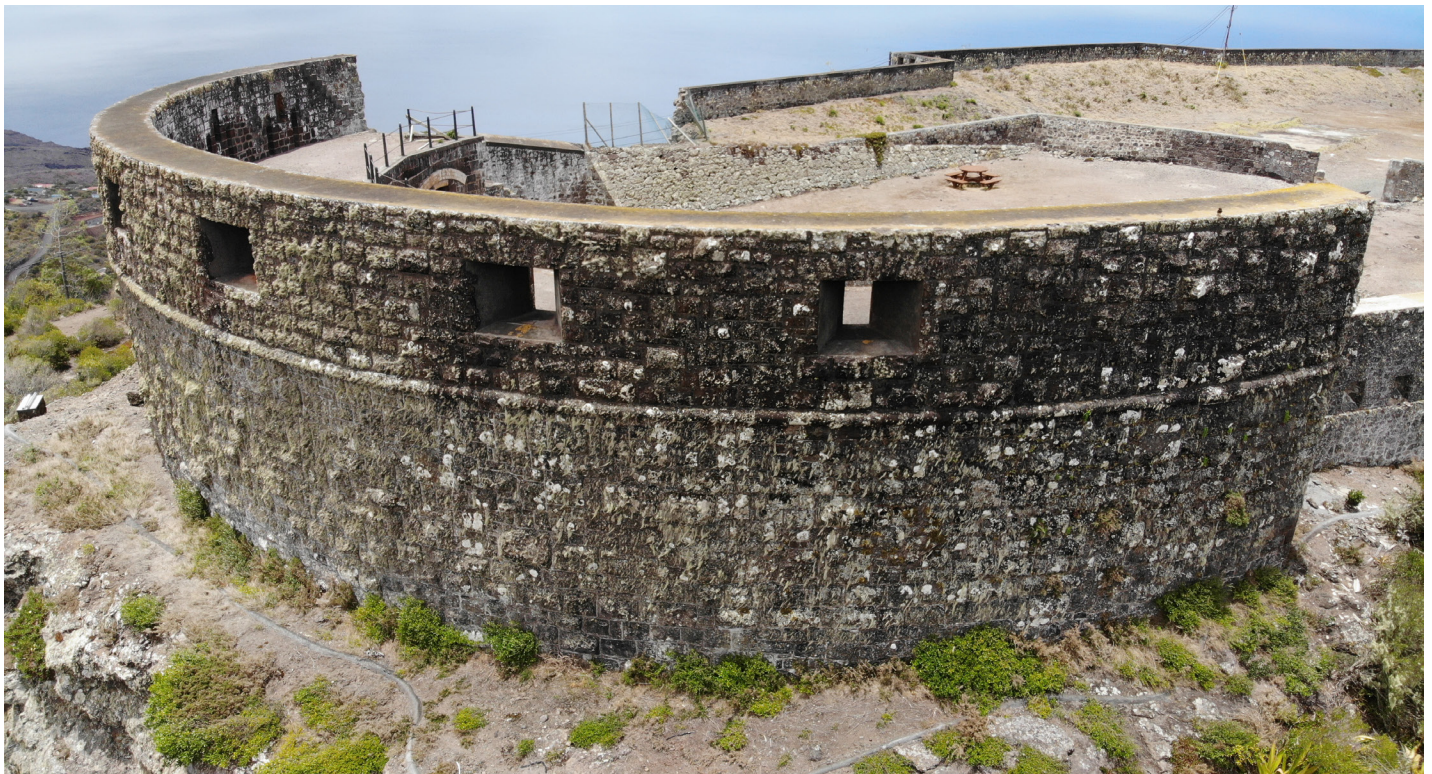
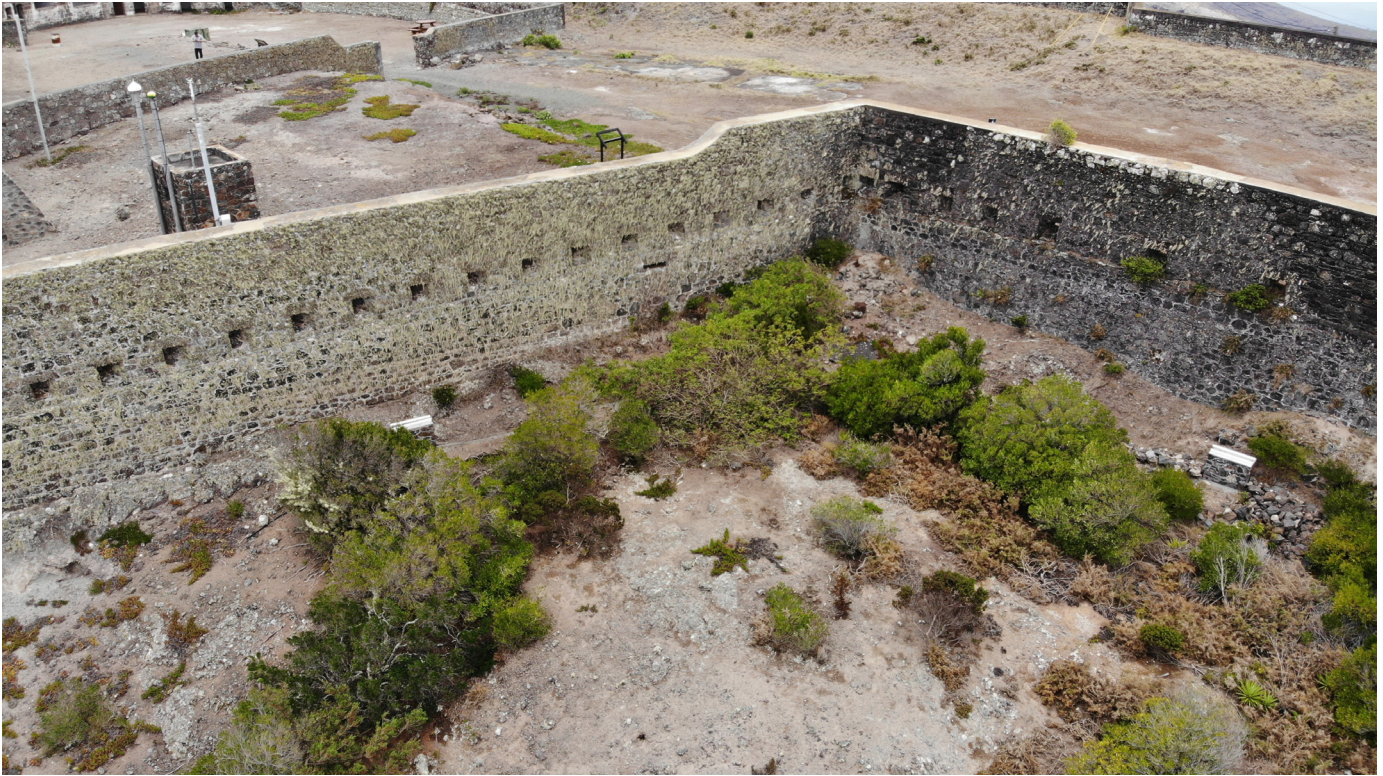
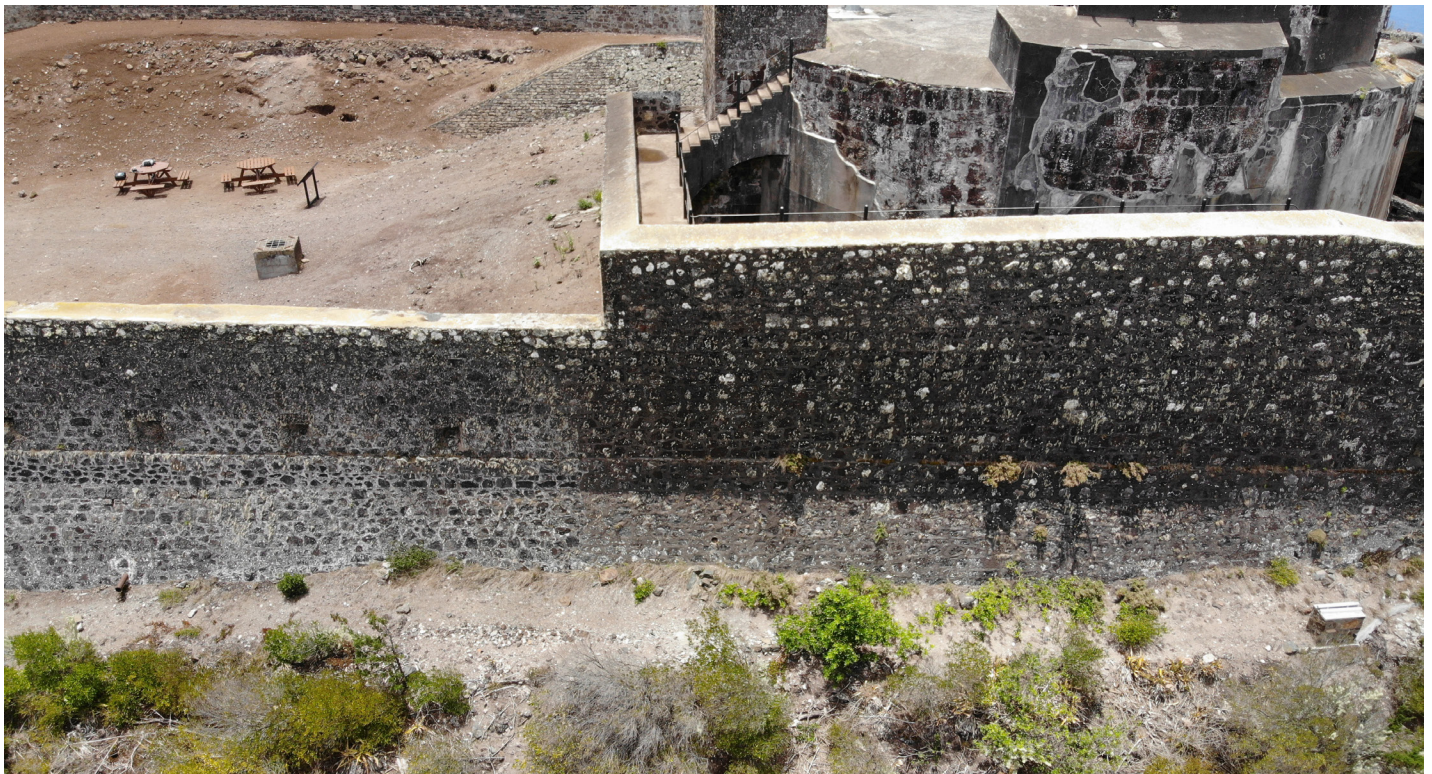
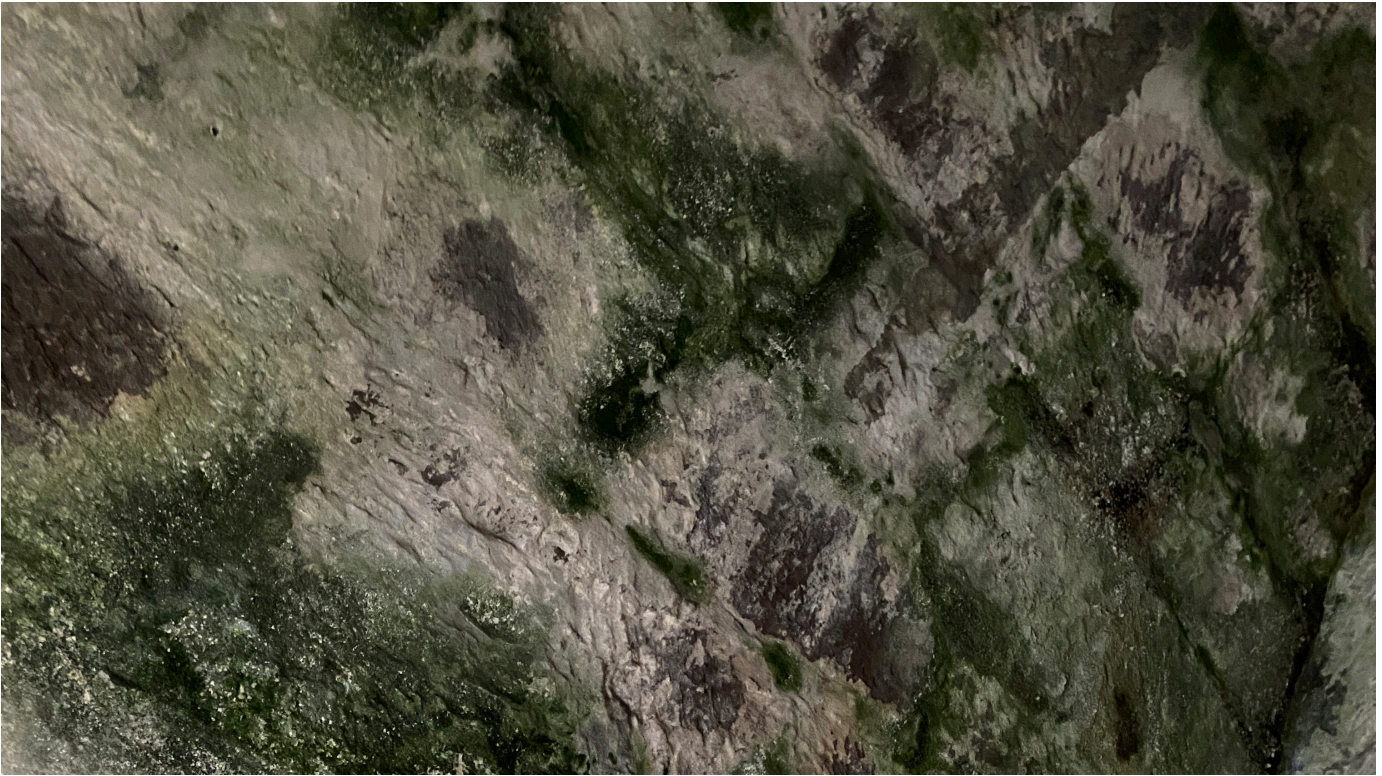
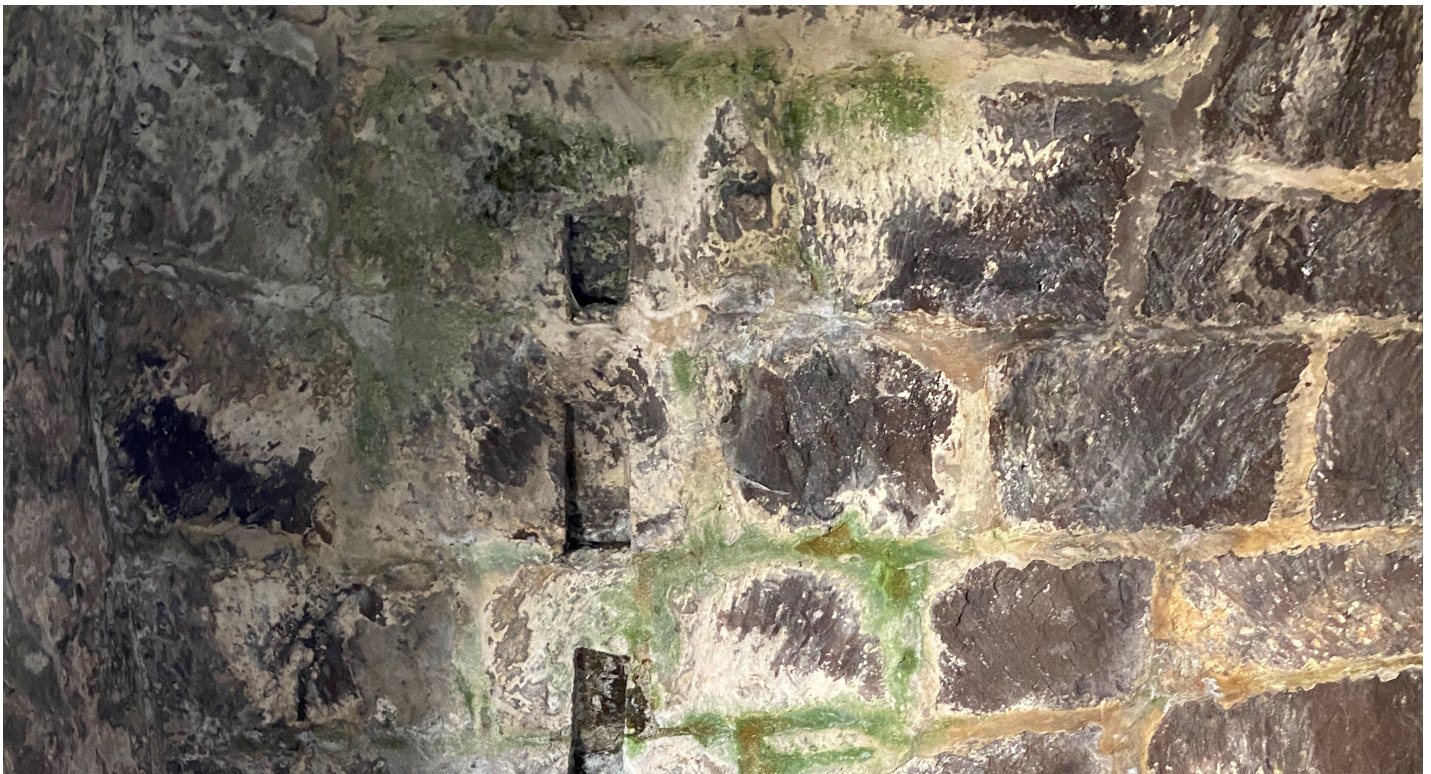
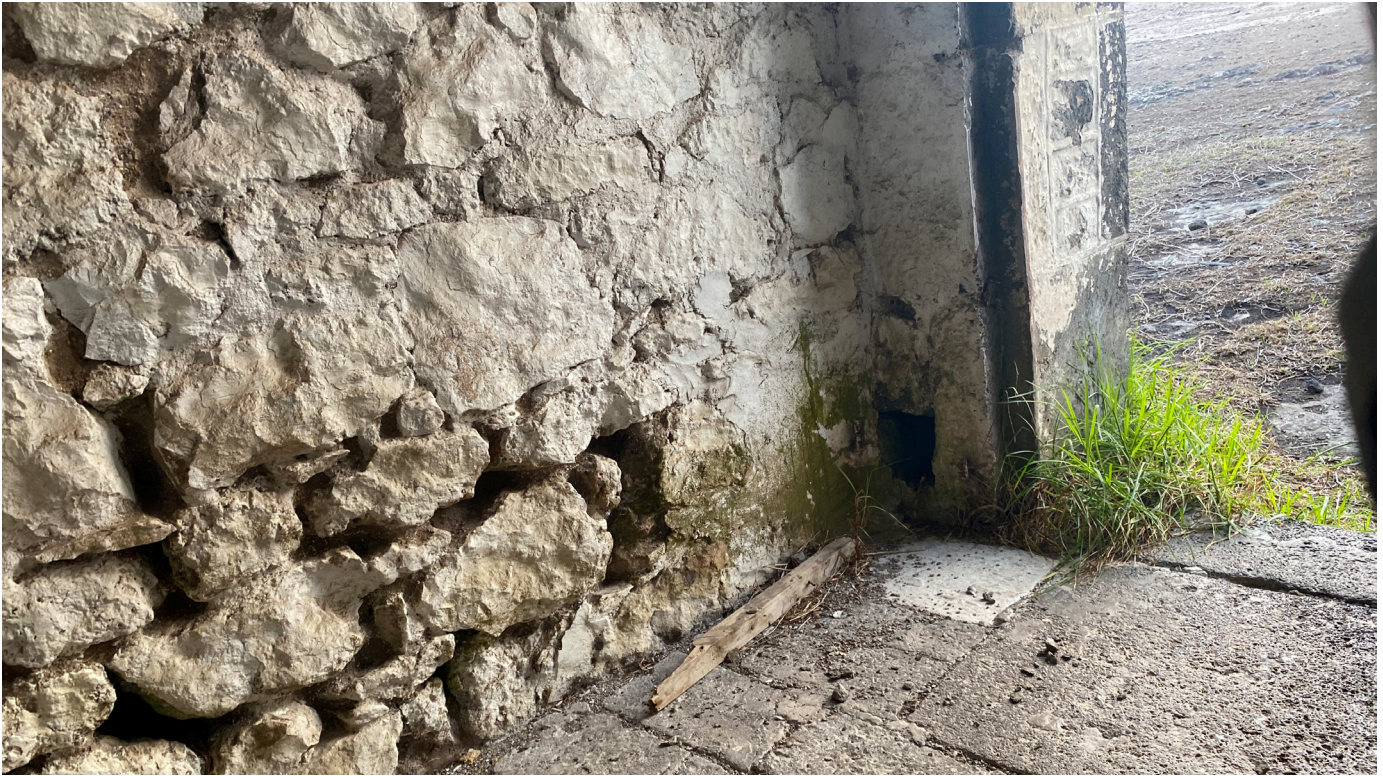
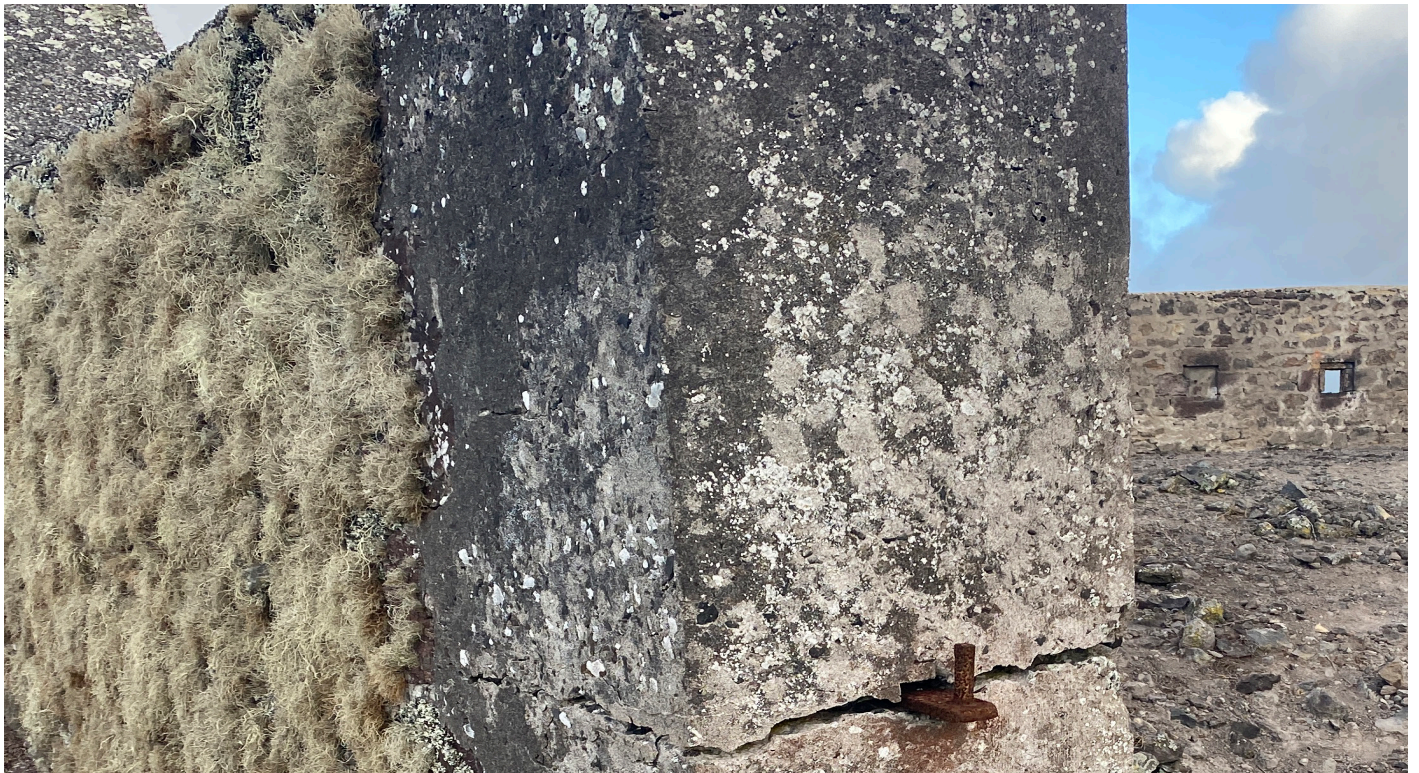
Bio-growth occurs intermittently on several areas of High Knoll Fort, particularly in areas where water pools. In the southern barracks, uneven floors allow water to pool after rain events. Still too, non-structural wall cracking allows water infiltration from the walls and through the ceiling above. In the northern armory and magazine rooms, non-structural cracking has similarly allowed for water intrusion and invading bio-growth. Large amounts of bio-growth are also present in the dry-laid stone walls on the fort's interior (see Recommendation 2). Due to the size of the plants growing from the wall, the roots of the bio-growth likely penetrate deeply into the substrate. Bio-growth is also present on the flat surfaces such as the concrete caps on the walls.

Figure 46: Aerial image of bio-growth on the top surface of the southern firing platform (Image: B. Fortenberry).

Figure 47: Aerial image of bio-growth on the exterior western wall (Image: B. Fortenberry).

Figure 48: Aerial image of bio-growth on the southern bastion (Image: B. Fortenberry).

Figure 49: Aerial image of bio-growth on the eastern wall (Image: B. Fortenberry).

Figure 50: Aerial image of bio-growth on the southern bastion (Image: B. Fortenberry).

Figure 51: Aerial image of bio-growth on the eastern wall (Image: B. Fortenberry).

Figure 52: Aerial image of bio-growth on the northeastern wall (Image: B. Fortenberry).

Figure 53: Detail of bio-growth in the armory in the northern tower (Image: B. Fortenberry).

Figure 54: Detail of bio-growth in the magazine in the northern tower (Image: B. Fortenberry).

Figure 55: Detail of bio-growth in the barracks in the southern complex (Image: B. Fortenberry).

Figure 56: Detail of bio-growth on the interior fort wall (Image: B. Fortenberry).

1. Physically remove bio-growth using non-mechanical means (e.g., soft plastic or hair bristle brushes, wooden tongue depressors).
2. Use a conservation-approved bio-cide such as D2 to aid in the removal and prevent the additional growth of the bio-growth. Care should be taken in the removal of bio-growth from dry-laid stone walls as roots will extend into the wall fabric. Their removal could dislodge smaller stones.
3. In cases of non-structural cracking that is allowing the invasion of bio-growth, consult a conservator for use of restoration mortar to fill cracks.
4. To remove soiling and bird waste from the substrate, standing walls using a low-pressure water wash. Under no circumstances should a pressure washer.

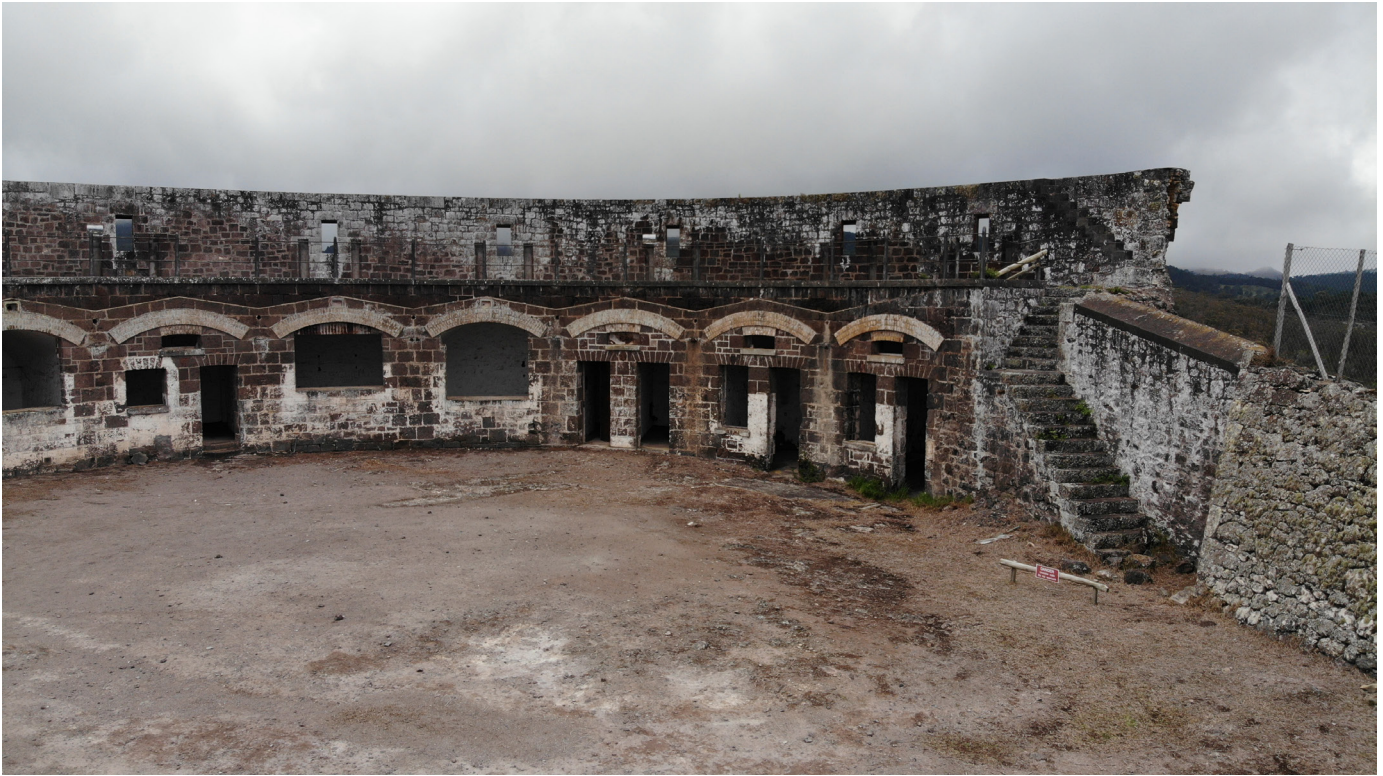
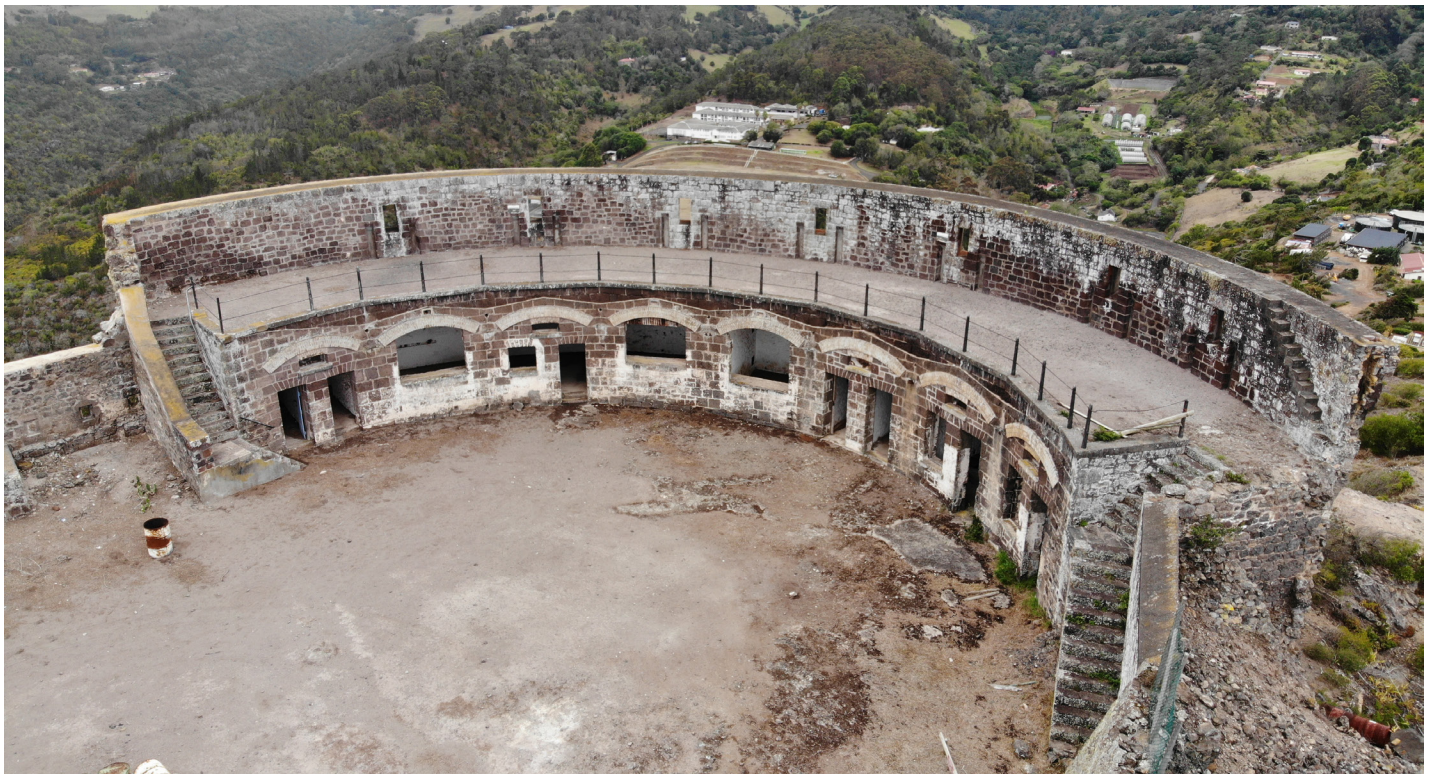
Soiling has occurred from constant wind activity depositing on the standing walls and platforms.

Figure 56: Soiling on the interior wall of the southern complex (Image: B. Fortenberry).

Figure 57: Aerial image of soiling on the interior wall of the southern complex (Image: B. Fortenberry).

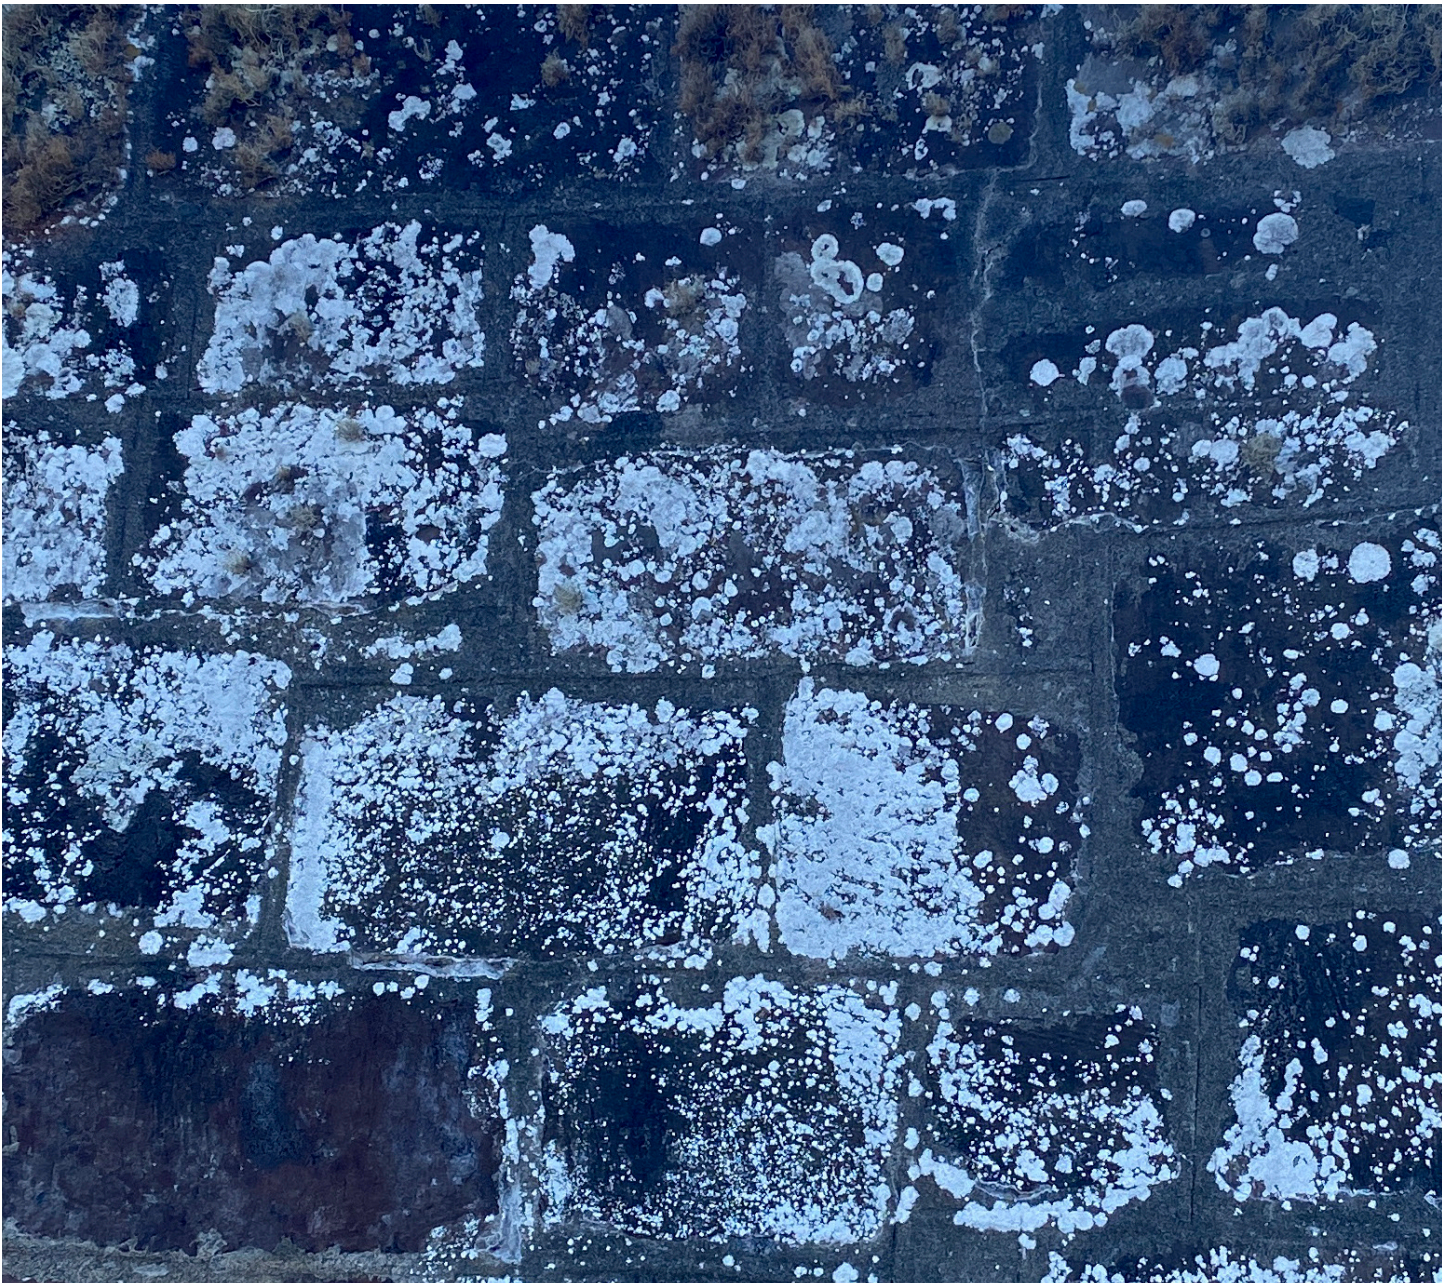
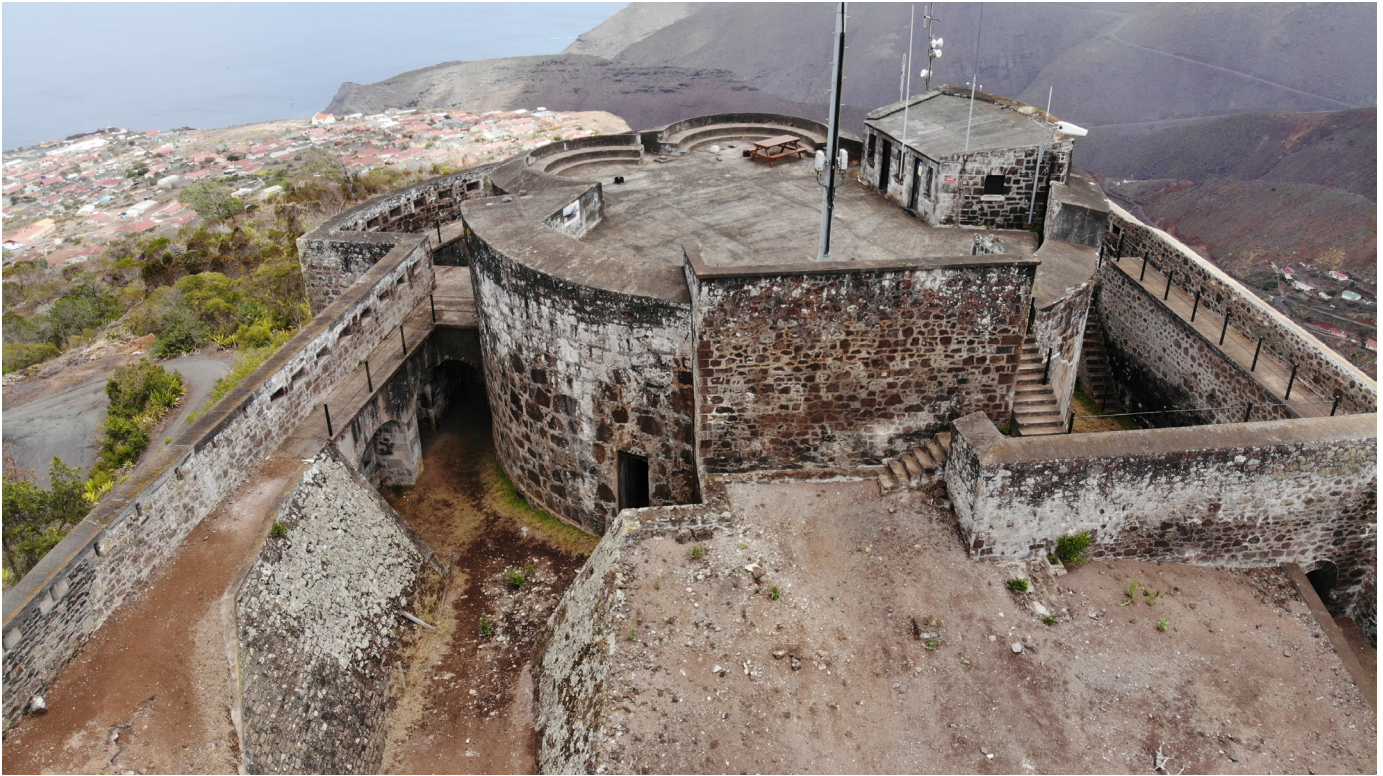
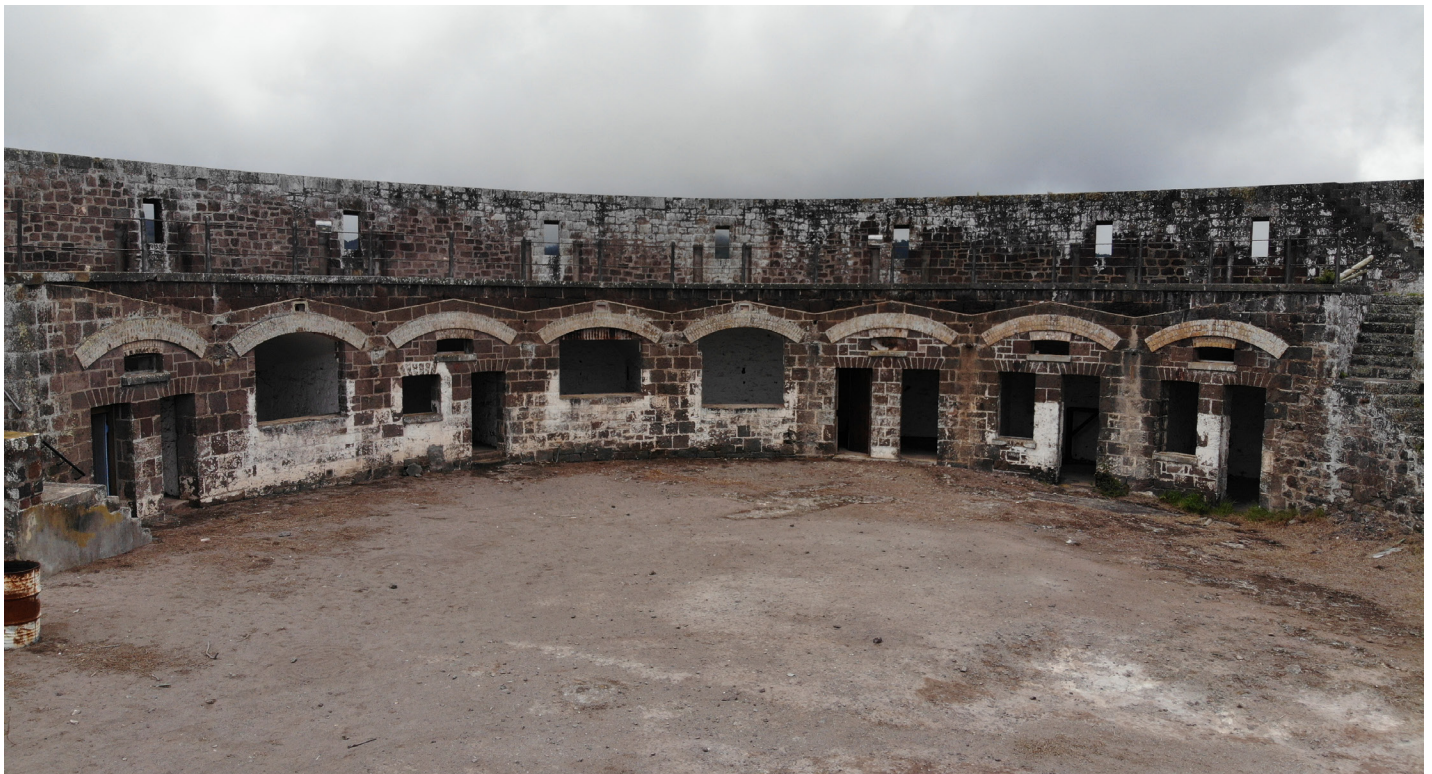
Salt build-up (efflorescence) due to the proximity to the ocean, this site is located in a marine environment. It will be impossible to prevent the build-up of salt on this site. It is primarily located on the southern firing platform. While not necessarily detrimental to the substrate, efflorescence can be unattractive.

Figure 58: Efflorescence detail on the firing platform of the southern complex (Image: B. Fortenberry).

Figure 59: Efflorescence on the southern face of the northern tower complex (Image: B. Fortenberry).

Figure 60: Efflorescence on the northern face of the southern firing platform (Image: B. Fortenberry).

1. If build-up becomes excessive, use a plastic bristle brush to gently remove salt from the substrate. Efflorescence is a natural process that allows the salt to escape the substrate. Under no circumstances should a water-proofing coating be applied to the substrate.
