Documentation and Conditions Assessment of High Knoll Fort, St. Helena (CHC-2020-01-01)

**Report prepared for the British Napoleonic Bicentenary
Trust and St. Helena Government**

**Brent R. Fortenberry, Associate Director, Center for Heritage Conservation
Jane Ashburn, Architectural Conservator**

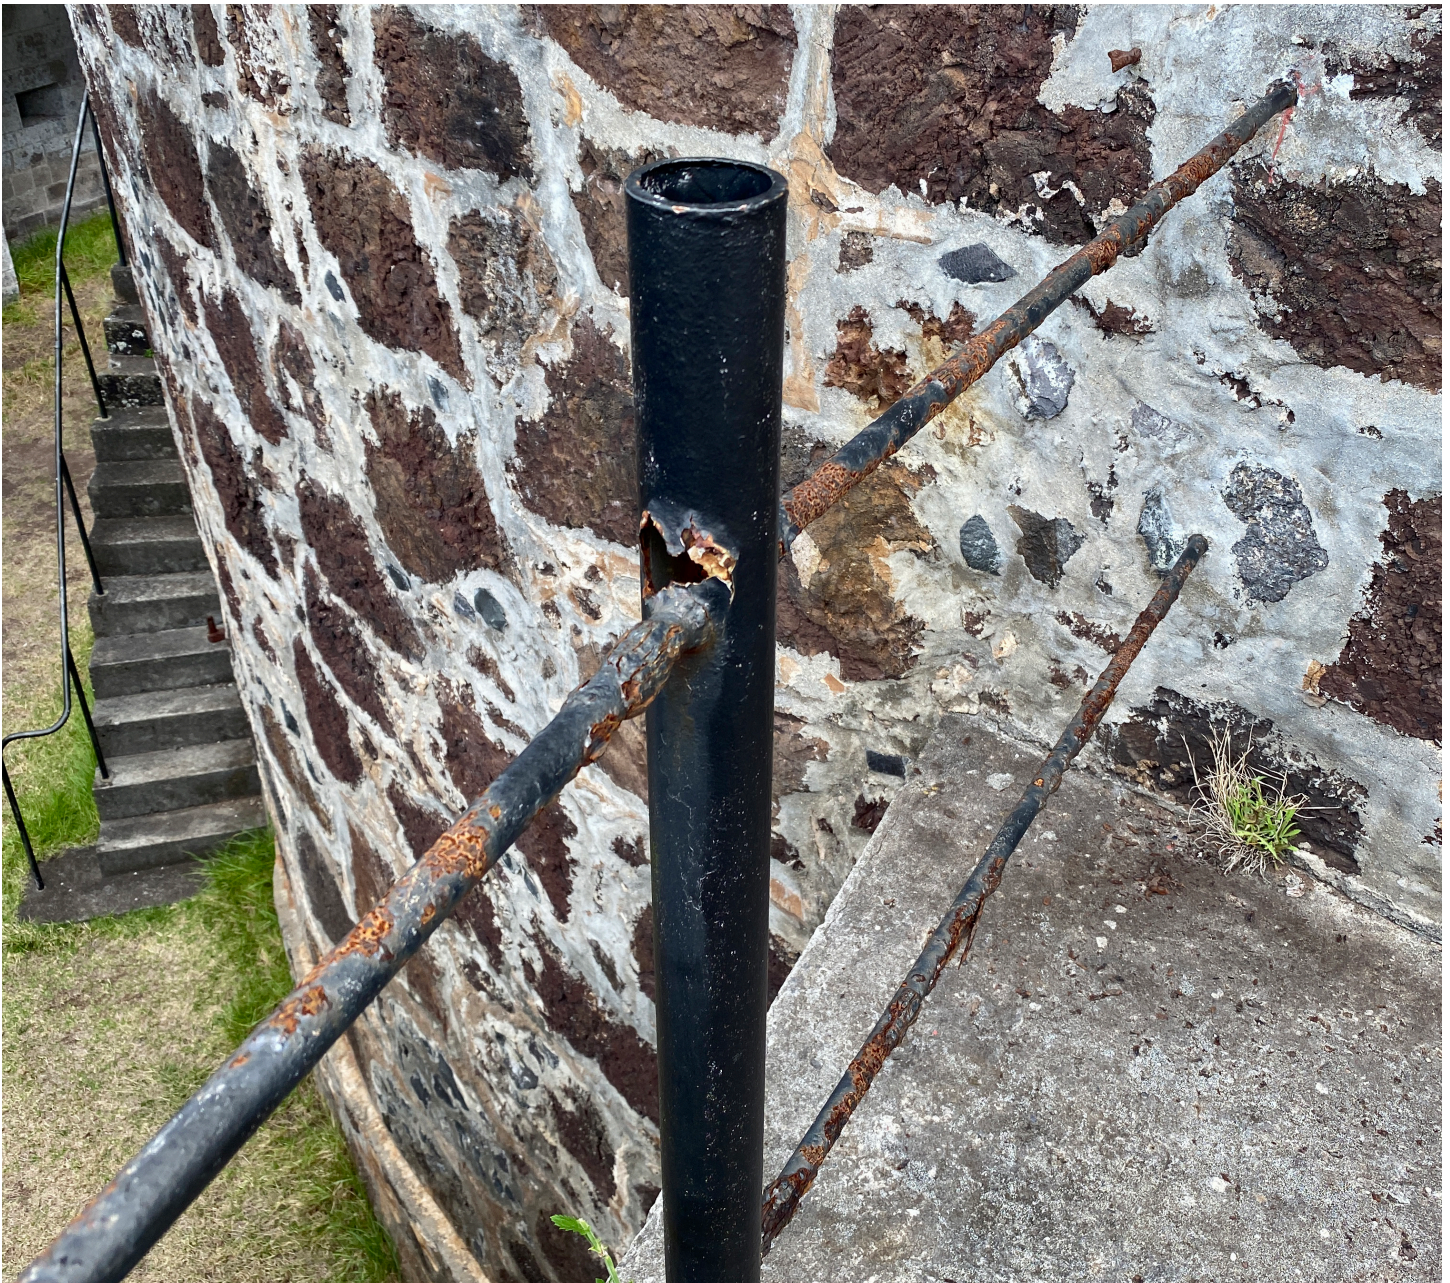
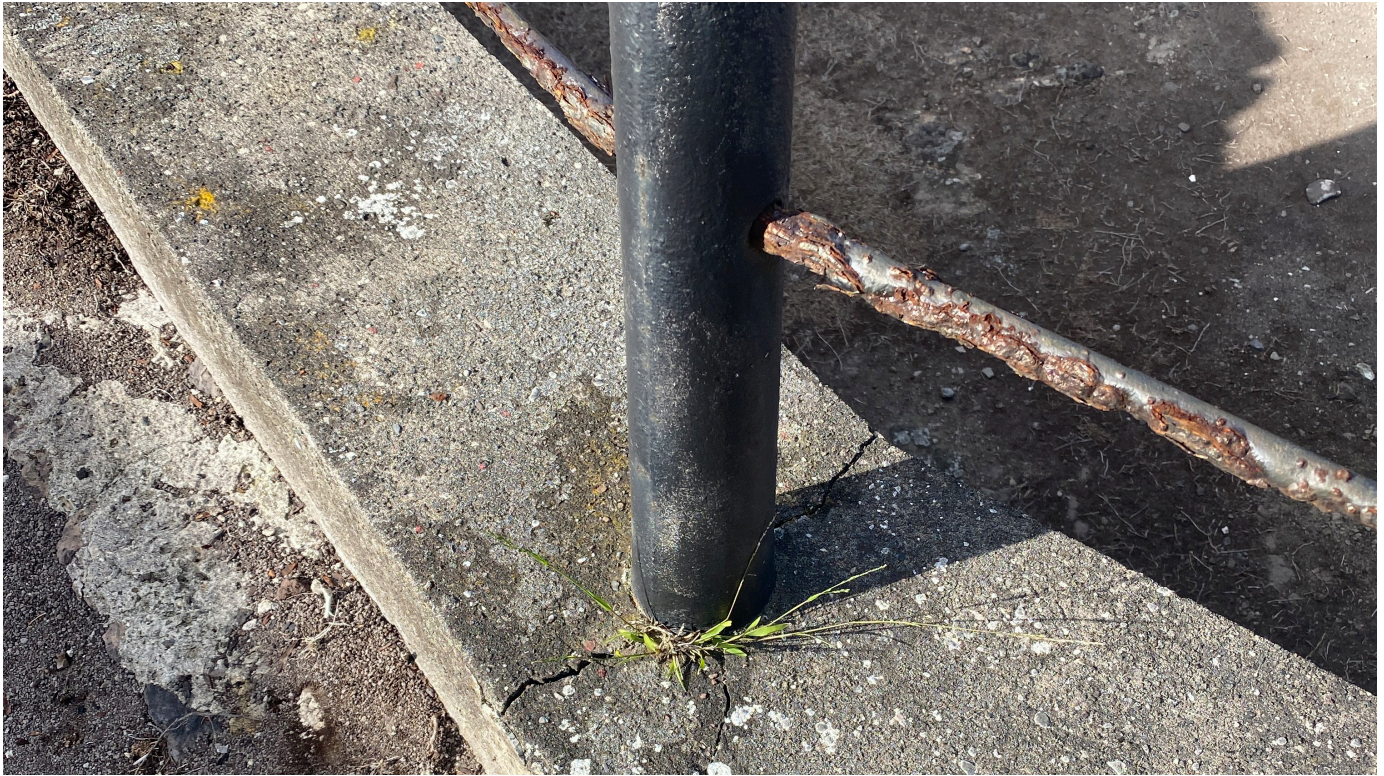
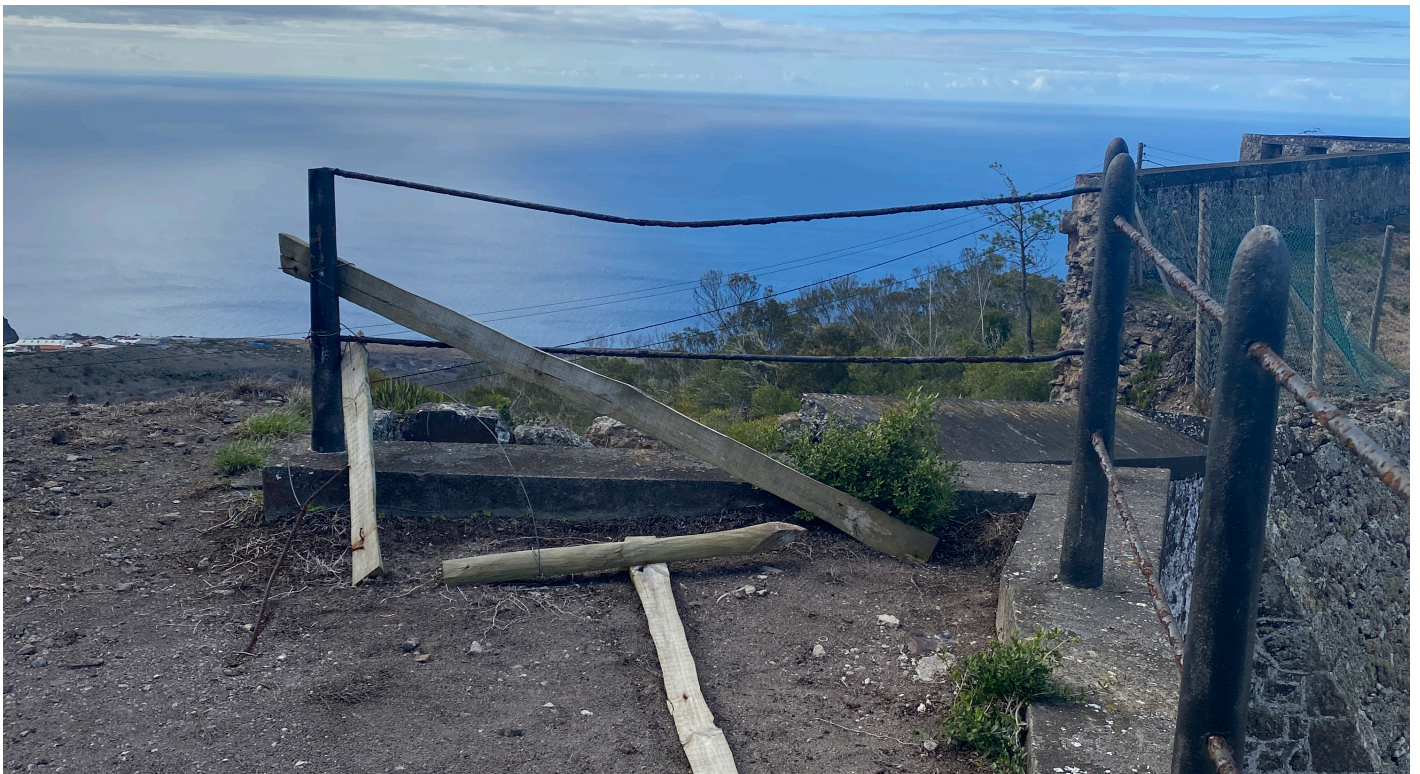
Cast iron guard rails on the southern firing platform are placed within a cast concrete footing. The guard rails consist of piers connected by two thin metal rails. Some of the rails are bent. Due to the combination of metal, concrete, and marine environment, the metal is experiencing heavy corrosion. This corrosion is causing several issues, a) causing the coating to de-laminate from the metal substrate, and b) causing rust jacking in the concrete footing.

Figure 61: Cast iron pier and guard rail failure in northern complex (Image: B. Fortenberry).

Figure 62: Cast iron pier failure and rust jacking in concrete footing on southern firing platform (Image: B. Fortenberry).

Figure 63: Cast iron pier and guard rail failure on southern firing platform (Image: B. Fortenberry).

1. Remove any loose metal elements from the guard rail. Use a rust converter to consolidate areas of corrosion, and re-coat with a marine environment approved appropriate coating. This coating should match the existing colors. If the original color is unknown, finish analysis by an architectural paint conservator is recommended.
2. Remove any loose fragments of concrete, and reattach them using appropriate restoration mortar. Using restoration mortars seal the bases of each loose pier.
3. Consult with historic cast-iron metals expert who can restore original form to bent piers and replace missing elements. New elements should be replaced in similar historic form and color.
4. The placement of these metal elements ensures the health and safety of visitors on the firing platform. If additional guard rails are installed, care should be taken that they match the historic examples.

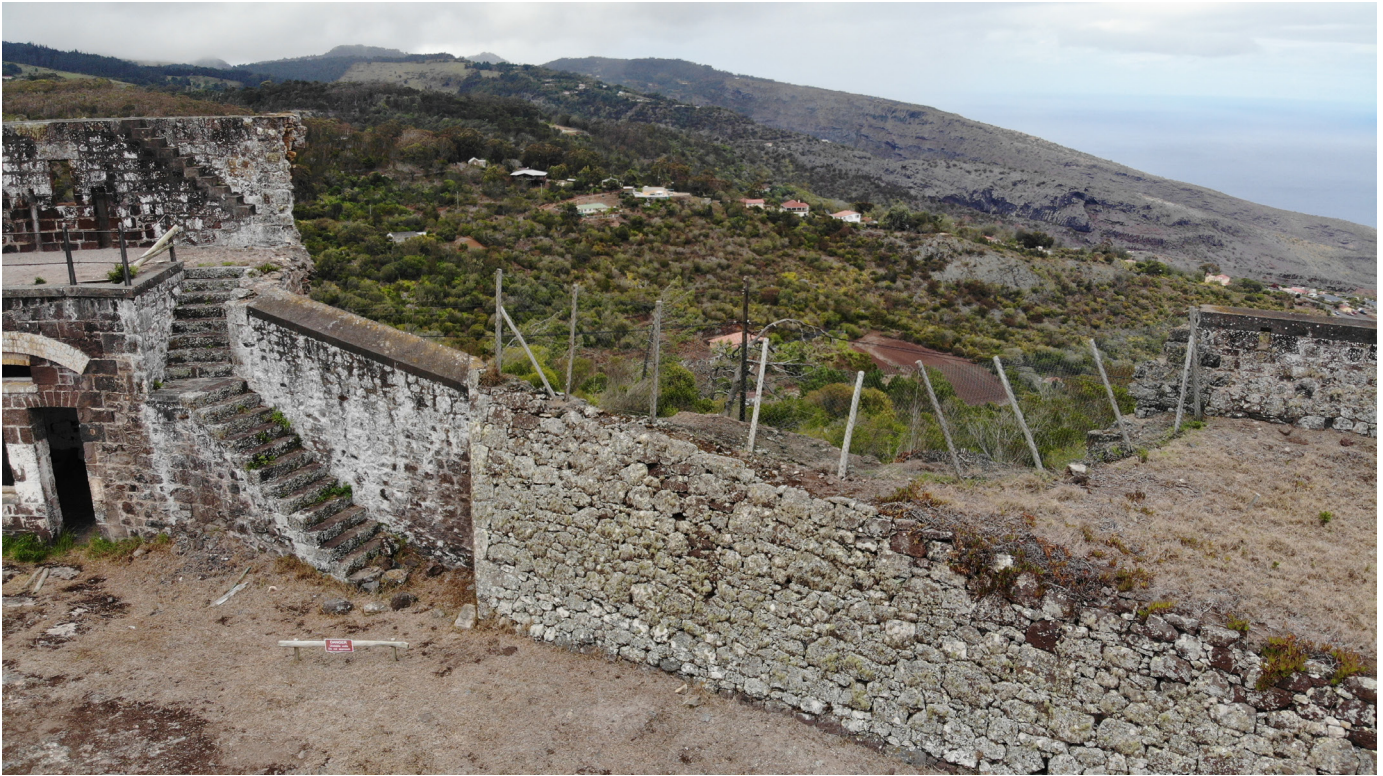
Figure 65: Danger sign and failing fencing near southwestern wall collapse (Image: B. Fortenberry).

1. Additional lights might deter after-hours visitors to the site.
2. An after-hours gate could also impede after-hours visitations.
3. Additional signage should be installed to indicate that visitors should not climb on any stone elements, or approach the collapsed wall section.
4. Additional guard rails should be installed on the western portion of the southern firing platforms to prevent visitors from injury from falling from high stone platforms.
5. The temporary “Danger Sign” should be replaced with more obvious signage.
6. The southwestern stair of the firing platform should be cordoned off.
7. Some interpretive panels appear to be missing and need to be replaced along the eastern wall.
