# Reciprocating Compressor Crankshaft Fatigue Failure

Scott Symons,  
Air Products

**TURBOMACHINERY & PUMP SYMPOSIA**

DECEMBER 14-16, 2021

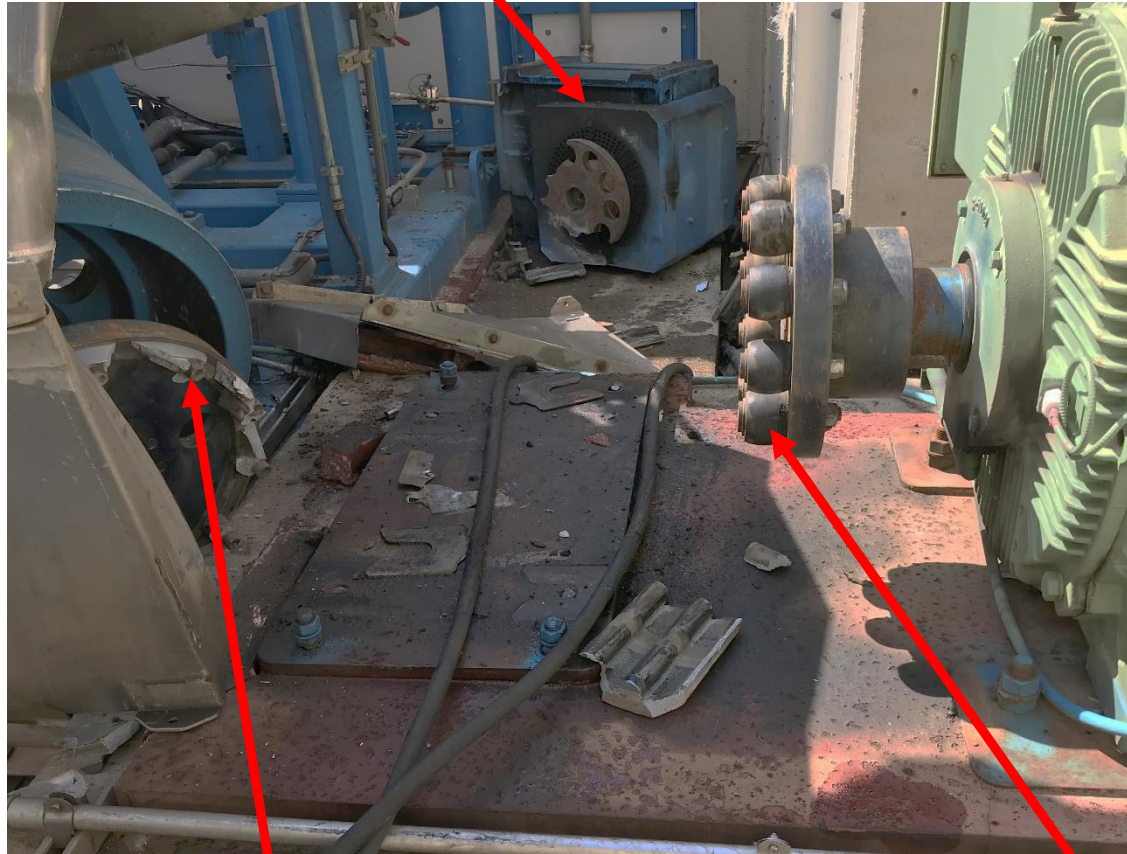
- Complete crankshaft fracture occurred between the crankcase and flywheel, significant collateral damage followed.
- The low-speed coupling broke and the gearbox hold-down bolts sheared off.
- The gearbox was thrown roughly 10 feet.
- The high-speed coupling hub slipped off the coupling elements.

Gearbox thrown 10 feet

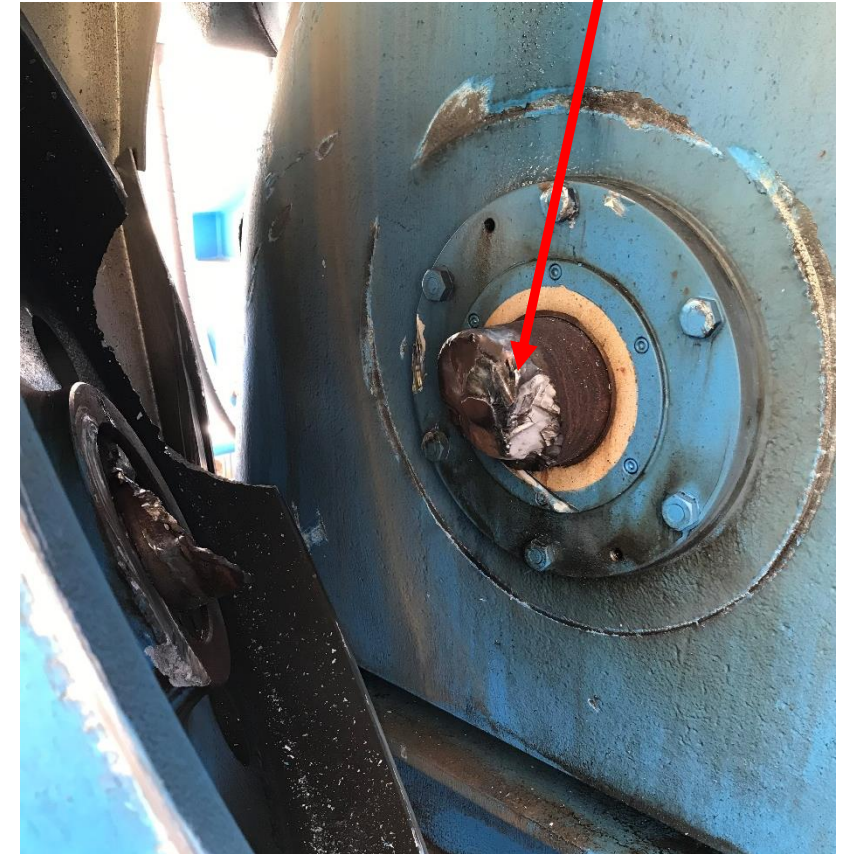
Broken low-speed coupling and flywheel

Crankshaft failed between crankcase and flywheel

High-speed coupling elements

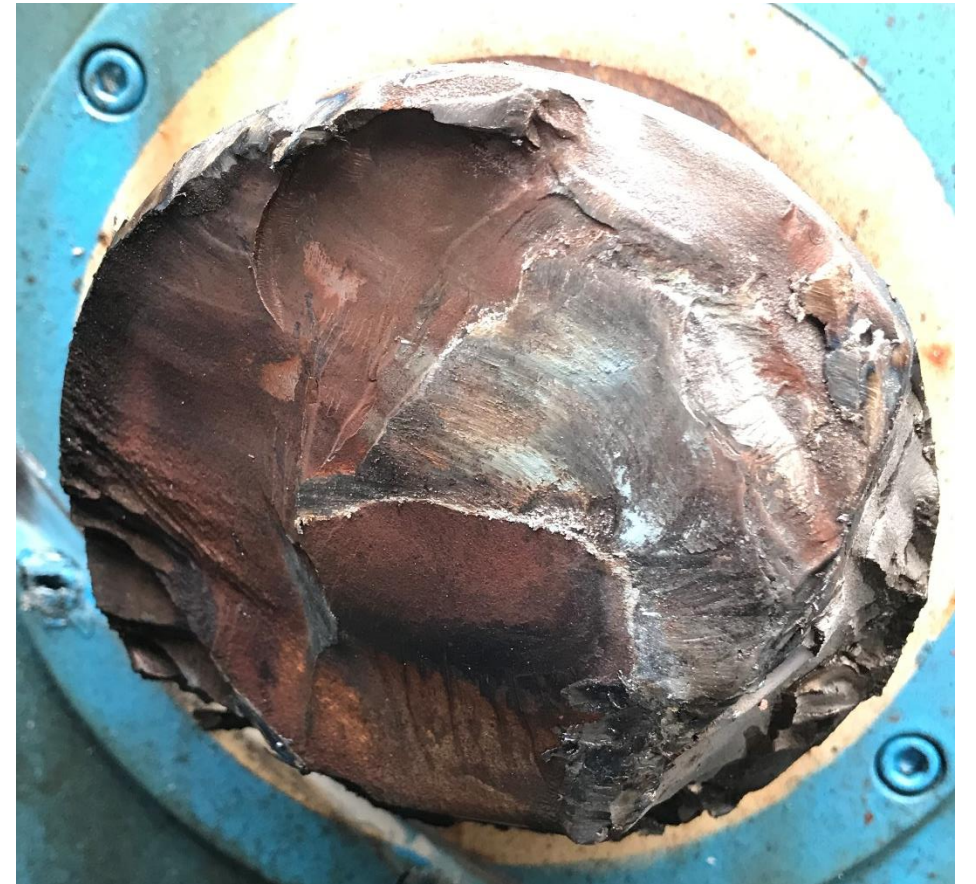
- Initial review of the compressor crankshaft showed corrosion on a significant portion of the surface area, indicating the crack propagated well before the final failure.

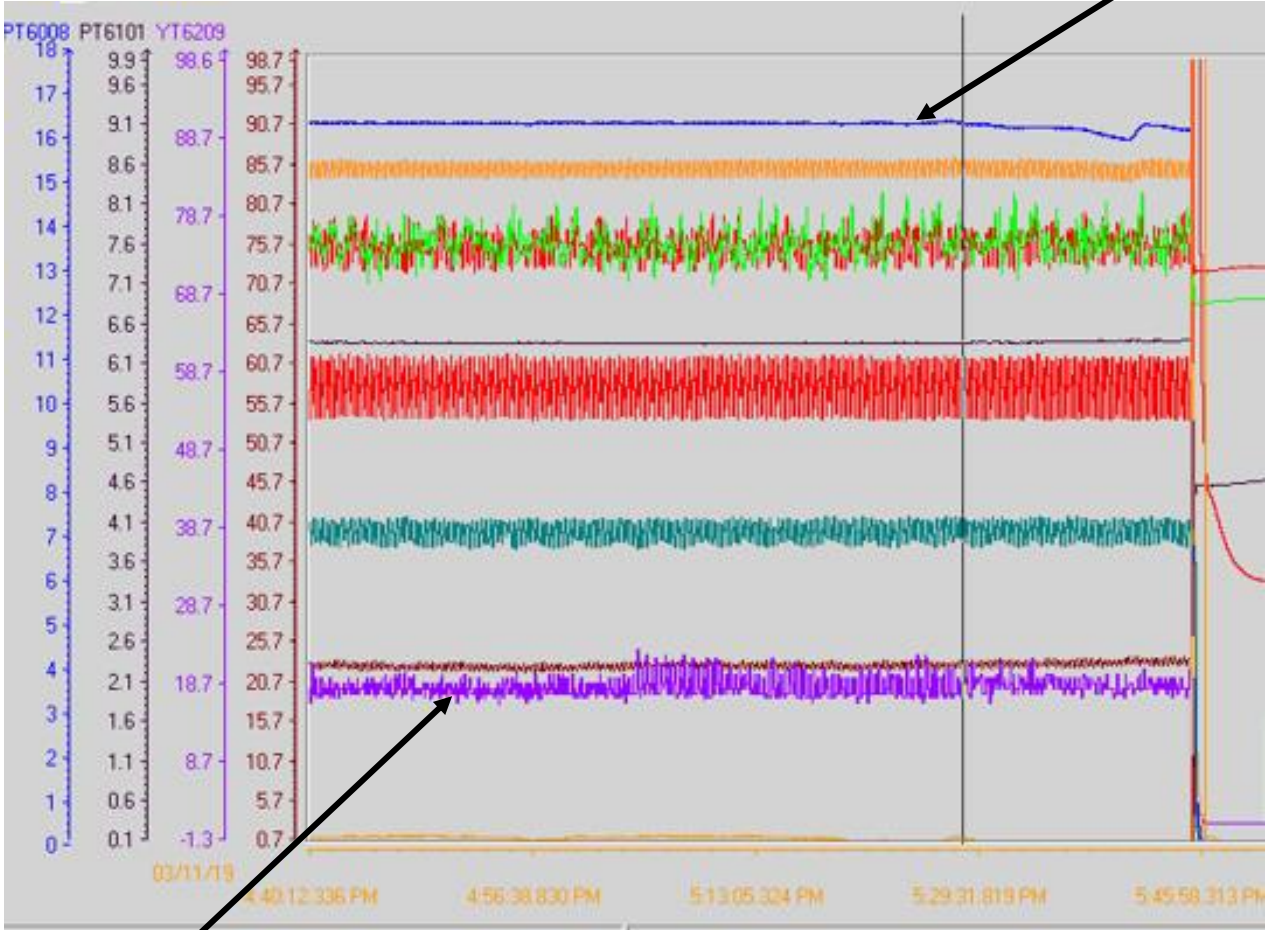
Discharge Pressure (Blue),  
Scale: 0 – 18 barg

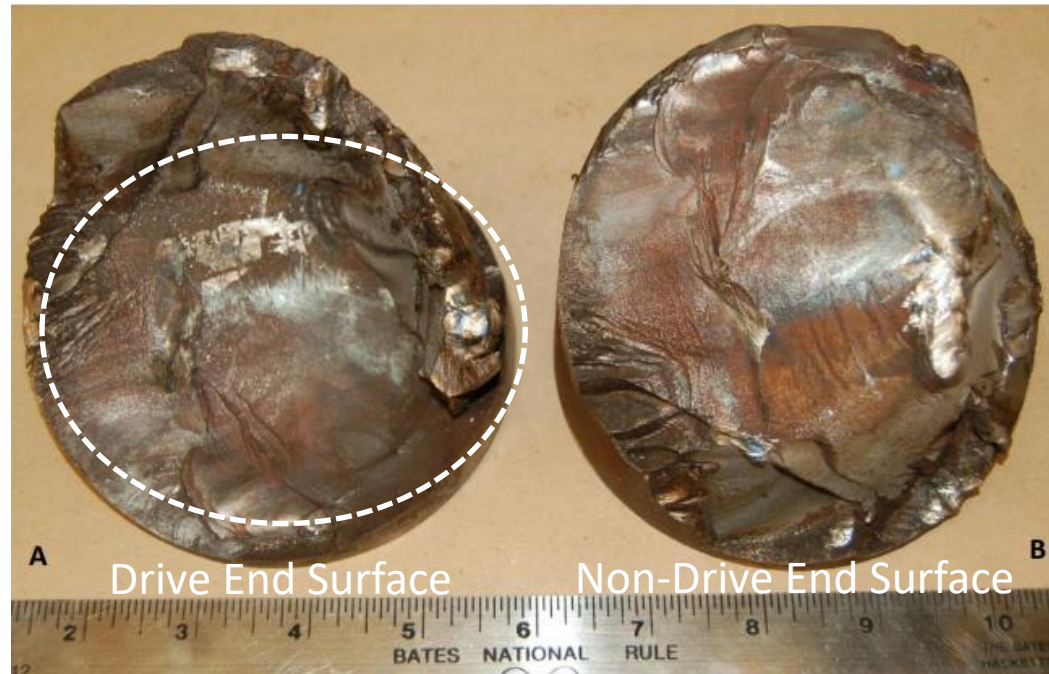
- The crank shaft had been in service for 5 years, accumulating approximately  $1.4 \times 10^9$  cycles.
- Fracture surface suggests a mixed mode of high-cycle and low-cycle fatigue failure, with the low-cycle fatigue occurring at the end.
- Significant torsional stress influenced crack growth.
- It is not believed that corrosion accelerated the crack or failure, although it allowed us to determine the crack propagated well before the failure.

Predominantly transverse to the shaft axis, upper section contains both transverse and oblique-angle fractures.

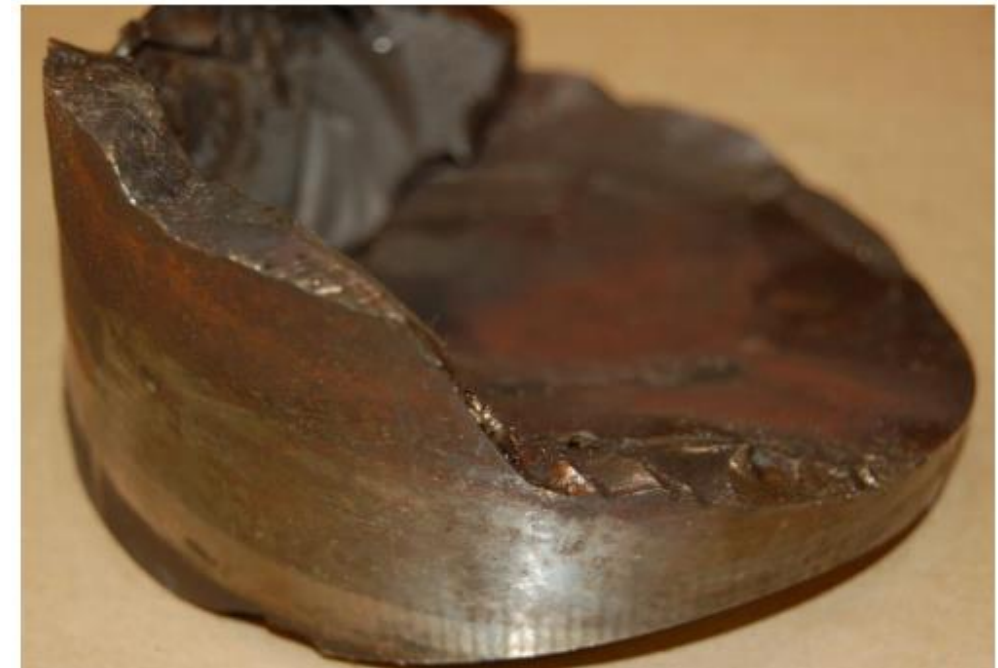
Closeup of 'A' surface showing the crack path around the periphery as a wavy pattern, indicative of a significant torsional stress influencing propagation.

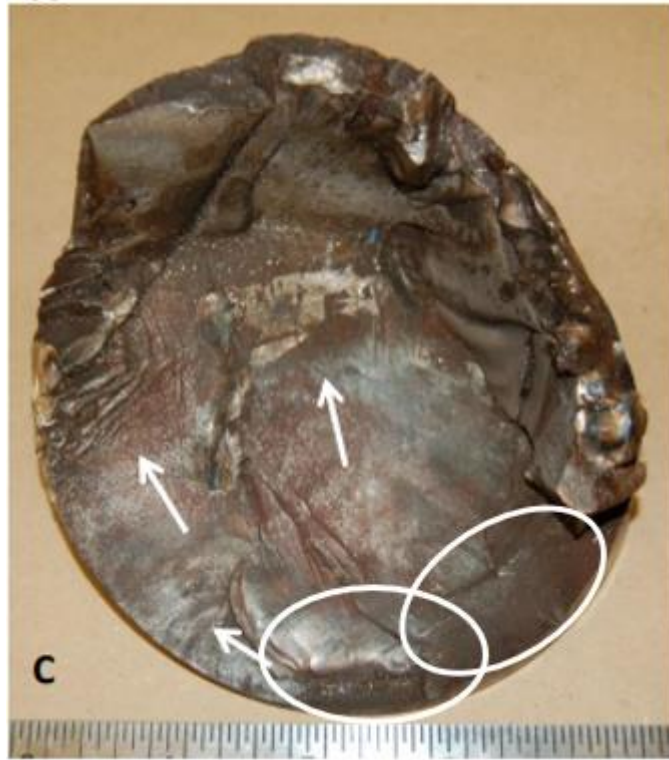
Crack initiation areas, post-fracture damage prevents further identification.

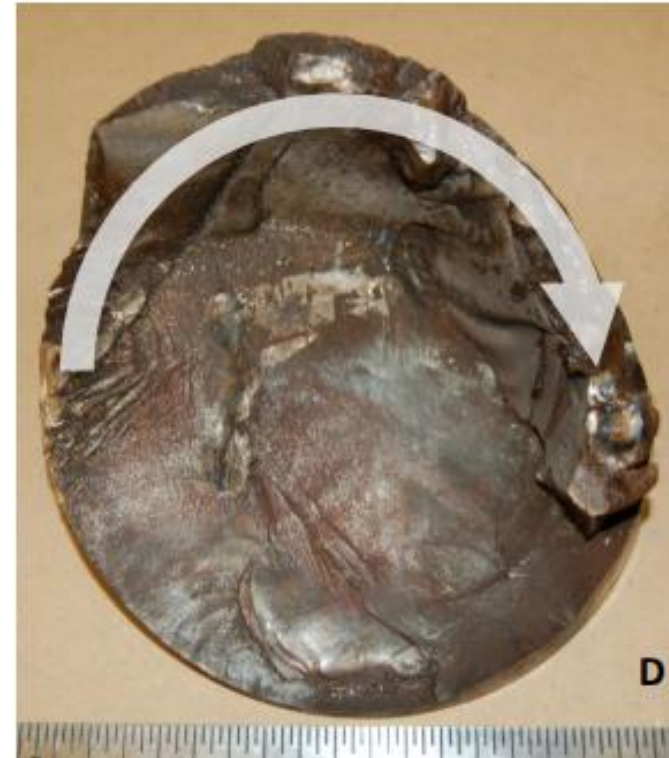
Arrow indicates a clear rotational component to the propagation of the end of the failure.
