## TURBOMACHINERY & PUMP SYMPOSIA

# Troubleshooting of Start-up for Rerated & Old Steam Turbine

# Problem Statement

During the start-up of an old steam turbine (about 30 years old), that was internally revamped, it was tripped due to high rotor vibrations.

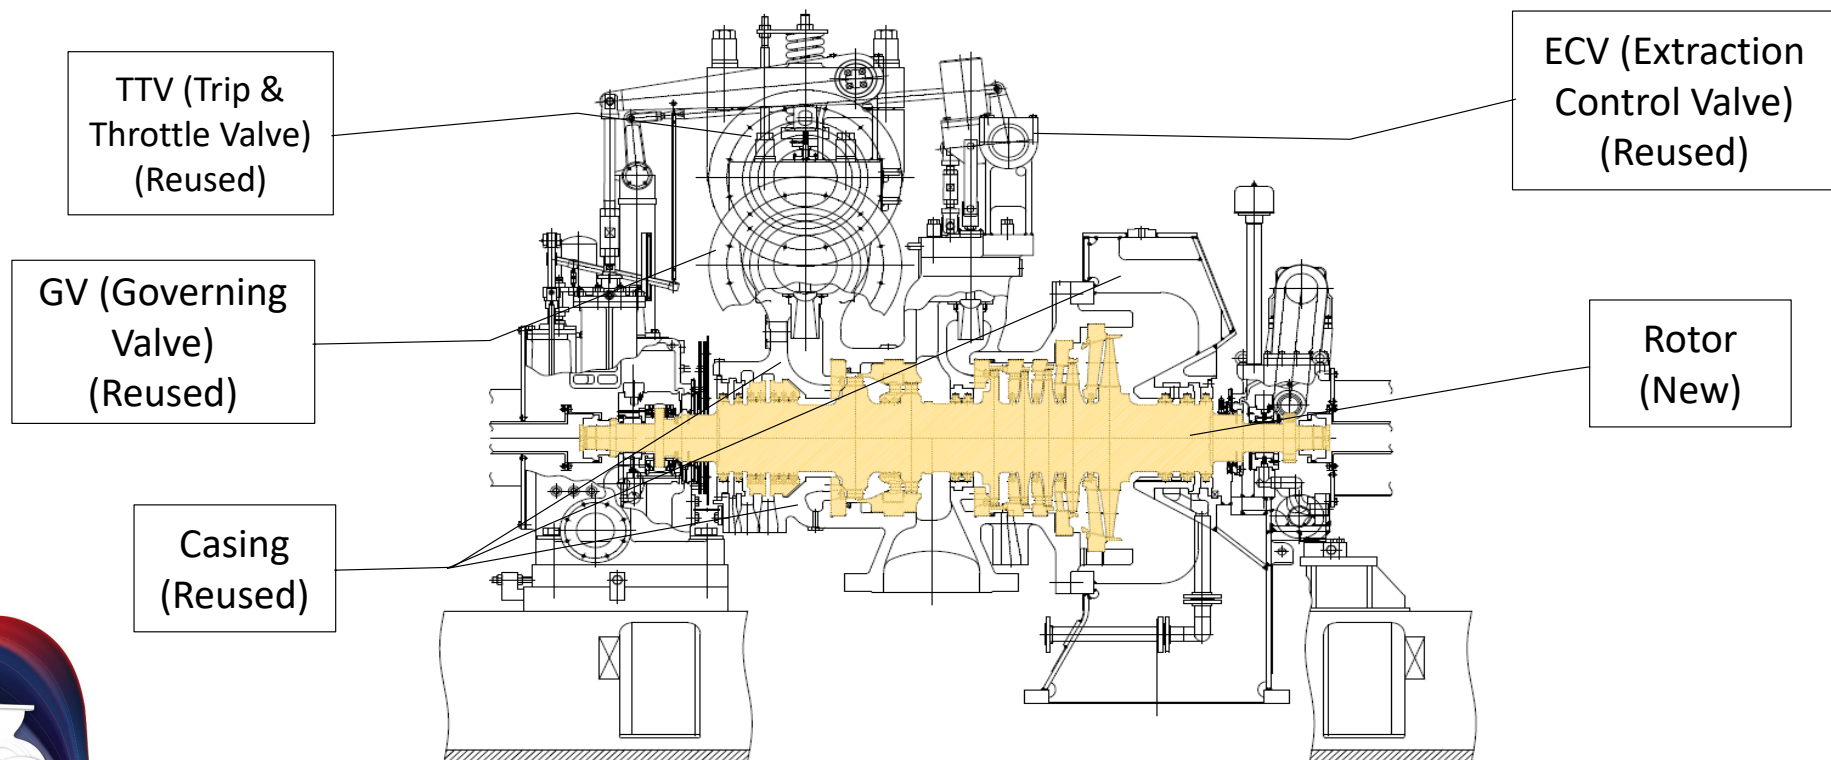
Figure-1 : Internal Revamp Modifications

- In Fig-1, the highlighted parts (yellow) are revamped, and the remaining parts are reused.

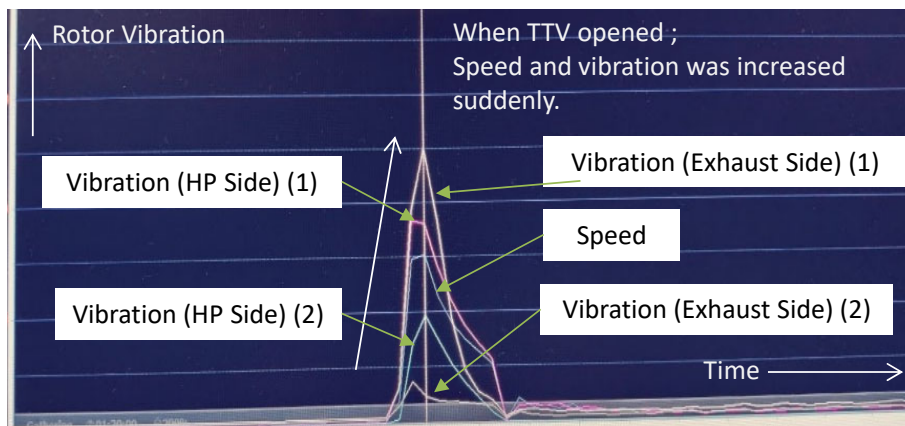
Figure-3 : Speed & Vibration Trend for 1<sup>st</sup> Trial

- Multiple trials were conducted by TTV start-up (speed increase by manual operation).
- In the 1<sup>st</sup> trial (Fig-3) there was a sudden increase in speed and vibration (Speed increase upto 4 times the target speed).
- After every trial, residual unbalance record showed varying rotor deformation.

Remarks : Similar trend was observed for next 3 trials

Quality of manual start-ups depends on the operator skill. Therefore, this phenomenon (rubbing due to the sudden speed ramp up) may be occurred in the past operation. It is required to turn (open direction) the TTV handle slowly to prevent the sudden speed ramp up. Operator has to turn (close direction) the handle of TTV immediately when the rotor start the rotation to prevent the sudden speed ramp up. The sudden speed ramp up is occurred due to the friction of bearing is reduced from the large static friction to the small dynamic friction. The great skill is required for these operator activities (slowly open and quick close).

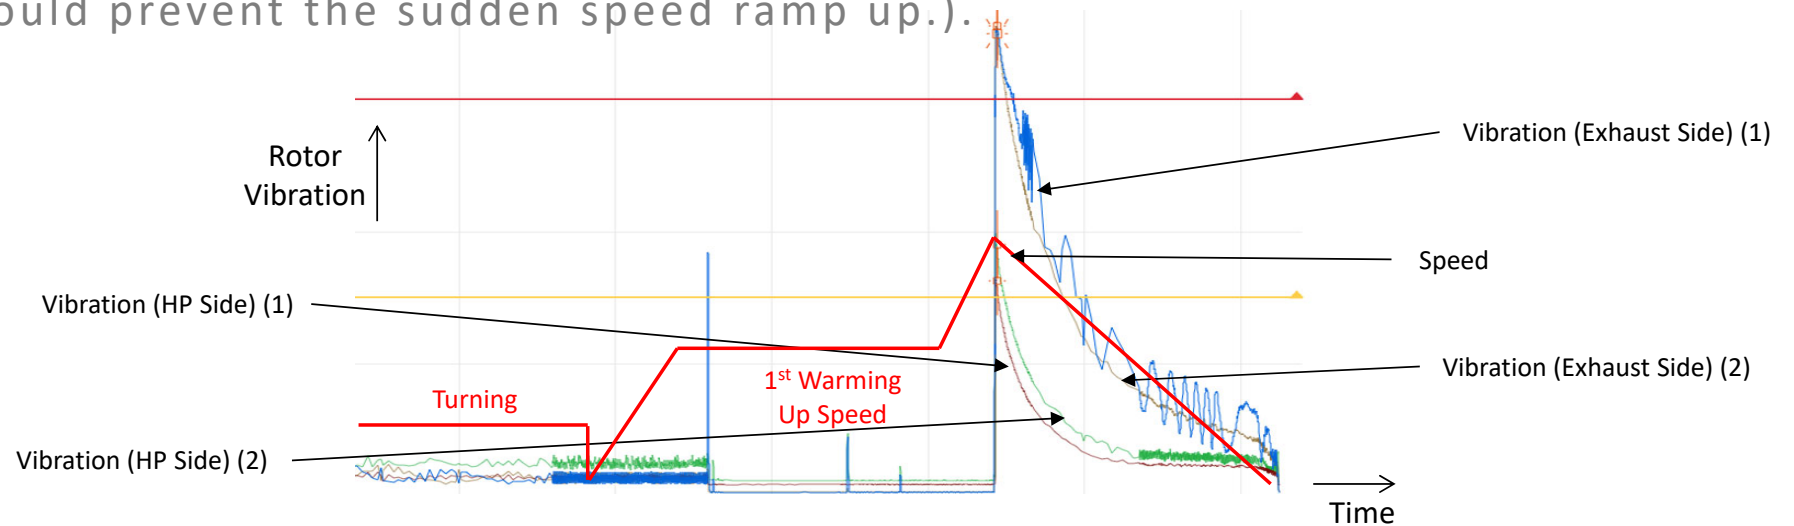
- Due to abnormal increase in rotating speed, there is a possibility of rotor rubbing with stationary parts.
- Labyrinth clearance was increased to prevent any potential rubbing of rotor.
- Similar to previous starts, speed control was difficult & turbine was tripped again due to high vibration (Fig-4).
- Due to the difficulty faced by operator in TTV start-up, GV start-up was applied from the next trial (6<sup>th</sup> trial) and the result was a successful (This could prevent the sudden speed ramp up.).

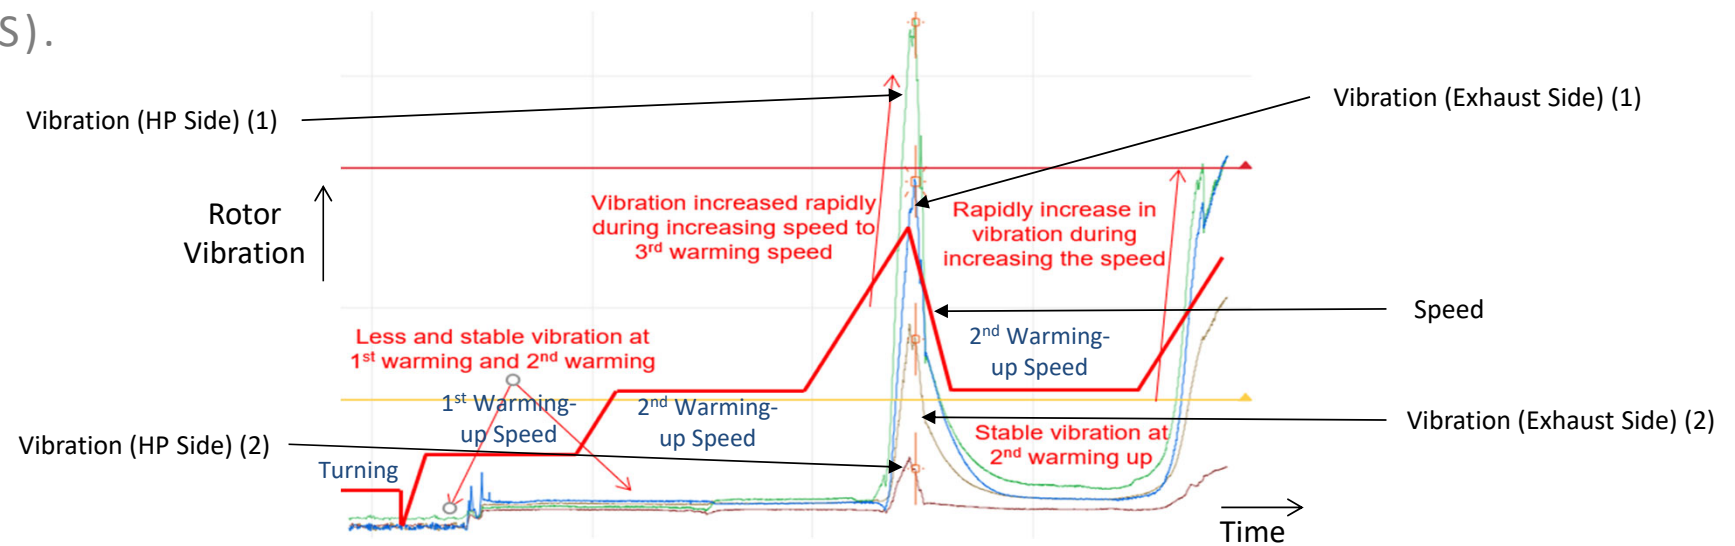
- Speed control was a success & Speed was gradually increased (GV Start) to 2nd warming up speed without any issues (Fig-5).
- At 3rd warming up speed high vibrations occurred, so the speed was decreased.
- Vibration fluctuations were observed at different speeds.
- So, the turbine speed was increased and decreased based on the fluctuations and finally the operator was able to achieve Minimum Governor Speed (MGS).

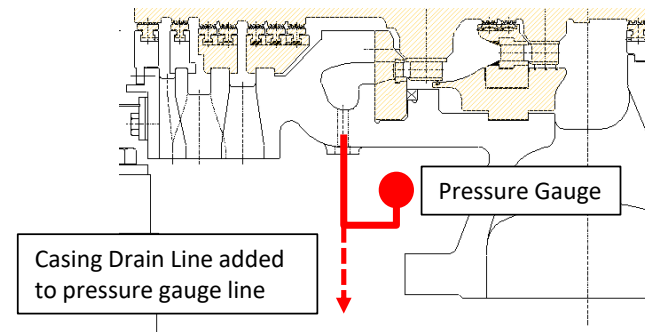
Figure-6 : Casing Drain

Added casing drain line is nearly low point. Casing drain line is usually installed in the lowest point and this casing drain line is used the line for casing internal pressure measurement (PG, PT) as common. In this project, the existing casing internal pressure measurement (PT) line was used as the added casing drain line.

- Casing drain line installation should be considered for the revamp of old steam turbines (Turbine age indicate if the casing drain line was installed or not).
- For turbines which are currently in operation and don't need revamp should also consider addition of casing drain line as a countermeasure for any future issues.
- Sudden change in operating conditions should be avoided to prevent any abnormal change in rotating speed.
- For deformed casing of old design style turbine start-up should be robust to prevent rotor deformation due to rubbing with stationary parts.
- If GV start-up is applied, large labyrinth clearance should be considered & customer's approval is required for performance deterioration.
- In case of internal revamp of old steam turbine, suitable labyrinth clearance should be applied.
