49TH TURBOMACHINERY & 36TH PUMP SYMPOSIA

**Multi-stage pump vibration caused
by excessive wear ring clearance,
Improper balancing, rotating stall**

Equipment Data

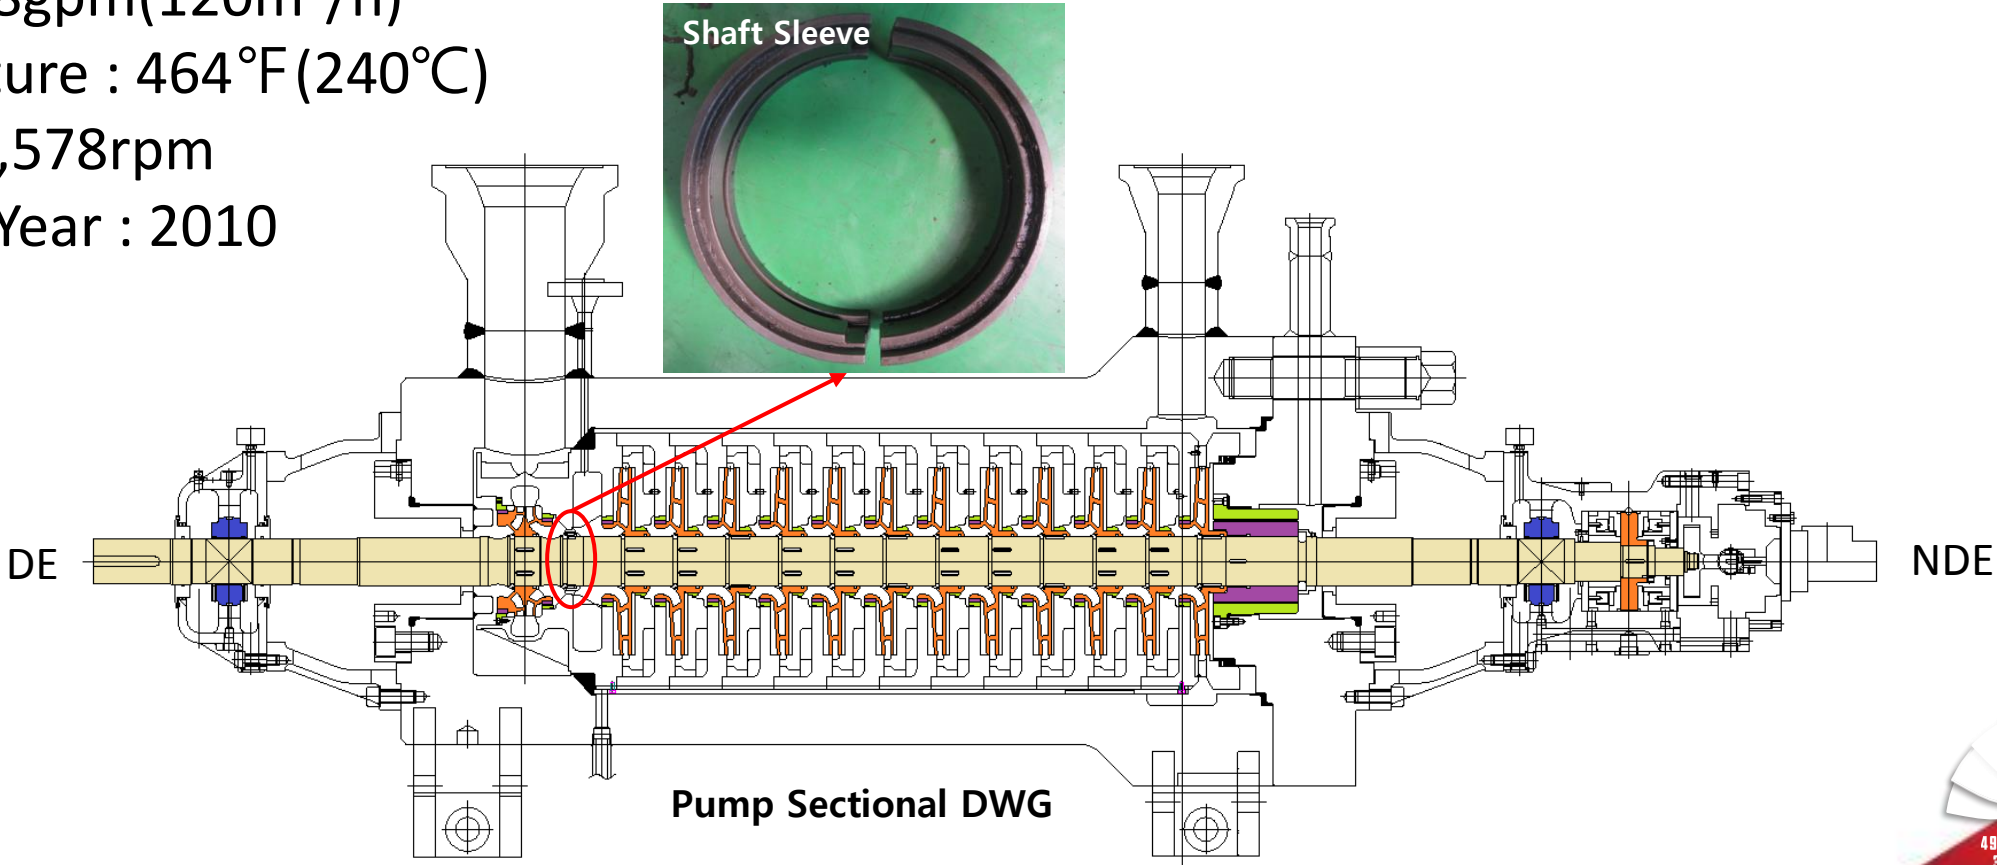
- **Pump overhauled due to DE bearing high vibration, 2.36mils(60μm)**
 - Broken shaft sleeve between 1st~2nd stage replaced
 - Impeller wear rings were not replaced even though it exceeded the allowable limit, because there was no performance issue.
 - Rotor assembly was 2-plane dynamic balanced without individual balancing.
- **During start up after above overhaul, pump tripped by DE vibration HH**
 - DE Radial vibration increased to : 4.33mils (110μm) with 1X(3,578rpm)frequency
 - Normal(before repair) < 0.78mils(20μm)
 - Alarm/Trip : 2.36/3.54mils(60/90μm)

Wear Ring Clearance	Front	Rear
Original Design	0.018~0.36inch (0.45mm~0.90mm)	0.013~0.025inch (0.32~0.64mm)
Measured Max.	0.032inch(0.83mm)	0.031inch(0.81mm)

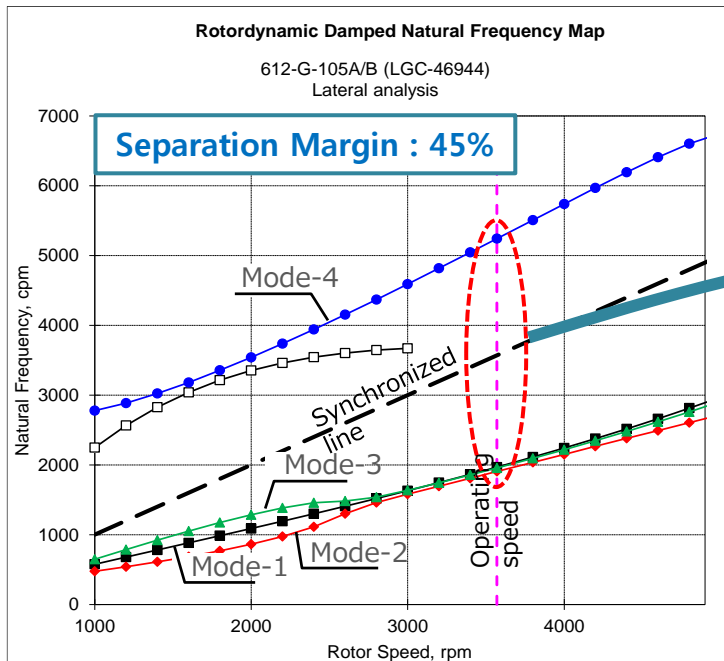
**New Pump Condition
(Design Clearance)**

- **Rotordynamic damped natural frequency map analysis(Campbell Diagram)**
 - Rotordynamic analysis conducted after repair of the pump to find out the root cause.
 - In case of impeller wear ring has excessive clearance(2x of design), the separation margin is not enough(5%) from 3rd critical speed.

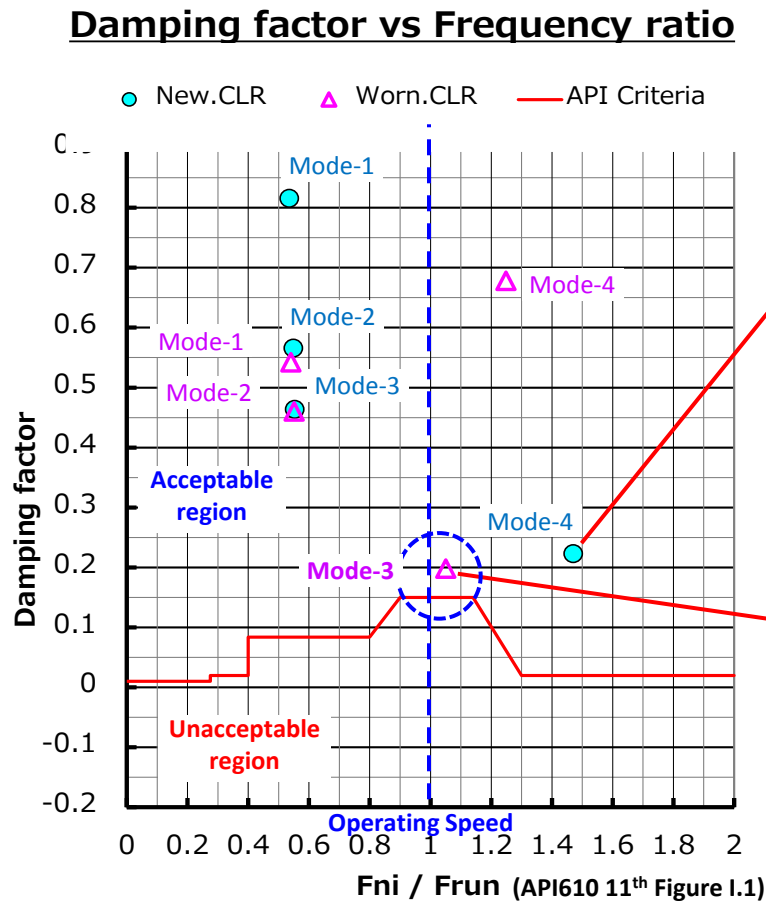
- **Damping Factor vs Frequency Ratio**

- In case of impeller wear ring has excessive clearance(2x of design), damping factor is close to the limit(0.1) of API610.

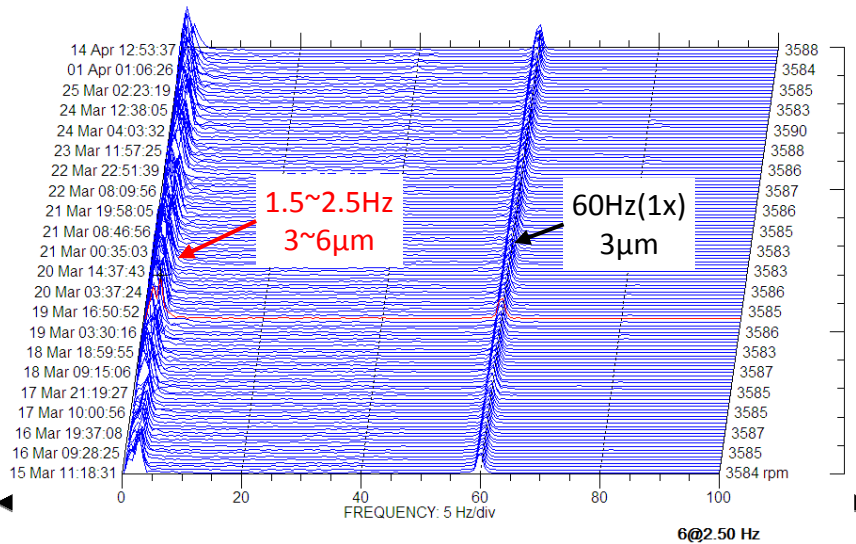
Waterfall Spectrum

- **Radial vibration fluctuation with sub-synchronous frequency**
 - The operating condition seems good after previous repair.
 - But, DE/NDE radial vibration started fluctuating between 0.47~0.78mils(12~20μm) when the pumping flow decreased below 405gpm(92Nm³/h) by process requirement.
 - Vibration frequency : 1.5~2.5Hz
- Vibration fluctuation disappeared with increased flow

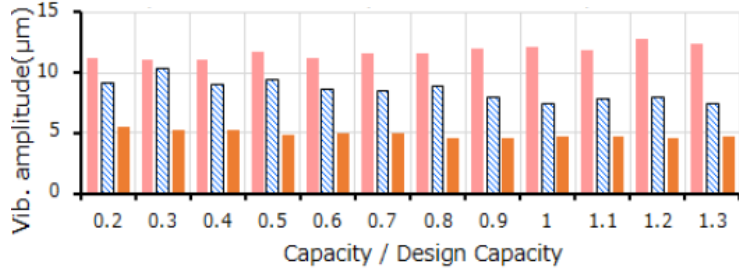
Synchronous Vibration

- Synchronous vibration decrease with bigger 'B' gap, because of lower vane pass vibration

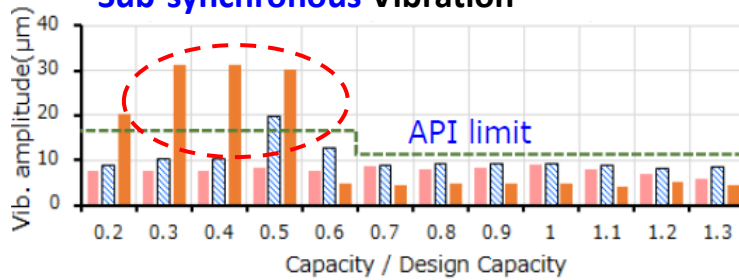
Sub-synchronous Vibration

- Sub-synchronous vibration increase with bigger 'B' gap at low flow, because of stall

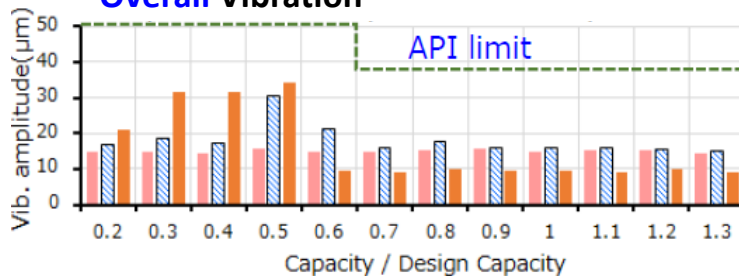
Overall Vibration

- Overall vibration increase with bigger 'B' gap at low flow, because sub-synchronous is dominant frequency

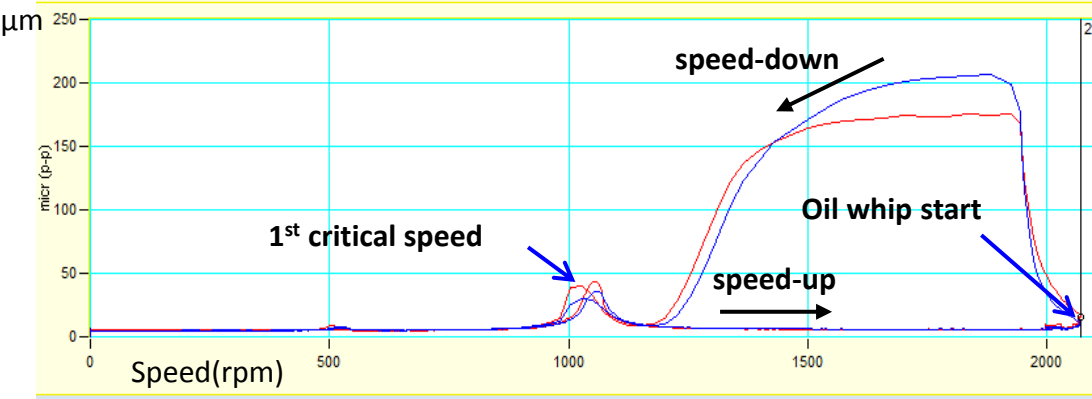
Oil Whip Vibration Trend

- High speed balancing for multi-stage pump is not recommended. Unstable rotor behavior and DE/NDE high vibration(5mils, 200 μ m) caused by oil whip at 2100rpm detected while speed up to 3578rpm.
- During high speed balancing, rotor does not have sufficient stiffness and damping because only DE/NDE bearing support the rotor without wear ring. Newly designed tilting pad bearing in lieu of original pressure dam bearing was required to remove oil whip for the high speed balancing of this pump.
