ASIA TURBOMACHINERY & PUMP SYMPOSIUM

SILO EXHAUST FAN – STRUCTURAL VIBRATION ODS AND MA

Kogan Creek Power Station

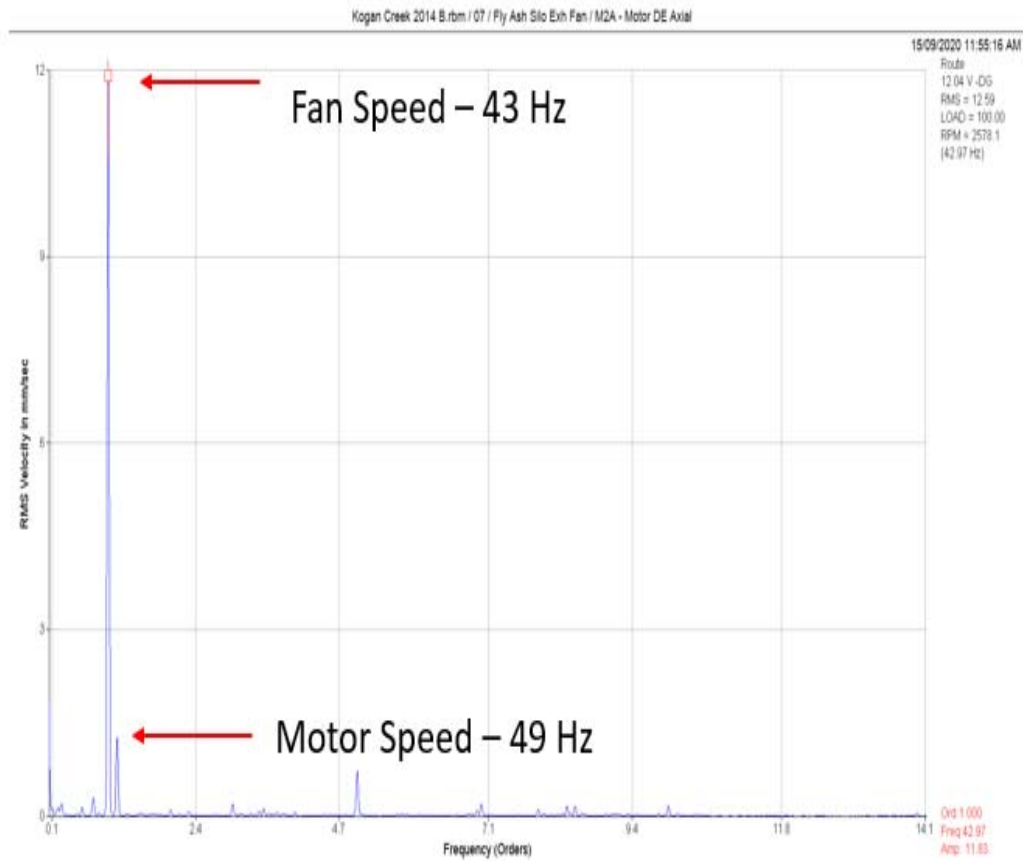
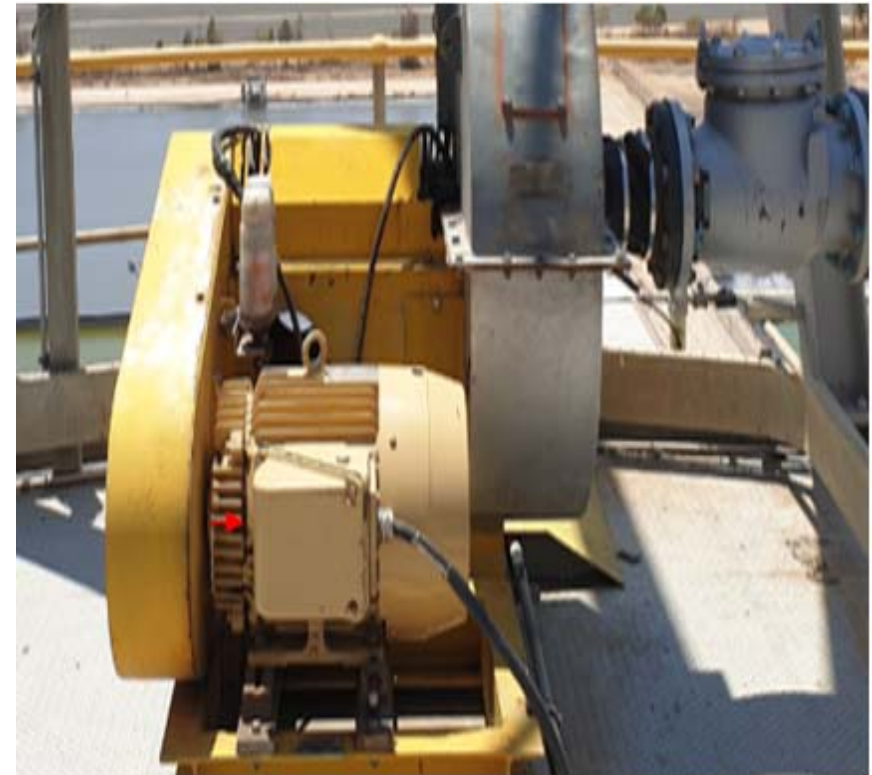
- High 1X Axial vibration evident at motor DE - 12 mm/s RMS. These high levels were consistent over couple of years.
- High 1X vibration in axial orientation is an indication of angular misalignment.
- Due to high structural deflection which we will see in the coming slides, motor and fan were out of alignment during operation.
- Cross channel phase analysis was also carried out confirming misalignment.

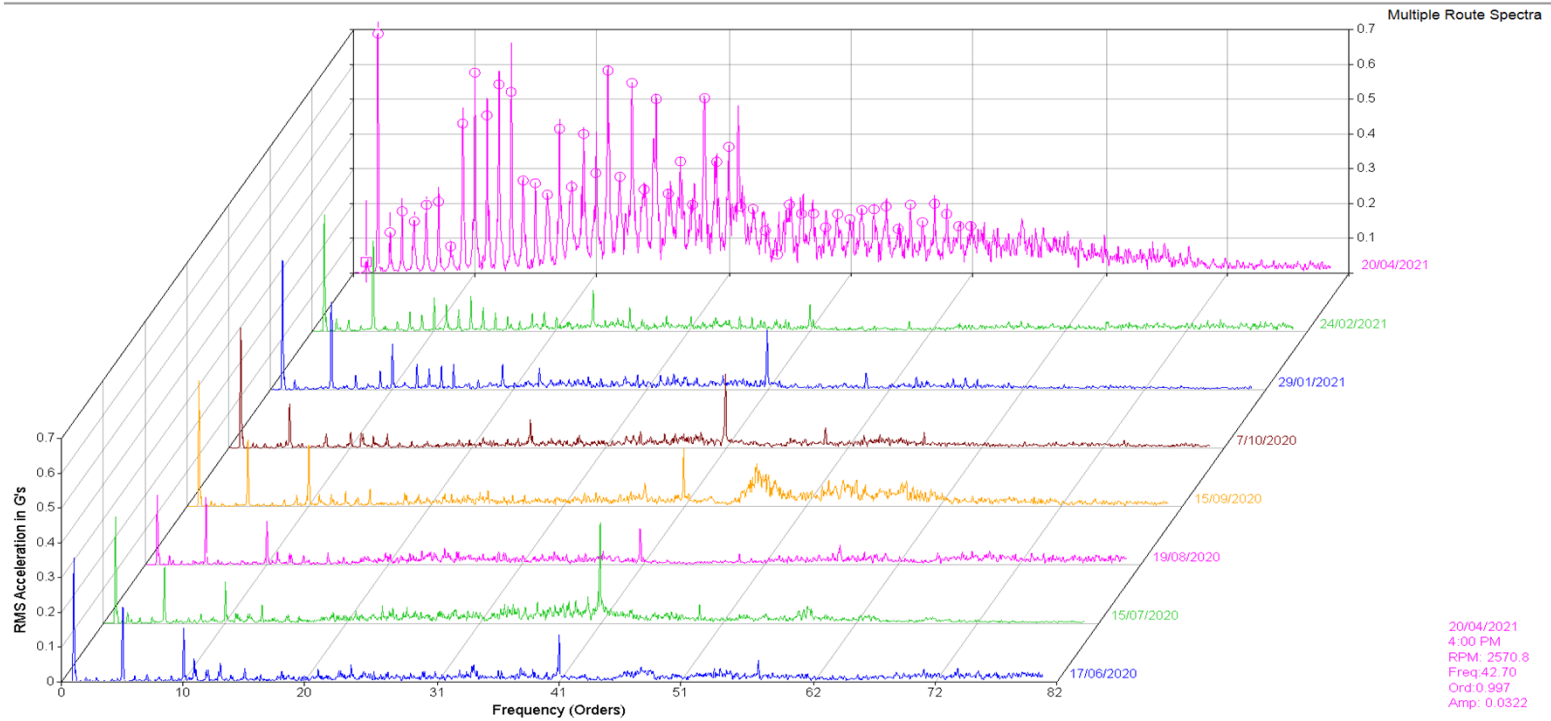
- Sudden appearance of fan speed harmonics which is an indication of developing looseness/clearance issue.
- Harmonics developed after the unit was already experiencing high vibration due to structural issue. Constant vibration has induced mechanical looseness.
- Raised noise floor activity is also an indication of rapid deterioration in the condition of the bearing.

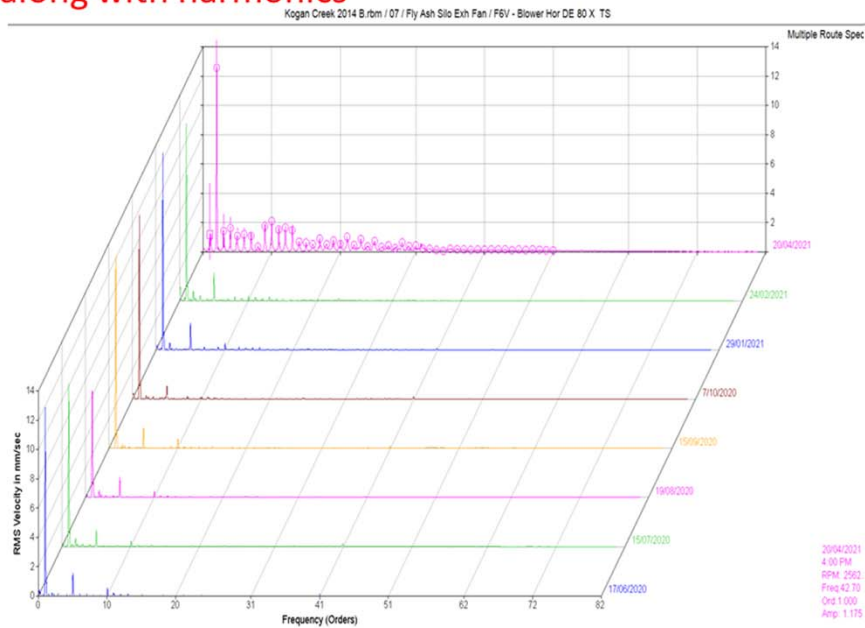
Spectrum showing elevated 2 X vibration along with harmonics

- Waterfall plot in velocity scale showing high 2X (Fan speed) which is an indication of misalignment issue, deteriorated over a period.
- Also, time waveform showing high G's impact at fan running speed frequency.

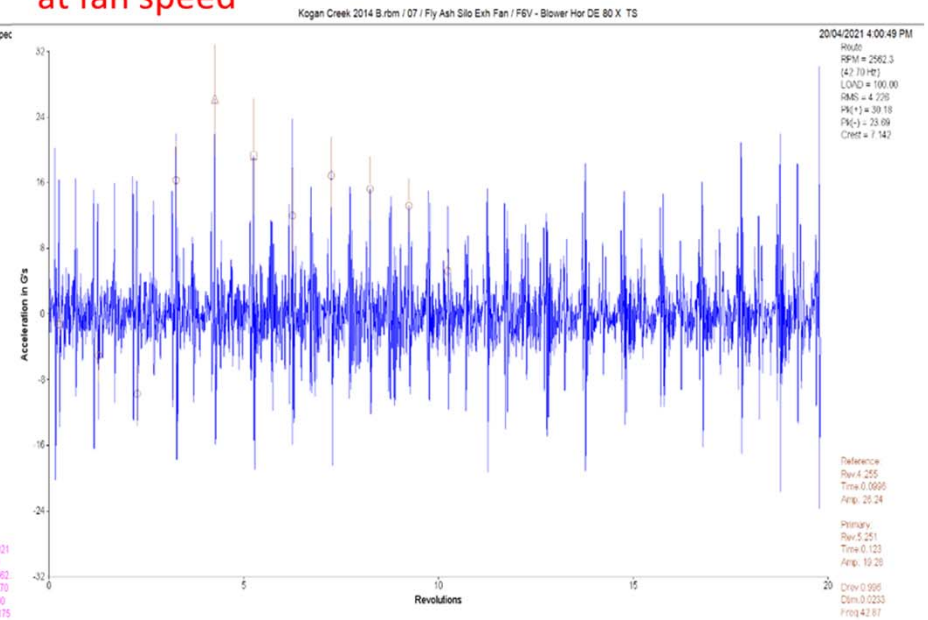
Time waveform showing impacting pattern at fan speed

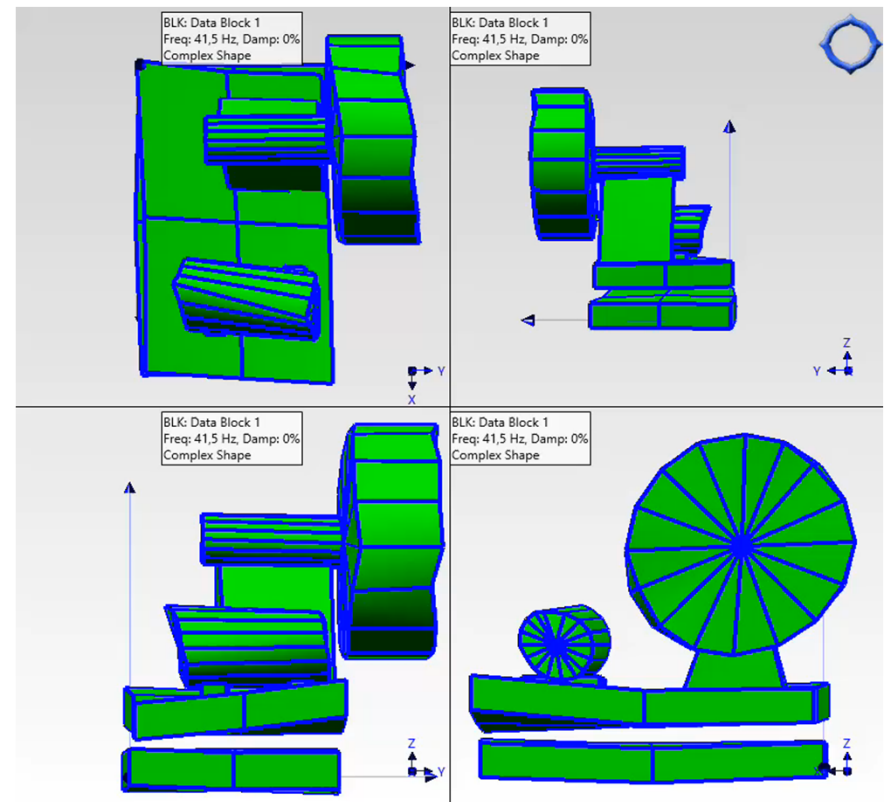
- From the modelling it was clear that substantial deflection was noticed at the base of the structure especially below the motor NDE.
- Twisting motion of the motor is also evident, potentially inducing dynamic misalignment.
- Animation shows structural stiffness issue.

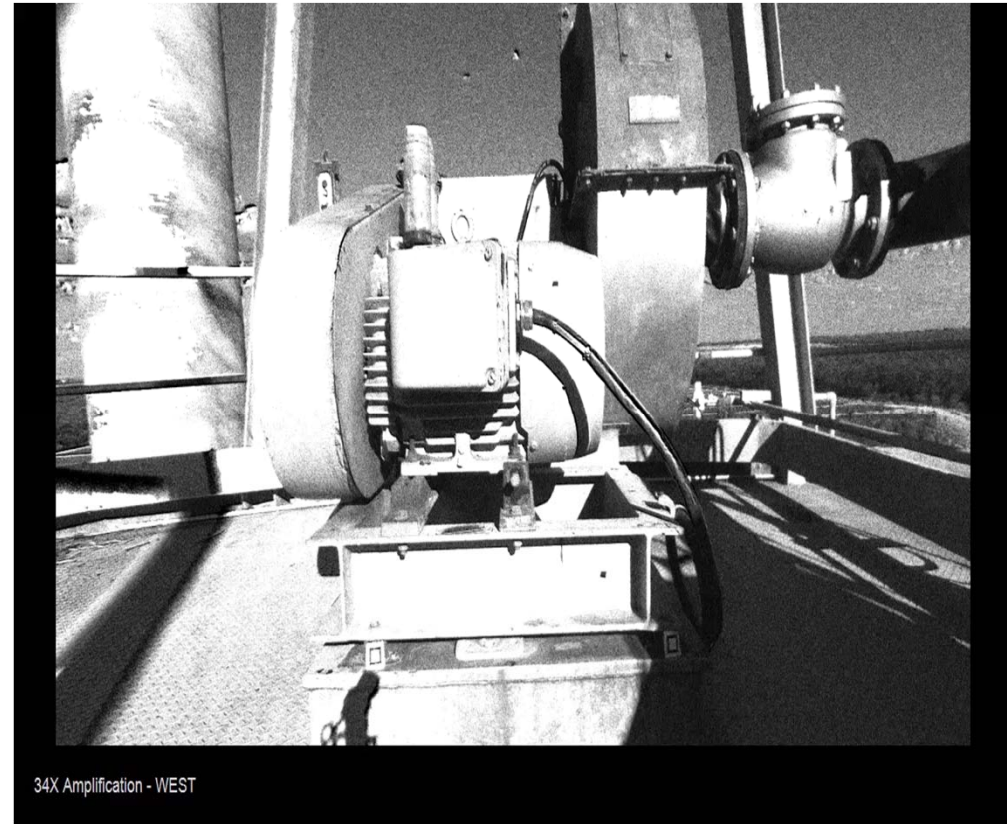
- From the MA camera recording we can see the support base flexing similar to what was seen in ODS animation.
- As seen in ODS animation significant movement is also noticed in motor and pulley structure causing the unit to go out of alignment.

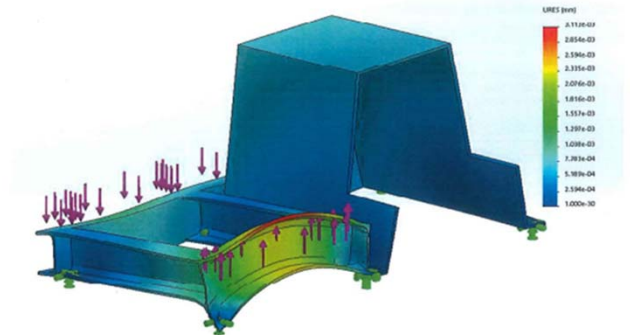
Figure 4: Original Frame - Deflection Simulation Result - Deflection Scaled up by 46000:1

- Post recommendations customer carried out modelling and stiffened the structure on all three sides of the base plate and the rubber isolators were replaced.
- From the image it is evident the deflection is minimized post modification when same load is simulated

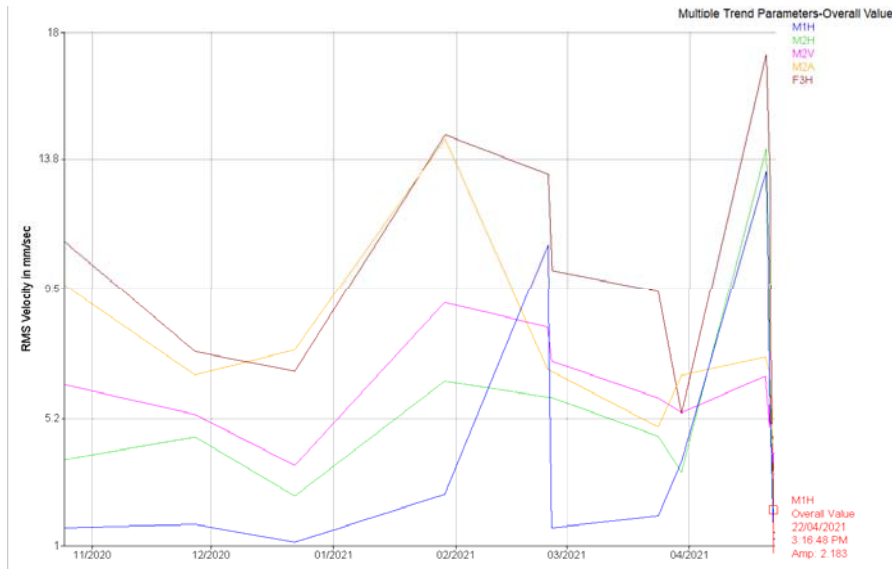
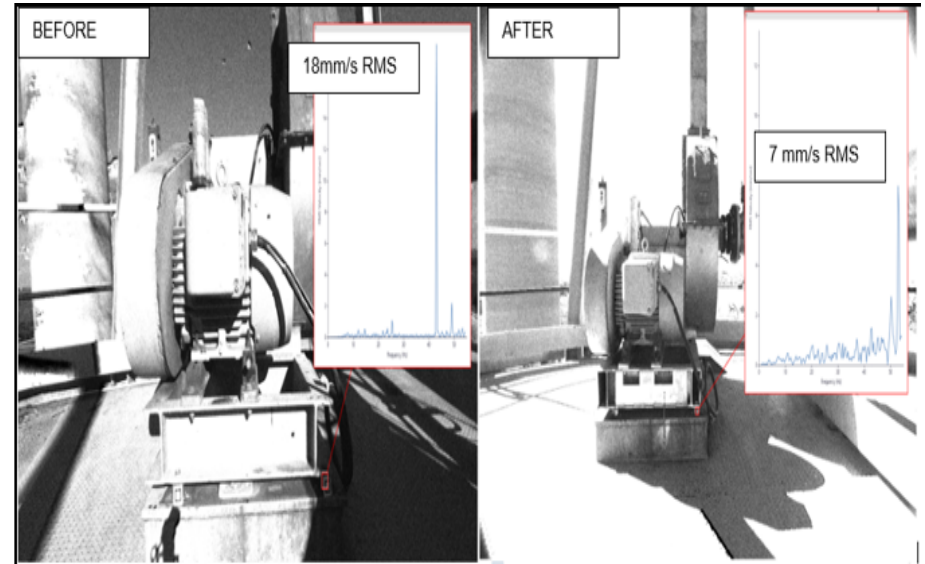
Substantial improvement was noticed at both motor and fan points post repair.

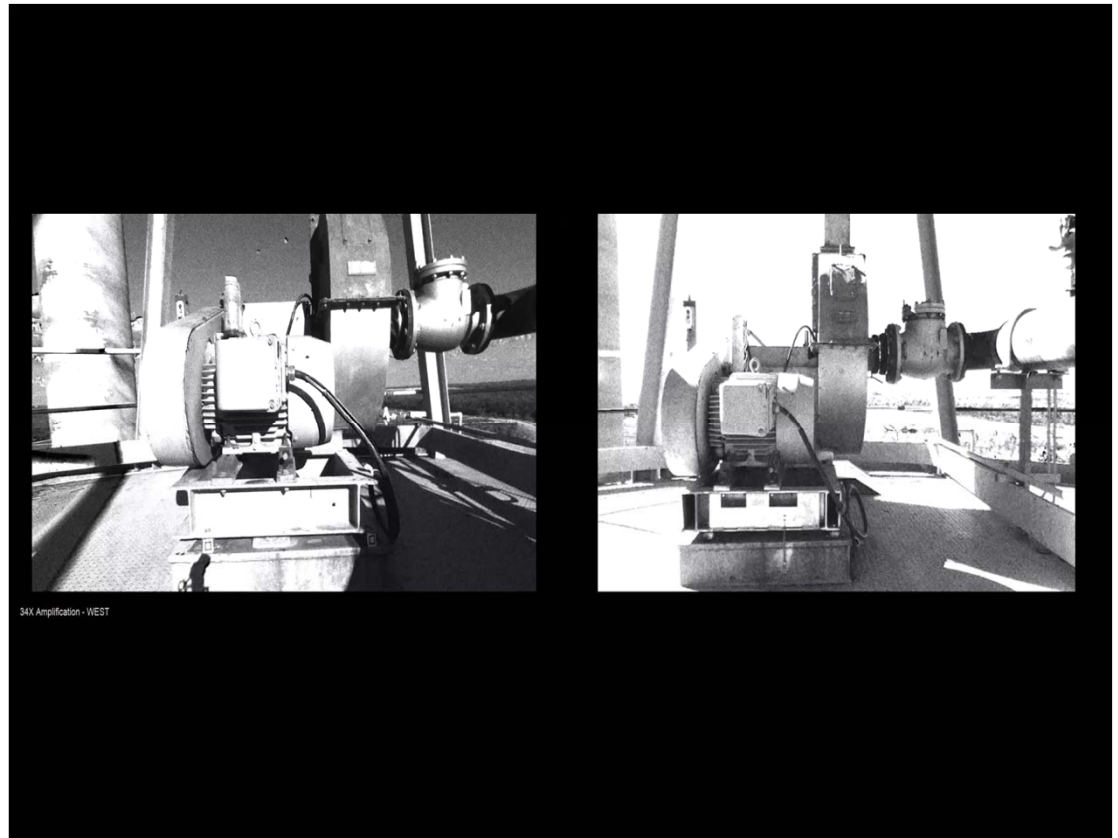
Post modification
substantial
improvement was
noticed in the vibration
levels

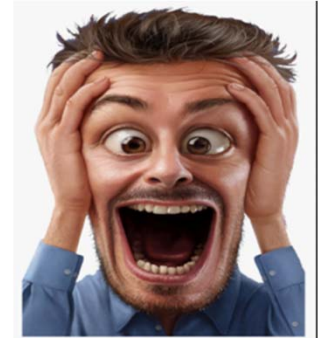
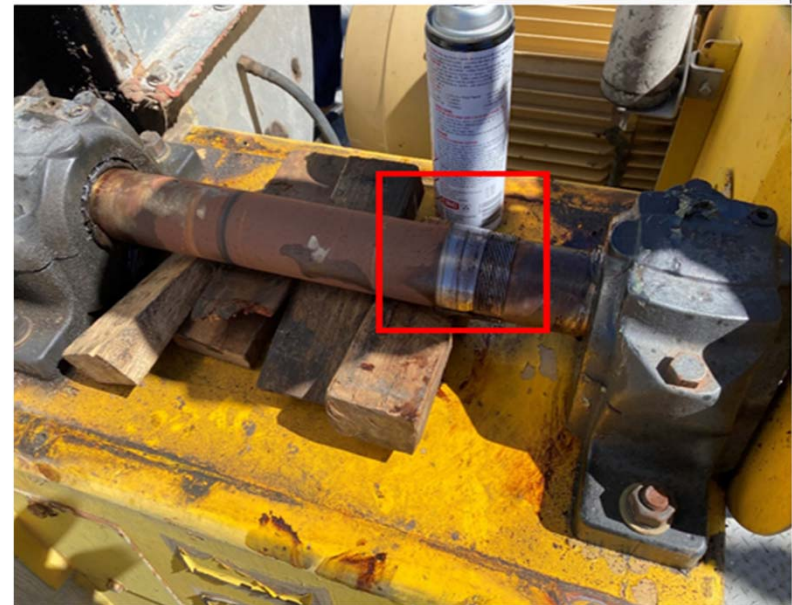
- Continuous high vibration over a long period can cause significant secondary damage and, in some cases, environmental and safety issues.
- In the image we can see the taper lock has worked its way into the middle of the shaft at high level of vibration whilst in operation.
