DIAGNOSIS OF SCREW PUMP FLOW INSTABILITY FROM CASING VIBRATION – A HOLISTIC MACHINERY DIAGNOSTIC APPROACH.

ABSTRACT

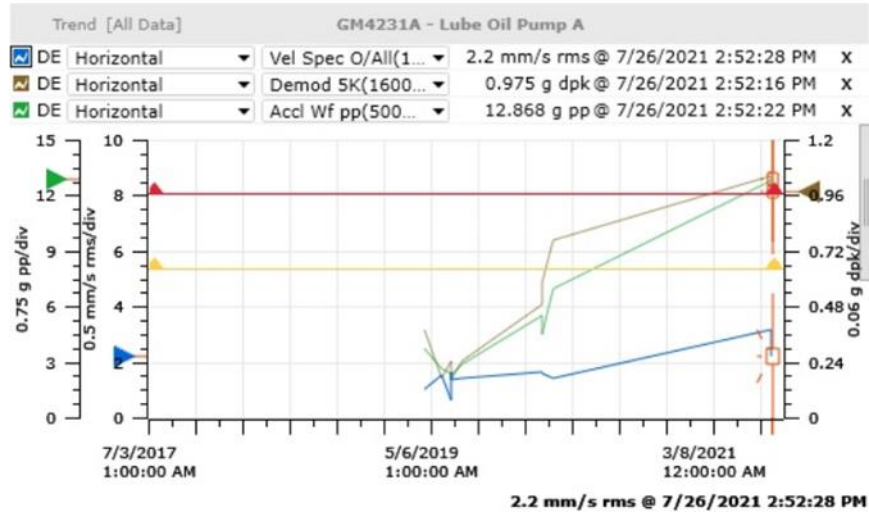
During periodic monitoring of machine trains at an onshore Oil & Gas terminal using a portable vibration data collector, abnormal high vibration and noise were detected on Lube Oil (LO) pumps A & B supplying the Turbo Expander Compressor (TEC), as Figure 1 shows.

Figure 1: Pump, Drive End, Direct vibration trends 2017 to 2021.

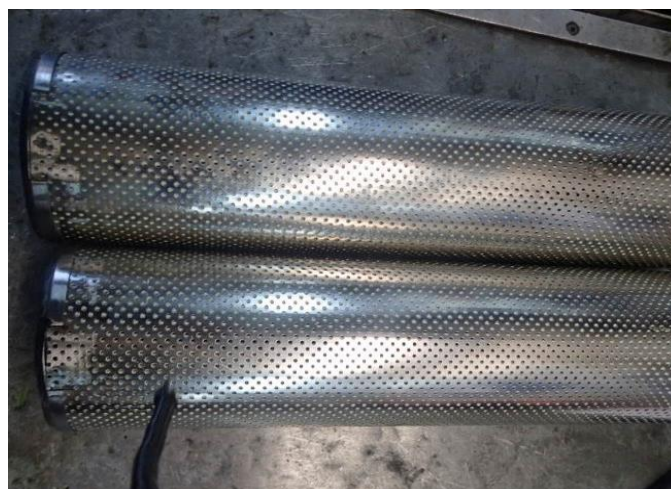
The filters were then replaced, but these were of a new design (Figure 4), on the 20th of September 2021. This filter design was said to be comparable, however Beta rating was not provided for confirmation, these were slightly smaller dimensionally and also featured a perforated metal tube cover where the older filters paper/resin element was exposed. The downstream guard filters were also inspected and confirmed to be clean. However, these were replaced (without a change in design) as a precautionary measure. Following the second attempt at commissioning of the LO System on 22nd September 2021 – the Filter DP again reported higher than previous levels (0.84 bar vs. 0.4 to 0.6 bar). LO Pump B was stopped due to high vibration & noise levels observed at the skid. Such behavior only occurred when the TEC 2 was online, known as "Stage 7". On running LO Pump A, the high vibration reported when the filters clogged had not returned during the initial running. However, several minutes after operating the TEC at "Stage 7," an intermittent vibration impulse was heard.

Figure 4: "New" LO Filters with protective plating.

Several weeks later the LO filters were replaced with a design comparable to that of the original filters (not shielded as per Figure 4) with the LO filter DP reducing to ~0.53 bar, within the previous range of 0.40 – 0.60 bar. Examination of the vibration behaviour using the portable data collector after this change confirmed velocity and acceleration levels had returned to low, normal levels and no indications of abnormal noise were found at the machine skid.

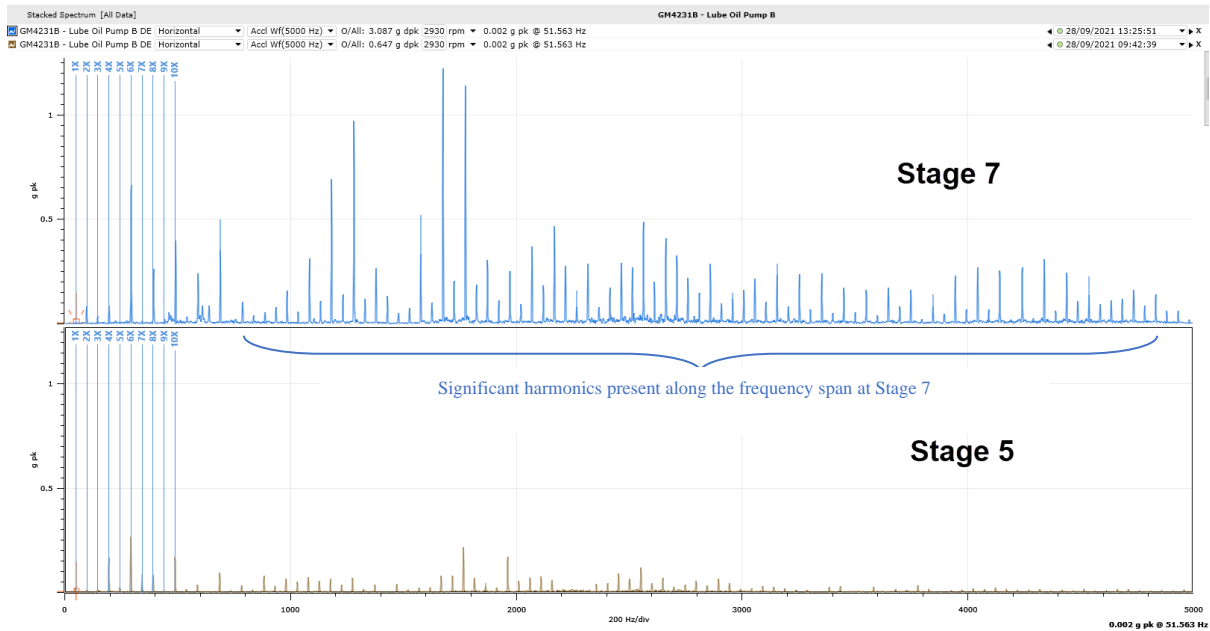
At Stage 5, the pump vibration was measured as satisfactory, indicating no mechanical issues with the pump as well as the DE bearing. However, when the TEC entered Stage 7 operation, increased vibration and noise were observed at the machine skid (Figure 7). A significant number of harmonics were generated during this time. Examination of the acceleration waveform showed a significant increase in amplitude and impacts (Figure 8). It was also noted that although the LO supply pressure remained at 50 bar(g) on the gauge at the skid, a drop in motor current from 48 A to 42 A was observed, indicating a change in rotor dynamics.

Figure 7: LO Pump B, Pump DE, acceleration stacked spectra, 28th September 2021.

The recommendation from the MDS team was to borescope the pipework, flush the system and to perform further testing with filters that were of the original design.

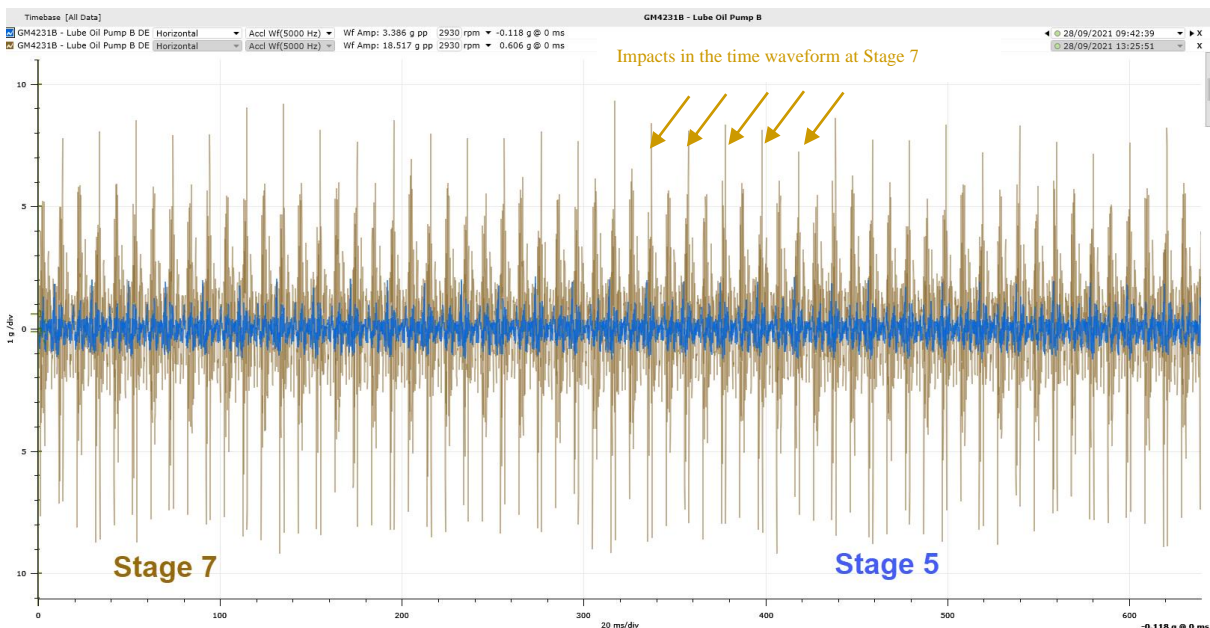
Figure 8: LO Pump B, Pump DE, acceleration Waveform, 28th September 2021.

Overall, the data suggested that a disruption in screw pump flow was occurring. The root cause of this was unclear, as with the changes to the LO cooling system, there were several potential causes:

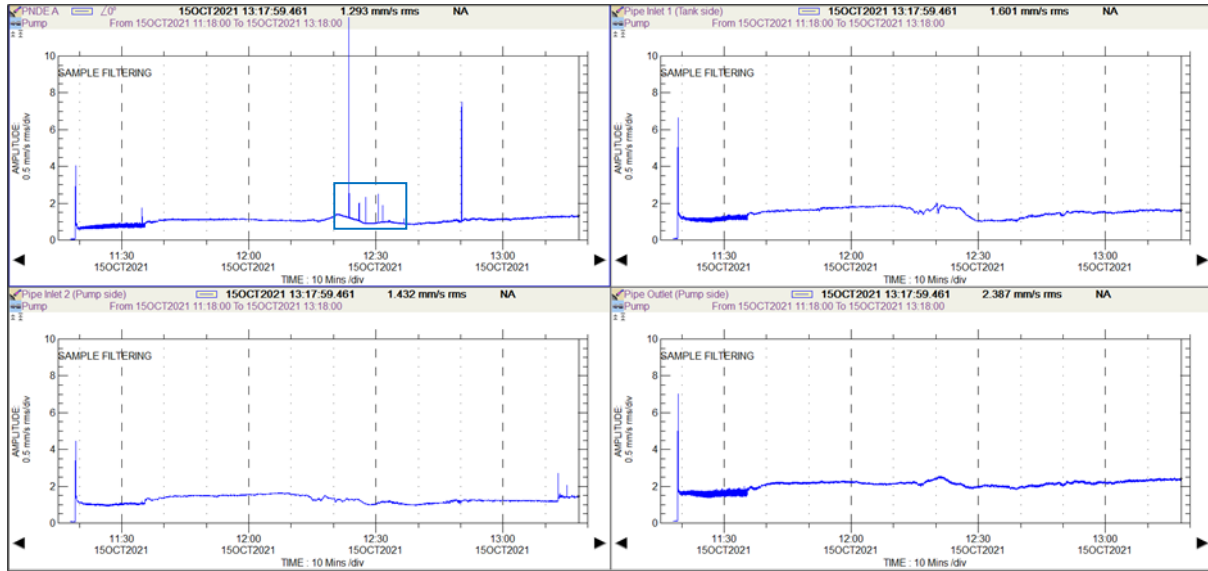
During the test run of LO Pump A, the intermittent low-frequency impulse type noise previously reported was observed. These coincided with low-level spikes in the vibration data (Figure 16). These events were most notable at the Pump NDE axial position then Pump NDE radial positions, and with very low magnitudes in the pipework (Figure 17). At this time, the LO filter DP was reading 0.80 bar on the gauge at the machine skid. Overall, the frequency components for LO PUMP A were comprised of 1X (50 Hz) and harmonics of 1X, with the 2X (100 Hz) the slightly dominant component (Figure 18 to Figure 20). The impulse events were seen to cause very slight increases across multiple harmonics (Figure 21).

This behavior was not driven from a mechanical or structural malfunction. The slight increase in activity across multiple harmonics during the “impulse noise” and elevated vibration indicate a behavior related to the LO flow.

Figure 16: LO Pump A, PNDE A vs. Pipework, Direct Velocity Trends, 15th October 2021. Note small spikes occurring in NDE measurements correlating with observed impulse noise.

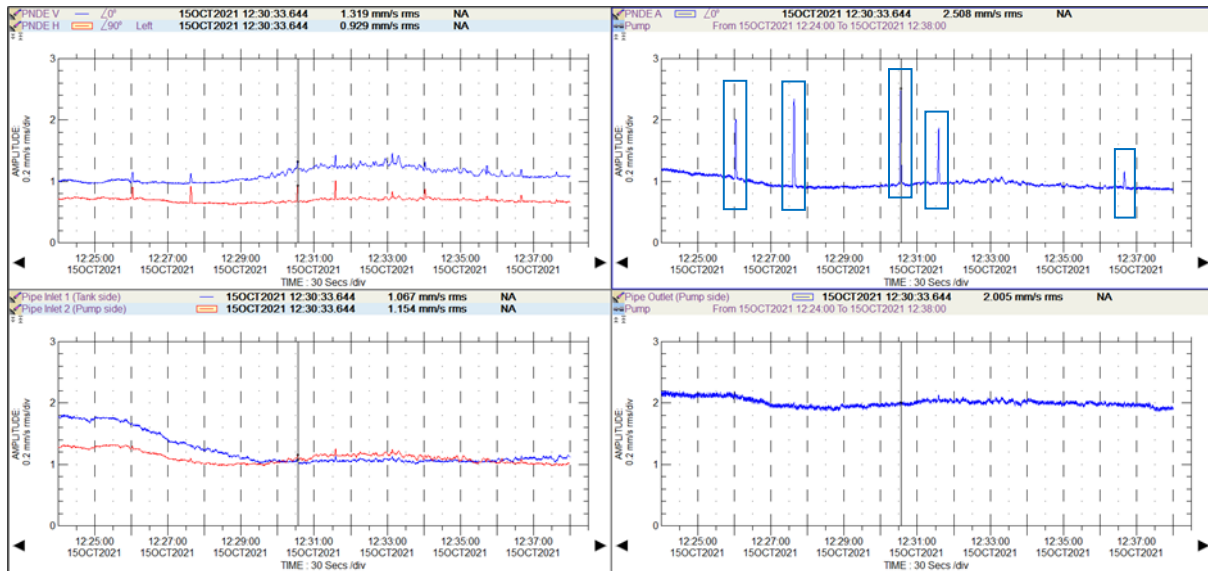
Figure 17: LO Pump A, PNDE V & H vs. PNDE A, Pipe Outlet & Pipe Inlet 1 & 2 (clockwise from top left), Direct Velocity Trends, 15th October 2021 12:24 to 12:38. Note scale reduced compared to previous plots and small spikes occurring in NDE measurements correlating with observed impulse noise (blue box).

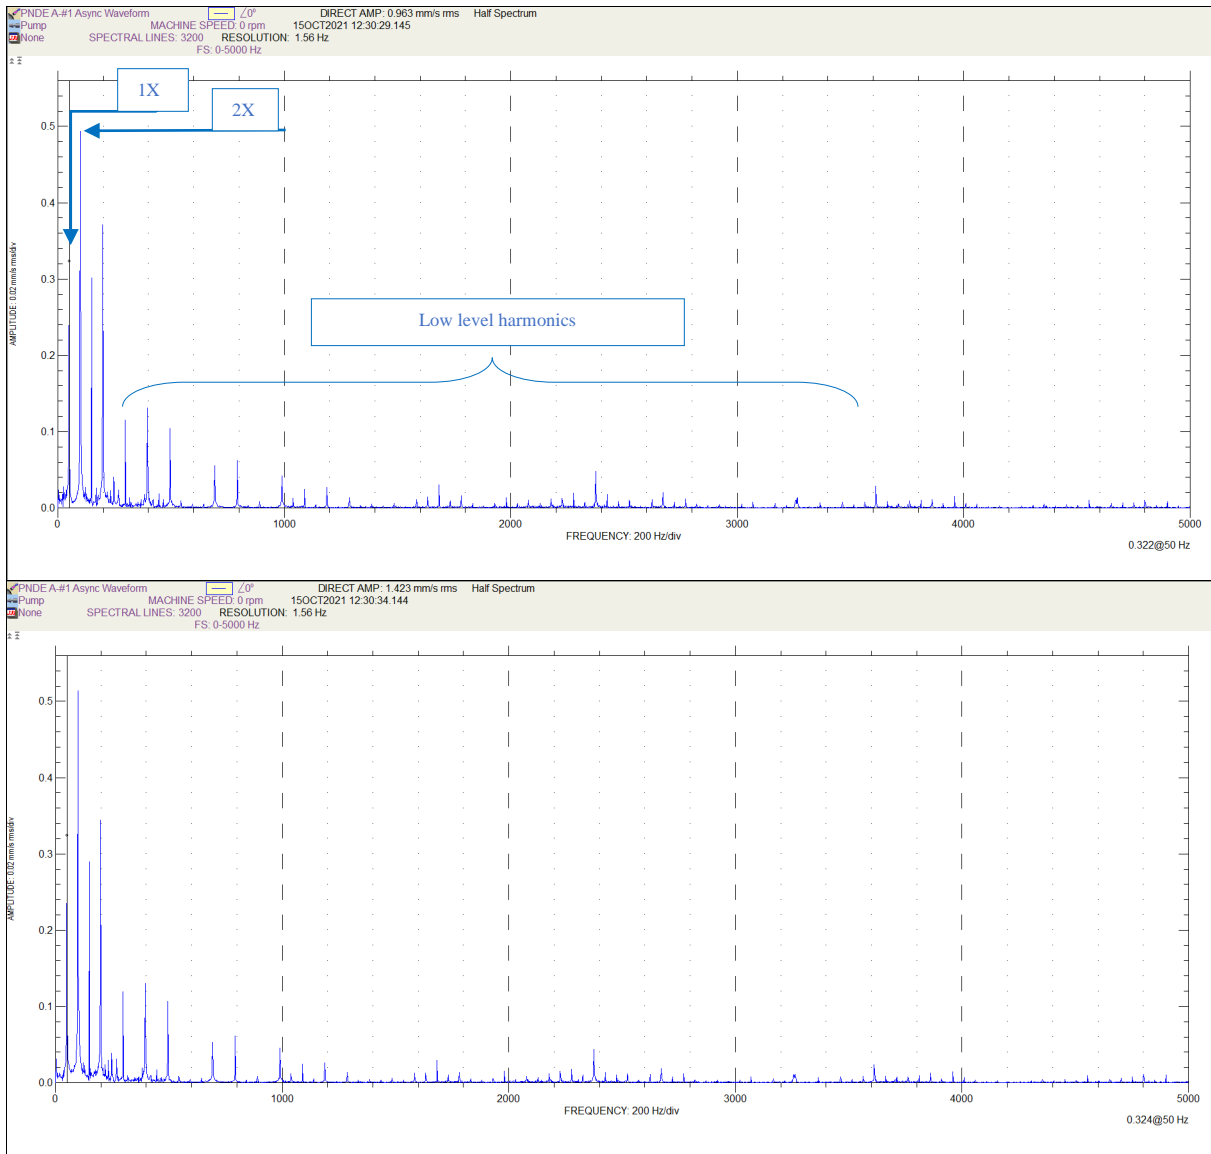
Figure 21: LO Pump A, Pump NDE A, Asynchronous Half Spectrum, 15th October 2021 12:30:29 (upper spectrum – prior to 3rd spike in axial vibration) vs. 12:30:34 (lower spectrum – near to 3rd spike in axial vibration).

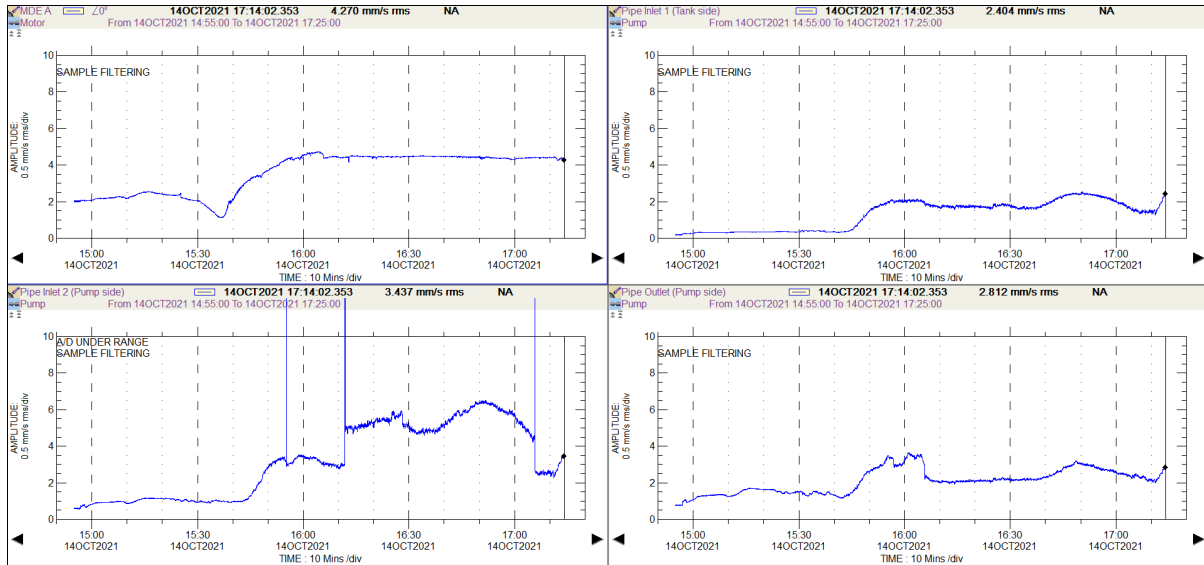
During the test run of LO Pump B, the consistent noise previously reported was observed. Twelve minutes after TEC reaching steady state operation at 11300 rpm the noise developed, increased, and then remained until shutdown at 17:14. This correlated with an increase in vibration measured across the motor DE axial and pipework transducers (Figure 22). After correction of pump measurement locations, similar behavior was observed (Figure 23). Examination of the spectral data showed increased activity in 1X and harmonics of 2X across the pump DE (Figure 24 and Figure 25). These were also detected in the pipework (Figure 26 to Figure 28 and Motor axial spectrums (Figure 29). The behavior measured at LO Pump B indicated an issue with the flow through the pump.

Figure 22: LO Pump B, Motor DE Axial vs. Pipework, Direct Velocity Trends, 14th October 2021.

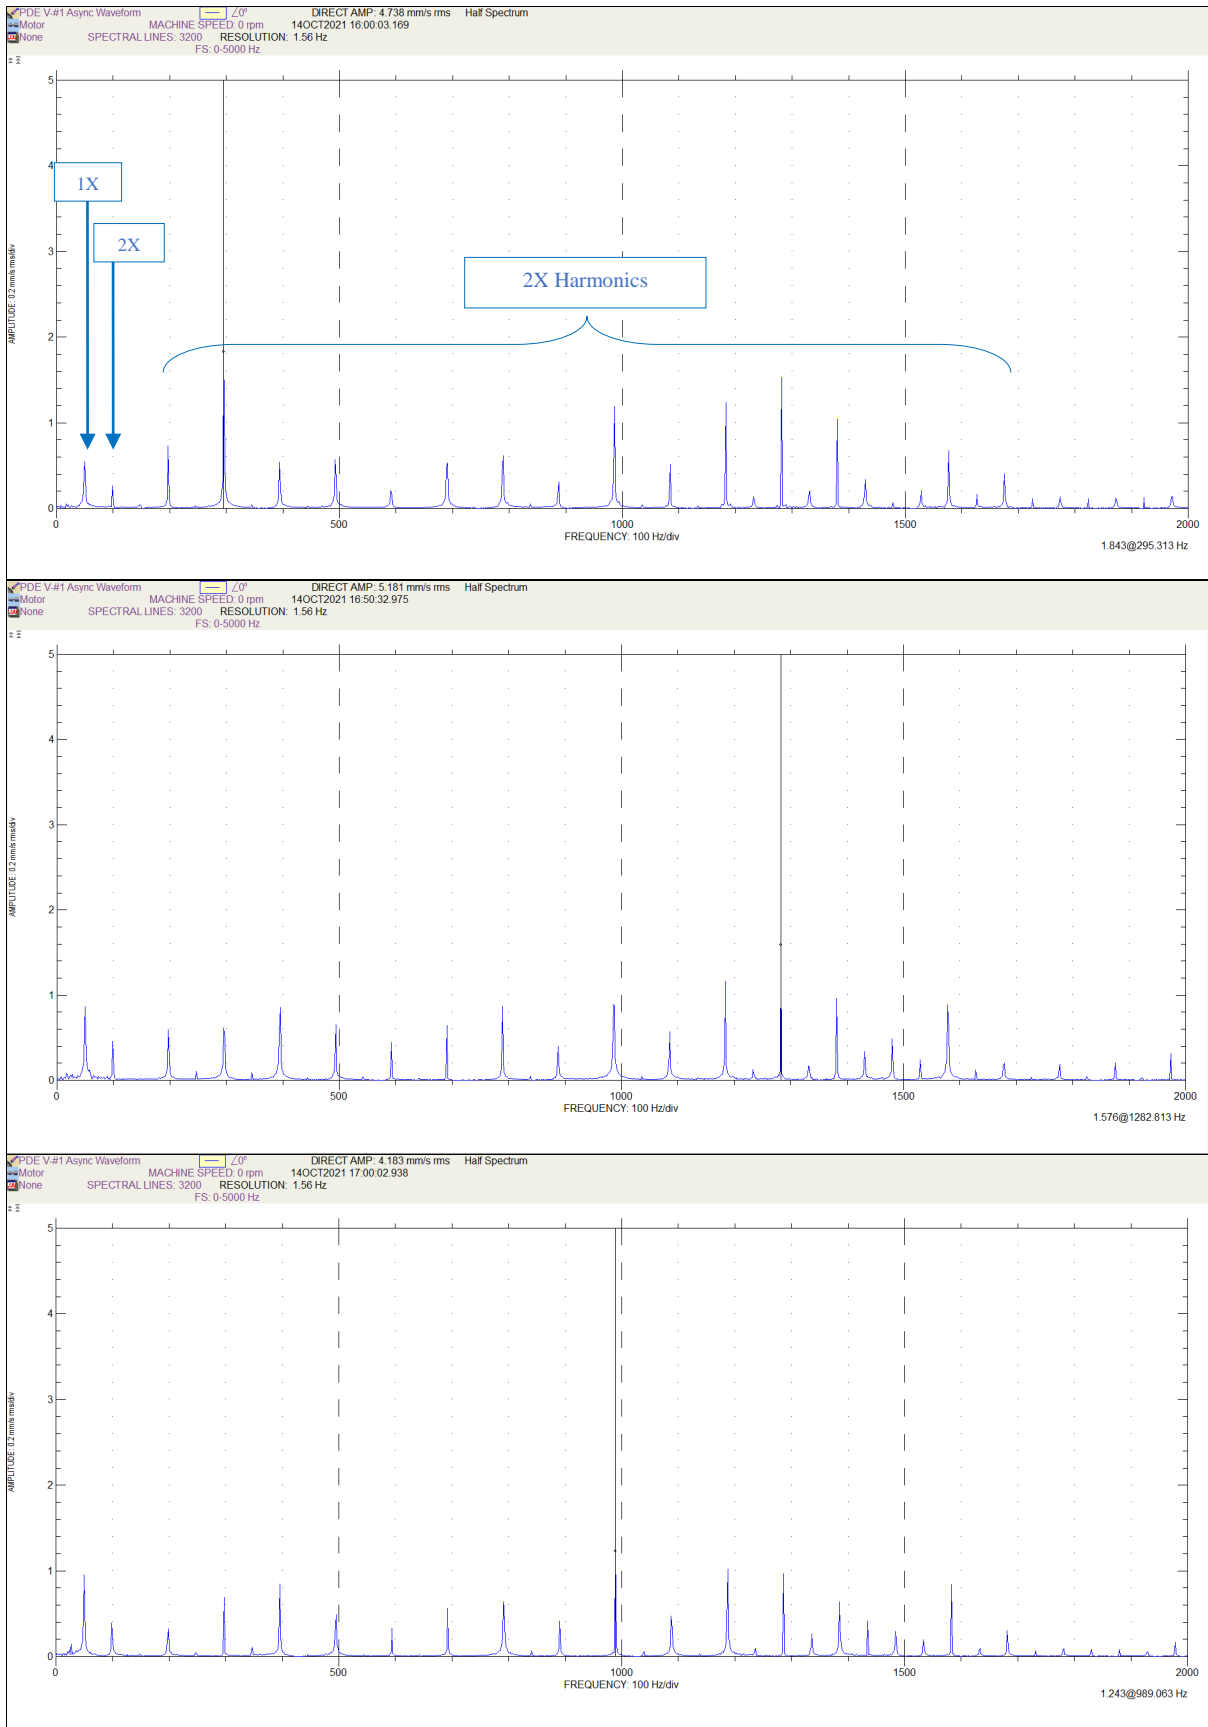
Figure 24: LO Pump B, Pump DE V, Asynchronous Half Spectrum, 14th October 2021 16:00:03 (upper spectrum – noise plateaued, TEC 11300 rpm) vs. 16:50:32 (middle spectrum – peak vibration, TEC 12500 rpm) vs. 17:00:02 (lower spectrum – TEC 11000 rpm).

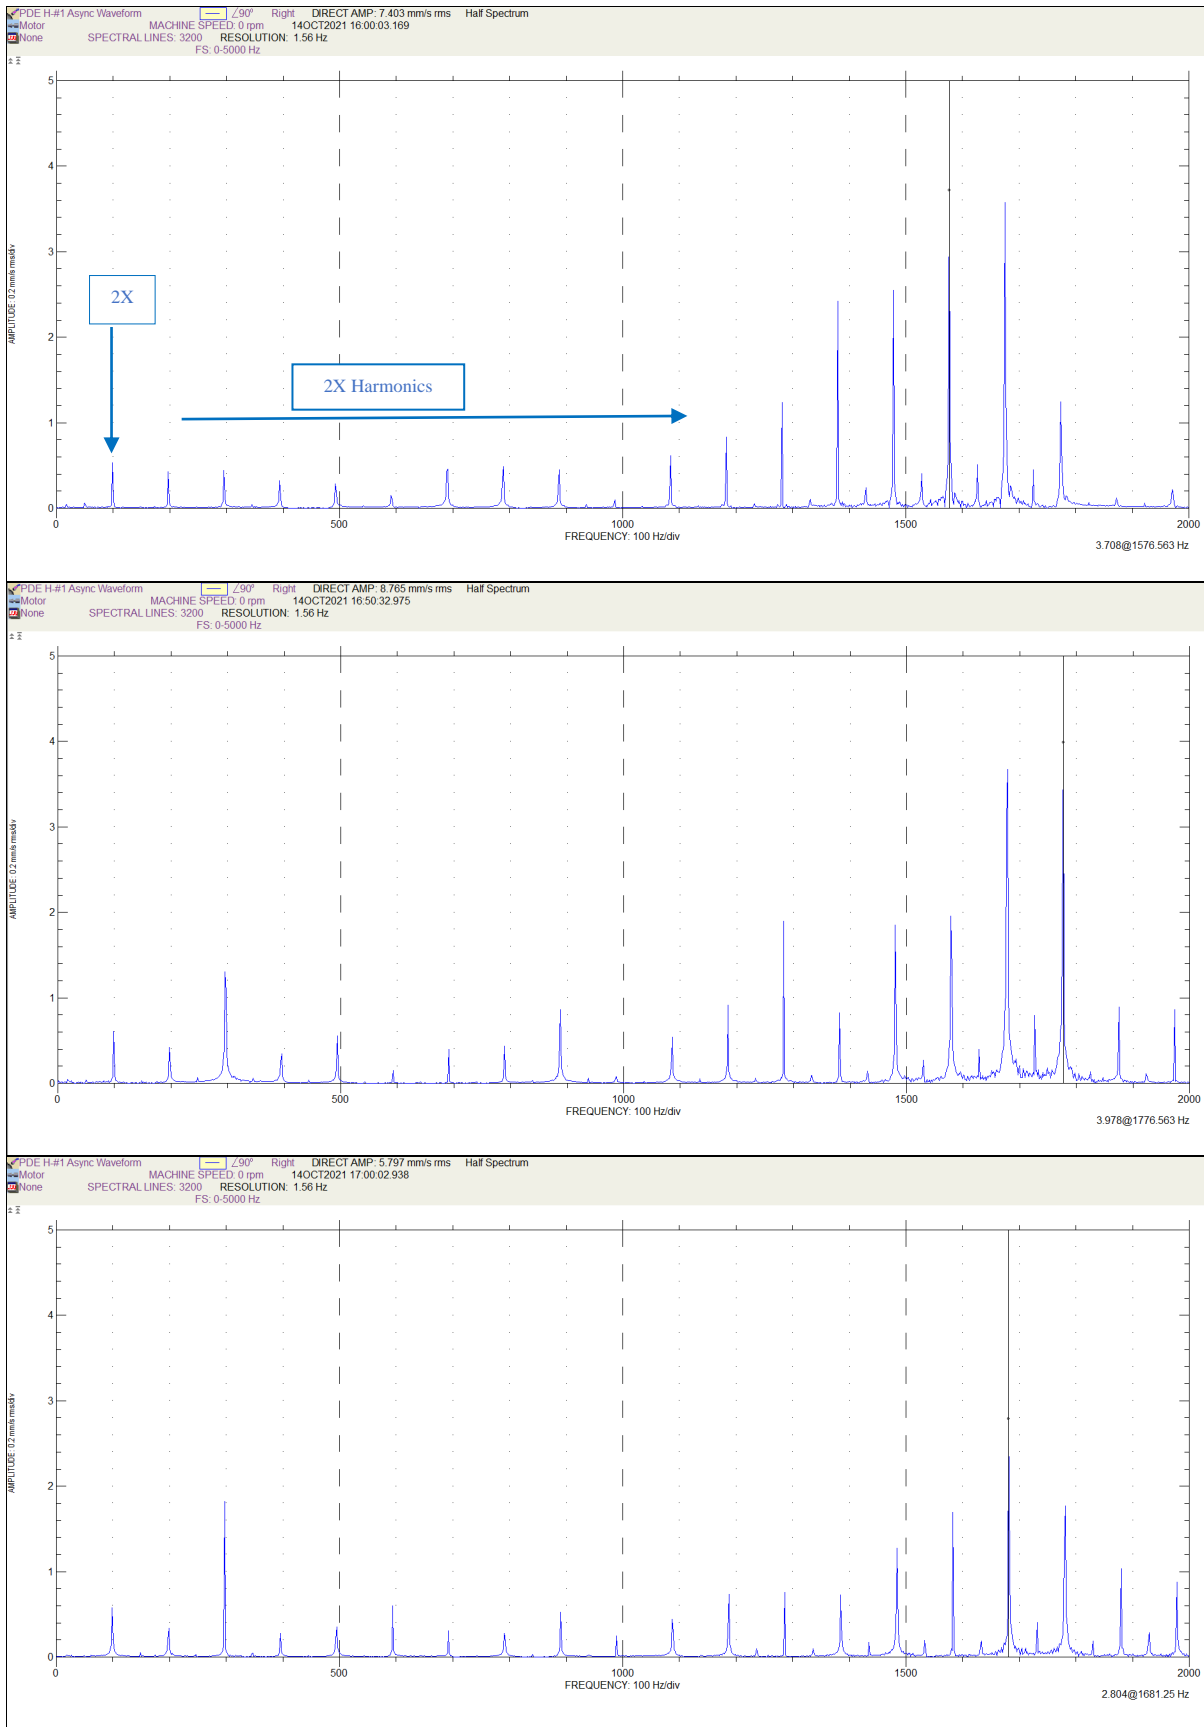
Figure 25: LO Pump B, Pump DE H, Asynchronous Half Spectrum, 14th October 2021 16:00:03 (upper spectrum – noise plateaued, TEC 11300 rpm) vs. 16:50:32 (middle spectrum – peak vibration, TEC 12500 rpm) vs. 17:00:02 (lower spectrum – TEC 11000 rpm).

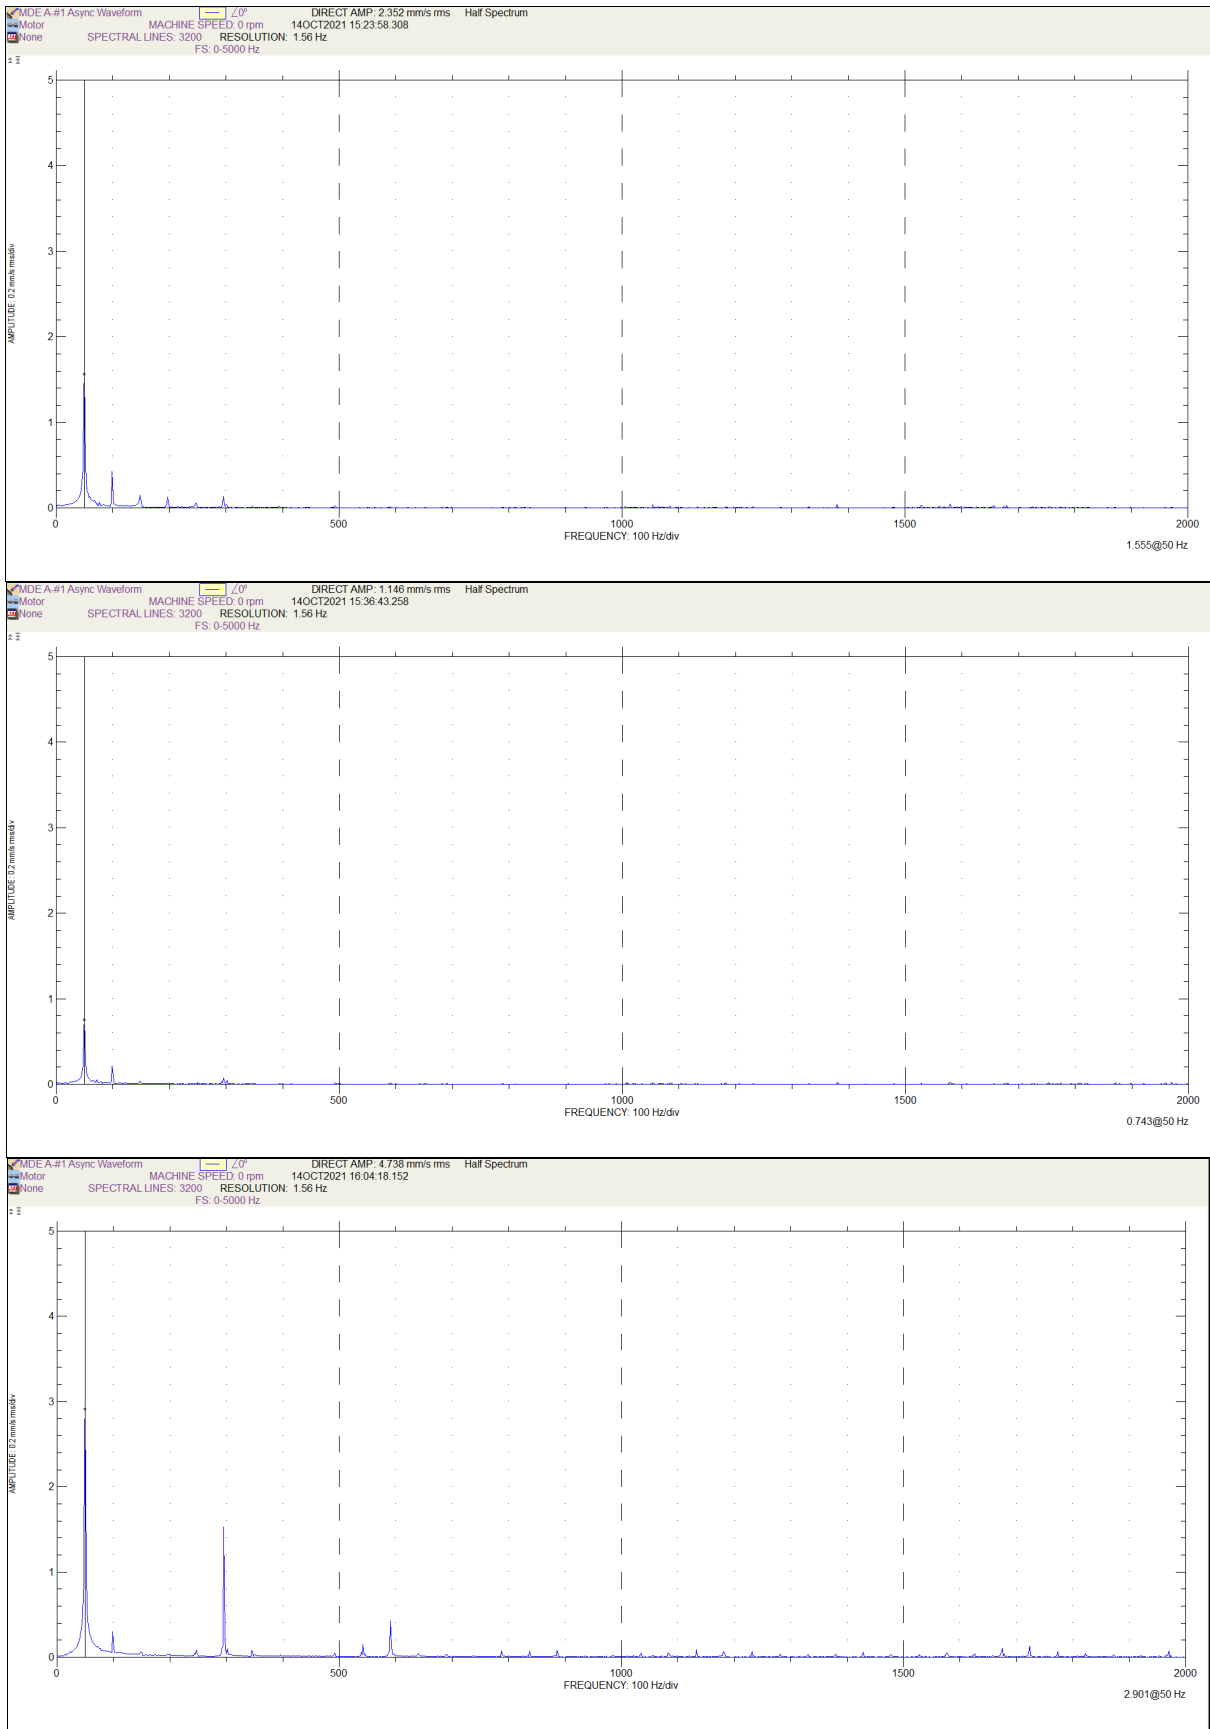
Figure 29: LO Pump B, Motor NDE Axial, Asynchronous Half Spectrum, 14th October 2021 15:23:58 (upper spectrum – TEC 2500 rpm) vs. 15:36:43 (middle spectrum – reduced vibration, prior to noise, TEC 11300 rpm) vs. 16:04:18 (lower spectrum – peak vibration, noise present, TEC 11300 rpm).

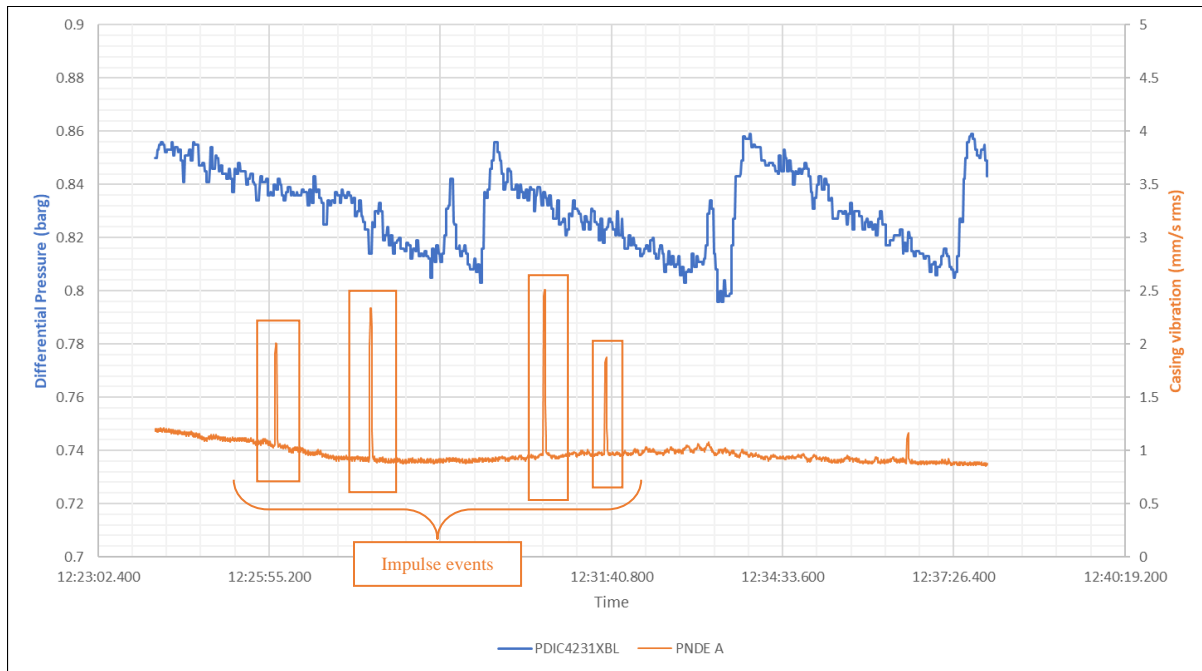
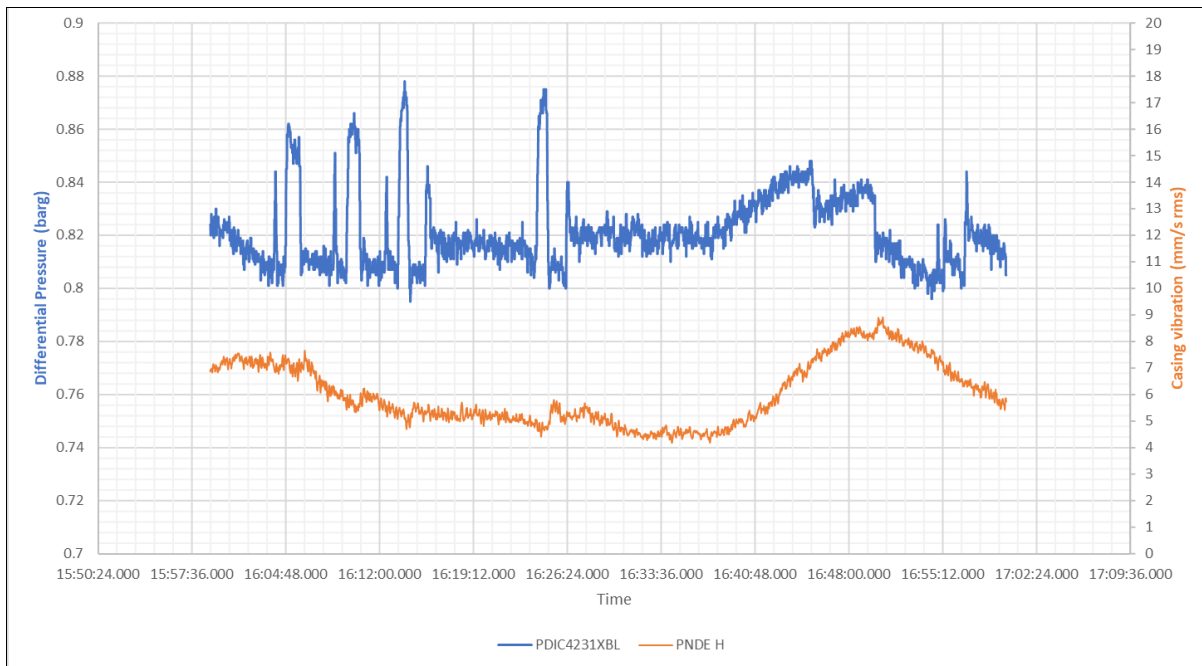
Process data provided from LO differential pressure was plotted in Figure 30 and Figure 31 for LO Pump A and B respectively. LO Pump A operated within a range of 0.785 to 0.880 bar where LO Pump B operated, slightly higher, within a range of 0.795 to 0.887 bar(g) during steady state. Similar fluctuations were apparent during operation of both Pump however LO Pump B did appear to have a slightly higher DP during the first hour of running.

Overall, the comparison of this to the vibration observed is inconclusive but the LO DP fluctuations are abnormal and would indicate intermittent decreases in flow across the filter.
