## 51<sup>ST</sup> TURBOMACHINERY & 38<sup>TH</sup> PUMP SYMPOSIA

# INTERACTION BETWEEN ROTODYNAMIC PUMP BEHAVIOUR AND WEAR SURFACE COATING TECHNOLOGY: A MULTISTAGE PUMP CASE ANALYSIS

# Case study

- Seizure of two multistage pumps during performance test caused by coating detachment from the wear surfaces.

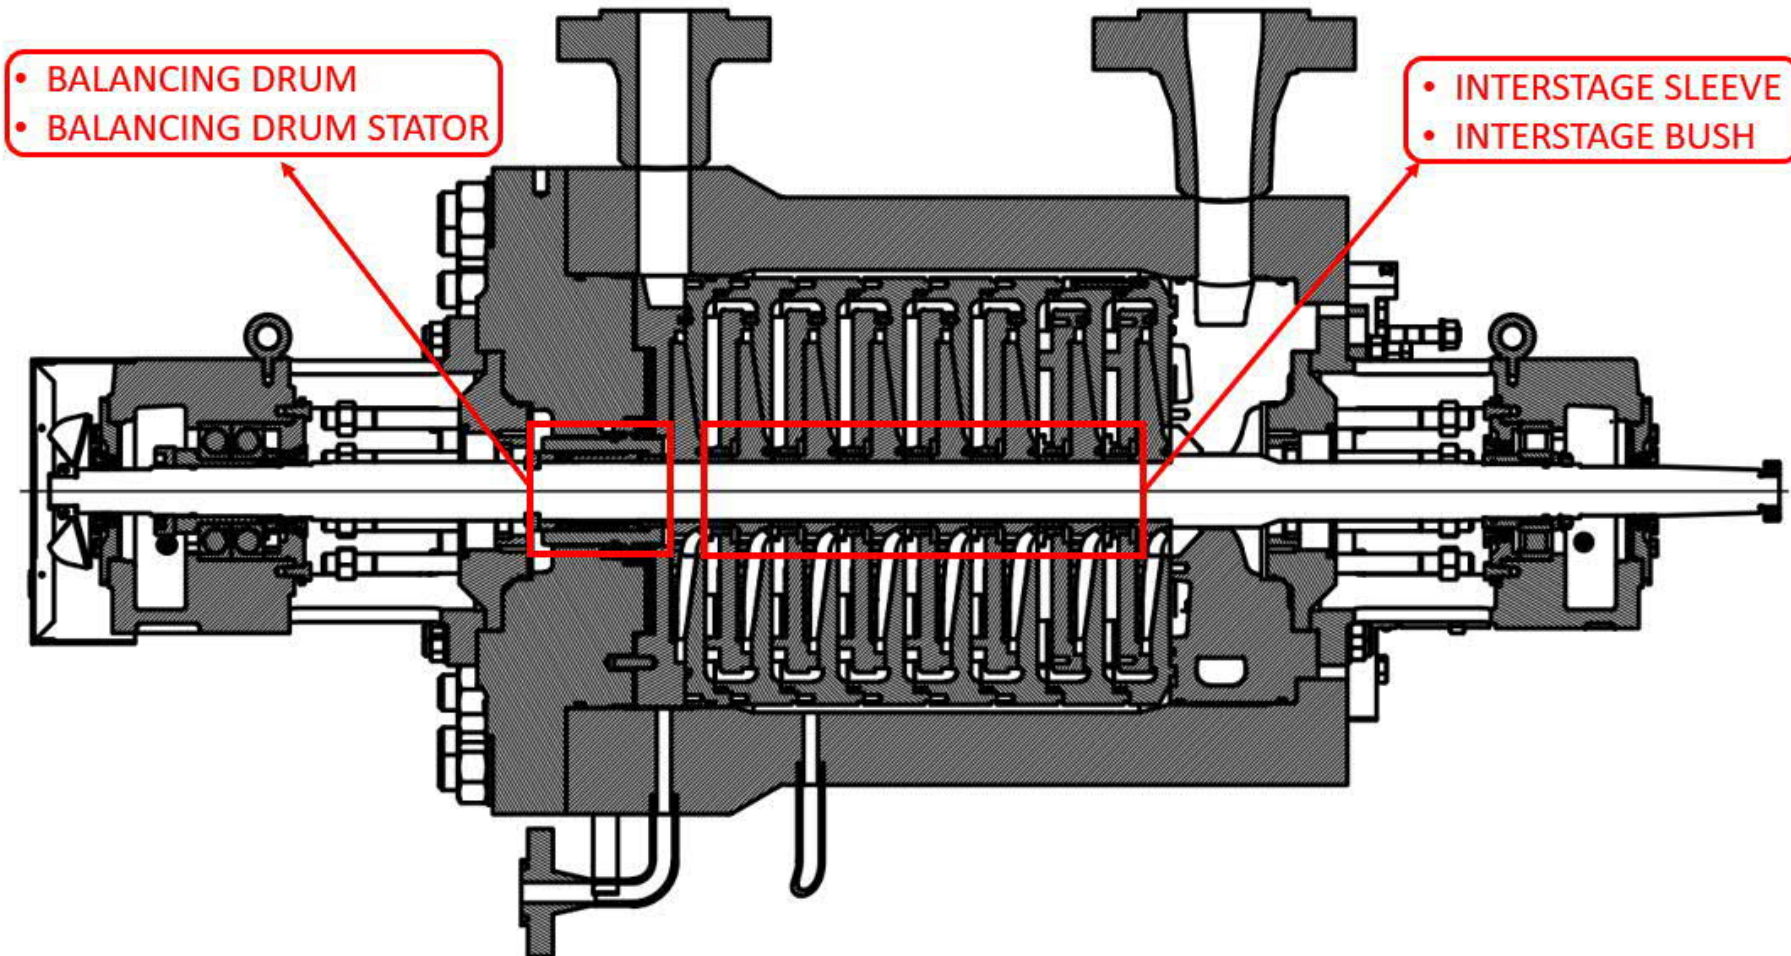
# Components damaged

- Shear stress concentration on interstage sleeves due to grooving design of paired surfaces
- Insufficient metal bonding of the coating on wear surface

- Reduce shear stress concentration
  - interstage bush design changed from grooved to flat in all stages
- Optimize coating to increase its substrate bond strength and wear resistance
  - change coating process from thermal spray (HVOF) to welding
- Different hardness for the mating surfaces (stator and rotor components)
  - Old material: Colmonoy 6 (rot. and stat.) - hardness ~60 HRC
  - New material:
    - Stellite 12 (rotating) – hardness 59-60 HRC
    - Stellite 6 (stationary) – hardness 43-54 HRC

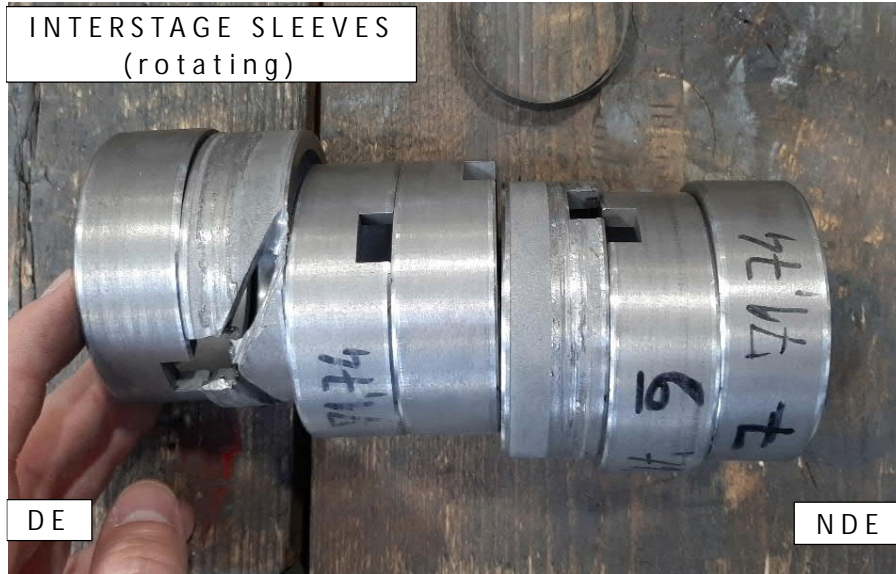
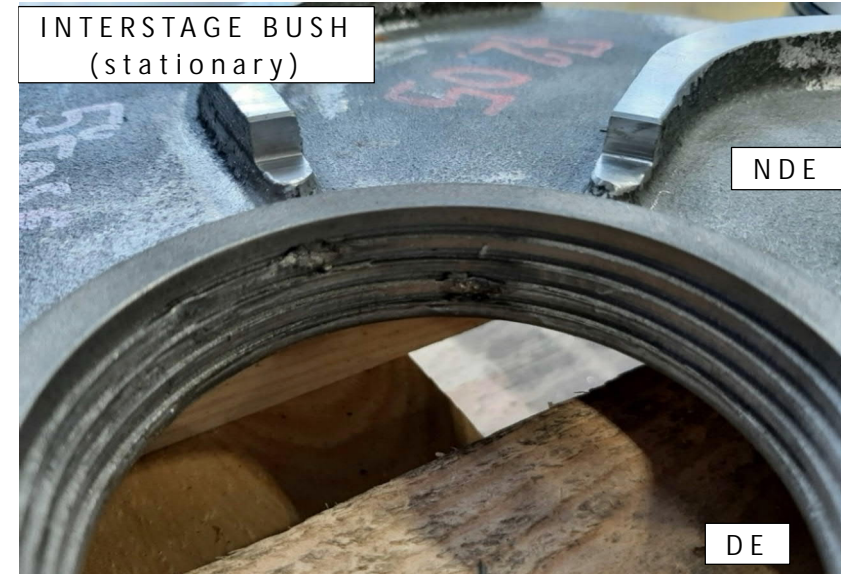
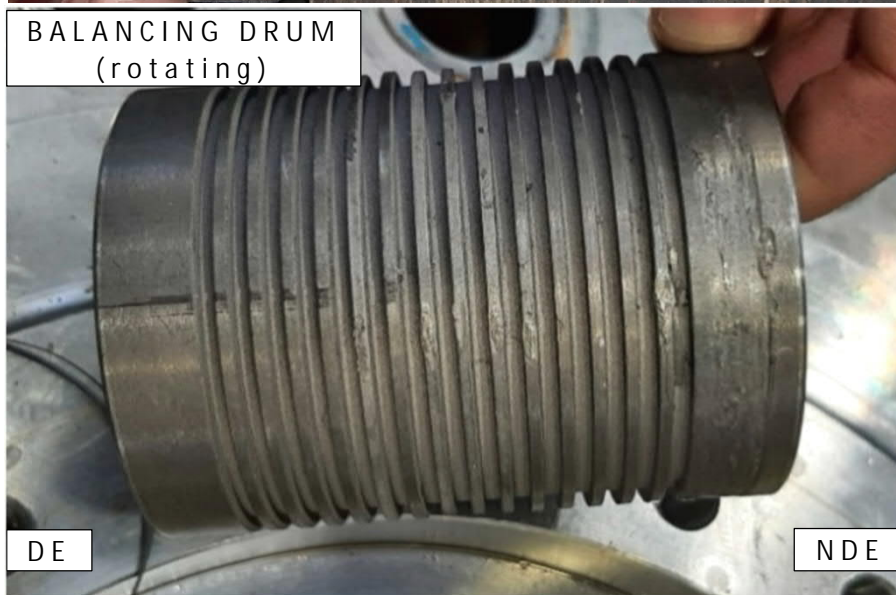
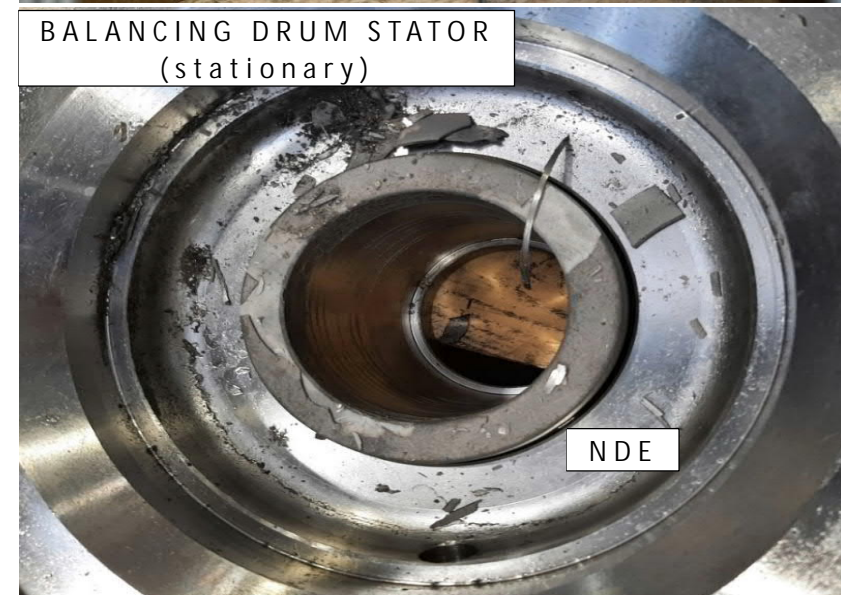
Signs of adherence and coating detachment

After running: signs of abrasion and adhesive delamination are present on the coated components

- shear stress concentration → grooved design on interstage bushes
- presence of microdefects in the coating structure
- Lower substrate bond strength of HVOF coating

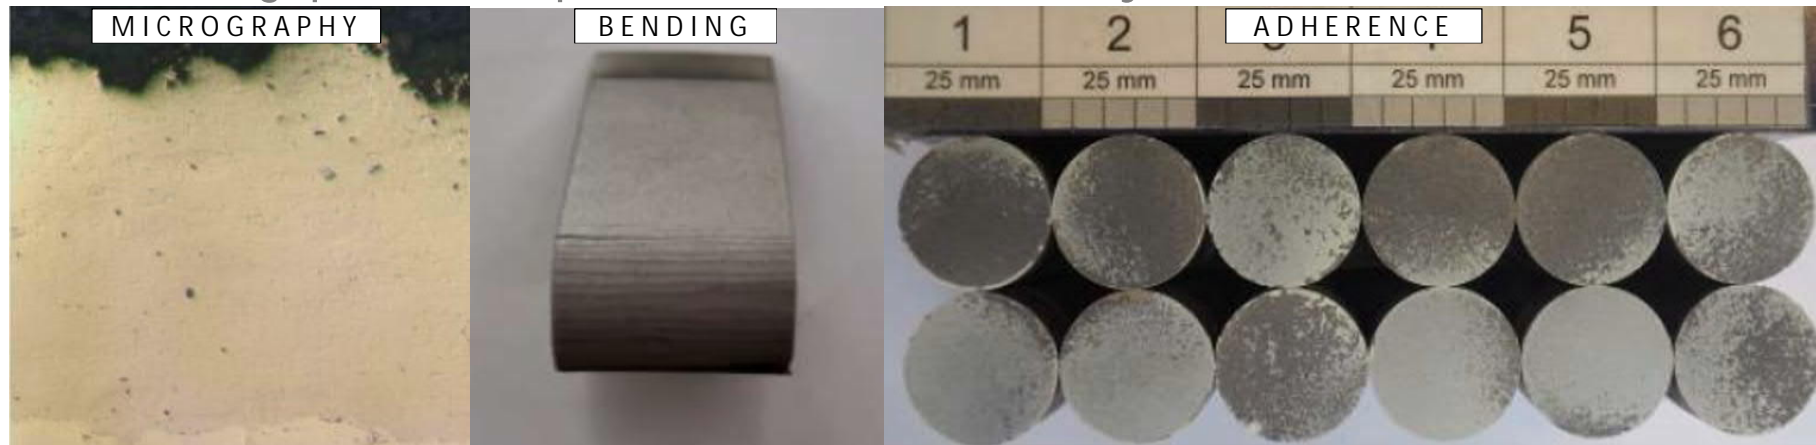
- Micrographic examination
  - Bend test
  - Adherence test
- } Satisfactory results

→ Coating process performed correctly

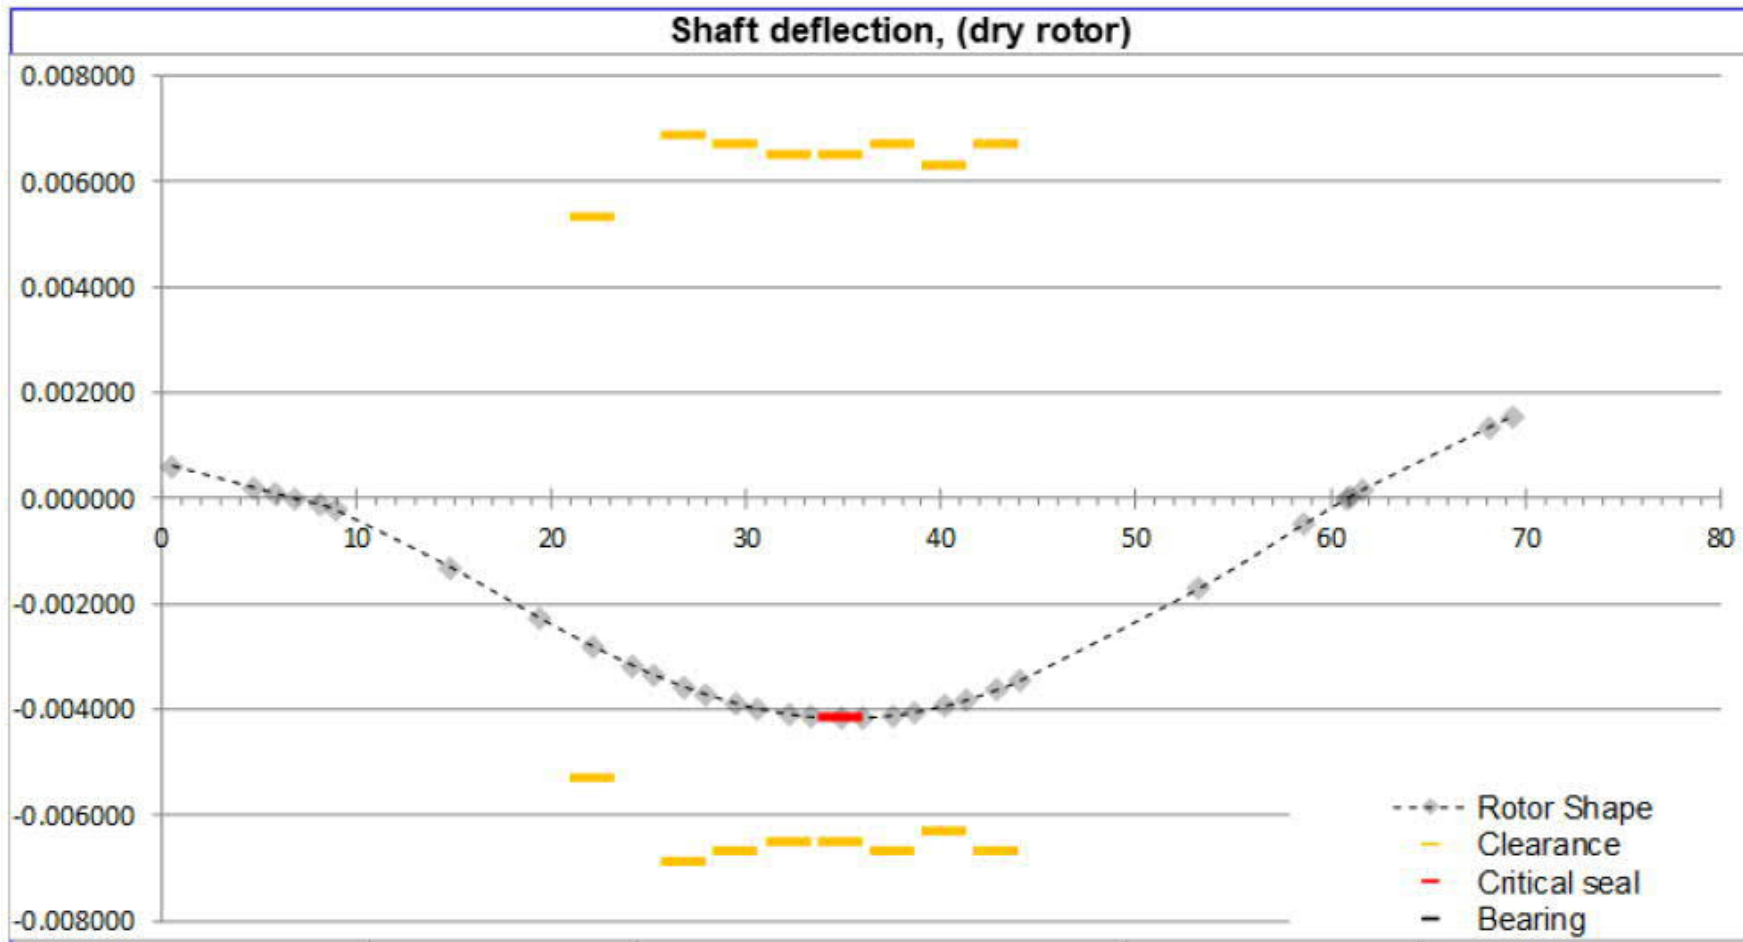
Rotor static study indicates no touch due to shaft deflection

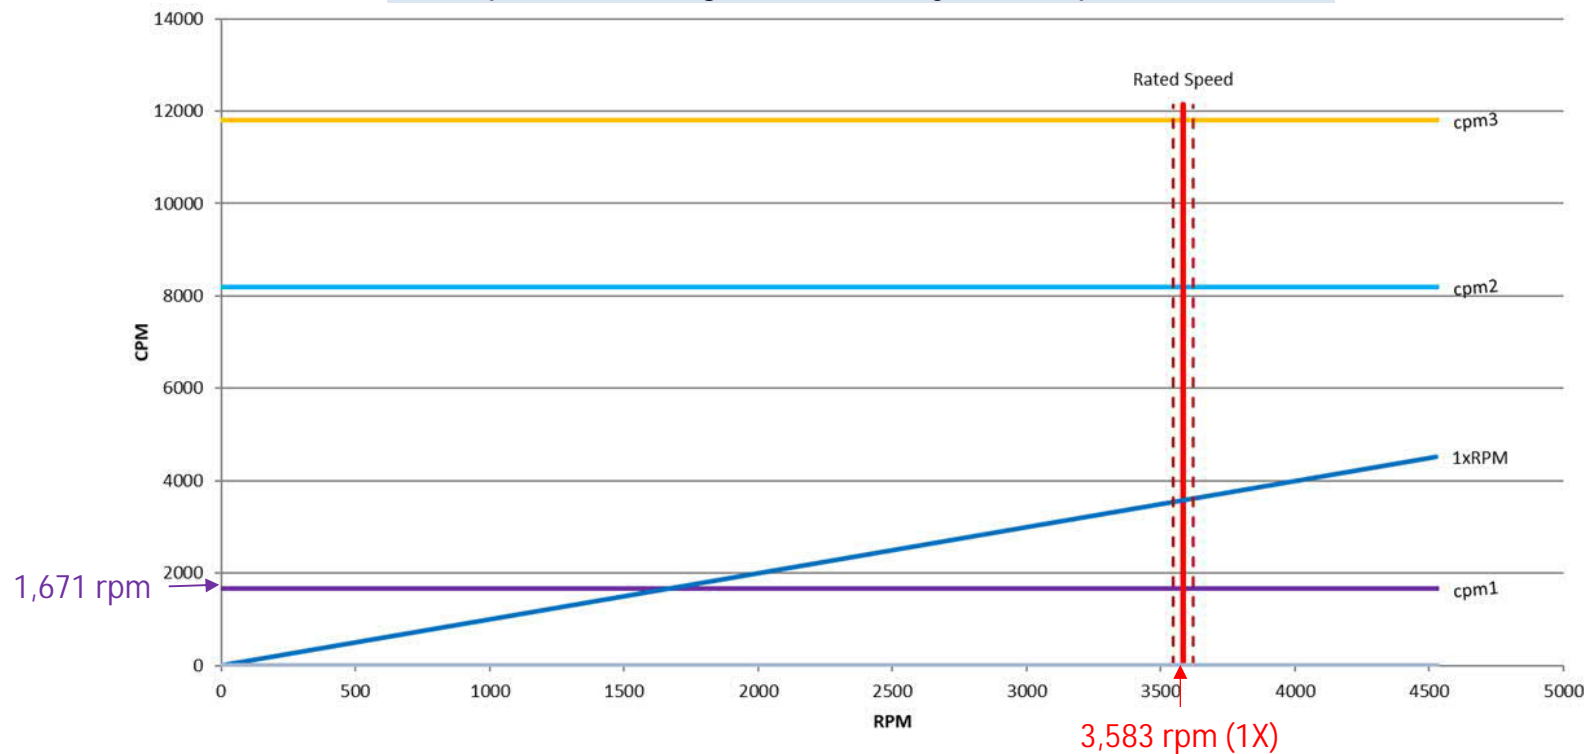
Campbell diagram – Dry Pump modes

Undamped (dry) lateral analysis: first dry bending mode (1,671 rpm)  
lower than 1.2 x pump running speed (3,583 rpm)  
→ Rotor not classically stiff

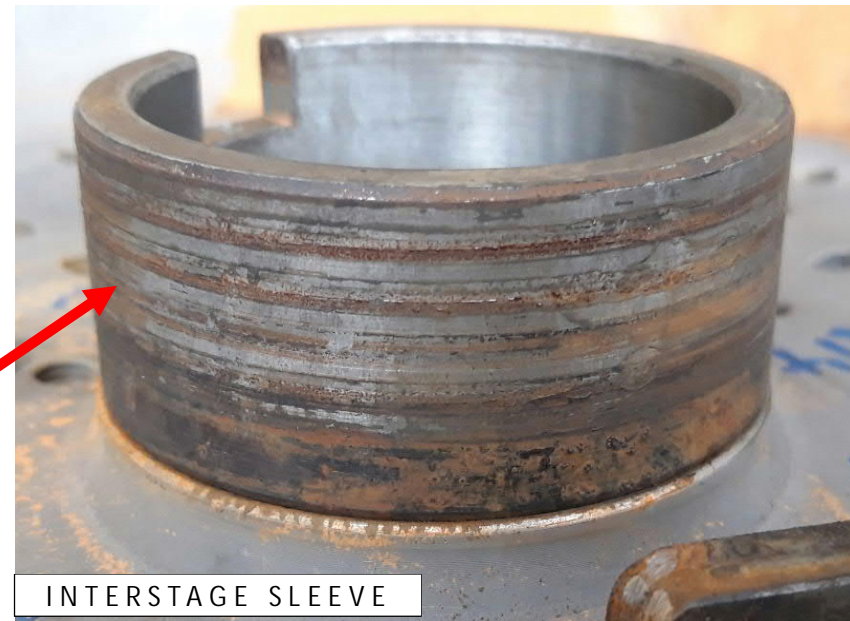
- No seizure
- Signs of contact on the wear surfaces

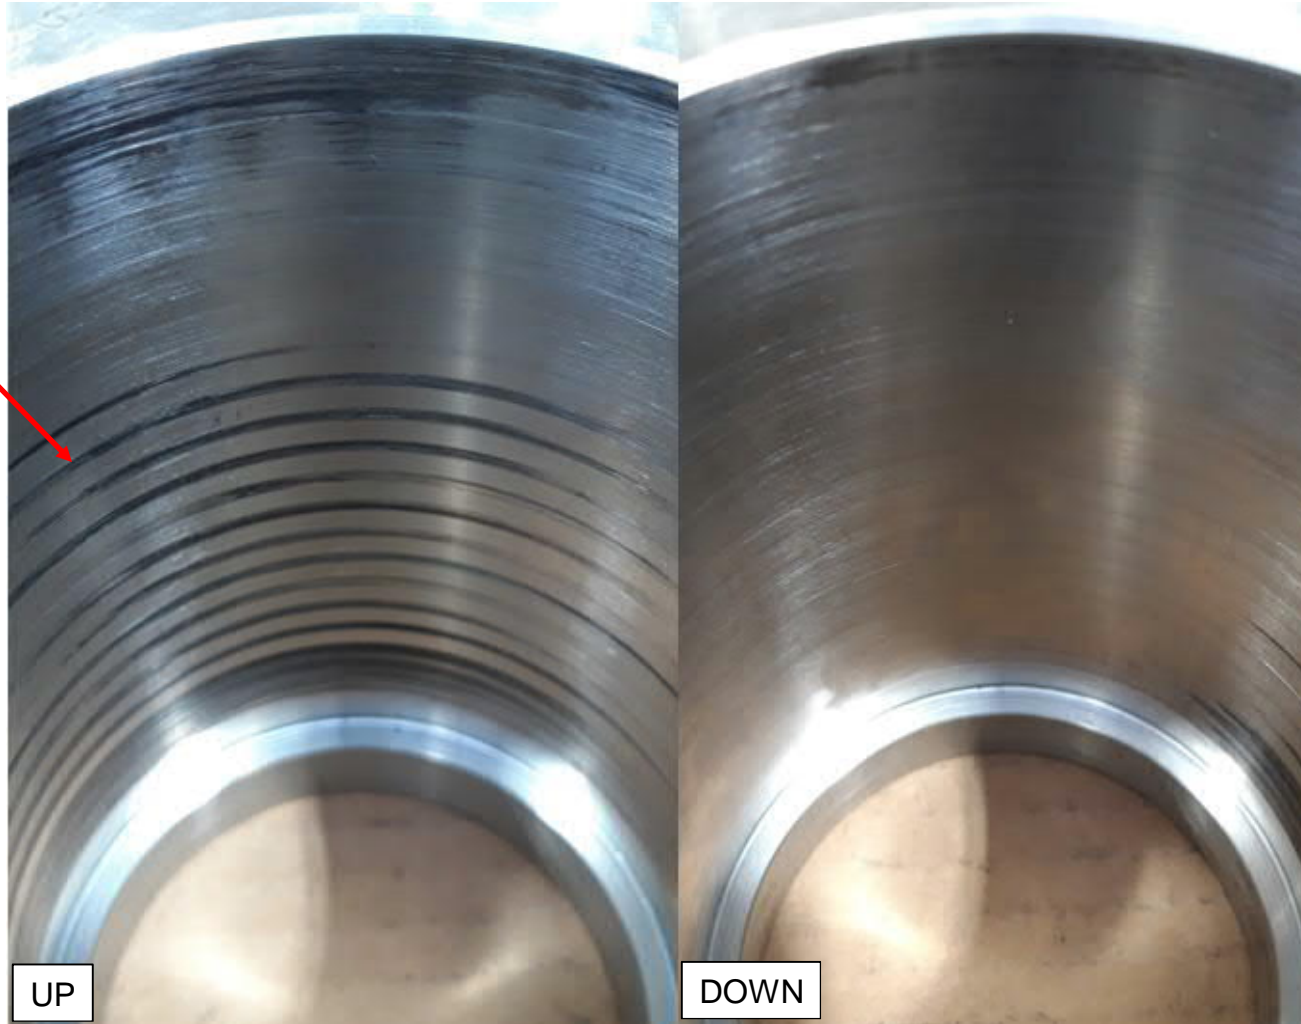
# Visual inspection: Balance drum stat.

- Pump runs without mechanical issues
- Performance results: satisfactory
- Visual inspection after test: persisting minor signs of contact in rotating wear surfaces

SIGNS OF CONTACT
