51ST TURBOMACHINERY & 38TH PUMP SYMPOSIA

Turbine bearing housing fire accident due to hydrogen inflow into nitrogen line of dry gas seal

Hyeongjun Kim / Sanghun Lee
Jinseok Yang

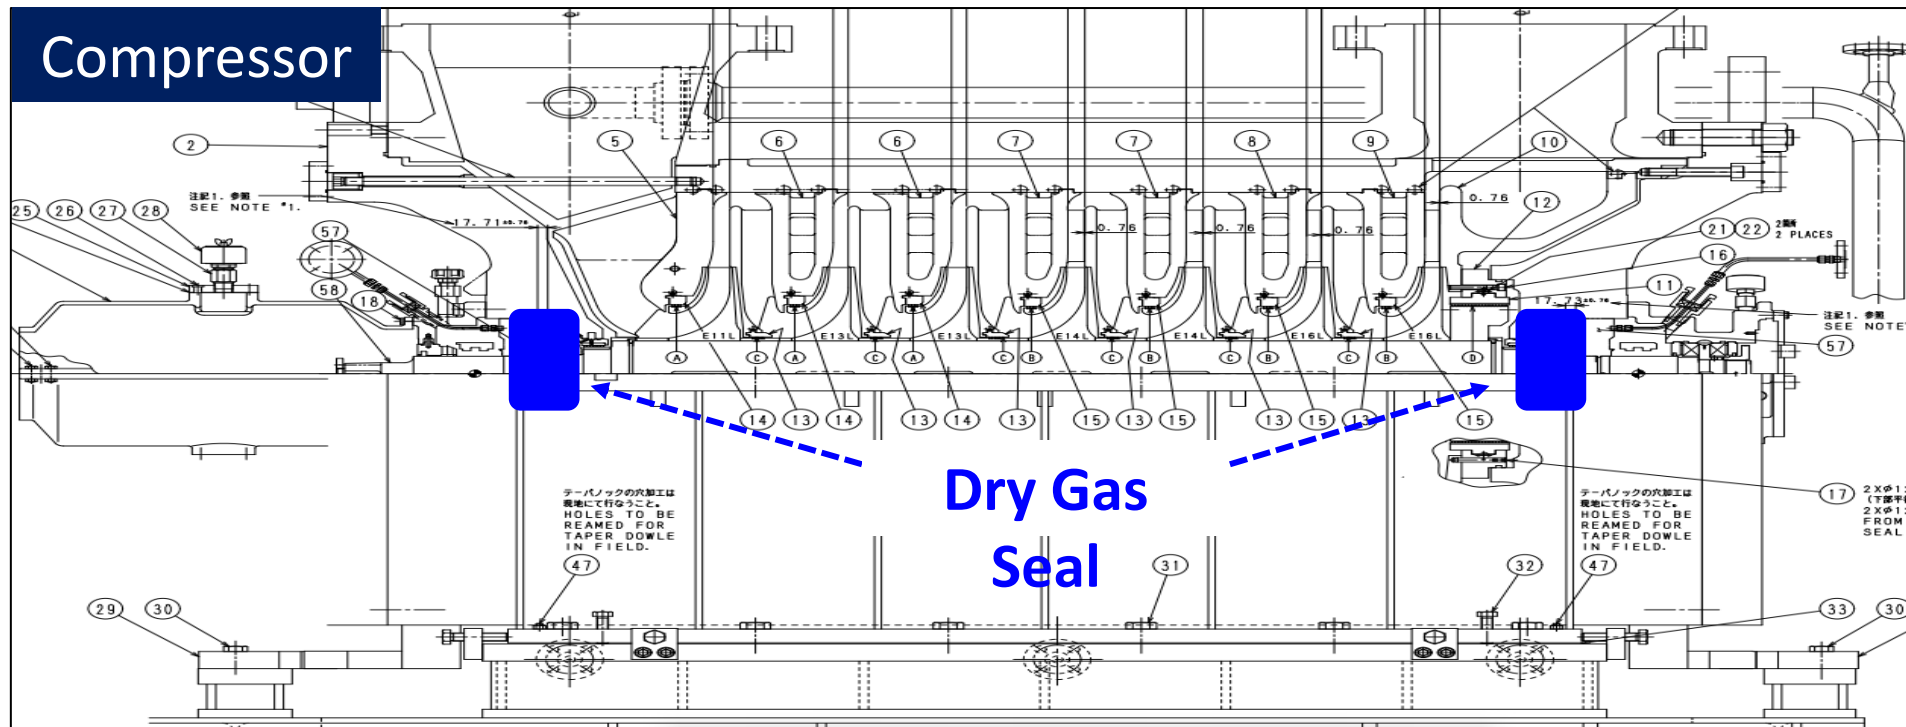
1. **Process** : No.1 CCR(Continuous Catalyst Regeneration) Unit
2. **Compressor**
 - 1) Recycle Gas Centrifugal Compressor, Hydrogen(87%) service
 - 2) Seal Type Modification : **Wet Seal** → **Dry Gas Seal** (2012)
3. **Steam Turbine** : Condensing Turbine Type, speed 8,145rpm

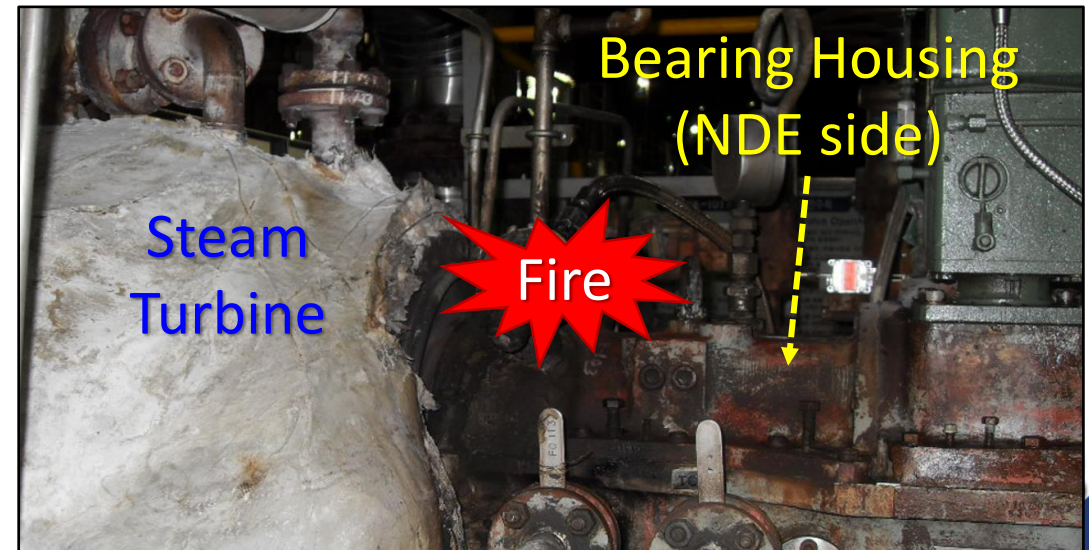
- Frequent fire accidents in the steam turbine bearing housing occurred every start-up, which resulted in urgent shutdown (by manual stop).
- In an initial investigation that focused only on the fire location, oil leakage from the bearing housing was regarded as the cause. However, despite various measures and modifications to prevent oil leaks, the fires continued to appear during start-up.
- After a thorough investigation, two abnormal phenomena were observed and the root cause found in the compressor DGS.
 - 1) H₂ detected in bearing housings (compressor and turbine) and oil reservoir.
 - 2) H₂ detected in the N₂ line, although there are two isolation valves (closed) and one check valve in the H₂/N₂ common line.

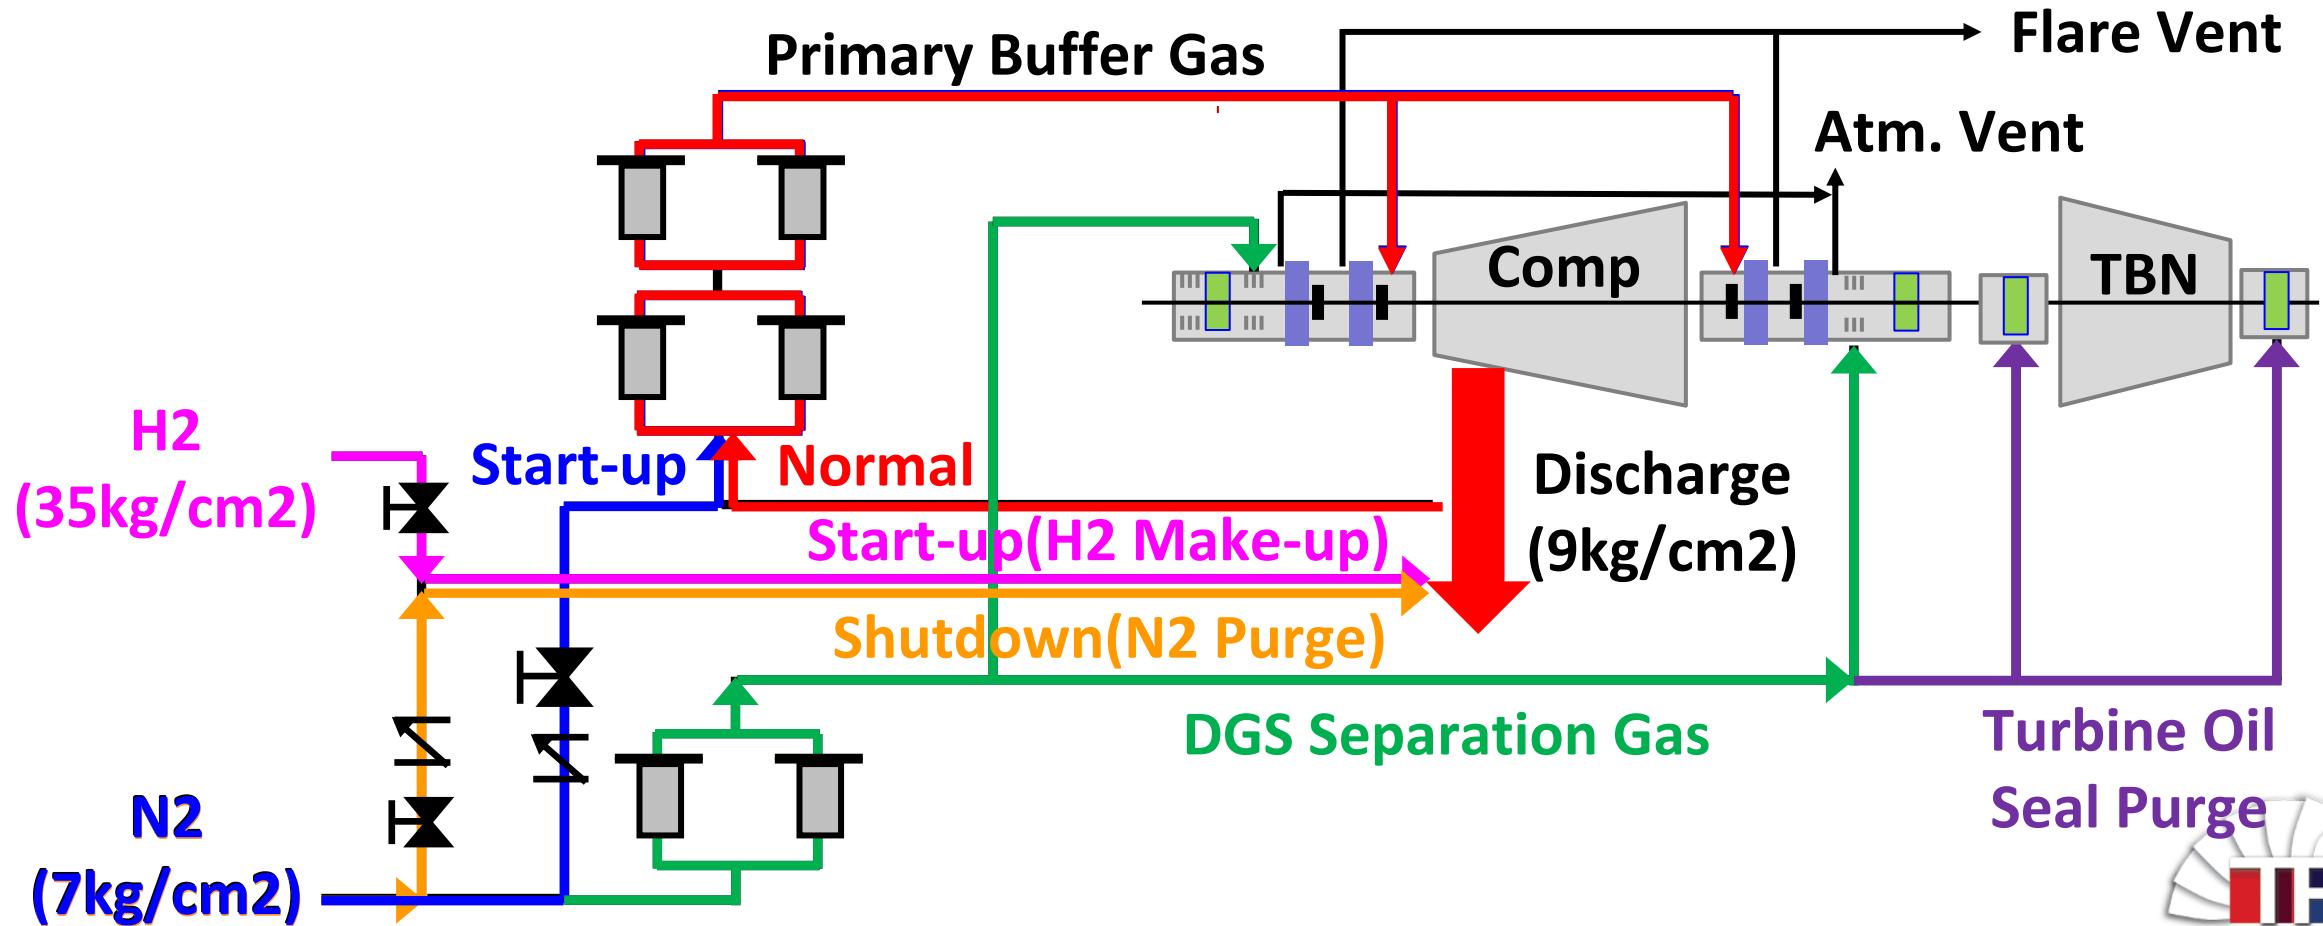
Compressor DGS & Turbine Oil Seal Purge System

- The header line of **Hydrogen make-up** and **Nitrogen purge** is connected to a common line.
- The header of separation gas and turbine oil seal purge is connected to a common line.

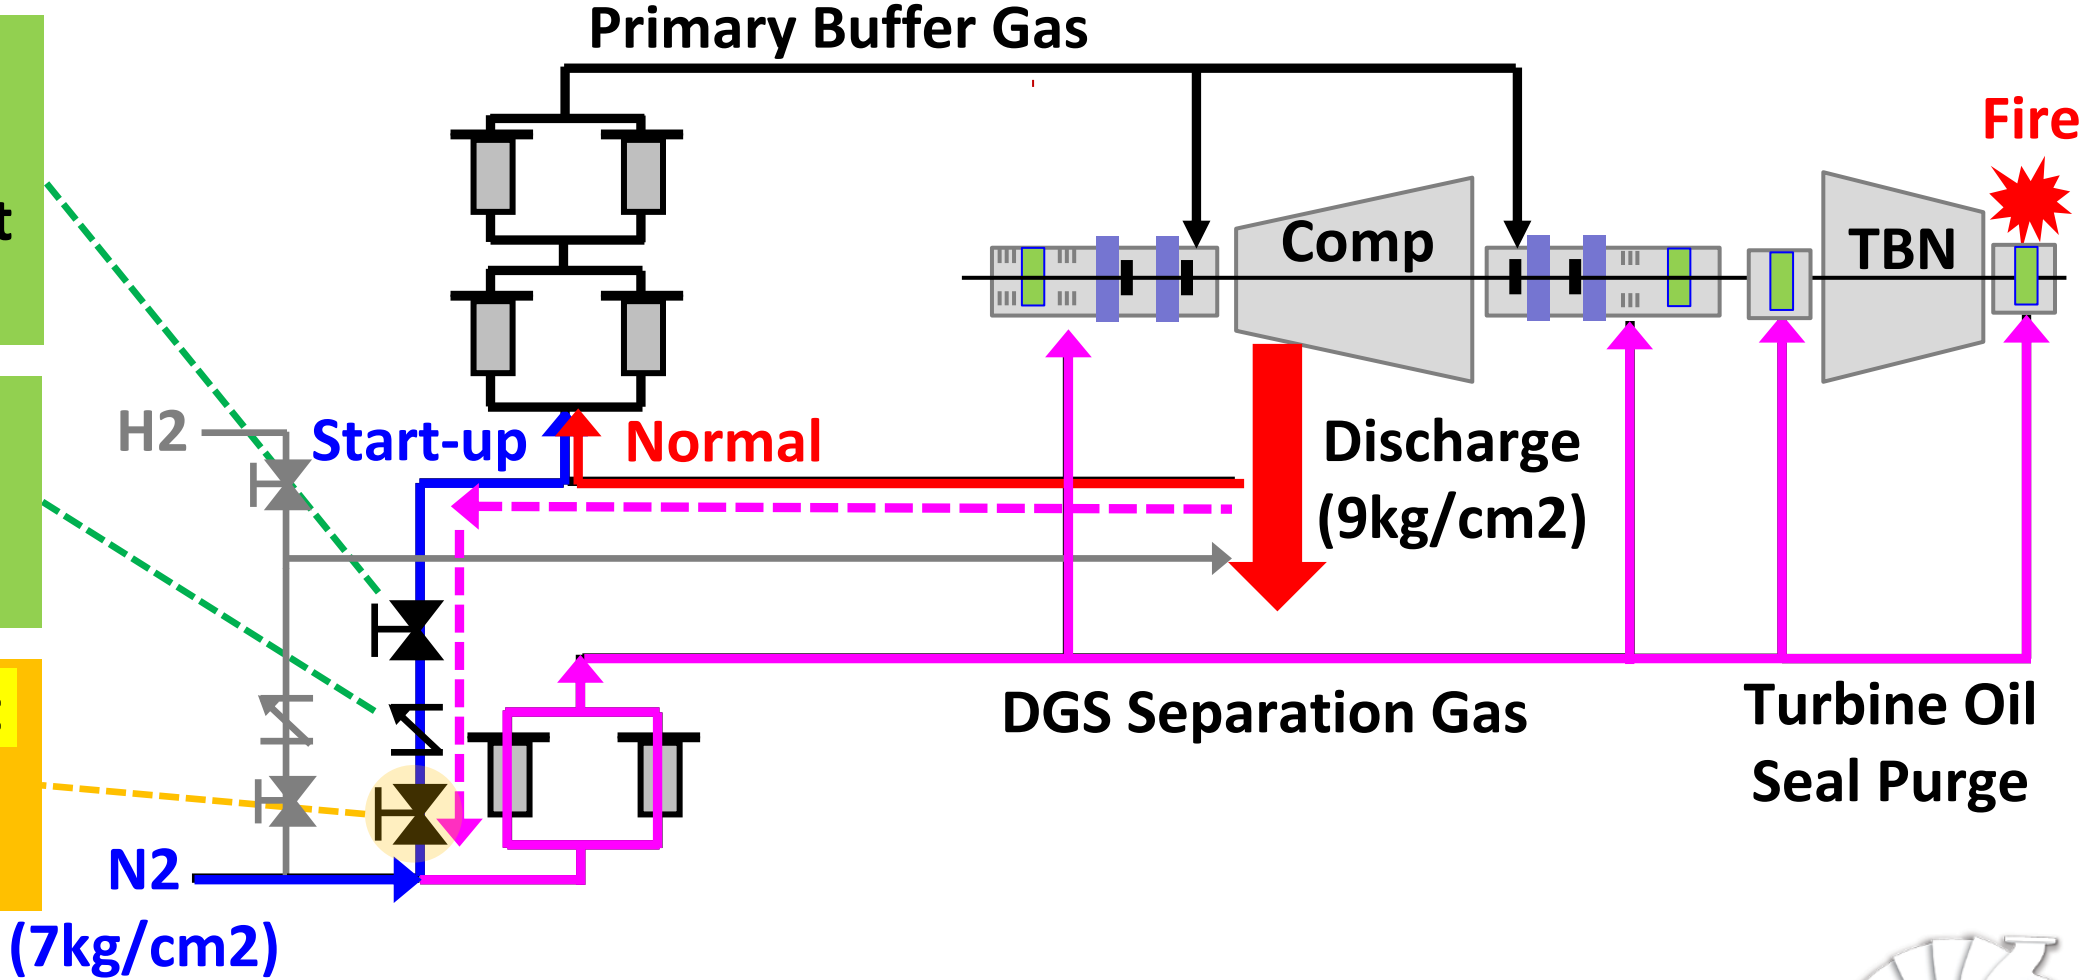
Event #1 – Operation Leading to Fire

- **Immediate Cause : H₂(from compressor discharge) inflow into N₂ header line**
 - Primary buffer gas is supplied from N₂(back-up) during an initial start, and after compressor discharge pressure becomes higher than N₂ pressure, discharge gas(H₂) should be supplied to the primary buffer gas line. At this time, the block valve should be fully closed to prevent H₂ from passing over to the N₂ header.
 - **But in our case, the closing procedure of the valve was omitted when the discharge pressure > N₂ pressure, which resulted in H₂ reverse flow into the N₂ header and further migration into the turbine bearing housing.** Consequently, the fire occurred in the turbine bearing housing.
 - One check valve in the common line of H₂ and N₂, but it was by-passed.

Cause #1
Reverse flow caused by not closing valve

Cause #2
Check valve leak

Improvement
Install new valve

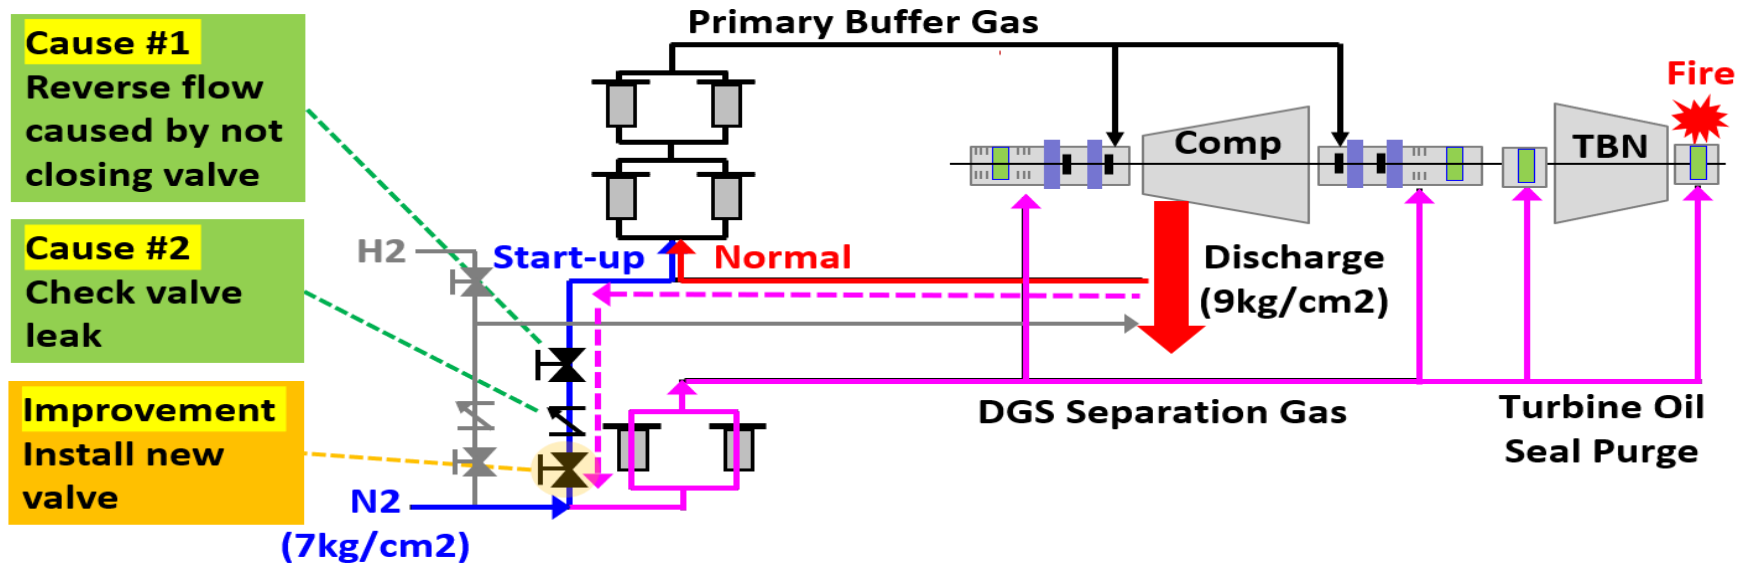
No.	Root Cause	Recommendation
1	<p>Not closed the block valve between H2 and N2 at an appropriate time</p> <p>The lack of operator understanding for related system and working principle</p>	<p>Add specific valve close timing in start-up operation procedure</p> <p>Operator training on the dry gas seal system operation</p>
2	<p>Check valve leak(reverse flow)</p> <p>*Nothing was found in check valve overhaul, but it can potentially leak (prior experience)</p>	<p>Single block valve in common line(H2 & N2) can also leak → Install additional block valve (Double block valve and one check valve)</p>

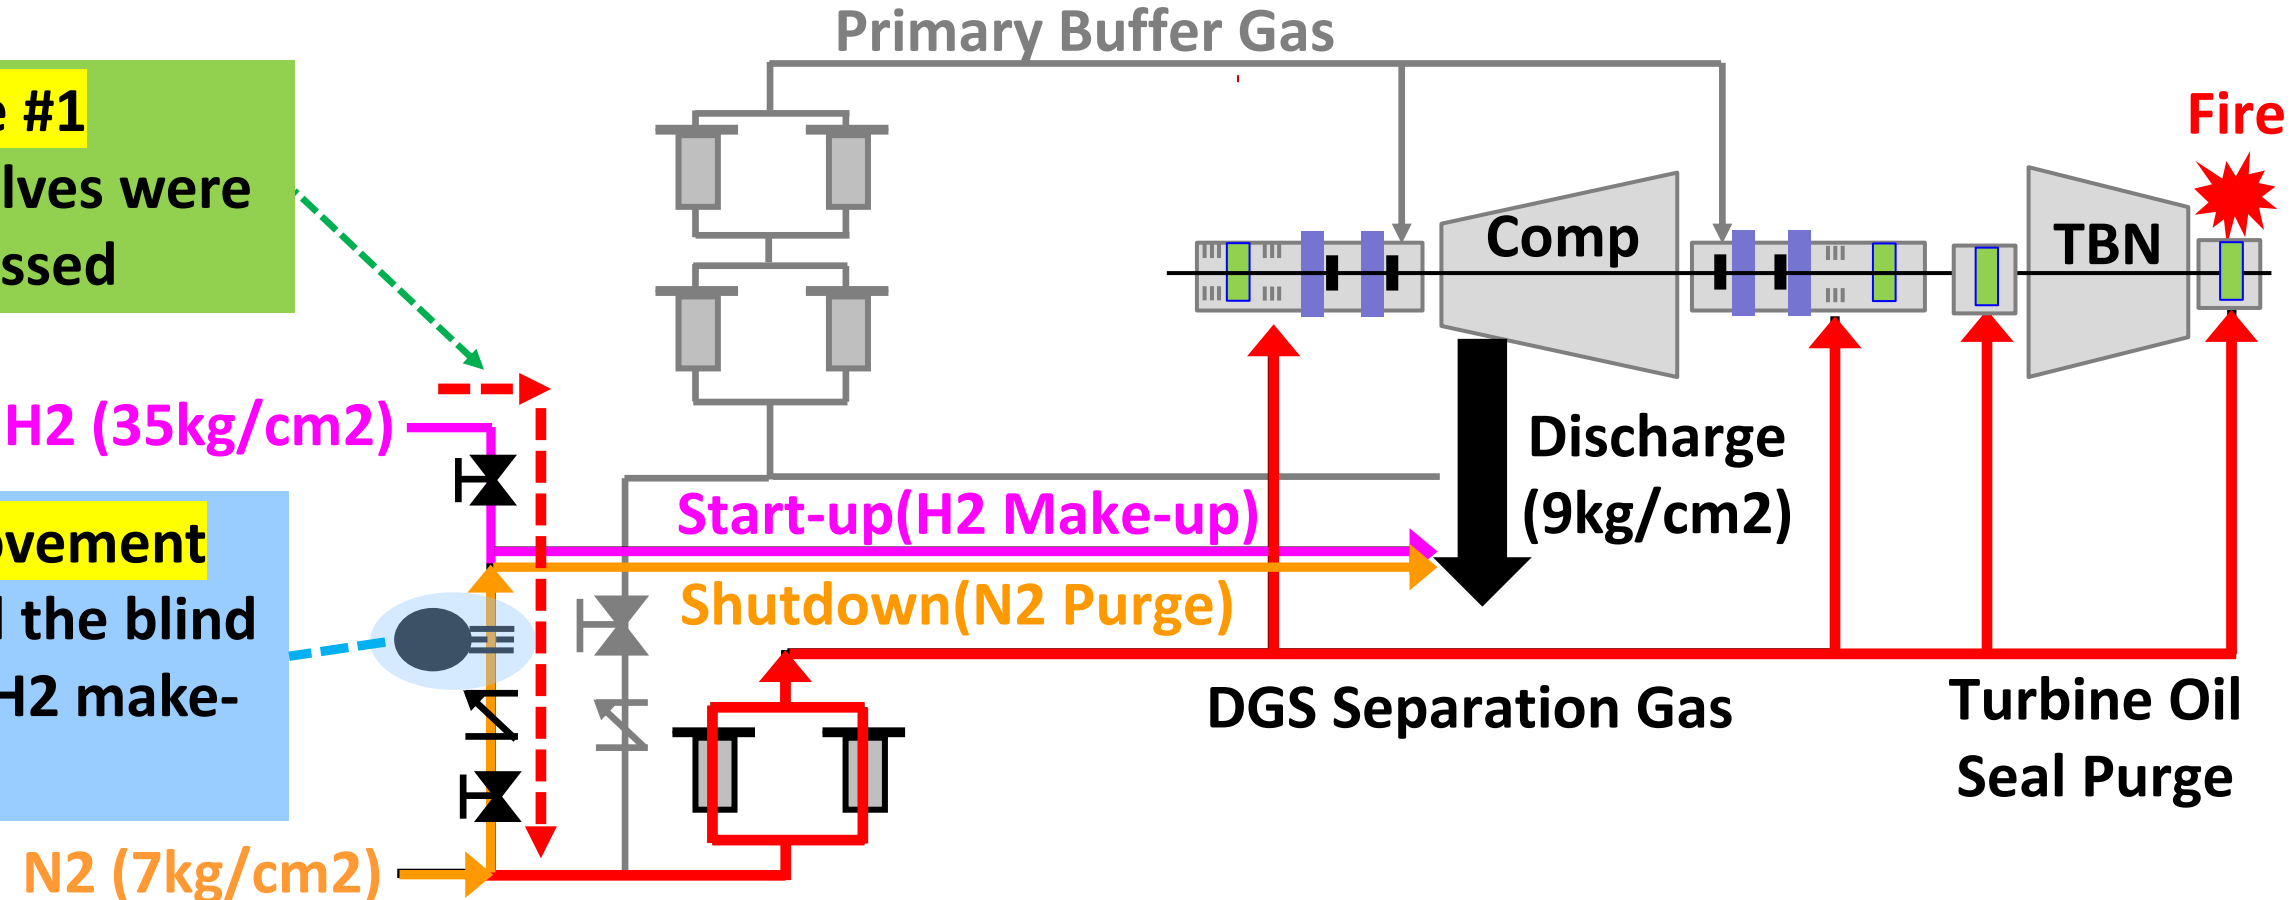
Event #2 – Operation Leading to Fire

- Immediate Cause : **H2(make-up for compressor start) inflow into N2 header line**
 - H2 make-up line for compressor start and N2 purge line for shutdown are connected to a common line.
 - There were two block valves and one check valve in the common line of H2/N2. However, in our case **H2 passed over all valves**, and H2 high pressure(35 kg/cm²) into the nitrogen line.

Cause #1
All Valves were by-passed

Improvement
Install the blind after H2 make-up

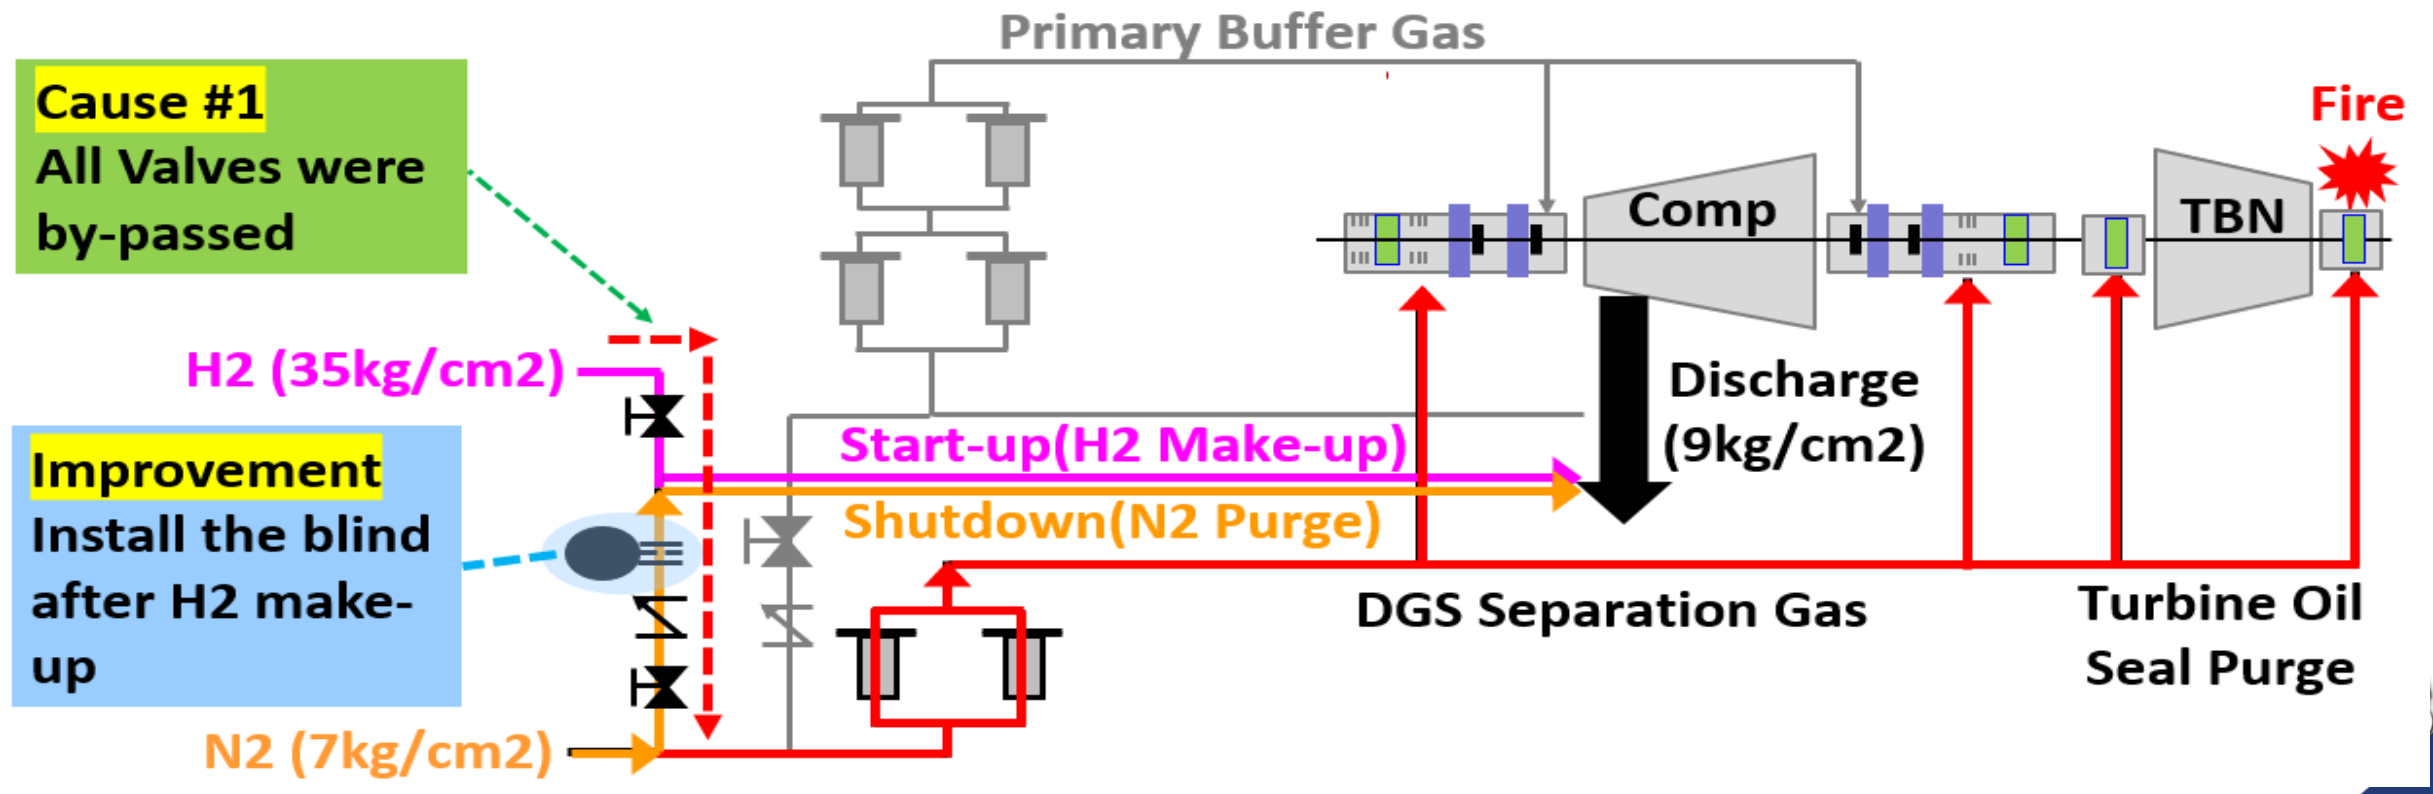
No.	Root Cause	Recommendations
1	All valves were by-passed (two block valves and one check valve)	Revise operation procedure to install the blind between H2 and N2 after H2 make-up
2	Common line of H2 and N2	Detailed review required to prevent recurrence in new projects
