**Investigation of PVC Pipe Failure at Terrell State Hospital  
- Final Report**

**Terrell State Hospital  
Texas Department of Mental Health and Mental Retardation  
(MHMR)**

**Energy Systems Laboratory  
Texas A&M University  
College Station, TX 77843**

**May 2000**

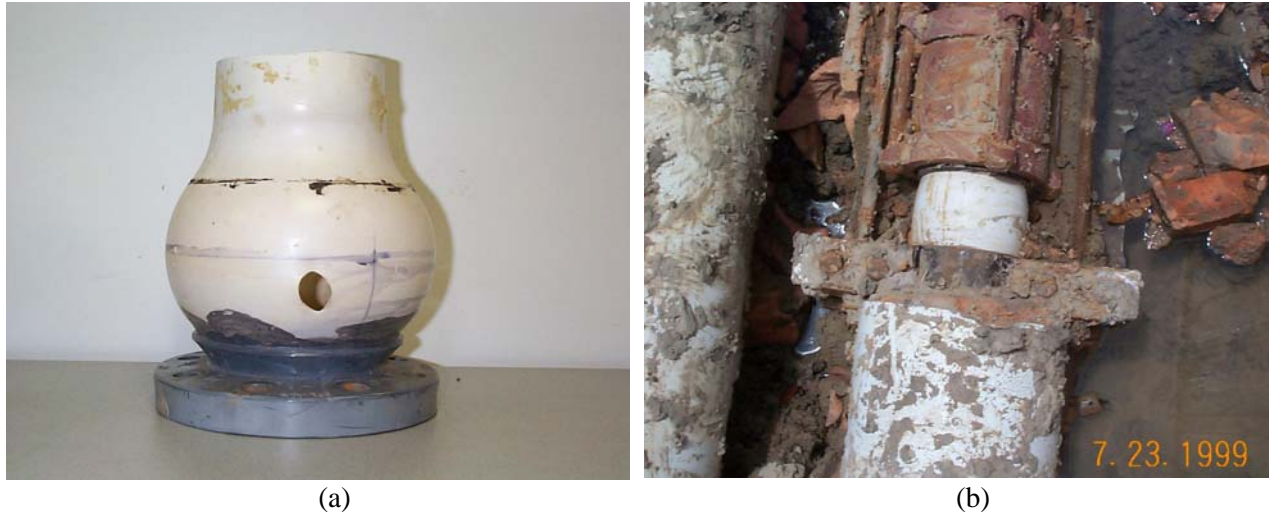
During the course of this investigation, it was found from the building automation system that the failed section of the PVC pipe was located closed to a chilled water pump which had been accidentally deadheading for over 52 hours prior to the second failure. It is concluded that the failure of the PVC pipe was caused by high temperature inside the pipe as a result of pump deadheading. This conclusion is strengthened by high chilled water temperature measured (170°F) after similar chilled water pump deadheading situations occurred in buildings at Texas A&M recently.

The first failure occurred at the junction of the PVC pipe and the steel pipe on the chilled water supply side, approximately 50 feet upstream of the building chilled water pump. Figure 3(a) is the picture of the ballooned PVC pipe. The failed PVC pipe was removed and replaced by a new steel pipe about 20 feet long. The second failure occurred at the place where the new steel pipe made the connection with the PVC pipe. Figure 3(b) shows the failed section. Note that the pipe just started to swell.

Figure 3. Failed section of the PVC pipe with flange in one end.

We felt that the PVC pipe failure was caused by the deadheading of building chilled water pump. However, the cause of the deadheading is not clear yet. We will continue to investigate the problem. Meanwhile, it is recommended that we keep the building isolation valve open (has been implemented after the failure) and fix any wiring problems at the buildings.

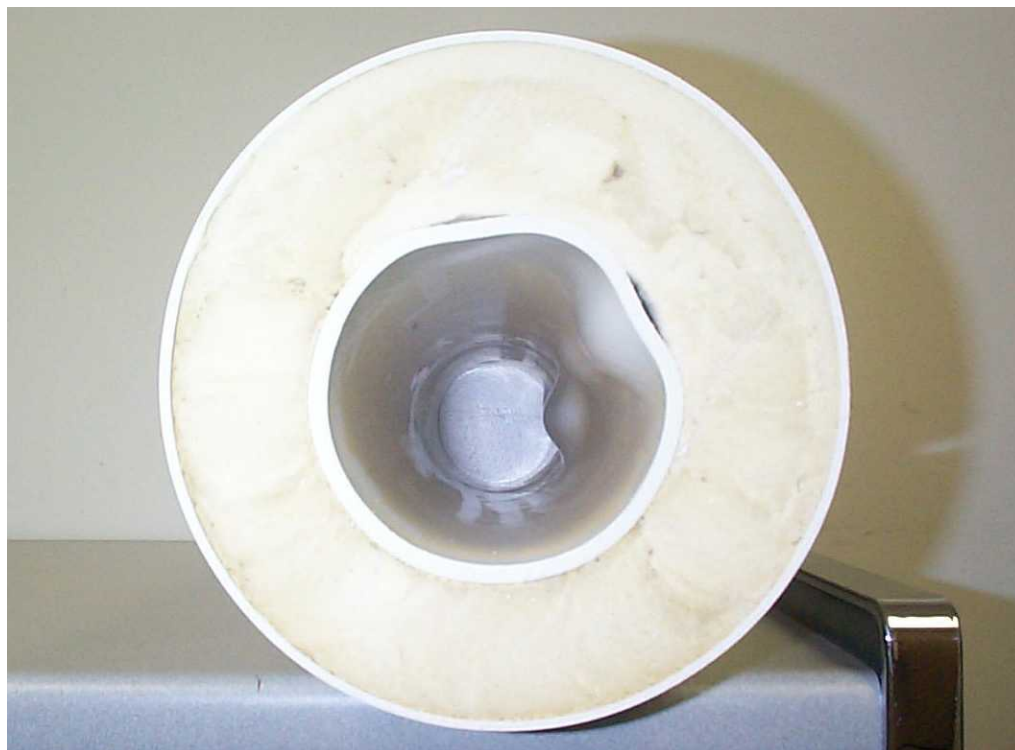
When the second failed PVC pipe was removed, it was found that one section of the PVC pipe had a lot of bulges inside the pipe. See Figure 4.

Figure 4. Inside of the PVC pipe cut from places closed to the failed sections.

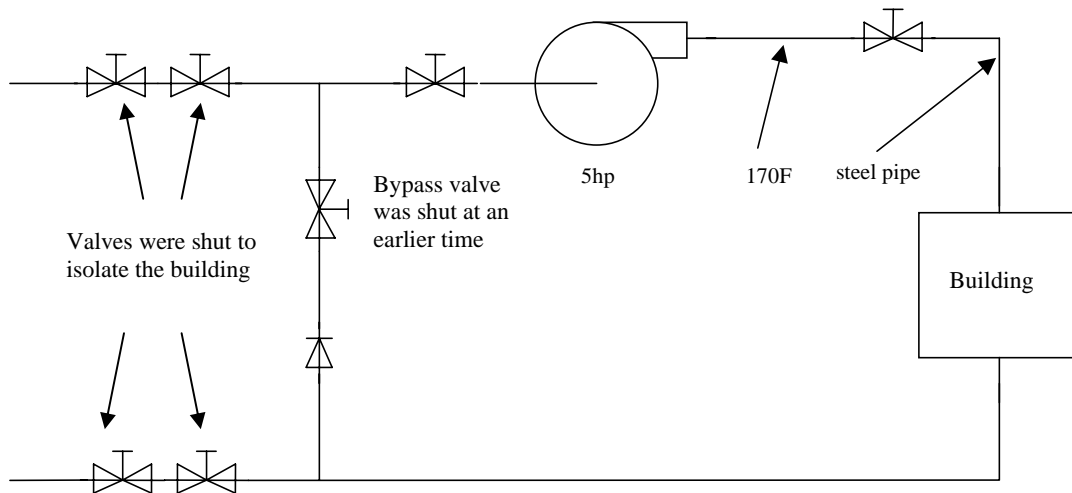
One of the two incidents happened in the beginning of January 2000. Right before the incident, some loop work was performed and the building had to be isolated from the campus loops with its isolation valves. Meanwhile, building chilled water pump was turned off. As shown in Figure 5, four valves (2 sets of supply and return valves) were shut to isolate the building, and the manual valve in the building bypass line had been shut at an earlier time. After loop work was done, a different operator was assigned to go to the building to put it back on line, who only opened two of the four closed valves (1 set of supply and return valves) and turned on the building chilled water pump. After a couple of days, hot call came from the building, and hot water temperature was measured in the chilled water line. It was thought that somehow the chilled water lines of this building was cross connected to the campus domestic hot water loop, which normally have a supply water temperature around 150 °F. Later, another team went to the building and checked the valves. One of the two closed valves was opened, and the other one was assumed to be open since the valve could not be turned due to rusty conditions. Finally, this closed valve was identified and opened, and the building was put back to normal operation. The longest recorded pump-deadheading period is about 20 hours (from noon to the next morning 8:00), and the temperature besides the pump was measured to be 170 °F after this.

Figure 5. Case 1: deadheading of a 5-hp building chilled water pump caused 170 °F water temperature being measured in the chilled water line

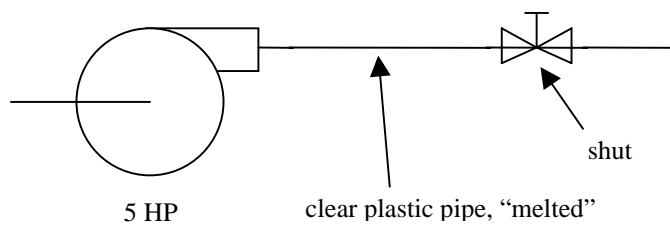
Another incident happened a little earlier in a mechanical lab, where a water loop with a 5 hp pump was set up for some testing. As shown in Figure 6, the discharge side of the pump was built with clear plastic pipe for observation of the local flow pattern and conditions. One day, the pump was left deadheading, and it was told that the clear plastic pipe was resulted to be "melted".

Figure 6. Case 2: deadheading of a 5-hp lab pump caused clear plastic pipe at discharge side "melted"
