CORROSION OF ALUMINUM-FIN, COPPER-TUBE HEAT EXCHANGE COILS

JAY E. FIELD, PH.D. TRANE RESIDENTIAL SYSTEMS TYLER, TX

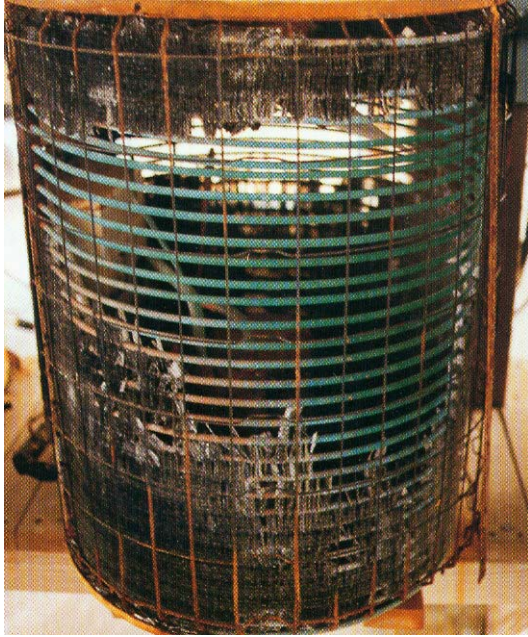
Most corroding agents produce relatively straight tunnels through a copper tube wall. This is the more common experience with outdoor heat exchange coils and is usually attributed to galvanic corrosion. This occurs whenever there are dissimilar metals in the presence of water containing an electrolyte. Dissolved salts of chloride are the most common electrolytes. Although, any soluble salt can lead to galvanic corrosion, such as those containing fluoride, bromide, iodide, sulfate, nitrate, borate, etc. When galvanic corrosion occurs, the more sacrificial metal (aluminum in our coils) will preferentially corrode, and by doing so, protect the more noble metal (copper in our coils). Figure 1 shows an outdoor condensing coil that was exposed to a severely contaminated environment. Note the copper tubes are intact but the aluminum fins are gone. This is the image and mechanism that most people think of when considering coil corrosion.

Figure 1. Outdoor Coil showing evidence of galvanic corrosion.

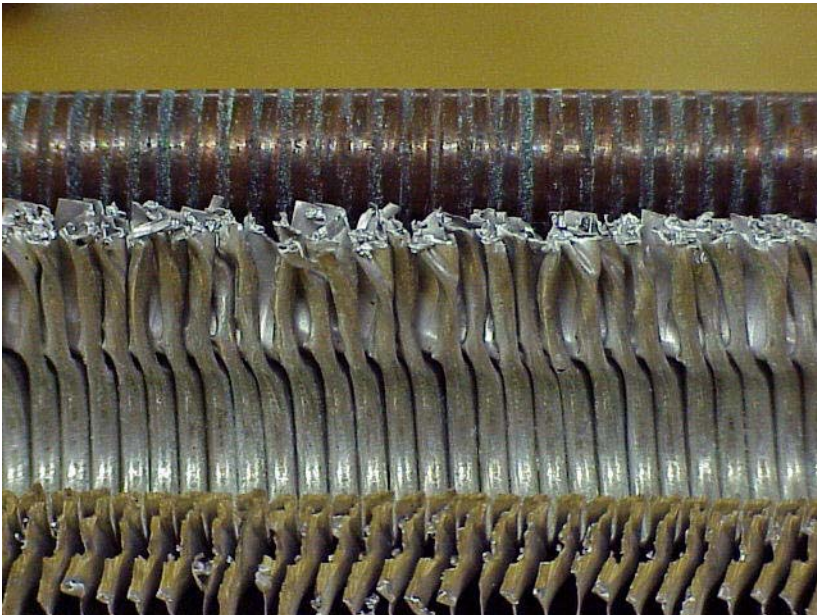
In most failures of indoor coils, however, the copper tubes will have been penetrated while there will be little corrosion on the aluminum fins in direct contact. Figure 2 shows pits in the copper tube surface and the contacting aluminum fin surfaces. In these cases the corrosion appears to be caused by a direct attack of the corroding agent on the copper in spite of the presence of the 'more sacrificial' aluminum. Hydrogen sulfide, carbon disulfide, and ammonia have been known for centuries to cause copper corrosion without the presence of a conductive electrolyte solution or a 'more noble' metal. The capability of low molecular weight organic acids to directly attack copper and produce leaks in heat exchange coils is new knowledge to the HVAC industry. This is not to say that it is new to chemistry, or that chemists in the HVAC industry somehow lacked this important information, but that it was never understood to be a cause for actual leaks. In fact acetic acid has been used for centuries to treat copper by mild, uniform surface attack. What is unexpected is that this attack will concentrate in specific places and penetrate the tube wall, rather than just uniformly etch the tube surface.

Figure 2. Corroded copper tube and adjacent aluminum fins.

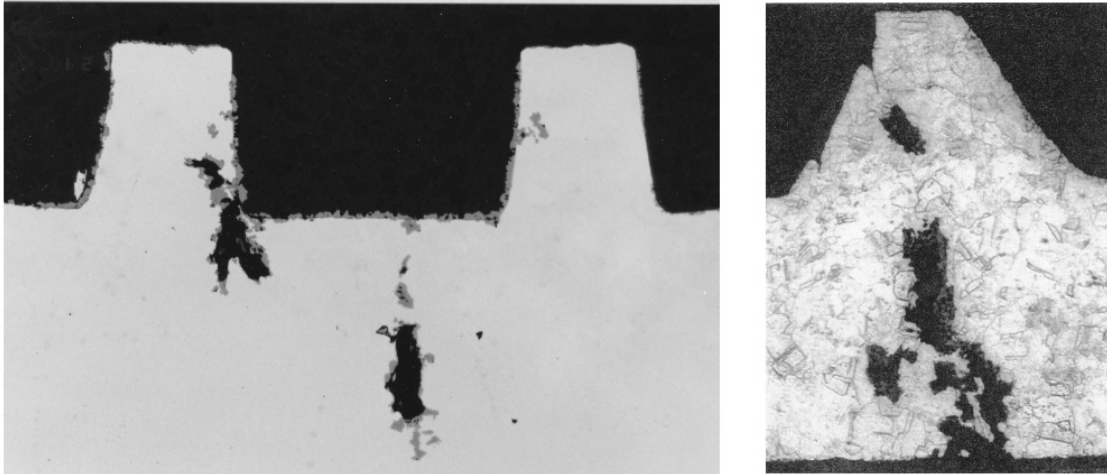
Leaks caused by organic acids typically appear as a single initiation hole that branch into several tunnels of which only one or a few actually penetrate the entire tube wall. As these tunnels appear similar to those in an ant colony, they are often referred to as 'formicary' corrosion. Figure 3 shows microscopic images of the cross section of two copper tubes showing this phenomenon – one starting from the inside and one from the outside.

Figure 3. Cross sections of copper tubes with formicary corrosion initiating from the inner wall (left) and outer wall (right).

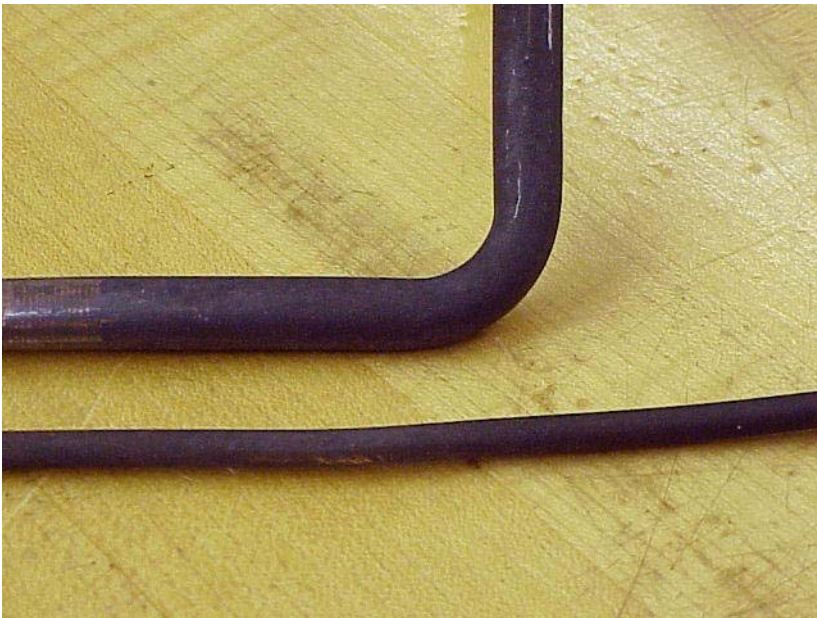
There is nothing more frustrating than trying to find leak causes on a coil that never had a leak or had one caused by a manufacturing defect. Defects in tube welding, and in tube processing can produce leaks at any position in the coil. These kinds of failures are suspected when only one leak is found in the coil, or found in only one U-bend. The general appearance of the coil can reveal candidate causes. For instance, a coil with black copper tubing and clean shiny aluminum has likely been attacked by sulfur. The next steps would be confirmation of sulfur. Figure 4 shows copper tubes with typical black sooty appearance of sulfur attack.

Figure 4. Appearance of sulfur attack on copper tubes.

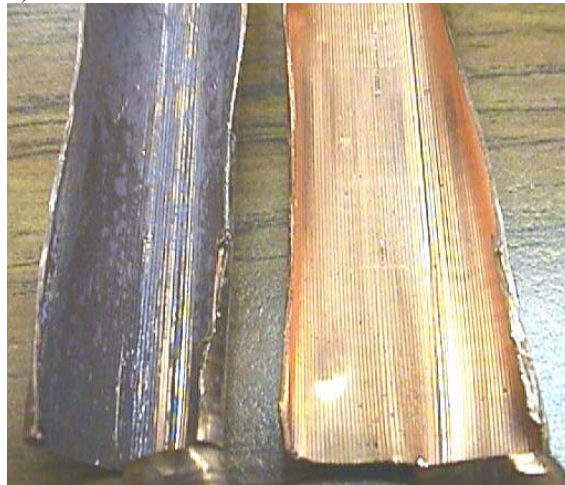
Pinpointing the leak location(s) is important for later analyses. Leak location can provide evidence of the corroding agent source. Figure 5 shows internal tube corrosion in a coil. The corrosion was only present in the first tube in each circuit. This indicated that the corroding agent was not from the coil itself, but from somewhere upstream. Leaks that occur in only the bottom row of the coil are likely to be caused by some corroding agent in the condensate water, if not by some physical defect. High chlorine was found in the bottom row of one coil returned from a home. A little diplomatic questioning revealed that the homeowner had been pouring chlorine bleach in the drain pan to kill ‘bugs’ growing in there!

Figure 5. Interior surface of corroded copper tube at capillary inlet end (left) of circuit and at suction manifold end (right) of circuit.

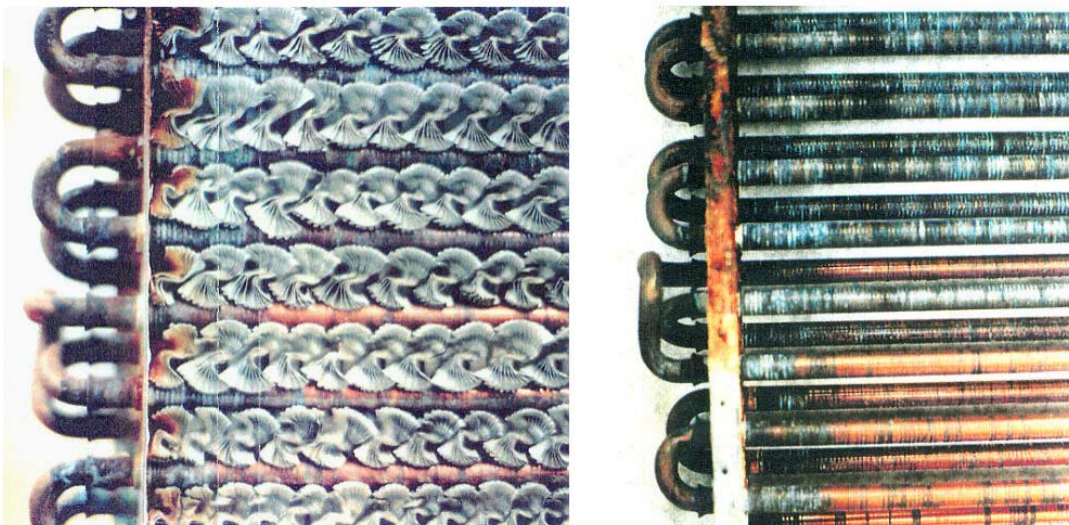
This is a laborious exercise that requires a lot of persistence. The intent is to reveal the leak location in the copper tube for further analysis. The Japanese copper tubing manufacturers seem to have perfected a technique for an entire coil as shown in Figure 6. It works relatively well on 1-row and 2-row coils, but poorly on deeper coils. The steps are slitting the fins along the tubes, twisting/tearing the fins, and finally pulling the fins out. The picture on the right shows the typical purple to black color of formicary

corrosion on the upper rows and little corrosion on the bottom rows. This followed the airflow pattern for this coil, indicating the corroding agent was likely from the application environment.

Figure 6. Two row coil with fins cut and twisted (left) and completely removed (right). Note blue-black color typical of formicary corrosion.

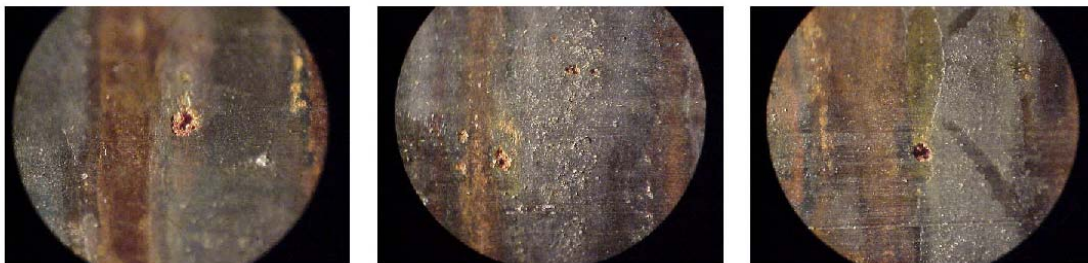
With the fins off and the tube surface exposed, microscopic examination is possible. If the tube in the area of the leak is clean and no pitting is observed, it may indicate that the leak initiated from the inside. Slitting the tube and spreading it open would reveal darkened inside surfaces and pitting in these cases. Most often though, the exterior will resemble a lunar landscape – pockmarked with pits. Often times these areas also show salt deposits. Analyses of these deposits can sometimes reveal the corrosion cause. Figure 7 shows microscope images of several pitted tubes. The vertical stripes are caused by the contact of the aluminum fins. The light-color copper bands are where the fin collars touched the copper tube. The darker gray or black bands are the spaces between the fins. It is in these bands between the fins that pitting is predominant. The edge of the fin collar creates a miniature crevice in which corroding agents can concentrate during drying cycles and thus focus their strength in one spot creating a pit, rather than general surface corrosion.

Figure 7. Microscope images of pits in copper tubing. (60X Magnification)

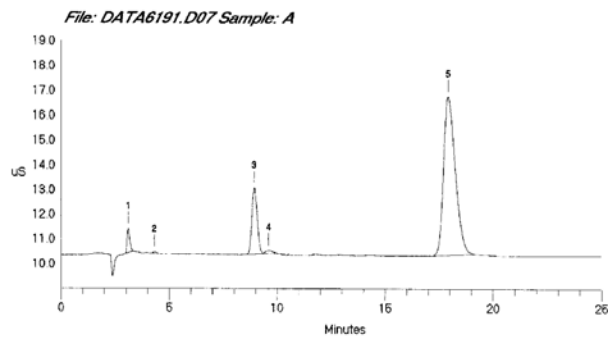
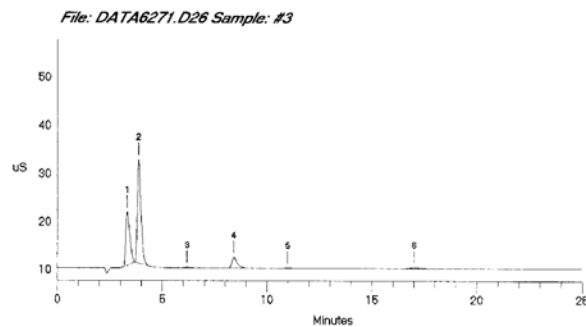
Figure 8 shows two ion chromatograms for air conditioner condensate samples from two homes. In Sample A the condensate contained high levels of sulfate, and the condensate in sample 3 contained both acetate and formate indicating formicary corrosion.

Figure 8. Ion chromatograms for condensate from two coils. One with high sulfate (top) and one with acetate and formate (bottom).

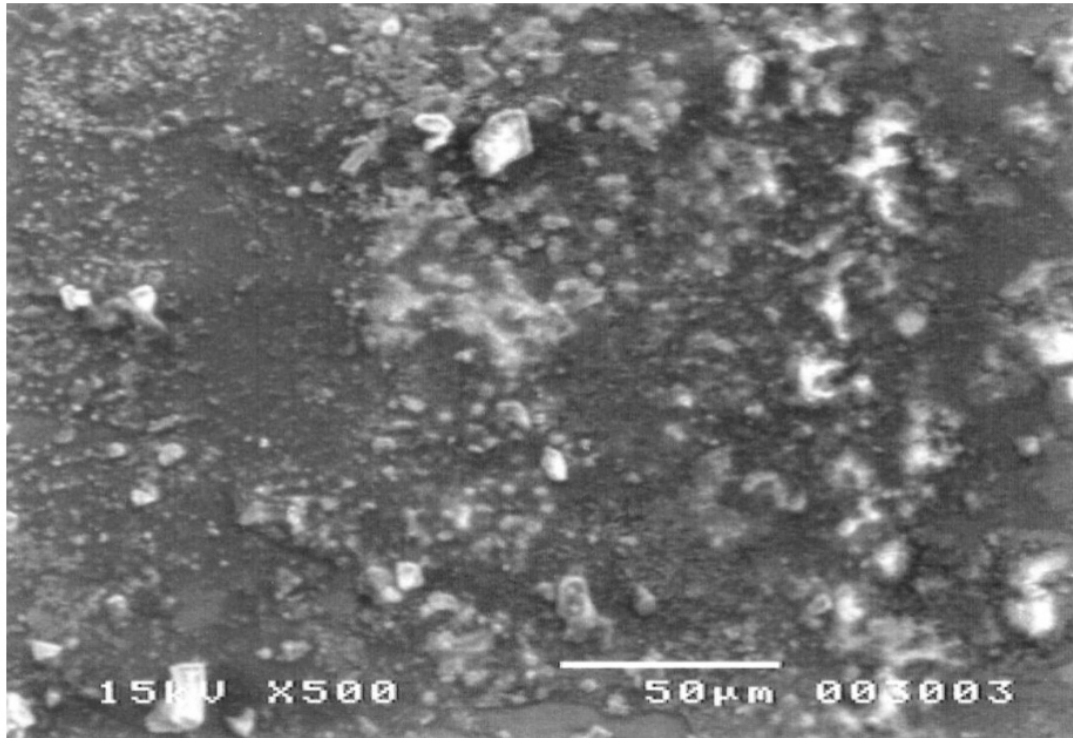
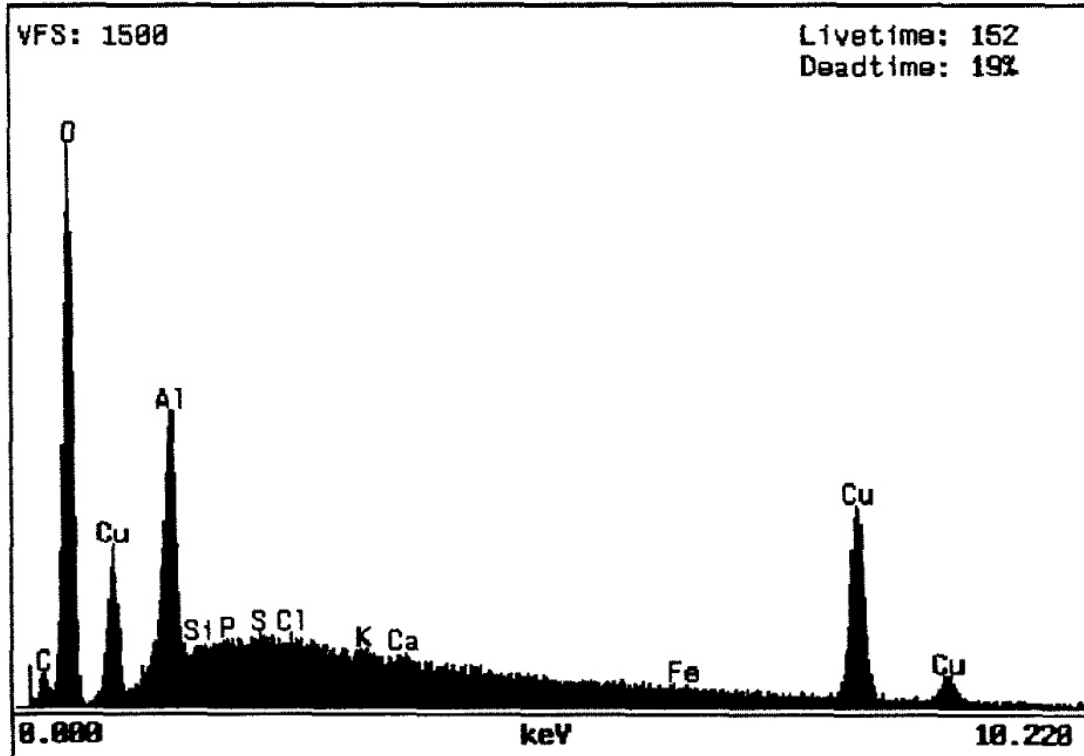
The Scanning Electron Microscope (SEM) has proven to be a very valuable tool for analyzing leak sites from HVAC coils. First, detailed photographs can be made at very high magnification that show the topography around the leak site. Figure 3, mentioned above, shows SEM photos of tubing cross sections at 200X magnification. Then using the Energy Dispersive X-ray (EDX) feature on the machine, the elemental content of the feature can be obtained. Figure 9 shows an SEM image of a contaminated tube surface and the EDX analysis of the salt on the surface. With careful sample preparation, the elemental composition in the bottom of a pit can also be determined. Analysis of these pit contents can be very valuable in sorting out the responsible corroding agent when there are multiple contaminants on the tube surface. Figure 10 is an image of a typical corrosion pit with the associated EDX elemental analysis of the bottom of that pit. Note the increase in silicon in the pit as compared with the surface analysis in Figure 9. Silicic acid has been implicated in some coil leak instances.

Figure 9. SEM photo and EDX analysis of salt deposits on copper tube showing presence of oxides of aluminum and copper.

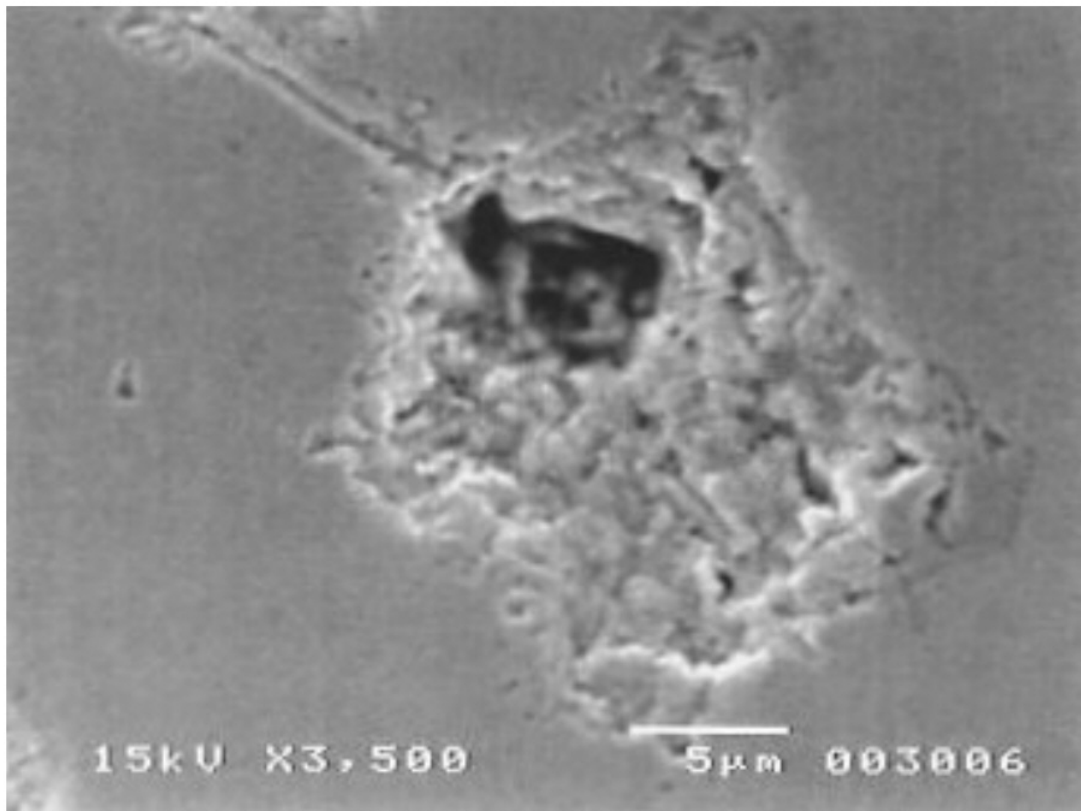
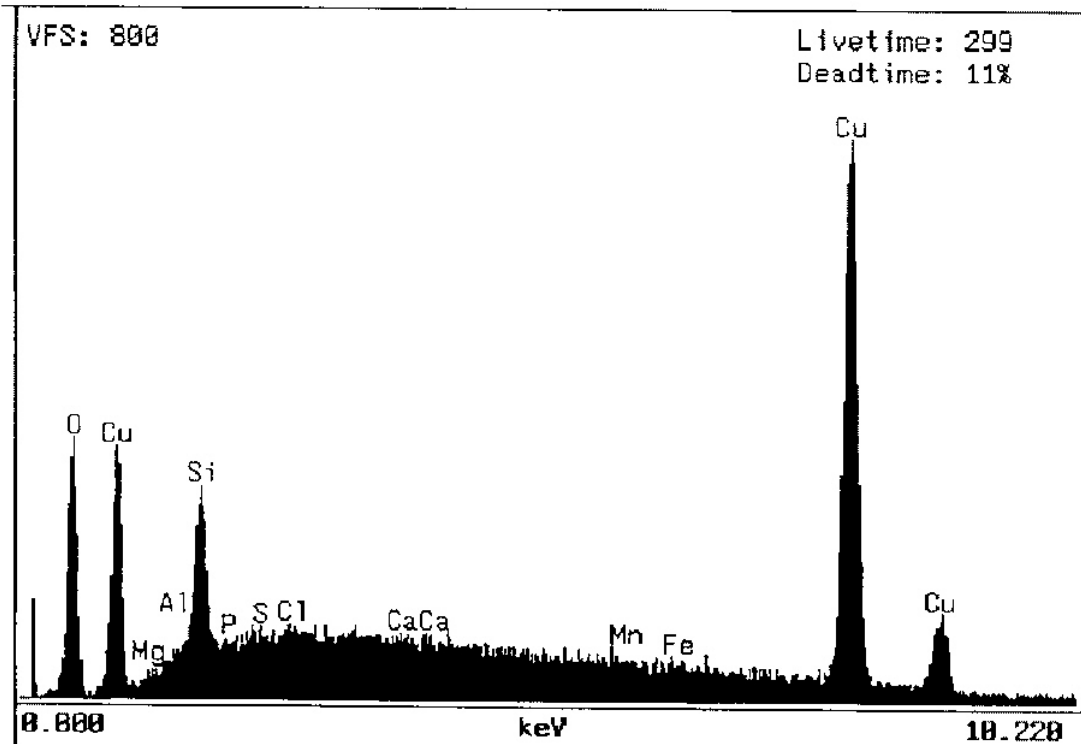
Figure 10. SEM photo and EDX analysis of a pit bottom in a copper tube. The analysis reveals the presence of silicon in the pit.

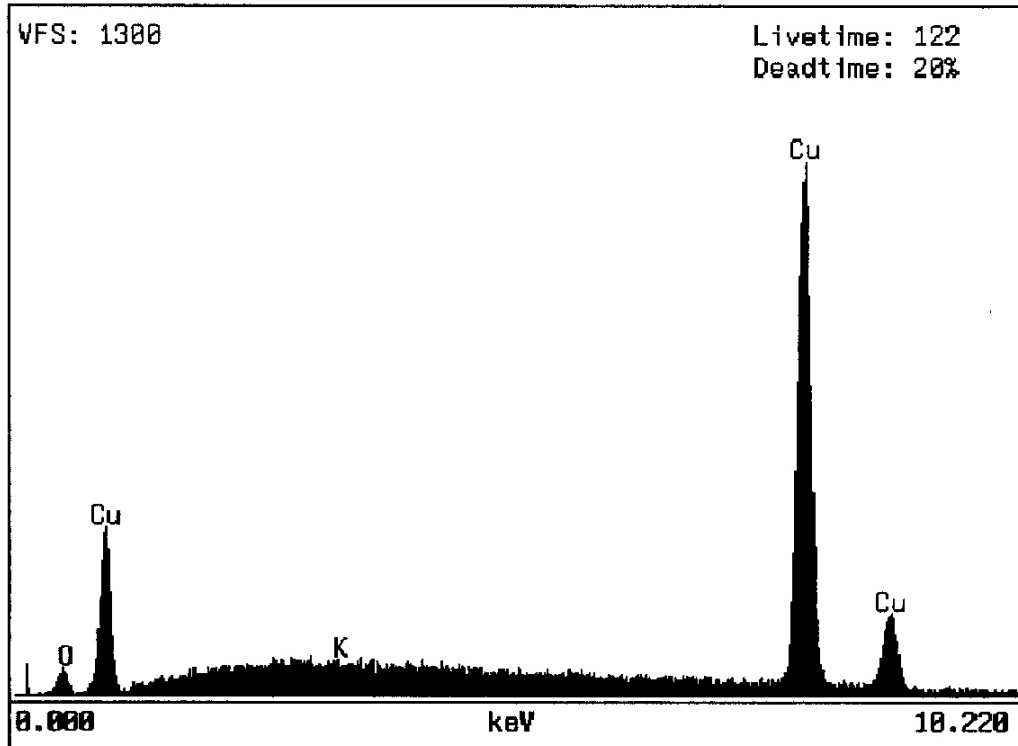
One problem with SEM and EDX analyses is that they are conducted on samples under vacuum. If the corroding agent is volatile – as is the case with formicary corrosion caused by acetic or formic acid – then the vacuum will remove most, if not all, of the critical evidence. Figure 11 is an EDX analysis of a typical formicary corrosion pit. One would expect to see the elements from the acid – carbon, oxygen and hydrogen. Only oxygen is found in the analysis. The hydrogen cannot be detected by EDX anyway, and the carbon is gone. Oxygen is present as oxides of

copper. The current theory on formicary corrosion includes formation of copper oxide as a necessary step.

Figure 11. SEM/EDX analysis of a formicary corrosion pit showing only copper and oxygen.

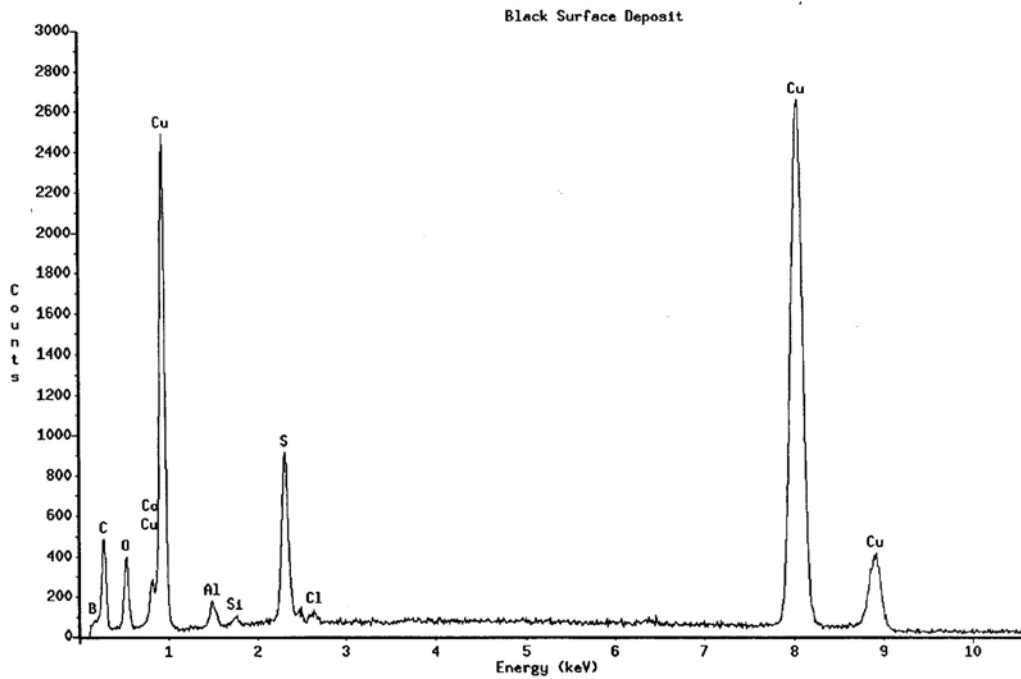
Figure 12. SEM/EDX analysis of copper tubing surface showing presence of sulfur.
