Performance and Impact from Duct Repair and Ventilation Modifications of Two Newly Constructed Manufactured Houses Located in a Hot and Humid Climate

Florida Solar Energy Center
Cocoa, Florida 32922

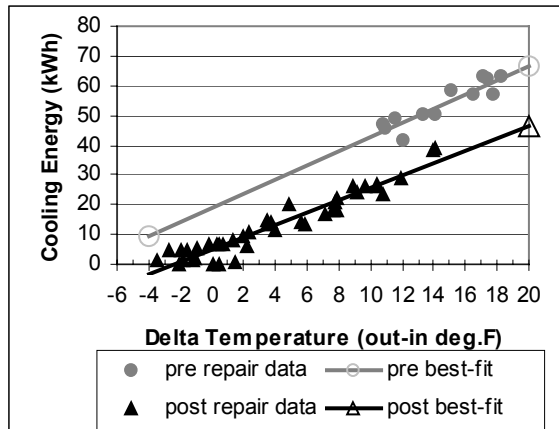
Figure 1 House A Cooling Energy vs. dT.

Figure 1 shows measured data and best-fit lines for House A (R^2 before repair was 0.83 and 0.92 after.) Using a typical summer average outdoor temperature of 83 F (28.3 C) and the indoor monitored temperature of 71 F (21.7C), the dT would be 12 F. Calculating the energy used before and after duct repair with a dT of 12 F results in a pre-repair

daily energy use of 47.66 kWh and a post-repair daily energy use of 29.78 kWh. Therefore, duct repair with the ventilation system operating and bath exhaust schedule off results in a daily reduction of 17.88 kWh (37.5% savings).

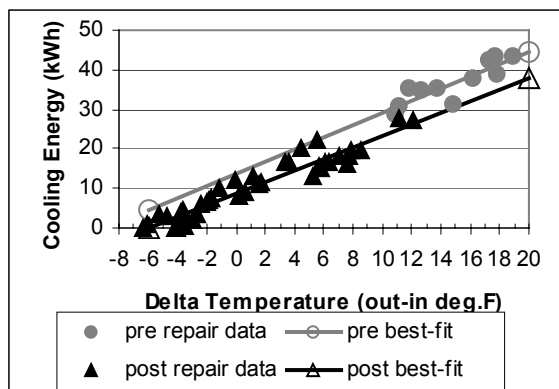
Figure 2 House B Cooling Energy vs. dT.

Following the same calculation procedure as House A with a 12 F dT for House B, results in a pre-repair daily energy use of 32.24 kWh and a post-repair daily energy use of 26.42 kWh. (R^2 before repair was 0.75 and 0.92 after.) Therefore, duct repair with the ventilation system operating results in a daily reduction of 5.82 kWh (18.1% savings).

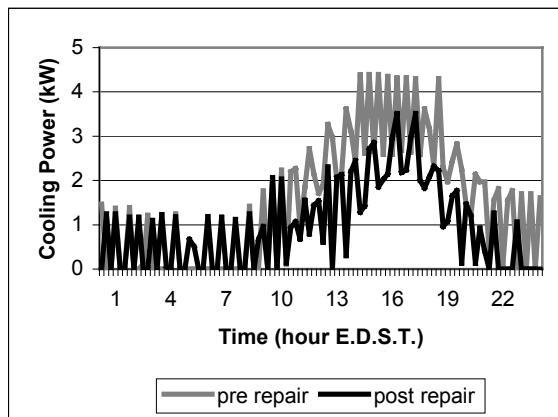
Figure 3 House A Cooling Demand

Figures 3 and 4 show the daily profile of measured power usage before and after modifications. Table 2 shows the average cooling demand during the peak utility period from 3PM - 6PM before and after.

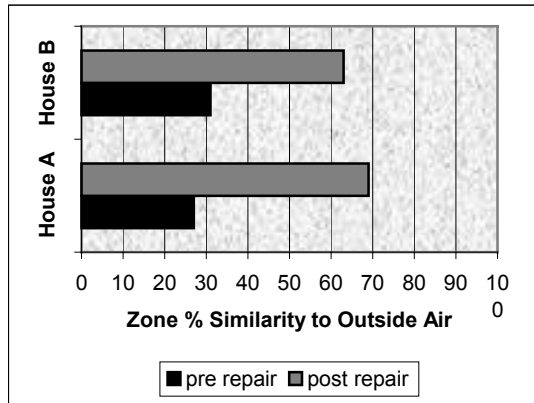
Figure 5 Belly Space Characterizations Before and After Repairs

Before repair, the belly space dewpoint was about 27 % similar to the outdoor dewpoint, but after repair, it was about 70 % similar to the outside as

illustrated in Figure 5. This means that the outdoor similarity increased 2.6 times more like outdoors after repair.

It became more like the outdoor conditions even though the indoor pressure was positive wrt outside. Positive pressure would cause indoor air to be pushed into the belly space wherever pathways exist. Based on the belly conditions, the interior floor is more airtight than the belly barrier. Since the temperature and relative humidity were only measured in one place in the belly, these results represent the measurement location and not necessarily the entire belly space. It likely represents much of the interior portions of the belly, but the edge areas may be different. The measurement location was below the kitchen about 3/4 the way toward the center of the house from the edge.
