## AIR EXCHANGE RATES IN NEW ENERGY-EFFICIENT MANUFACTURED HOUSING

DONALD L. HADLEY

Pacific Northwest Laboratory

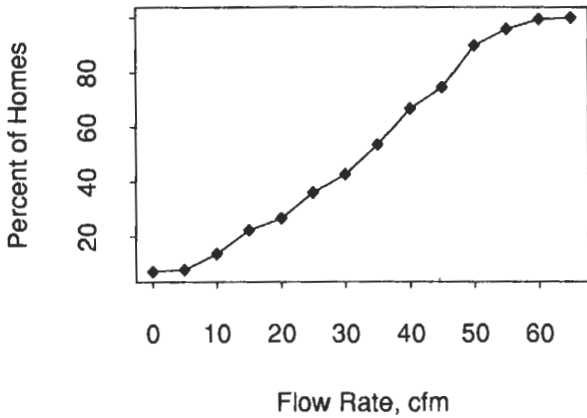
Figure 1 Cumulative Frequency Distribution of Whole-House Vent System Flow Rate

Figure 1 is a cumulative frequency distribution plot of the fraction of homes at different measured flow rates. One home did not appear to have a whole-house system installed. Of the remaining 138 RCDP homes, 125 (91%) had a vent system flow rate of 50 cfm or less; 10 of these homes had no measurable flow rate. The average flow rates for the whole-house ventilation systems, based on a one-time measurement, were 31.9 cfm for the integrated bath system and 28.1 cfm for the separate system.

Based on this information, these ventilation systems as installed and operated are not performing as specified. Why are these not providing adequate ventilation? Comments from field technicians included a discussion about the design of a designated bath fan. With this design, there is a duct/screen flush with the ceiling with a standard cover attached by stand-offs approximately 0.5 to 1 in. high. The air must flow around the cover and then up the duct to be exhausted. In one home, by simply removing the cover, the measured ventilation flow rate increased by 25% to 30%.

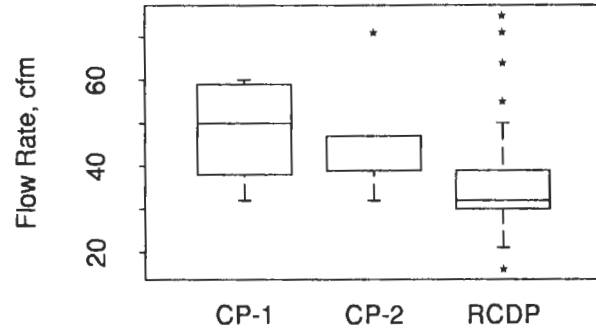
Figure 2 Furnace Fresh-Air System Flow Rates

Figure 2 is a standard boxplot of furnace fresh-air flow rate by class of home tested. It includes only those homes with a flow reading greater than zero. The most obvious finding in this plot is that the CP-1 and CP-2 homes have a significantly higher flow rate than the RCDP homes. Nearly 83% of the CP-1 homes that had furnace systems installed had a flow rate greater than 25 cfm. The average flow rates were 35 cfm, 46 cfm, and 48 cfm for the RCDP, CP-1, and CP-2 homes, respectively.

Field technician notes included observation that the end of the furnace flex duct was not always flush with the intended connection--often there was a gap where air flow would escape. In many homes, the furnace flex ductwork was pinched off during installation when sharp bends were made--as many as two near-90 degree bends were made in some of the ducts examined. With a bend this sharp, the duct essentially collapses and restricts air flow.

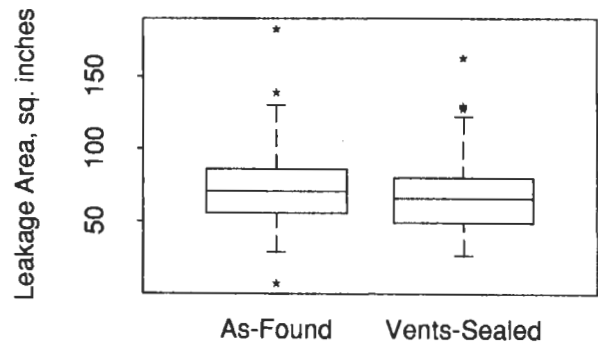
Figure 3 Effective Leakage Area

The ELAs for the as-found tests and the vents-sealed tests are compared graphically in Figure 3. The overall sample mean and standard deviation of the ELAs for the two tests are  $72.8 \pm 24.1 \text{ in}^2$  and  $67.0 \pm 24.0 \text{ in}^2$ , respectively. The difference between the two tests ranged from  $-47.5 \text{ in}^2$  to  $61.7 \text{ in}^2$ . Surprisingly, for 29 homes, the ELAs for the vents-sealed tests were less than the as-found ELAs (negative values). Ten homes showed no difference in ELAs, while the differences in ELAs for the remaining 155 homes were positive. Although the ELAs were not expected to increase when the vents were sealed, they did so enough times that this finding cannot be dismissed as a random event. The cause is related to something physically happening in the home.

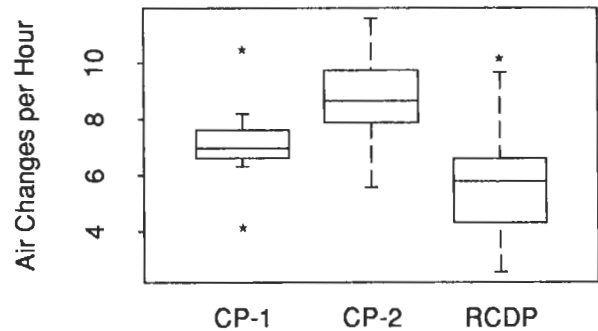
Figure 4 Air Change Rate at 50 Pa Pressure

The results of the ELA and ACH-50 calculations for the vents-sealed test for each category of homes tested are summarized in Table 3 and shown graphically in the boxplot in Figure 4. The RCDP homes appear to be slightly tighter than the CP-1 homes, and significantly tighter than the CP-2 home sample.

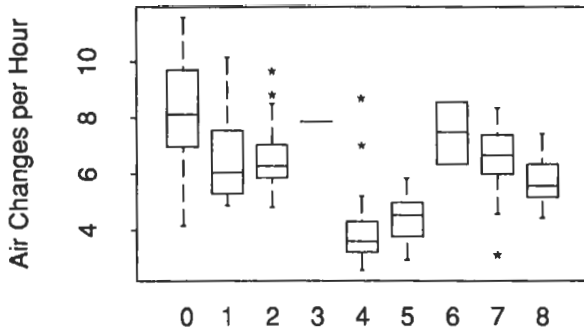
Figure 5 Air Change Rates at 50 Pa Pressure for Each Home Manufacturer

There is also a significant difference in the air leakage rates in the homes built by the different manufacturers. Figure 5 is a standard boxplot of the ACH-50 for the set of homes by each manufacturer. The manufacturers are identified by code number only. Manufacturer 0 is the current practice group (several unrecorded manufacturers). From these data, it is obvious that the homes built by two manufacturers (4 and 5), which represent 28% of the sample, are tighter than all of the others. The air leakage rate in the

homes built by the other six manufacturers were comparable to the current practice group of homes.

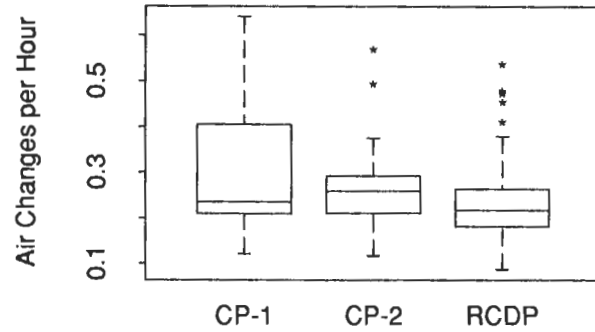
Figure 6 Air Change Rates for Each Class of Homes

The PFT testing results are summarized in Table 4 and shown graphically in Figure 6. The mean air exchange rates for the RCDP, CP-1, and CP-2 homes are 0.23 ACH, 0.30 ACH, and 0.27 ACH respectively. Although the RCDP homes tended to have lower infiltration rates than the other two groups of homes, the difference in mean air exchange rate is not statistically significant. This is partly because of the relatively small sample sizes of the two current practice groups. The within-group variances (indicated by the standard deviation) for the RCDP homes are much smaller than for the CP-1 and CP-2 homes, indicating that the manufacturers participating in this program were able to build homes with a high degree of consistency.

In the RCDP homes, 128 of the 139 homes failed to meet the minimum ventilation rate of 0.35 ACH recommended by the American Society of Heating, Refrigerating, and Air-Conditioning Engineers, Inc. (ASHRAE) in Standard 62-1989. The current HUD code does not stipulate a minimum ventilation rate, but the new proposed HUD code recommends a minimum rate of 0.35 ACH.
