SHORT-TERM MONITORING TO DIAGNOSE COMFORT PROBLEMS IN A RESIDENCE IN CENTRAL TEXAS

V. Kootin-Sanwu¹, A. Sreshthaputra², J.S. Haberl³

ABSTRACT

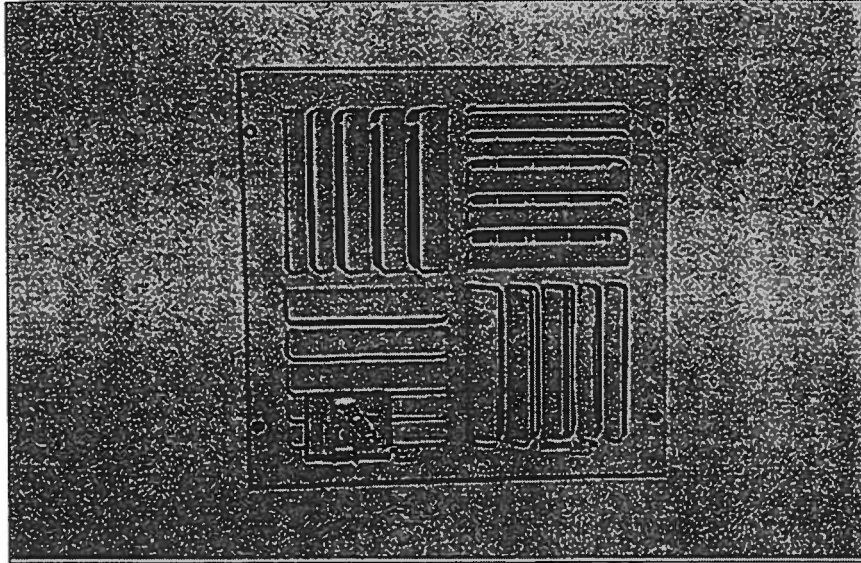
Figure 3. Portable measurement equipment at the diffuser. This photo shows the data logger attached to the ceiling diffuser in the case study house.

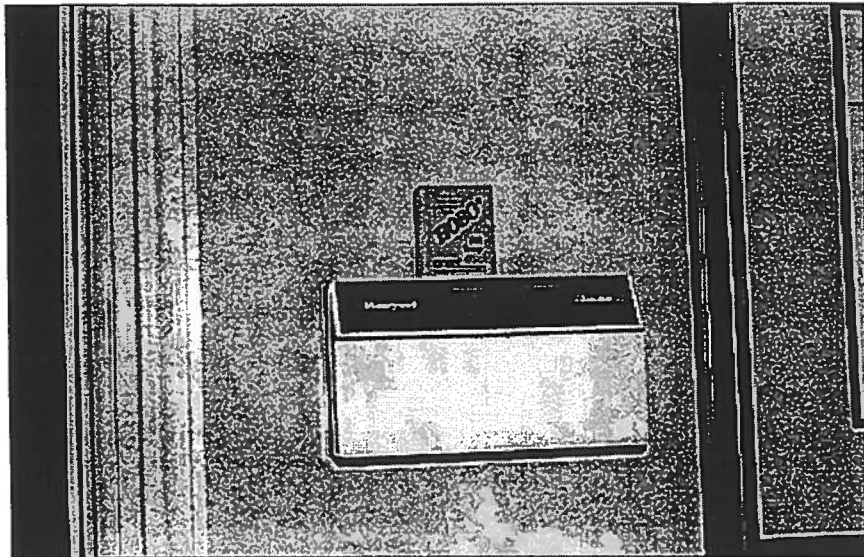
Figure 4. Portable measurement equipment at the thermostat. This photo shows the data logger measuring room temperature and relative humidity in the case study house.

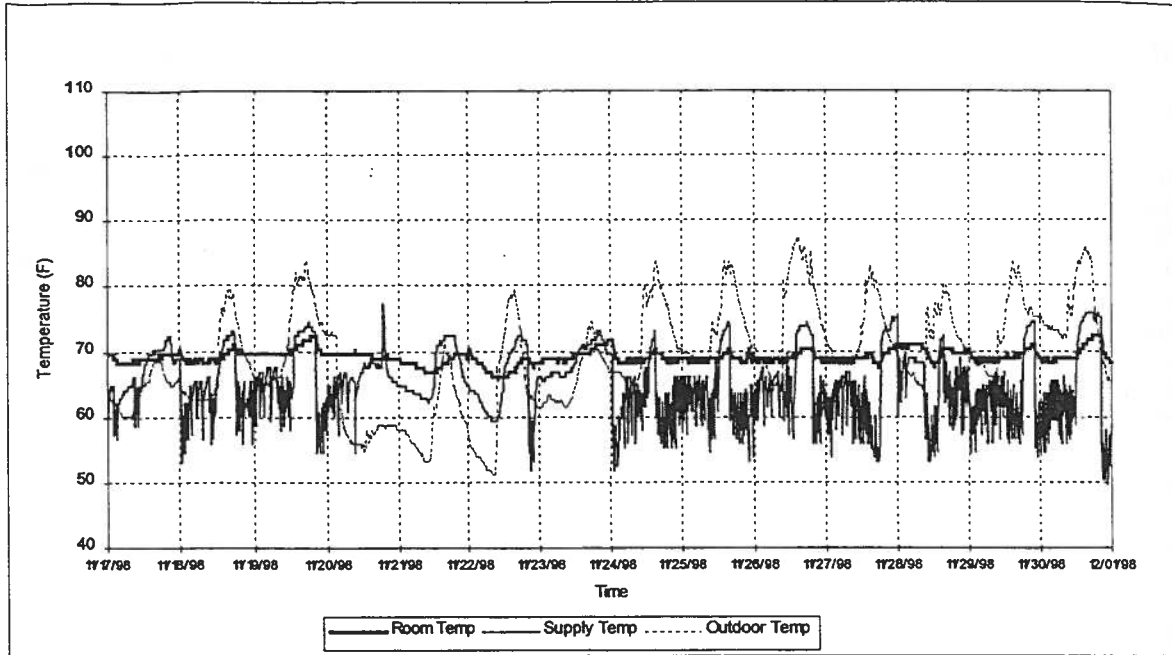
Pre-retrofit Temperature and Humidity Measurements. During the monitoring period, the indoor temperature on the first floor (at the thermostat) was maintained at approximately 68 °F. The supply air temperature from the diffusers on the first floor was found to vary between 55 °F and 65 °F. Outdoor temperatures for the same period ranged between 65 °F and 85 °F as shown in Figure 5. Several additional features are worth noting in Figure 5. First, during the monitoring period there were periods when the homeowner turned the air-conditioning system off on the first floor. During these periods the zone temperature (i.e., "the room temperature", located in the hallway in the front of the house) rose only a few degrees. However, the supply temperature (which measures to the ceiling temperature of the dining area when the blower is shut off) rose 5-7 °F above the thermostat set-point, indicating uneven heat gain on the first floor when the air conditioner was switched off.

Second, although there are instances where the supply air dips to 55 °F, the average temperature of

60- 62 °F from the diffuser indicates inadequate moisture removal in the air-conditioning coil. Finally, the cycling of the air-conditioning is evident during the afternoon and evening periods, indicating the unit was more than adequate to meet the load during the mild evening hours. A closer look at the data also indicates a small rise in the average supply temperature as the load dropped in the early hours of the morning, which is due to an increase in cycling.

Figure 5. Room, supply, and outdoor air temperatures (F) for the first floor of the house for the pre-retrofit period of 11/17/98 to 12/1/98.

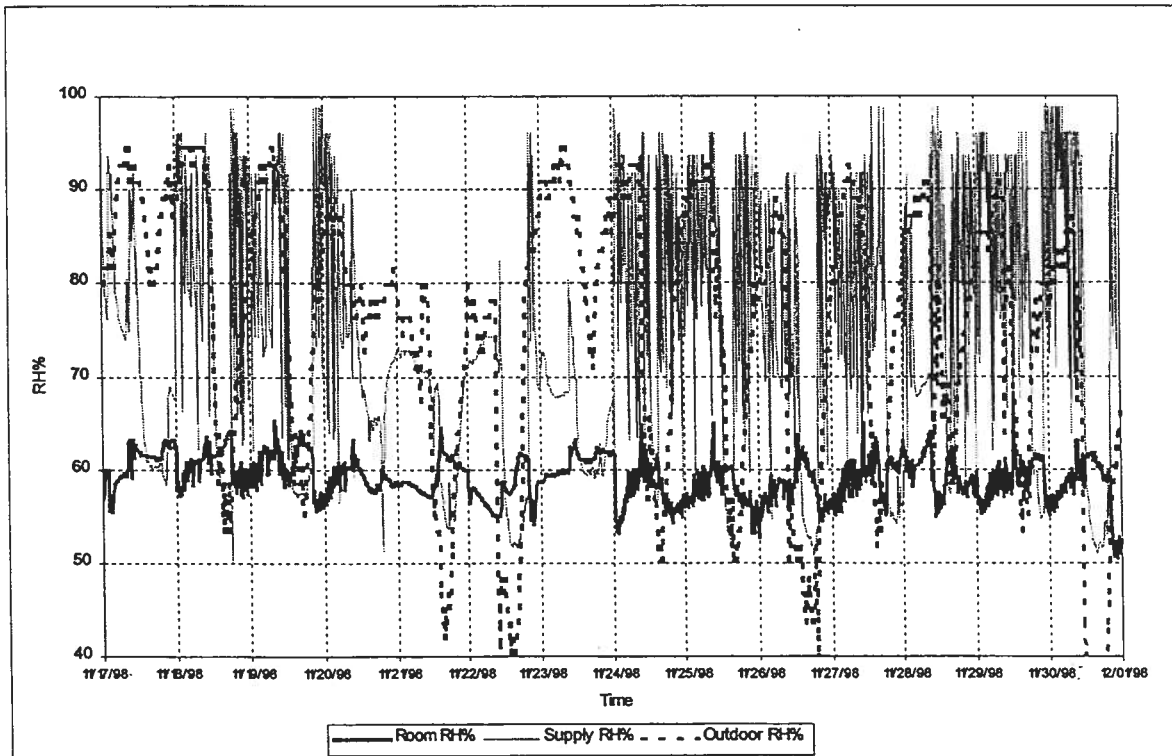
Relative humidity measurements for the same period are shown in Figure 6. The indoor relative humidity measured at the first floor thermostat varied between 55% and 65%. The relative humidity of supply air at the diffusers on the first floor was found to vary in the range of 50-100%. Outdoor relative humidity readings for the same period ranged between 40-95%. The temperature and relative humidity on the second floor was maintained at similar conditions to the first floor. A closer look at Figure 6 indicates that the highest room relative humidity (as measured at the first floor thermostat) rose during the daytime when the system was shut off, which would be consistent with the homeowner's comments about leaving on an exhaust fan (i.e., this actually raised the indoor humidity). A second consistent rise in the room relative humidity can also be seen each evening as the cooling load dropped off and the air-conditioner cycled to meet the load.

Figure 6. Room, supply, and outdoor air relative humidities (%) for the first floor of the house for the pre-retrofit period of 11/17/98 to 12/1/98.

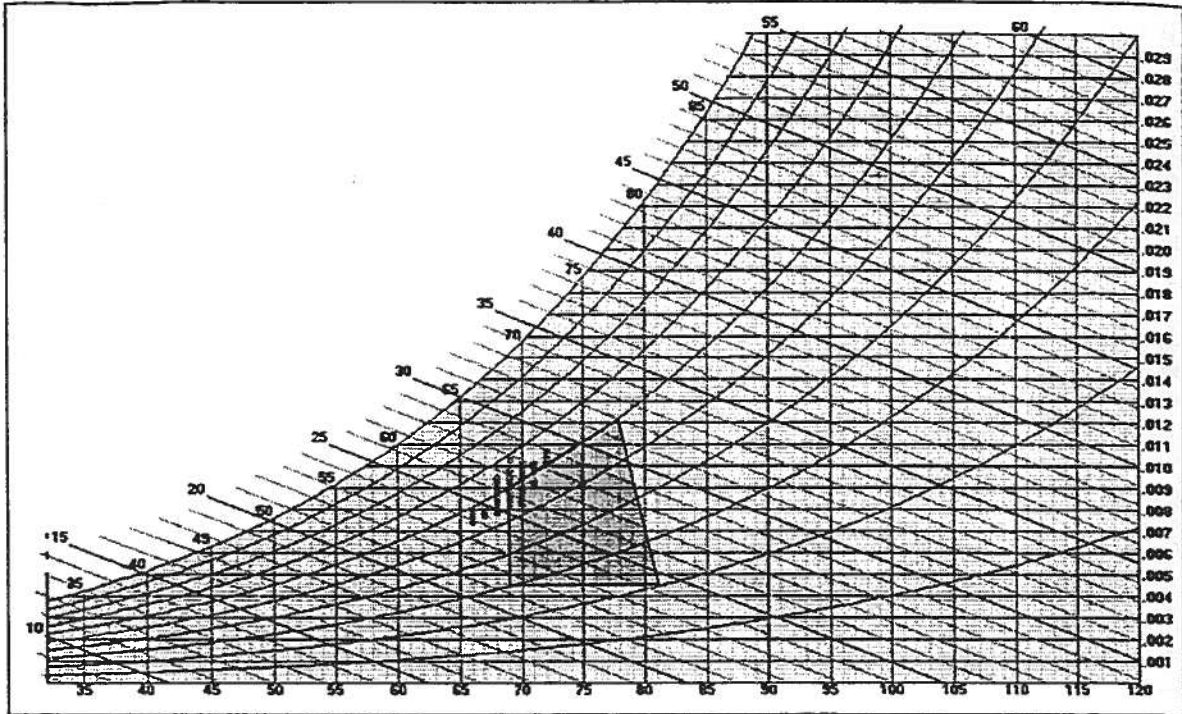
These same data are presented on a psychrometric plot in Figures 7-9. Figure 7 shows the first floor temperature and humidity as measured at the thermostat. The ASHRAE comfort zone is also shown on the psychrometric chart (i.e., 60 % RH upper humidity bounds, 68-78 °F effective temperature, and 36 °F dewpoint lower humidity bounds). From Figure 7, it is clear that the first floor was colder and more humid than recommended ASHRAE conditions. Figure 8 shows the conditions of the supply air for the same period. In a similar fashion to Figure 5, Figure 8 indicates that the supply air to the first floor was not being cooled enough for adequate moisture removal. Figure 9 shows the outdoor temperature and humidity for the same period. This figure shows the significant variation in the outdoor conditions during the pre-retrofit period. This is quite a contrast to the very tightly controlled indoor condition for the first floor (Figure 7).

Figure 7. First floor temperature and relative humidity as measured at the 1st floor thermostat for the pre-retrofit period of 11/17/98 to 12/1/98.

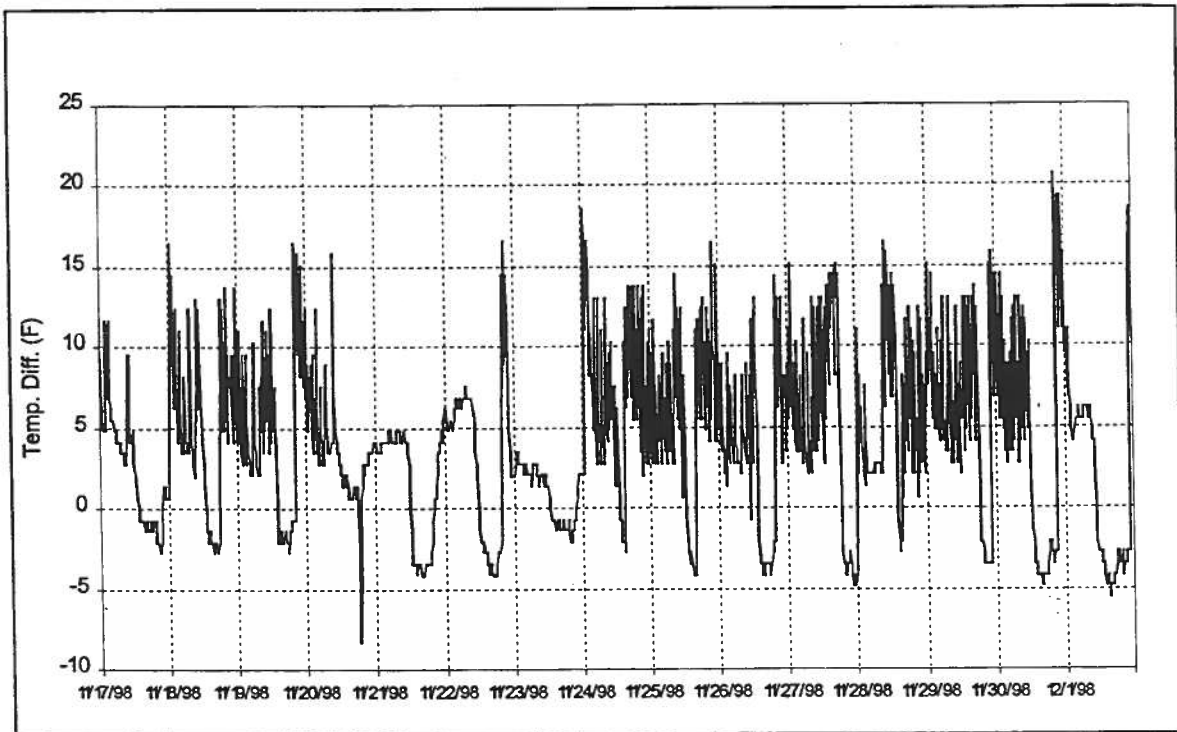
In Figure 10 the temperature difference is shown between the supply air and the return air (i.e., Room - Supply temperature). During the monitoring period, the data show a temperature difference of 5-7 °F between the return air and the supply air during the periods of air-conditioning operation. This is well

below the necessary 10 to 20 °F temperature difference needed for proper humidity control.

Figure 10. The first floor difference in temperature between the return air and supply air the case study house during the pre-retrofit period.

Recommendations to the Homeowner. The observations from the monitoring and inspection lead us to believe that several problems were contributing to the high humidity conditions. First, the supply air was not cold enough for proper dehumidification which could be caused by an evaporator coil with inadequate latent heat removal, and return air leakage, or some combination of the above. Second, the constant use of a bathroom fan may be drawing in more humid air through infiltration. Third, part of the homeowner's discomfort may be due to uneven heat gain on the first floor. Based on these observations we recommended that the return air duct be re-sealed and the evaporator coils either cleaned or replaced with newer coils with a higher latent heat removal capacity.

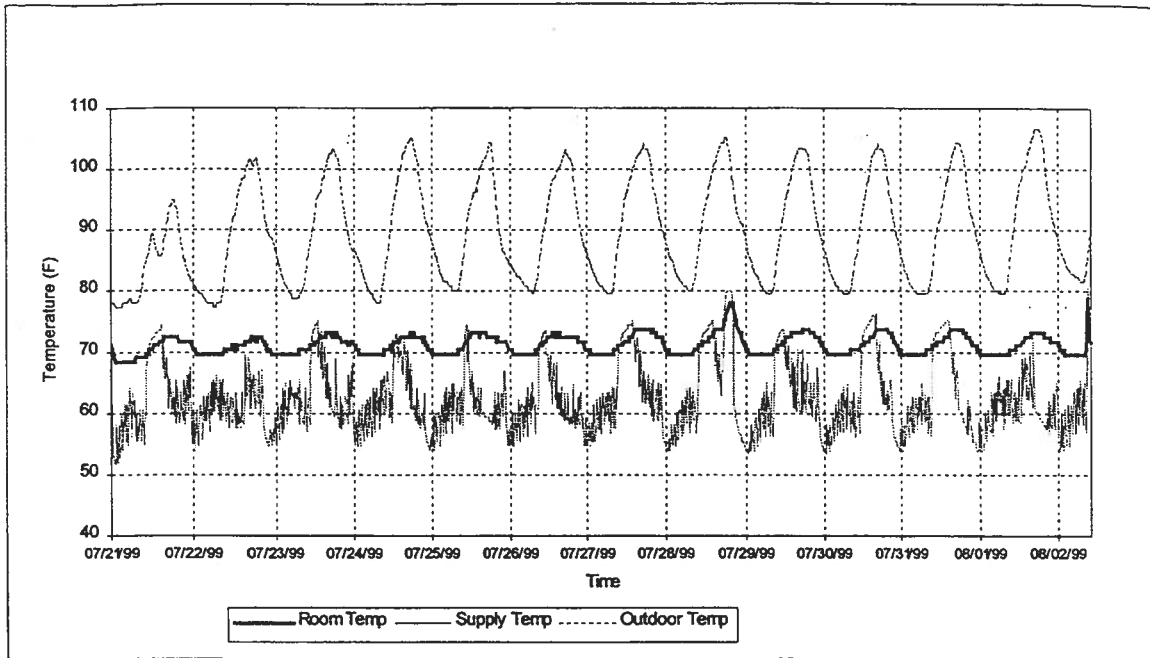
Post-retrofit Measurements. Measurements were then repeated to confirm the success of the retrofits as shown in Figures 11 – 14. Although, these measurements were taken during a much hotter period of the year they still show a marked improvement in the comfort conditions. In Figure 11, supply temperatures dropped to the 57-60°F range. Relative humidity dropped well below 60% as shown in Figure 12. The homeowner appears to have increased the set point as well (possibly in response to the drier conditions). Figure 13 also confirms the post-retrofit conditions are well within the recommended ASHRAE comfort range. Figure 14 indicates an improvement of the supply-return temperature difference as well.

Figure 11 Room, supply, and outdoor air temperatures (F) for the first floor of the house for the post-retrofit period of Jul 21 - Aug 2, 1999.

Retrofit Measures. Following a meeting with the homeowner where the recommendations of the study were presented the homeowner hired a new contractor who was given a copy of the report and asked to perform their own analysis on the house. The contractor performed his own tests and then decided to clean the evaporator coils, reseal the return chase and further increase the size of the air-conditioning system from 5.5 to 6.5 tons (reducing the tonnage/sq. ft. from 618 to 523).
