## **Building Envelope Air Leakage Failure in Small Commercial Buildings Related to the Use of Suspended Tile Ceilings**

Charles R. Withers, Research Analyst  
James B. Cummings, Principal Research Analyst

Florida Solar Energy Center  
Cocoa, Florida

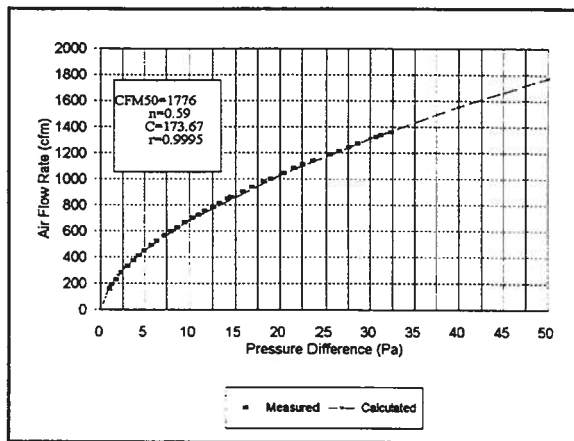
Figure 1. Ceiling Airtightness Flow Curve

Figure 1 shows a plot of the air flow versus airtightness of the ceiling. The amount of leakage is measured as airflow in cubic feet per minute when the building is depressurized to 50 Pa also known as CFM50. The CFM50 of the room was 1776. The variables  $n$  and  $C$  are shown in figure 1 and can be used to calculate airflow for the building if the pressure is known using the equation  $Q = C \times dP^n$  where  $Q$  is airflow,  $C$  is the flow coefficient,  $n$  is the flow exponent, and  $dP$  is the differential pressure. The normalized airtightness (mentioned previously as ACH50) is 33.6. ACH50 was calculated as follows:  $1776 \div 3168 \text{ ft}^3 \text{ room volume} \times 60 = 33.6 \text{ ACH50}$ . When the ceiling tightness is normalized by the square foot area of the ceiling, CFM50 per square foot of ceiling area is 5.0.

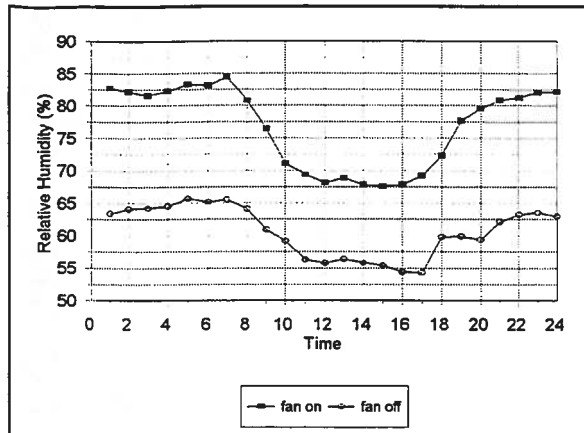
Figure 2. Relative Humidity in Office

After duct repairs were complete, the building ventilation rate declined slightly from 0.87 air changes per hour (ach) to 0.79 ach and CFM25 in the ducts decreased by 80% from 571 to 112. Notice in Table 1 the indoor relative humidity increased because air conditioner run time decreased by about 30% while the building ventilation rate remained largely unchanged. Building depressurization did not disappear until the attic exhaust fan was turned off. Turning off the attic exhaust fan also caused daily

relative humidity levels to decrease from 77% to 61% and from 68% to 55% during normal business hours of 11 AM to 5 PM (Figure 2). It also caused the building ventilation rate to decrease from 0.79 ach to 0.33 ach.

As a result of duct repair, average cooling energy consumption (based on a TMY predicted eight-month cooling season) decreased from 99.6 kWh/day to 69.1 kWh/day (31% savings) and cooling peak demand decreased by 20% from 6.5 kW to 5.2 kW. As a result of turning off the attic exhaust fan, average cooling energy consumption (based on an eight-month cooling season) decreased by an additional 14.3 kWh/day (36%) and peak electric demand (including attic fan power of 0.47 kW) was reduced by 21% from 3.4 kW to 2.7 kW.

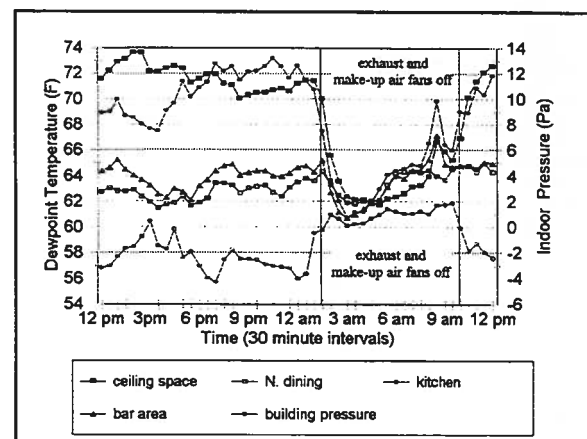
Figure 3. Restaurant Dewpoint Temperature and Pressure With Reference to Outside With Kitchen Fans On and Off

Preliminary testing and inspection found the building to have an airtightness of 12,021 CFM50. This calculates to an ACH50 of 14.1 based on an occupied conditioned space of 6061 square feet with ceiling at 8.5 feet. This building was tighter than the average of 69 small commercial buildings mentioned previously. The primary air and thermal barriers were identified to be at the roof deck. When the building was depressurized to 50 Pa with reference to outside, the ceiling space was -42.9 Pa with reference to outside. The pressure drop across the ceiling was only 7.1 pa. The building normal operating pressure, which is the indoor pressure with reference to outside when all RTU's are on, kitchen exhaust, and make up air fans are operating, was -2.7 Pa. The dishwasher exhaust only operates part time so it was not turned on, however the building pressure becomes -5.0 Pa when it is turned on. The negative building pressure indicates that the total exhausted air from the building exceeds the total incoming air. Short-term monitoring of space conditions revealed interesting findings for this building about unbalanced exhaust flow and leaky ceilings as is shown in Figure 3.

them off about 1:00 am. The ceiling space and conditioned space dewpoint go up drastically when the kitchen exhaust fans were turned on and would drop after the exhaust was turned off. When the exhaust fans are turned on, the ceiling space dewpoint increases to values near the outdoor dewpoint indicating this space becomes filled with outside air. The building operated at about  $-2.7$  Pa due to the unbalanced exhaust air of the building. This caused the ceiling space to also be depressurized about the same amount. Although the primary air barrier is at the roof deck and walls of the ceiling space, this does not mean it will act as a good air barrier. In fact, all around the perimeter walls of the ceiling space there are significant pathways between the ceiling space and the exterior vented soffit space. Notice also in the figure that the building pressure becomes positive once the exhaust fans are off and the ceiling space dewpoint becomes drier as conditioned air is pushed up through the ceiling into the space. This is due to more air being brought into the restaurant from the outside air than what is being exhausted.

A retrofit plan was developed that included recommendations to reduce kitchen exhaust flows to a minimum amount that would still effectively capture all cooking effluent. Capture would also be improved by increasing make-up air flows to 80 % of the exhaust flow and modifying delivery of make-up air so that it is discharged outside the hoods. The outdoor air should be enough to satisfy ventilation requirements and at least 21 % of the exhaust flow. The last recommendation was to air tighten the ceiling space. With these changes, the building would be more airtight, operate under a significant positive pressure, and the ceiling space would then maintain lower relative humidity thereby preventing further damage to the ceiling tiles.

The recommendations were made to the restaurant which took responsibility of implementing the changes. Recommendations have been partially implemented at this time. The ceiling space has been tightened resulting in a total building tightness of 8867 CFM50 (10.2 ACH50). This is a 26 % improvement in building tightness, however, a target tightness of about 8 ACH50 was suggested. Modifying fan flow rates, the other portion of the recommendations, was recently carried out by a national test and balancing firm, but follow-up monitoring has not occurred and indoor temperature and relative humidity conditions are not known at this time.

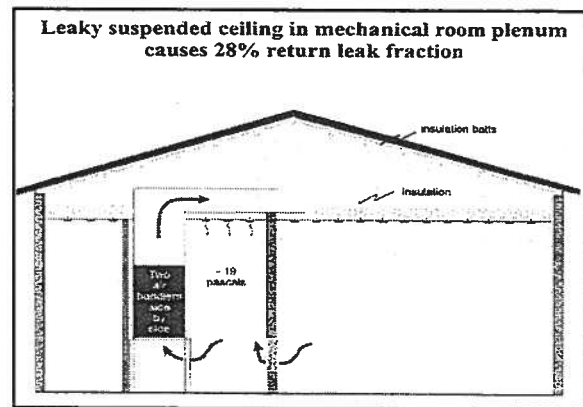
The building was air conditioned using two air distribution systems with all supply ductwork located in the ceiling space. The west system air handler was located in the ceiling space with a return ducted to a main hallway, however, the east system air handler was located on top of an unfinished support platform in a mechanical closet that was used as a return. A transfer grill from the room to the main hallway served as the pathway from the building back to the air handler. Use of the mechanical room as a return plenum caused it to be depressurized to  $-19.1$  Pa wrt the ceiling space when the air conditioner operated. Since the depressurized mechanical room has a suspended ceiling, 28% of the return air was coming from this relatively hot (though dry) ceiling space (Figure 4). As a general rule, building cavities such as mechanical rooms, walls cavities, closets, storage rooms, panned floor joists, etc. should not be used as a portion of the air distribution system since they are not built to the same airtightness standard as ductwork.

Figure 4. Airflow Failure Through Suspended Ceiling in Room Used as a Return Plenum

The business did not want to “hard duct” the return from the hallway to the east system return because they would lose valuable storage space. Since the room had to be used as a duct, efforts were made to make it more airtight to the ceiling space. The seams in the suspended ceiling were sealed with clear caulk and several tiles were adjusted so they fit in the t-bar grid more tightly. More importantly, the room was made leakier to the hallway by installing a louvered door to replace a solid door. As a result, the mechanical room pressure decreased, from -19.1 Pa to -4.2 Pa and return leakage decreased from 28 % to 4 %.

Reducing the air flow across the mechanical room ceiling by 86% decreased the cooling energy by 10.8% from 87.2 kWh/day to 77.8 kWh/day. Repair time was 5 person-hours and \$90 in materials. The payback is projected to be 2.2 years based on monitored energy savings and \$340 repair cost. If the ceiling space had been vented, the energy penalties associated with this uncontrolled air flow across the mechanical room ceiling would have been much greater.
