**Ponding Test Results
Seepage and Total Losses,
North Alamo Main Canal
Hidalgo County Irrigation District No. 2**

February 4, 2004

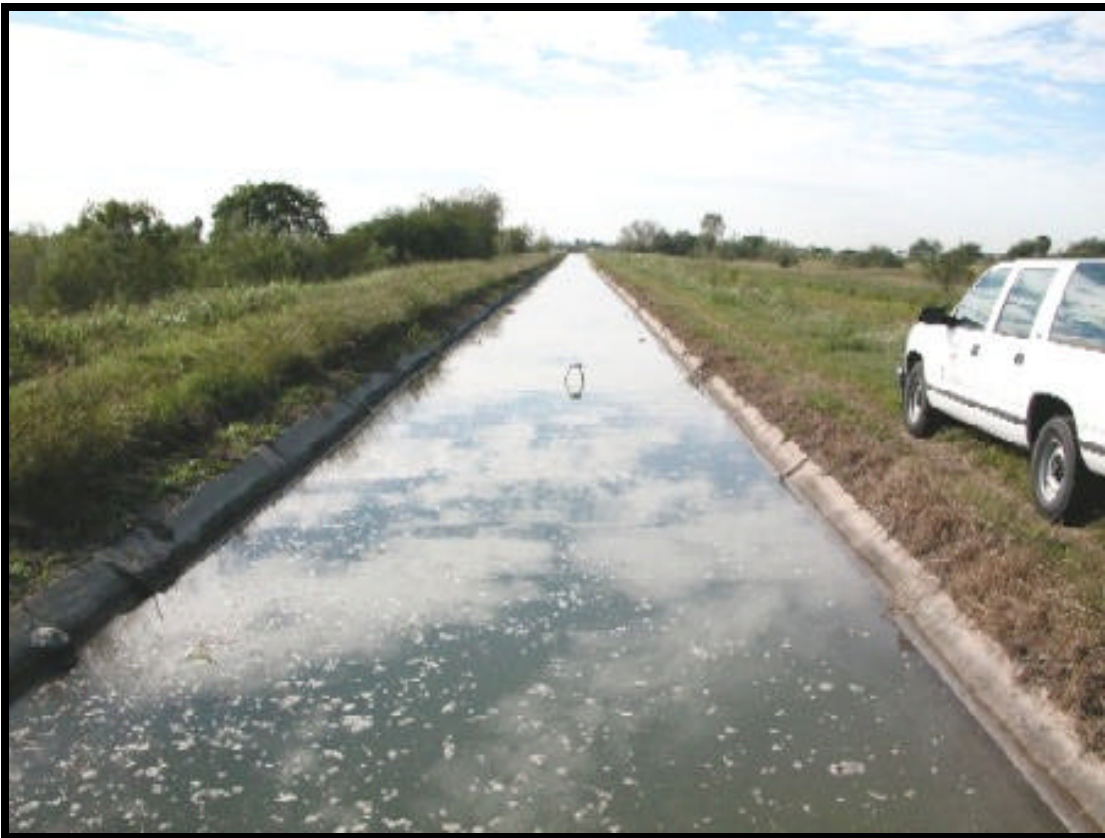
Test results are summarized in Table 1. The seepage loss of test segment SJ10 was 0.57 gal/ft²/day. Test segments SJ9 and SJ11 had valves which may have contributed to the total loss rates of 2.05 and 0.55 gal/ft²/day, respectively. Table 2 lists the loss rates in terms of water level change.

Figure 1. Photograph of test segment SJ9 of the North Alamo Main Canal.

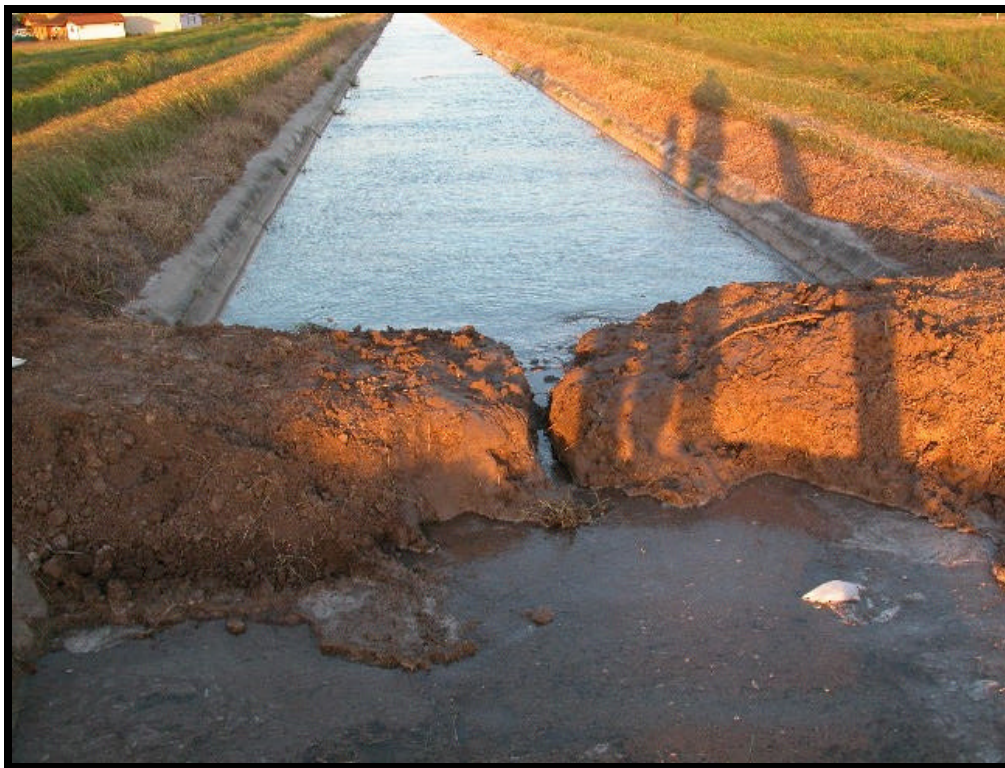
Canal loss rates were measured using the ponding method. In this method, the two ends of a canal segment are closed or sealed with earthen dams as shown in Figures 3 and 4. Once sealed, water elevations are taken for approximately 48 hours. Due to vandalism (Fig. 5), tests SJ10 and SJ11 were terminated after 43 hours. Two to three staff gauges (Fig. 6) were placed in each test segment, and stage levels were recorded manually. Canal dimensions and water spans were also surveyed during the test.

Figure 5. Photograph of damage to the dam between segments SJ10 and SJ11 that caused early termination of test.
