**Ponding Test Results
Seepage and Total Losses
Main Canal B
Hidalgo County Irrigation District No. 16**

February 17, 2004

Eric Leigh and Guy Fipps,¹ P.E.

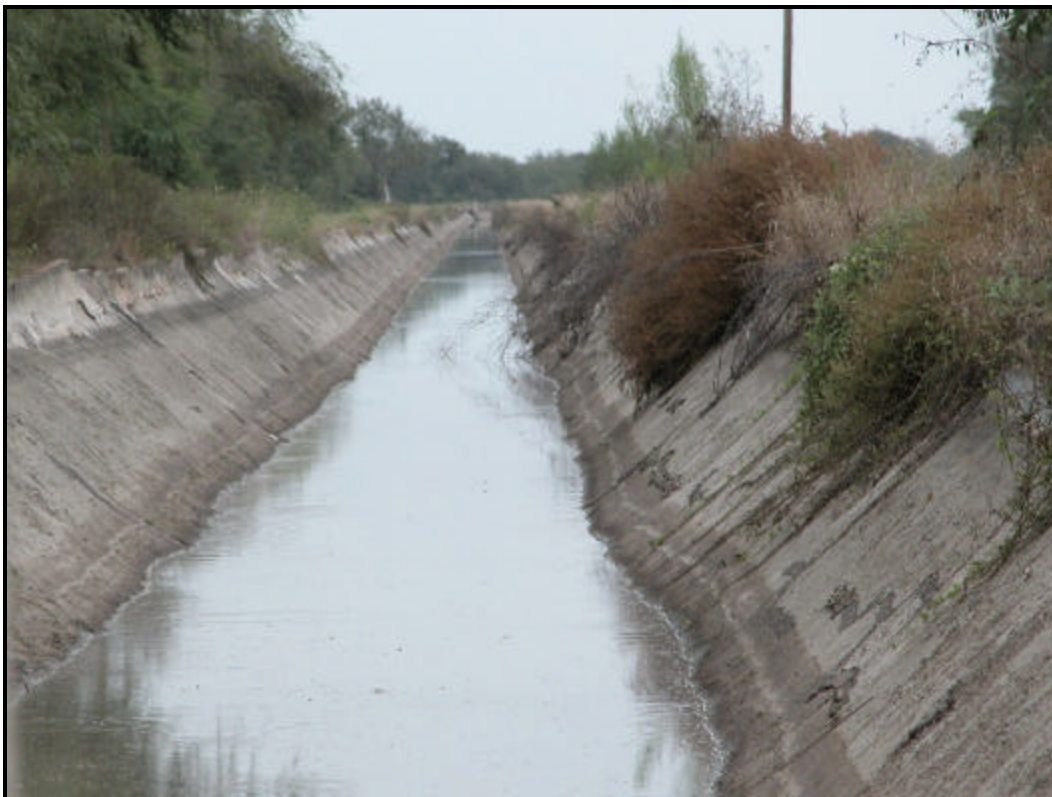
Figure 1. Photograph of test segment 16HC1 of the Main Canal B.

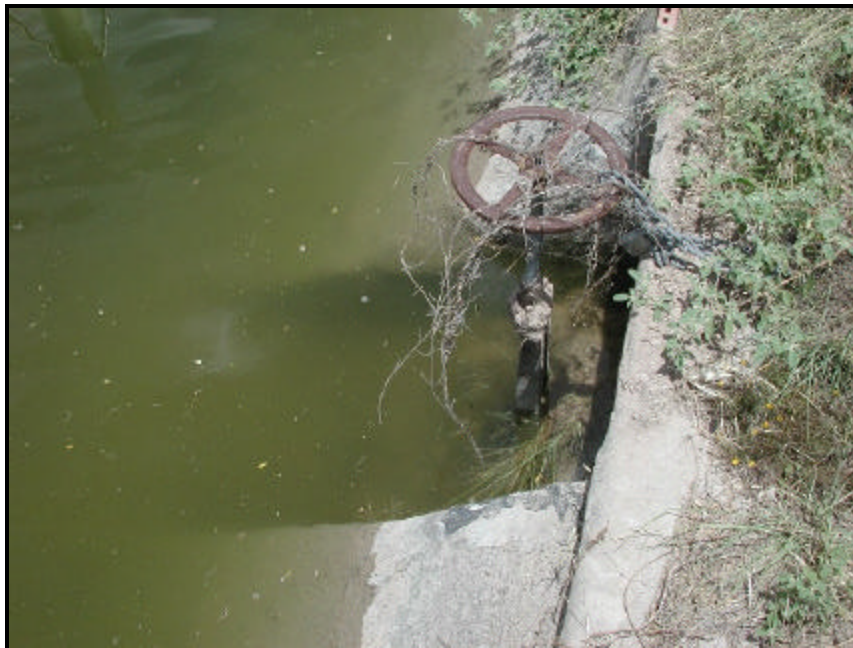
- The average seepage loss rate measured for Test Segment 16HC2 was 1.4 gal/ft²/day.
- Test Segment 16HC2 had at least three leaking turnout gates which contributed to the total loss rate of 1.9 gal/ft²/day.
- At normal operating depths in the Main Canal B, leakage from one of the gates was measured at 169 gal/day or a potential loss of 2.3 ac-in/yr (Table 3).

- Test segment 16HC2 did not contain valves or gates within the canal; thus, the seepage rate was measured.
- Test segment 16HC1 contained several leaking turnout valves (Fig. 6); thus, we classify this as a total loss test since the gates contributed to the measured losses.

Figure 6. Turnout gate located in test segment 16HC1.

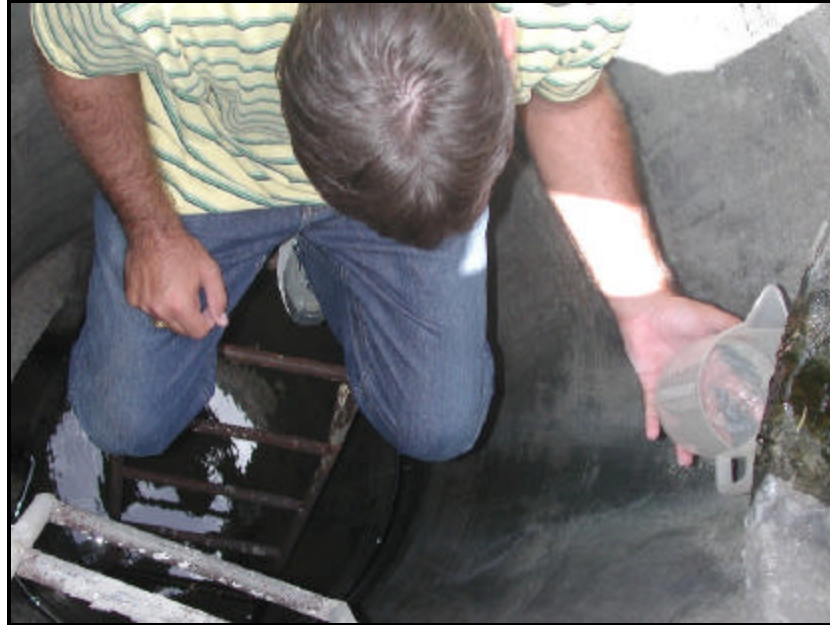
During the ponding test, we measured the leakage rate of one gate by catching the water in a graduated beaker as shown in Figures 7 and 8. Measurement details are given in Table 3.

Figure 7. Measuring the leakage rate through a turnout gate inside a standpipe.

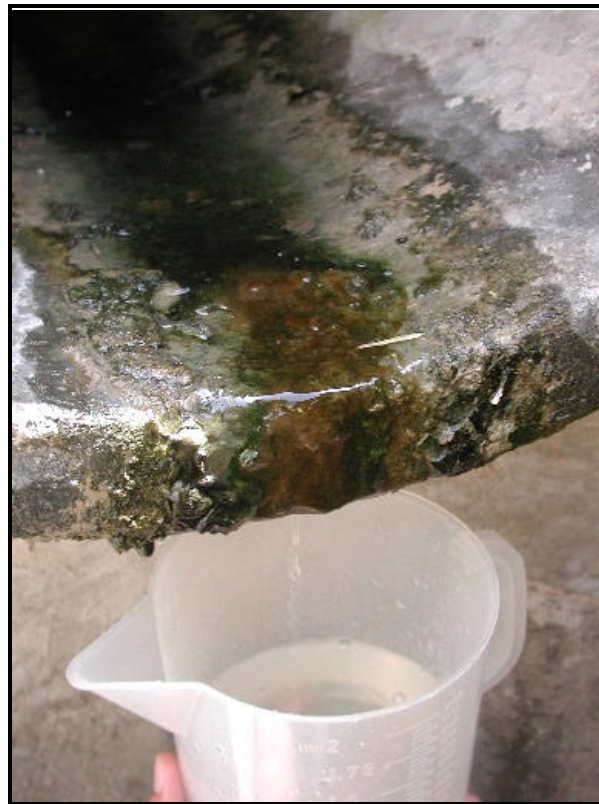
Figure 8. Close up of the graduated beaker used to measure gate leakage.
