ENGINEERING GEOLOGIC ASSESSMENT OF RISK TO VISITORS:  
CANYON LAKE GORGE, TEXAS

A Thesis

MASTER OF SCIENCE

May 2010

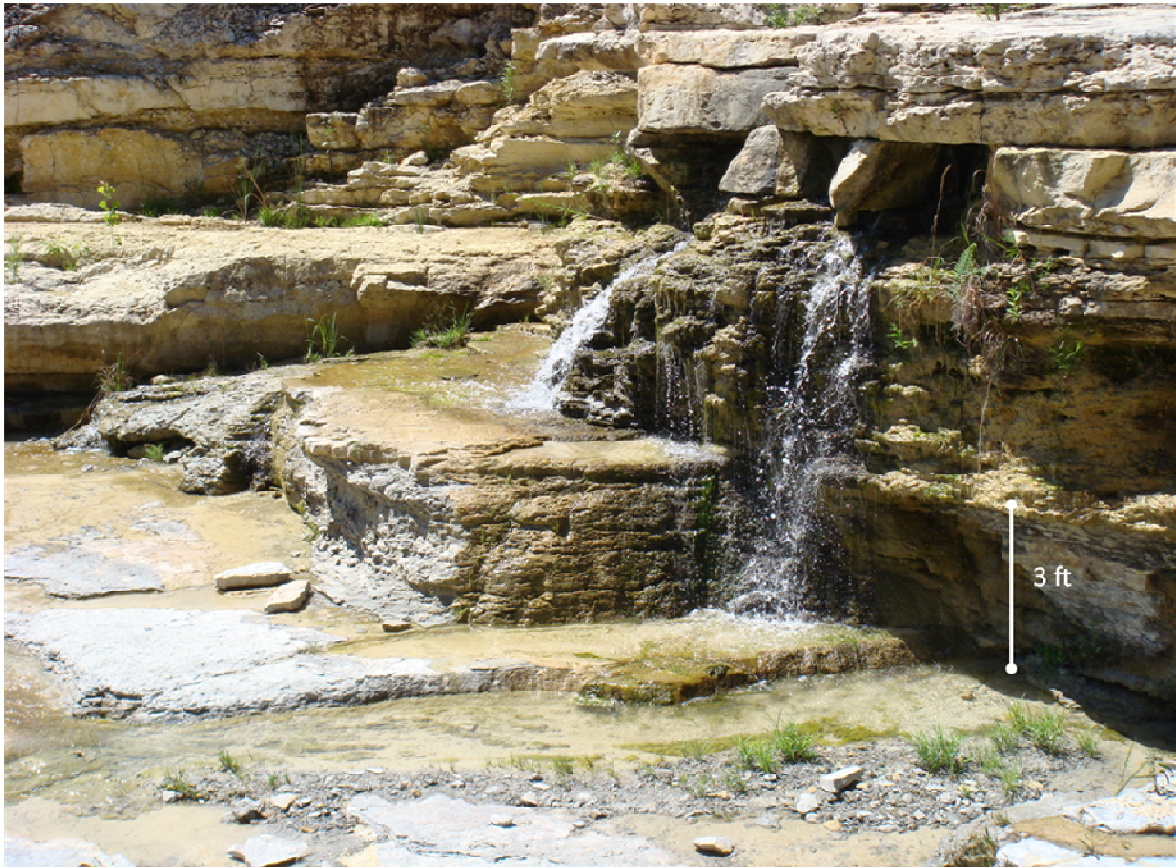
Precipitation and Canyon Lake provide the water needed to facilitate erosion in the gorge (Figure 11). Precipitation is the primary source of water, but water from Canyon Lake is also delivered through conduits present in the stratigraphy, such as bedding planes and fractures. Water promotes both chemical and physical degradation among the clayey layers, while the homogenous limestone has little reaction. Also, water can infiltrate rock, causing increased pore pressure and lowered shear strength, and increasing the likelihood of failure along planes of weakness (Braathen et. al., 2004). Precipitation would also reduce any frictional resistance inhibiting ledge failure or slope.

Figure 11. Photograph showing water flow conducted through bedrock.

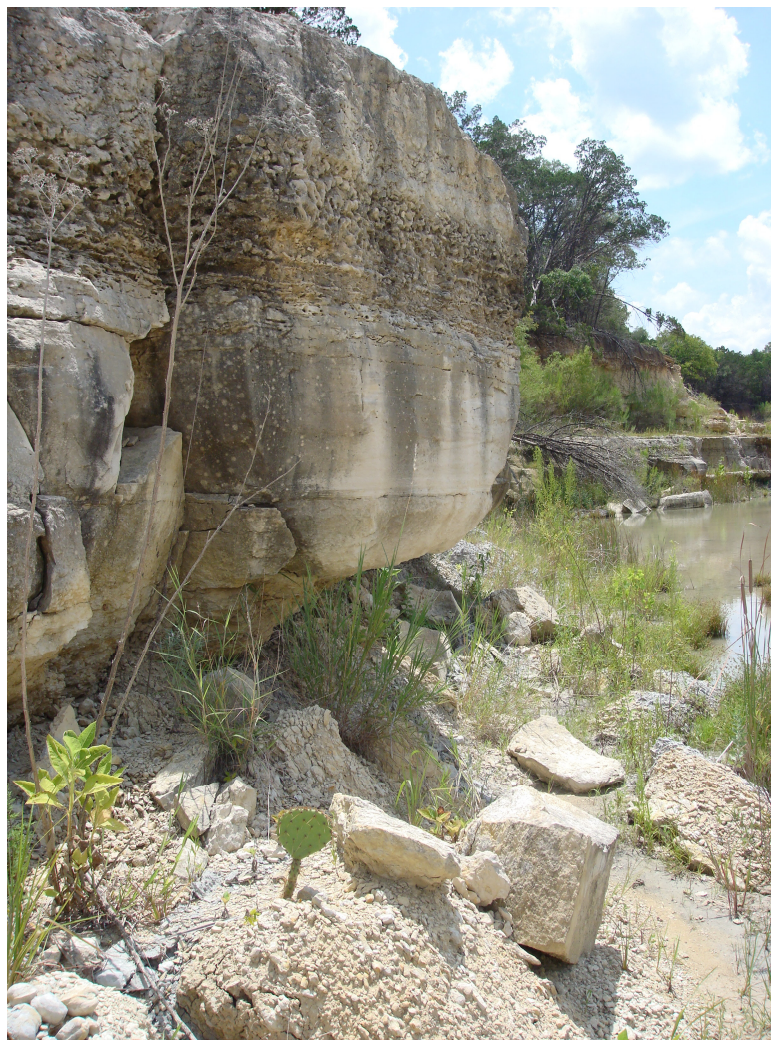
Equilibrium in Canyon Lake Gorge will occur once a sufficient amount of erosion has taken place, forming riser beds that will slow erosion in the gorge. As evident by the debris seen in Figure 12, the competent ledge forming rock above the wackestone has failed and fallen in large and small blocks that accumulate at the base of the vertical cliff face. The resulting accumulation of debris will slow down erosion of the clayey wackestone layers, shielding them from precipitation and runoff. A study by Woodruff and Wilding (2007) has stated that contrary to public belief, the steeply sloped riser beds of the hill country are very stable geomorphologically, and show very little sediment loss caused by precipitation runoff. The most runoff was measured along the gently sloping tread that extends out onto stable platforms of resistant limestone (Woodruff and Wilding, 2007). It stands to reason that once the gorge has built up enough debris to

Figure 12. Photograph of rock erosion accumulation.

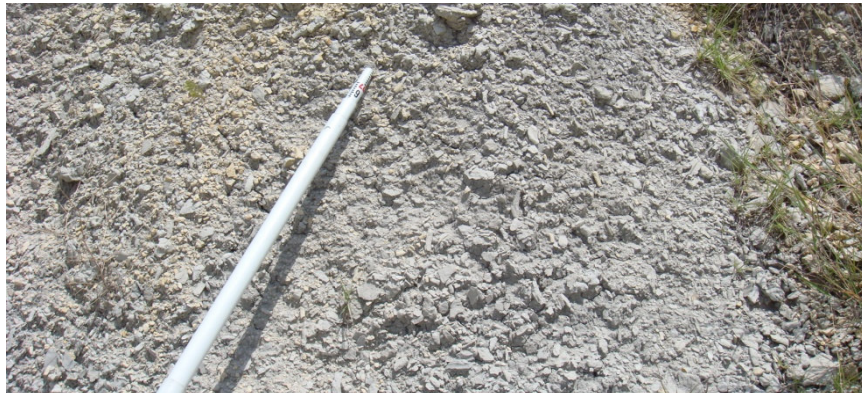
The base unit of Reach One is an easily eroded wackestone that forms a slope underneath a small cliff face. Because of how friable the rock is, the strike of the impact test hammer resulted in unit 1-1 crumbling under impact, yielding only measurements of zero (Figure 21).

Figure 21. Rock unit 1-1. Unit 1-1 is a wackestone that is 1.04 m (3.4 ft) thick. This rock is very friable, and is seen in this reach creating a slope.

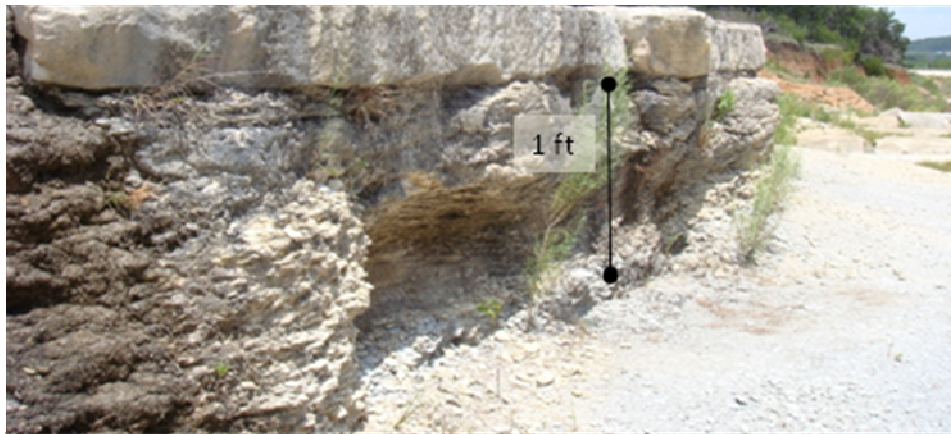
Figure 35. Rock unit 2-10. Unit 2-10 is a heavily clay dominated wackestone that is 2.2 m (7.2 ft) thick.

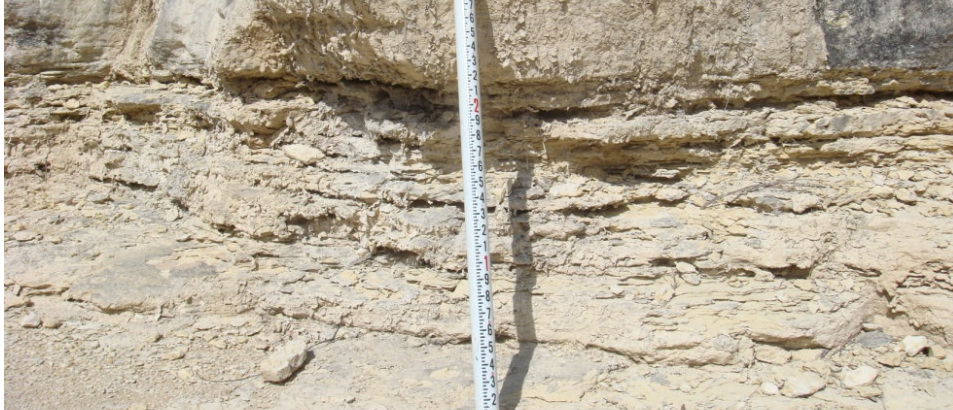
Unit 3-3 marks the first occurrence of wackestone in reach three (Figure 42). Unit 3-3 is a wackestone that undercuts the packstone of unit 3-4, but the thickness of unit 3-3 (1.5 ft (0.46 m)) makes any rock ledge failure a low risk of injury (Figure 43).

Figure 42. Rock unit 3-3. Unit 3-3 is a wackestone that is 0.46 m (1.5 ft) thick. This unit exhibits nodular weathering, and is friable.

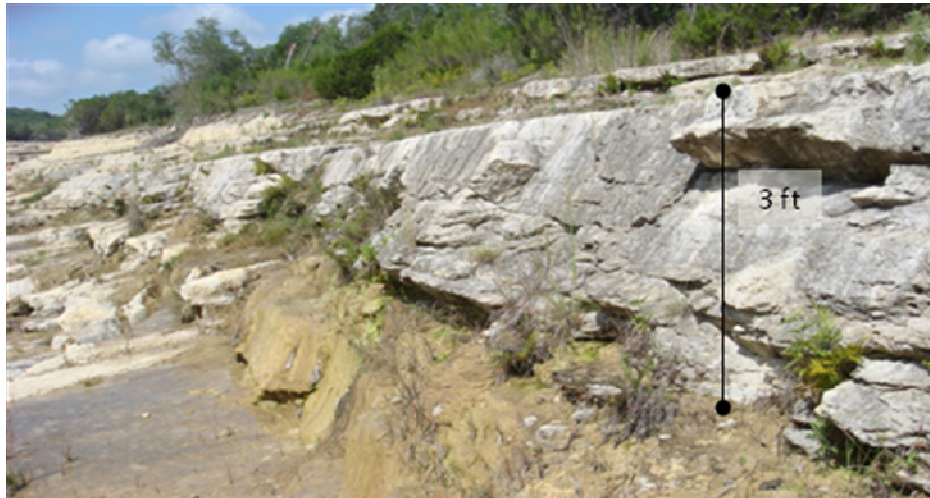
Figure 44. Rock unit 3-5. Unit 3-5 is a packstone that is 1.52 m (5.0 ft) thick. This unit is highly fractured at its base, but grades up to a more consolidated state near its top.

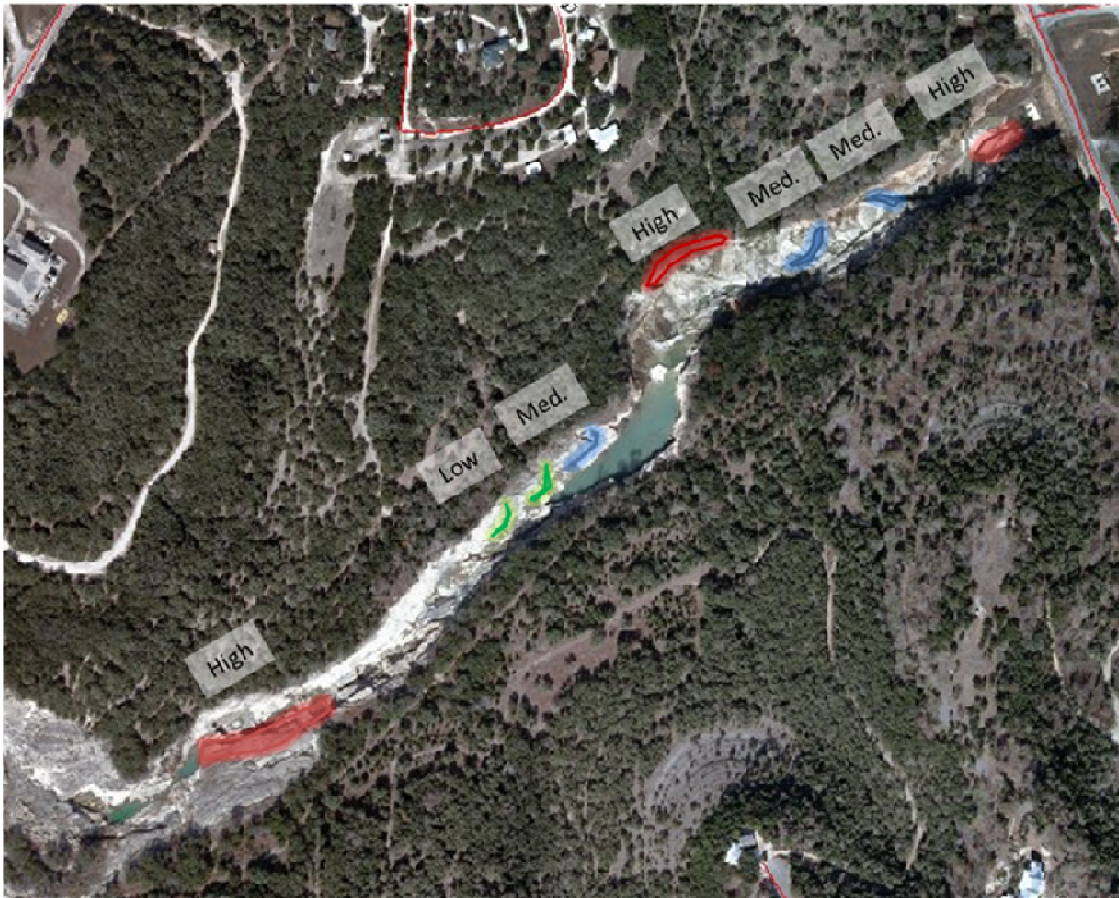
Figure 47. Aerial view of hazard locations in gorge, 2005. High risk – red, Medium risk – blue, Low risk – green. Base map courtesy Comal County Corp of Engineers (<http://www.co.comal.tx.us/giswebsite.htm>).

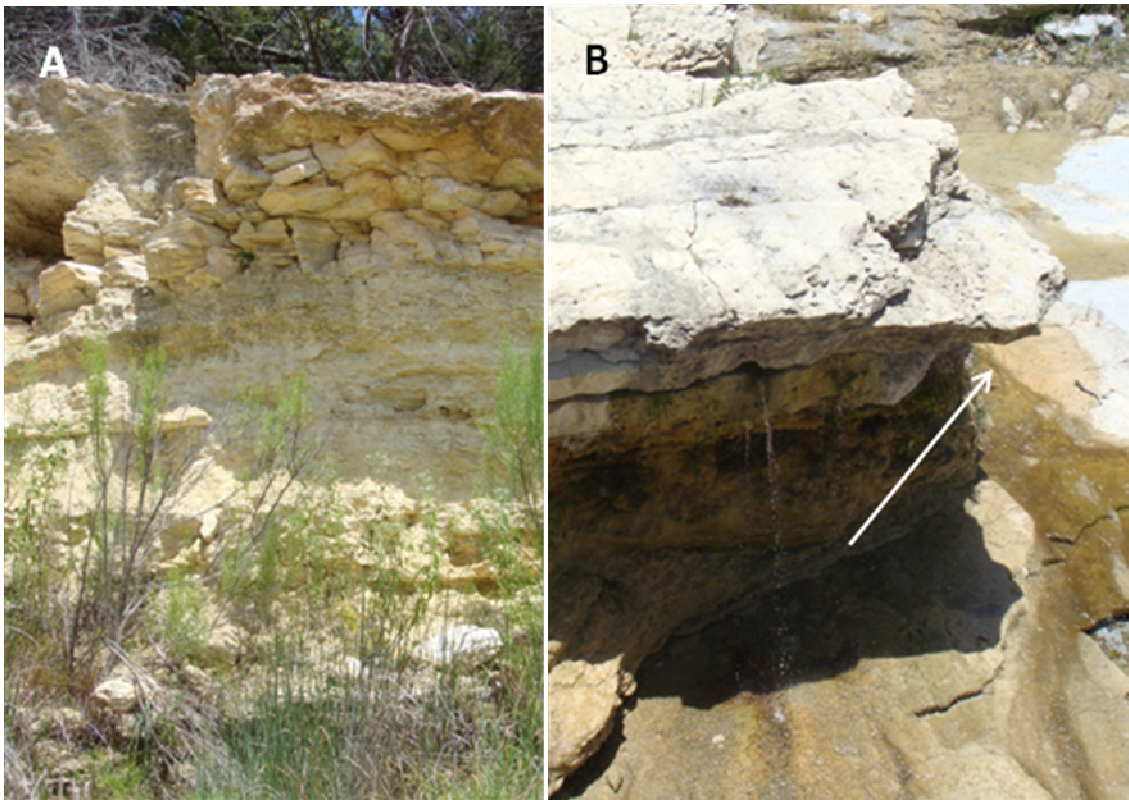
Figure 48. High Risk Areas. (A) is area of unit 2-12 where rock fall is a high risk hazard. (B) is an area in the center of the gorge where ledge failure is a high risk hazard.

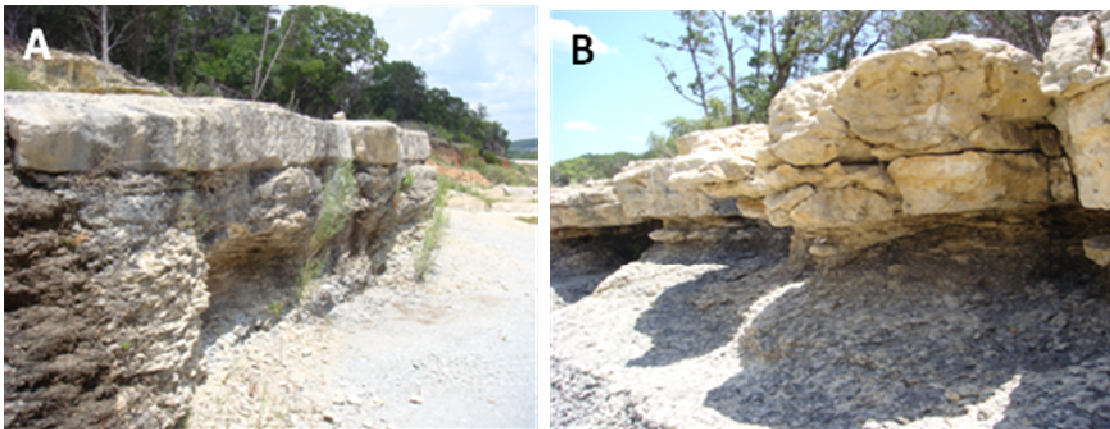
Figure 49. Medium Risk Areas. (A) is the junction of unit 2-1 and 2-2. (B) is of the junction of unit 2-10 and 2-11.
