45<sup>TH</sup> TURBOMACHINERY & 32<sup>ND</sup> PUMP SYMPOSIA  
HOUSTON, TEXAS | SEPTEMBER 12 – 15, 2016  
GEORGE R. BROWN CONVENTION CENTER

## TORSIONAL INSTABILITY OF COOLING TOWER FAN DURING INDUCTION MOTOR STARTUP

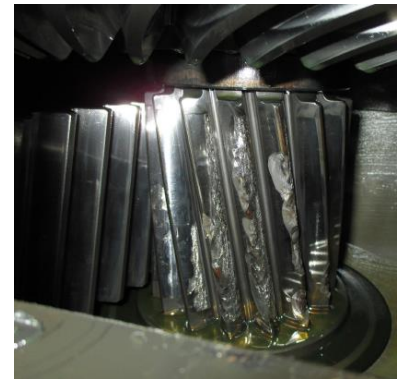
Figure 2. Damaged Pinion Teeth

Metal on the loaded side of the helical pinion teeth surfaces had flaked off. The damage appeared to have originated mainly from the linear cracks at the pinion teeth root. Meshing of a helical gear and its pinion could cause sliding motion leading to peak tensile stress at the root of each pinion tooth. If the pinion and gear teeth were pressed by abnormally strong loads, such damage would have resulted. It was also noticed that the severity of teeth damage was not uniform; some teeth were more severely damaged than the other teeth, and no clear pattern (such as in the case of assembly phase damage) could be found. Since the damage appearance and damaged teeth pattern were rather irregular, it was suspected that irregular contact pressure might have acted at the meshing surface. Mechanisms to cause such irregular contact pressure were, however, unclear at this initial investigation stage.

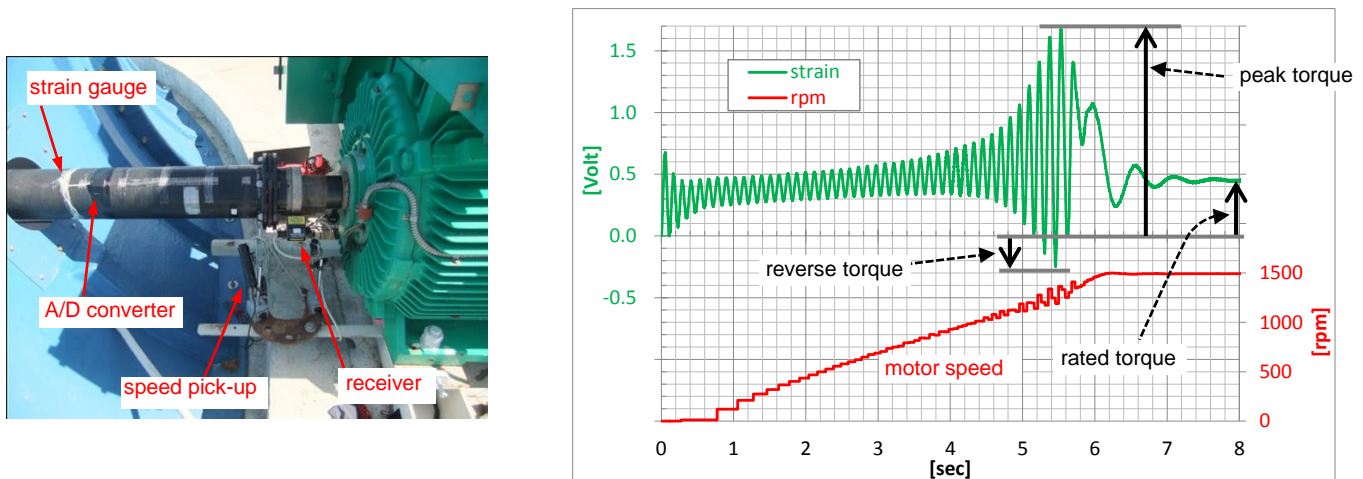
In Figure 3, the horizontal axis is the time from the moment of motor energizing, and the green line represents the measured strain gauge signal output while the red line represents measured shaft rotational speed. Motor rotation reaches its rated speed approximately 6.5 seconds after its starting. Torque oscillation starts to increase at around 4.0 sec, and reaches its maximum at around 5.5 sec (immediately before reaching the rated speed). At the timing of maximum torque oscillation, the motor speed also noticeably fluctuates. This correlation clearly demonstrates that the torque and the speed oscillations are caused by significant torsional vibration. Moreover, torque and motor speed oscillations appear near the calculated torsional natural frequency of the train (8.4 Hz). A key observation is that the frequency of vibration exhibits no tendency to track running speed. The frequency remains essentially constant at 8.4 Hz during the entire startup.

Because of the torque oscillation, peak torque reaches roughly four times the rated torque, far exceeding the gearbox service factor of 2.63. Although the measured peak torque factor of four is below the maximum momentary or starting load factor limit of twice the service factor recommended by the Cooling Technology Institute in CTI Std-111 (see list of references), it is still considered significant. Moreover, torque reversal also occurs during the maximum torque oscillation.

**Figure 3.** Instrumentation Set-up (left) and Measurement Result (right) of Shaft Strain and Motor Rotational Speed

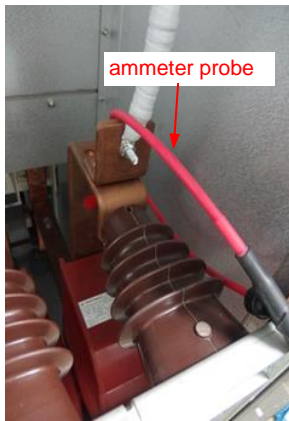
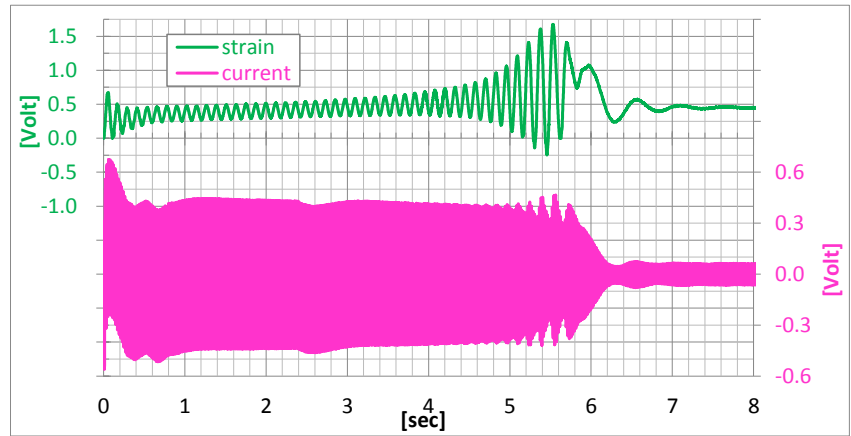
In Figure 4, the measured output signal of motor current (pink line) is plotted together with the measured driveshaft strain (green line). Measured motor current pulsates during 5.0 ~ 6.0 sec, coinciding with the timing of maximum torque oscillation. This current

pulsation is evidently caused by torque oscillation due to torsional vibration. (Note: In Figure 4, output signal of the ammeter is plotted. Although unit of this graph is in voltage, it does represent the motor current in ampere, not motor voltage.)

Figure 4. Ammeter for One Phase (left) and Measurement of Motor Current and Strain (right)

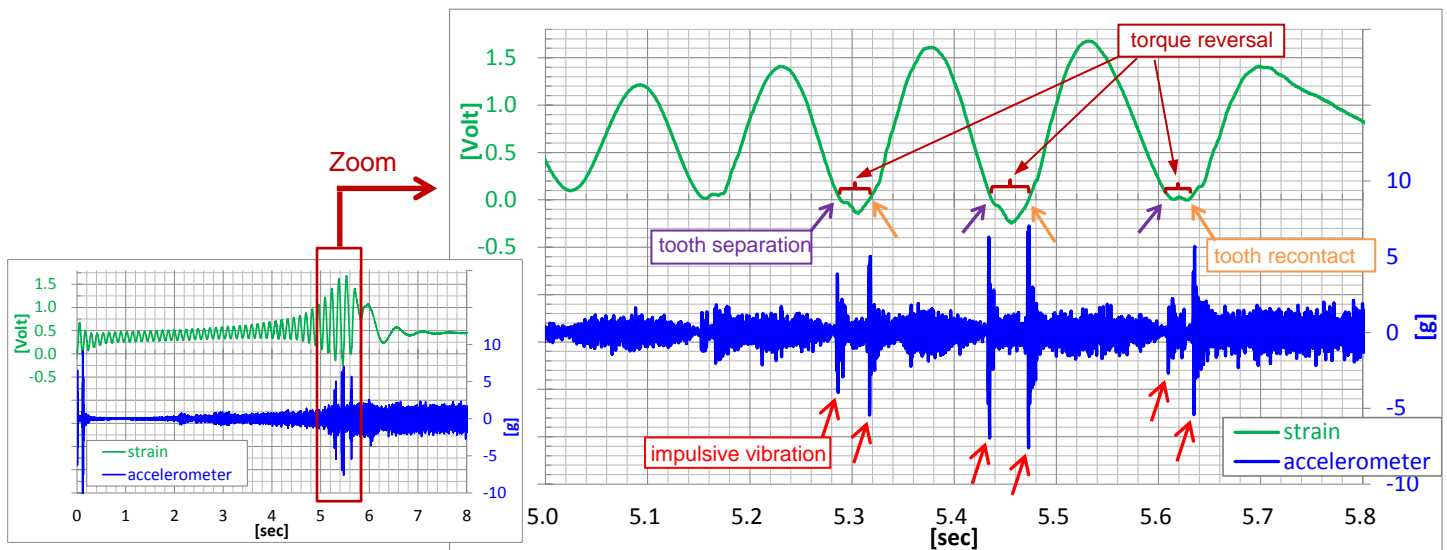
In Figure 5, measured accelerometer vibration (blue line) is plotted together with the measured driveshaft strain (green line). At the timing of maximum torque oscillation (5.0 ~ 6.0 sec), impulsive vibrations are observed. Torsional vibration causes massive torque oscillation, and when the torque oscillation is at its maximum, torque reversals occur. Because of the torque reversal, tooth meshing is temporarily separated, and the separated tooth travels in reverse direction within the backlash and bounces with the backside of the adjacent tooth. Afterwards, when the positive torque is recovered, it is rapidly accelerated and bounces with the mating tooth (tooth recontacting). The fact that the impulsive vibrations in accelerometer signal exactly coincide with the occurrence of each torque reversal (i.e. timing of tooth separation and recontacting) endorses this mechanism. It is judged that an impact load certainly acts due to tooth recontacting after each torque reversal.

Figure 5. Measured Shaft Strain and Gearbox Vibration

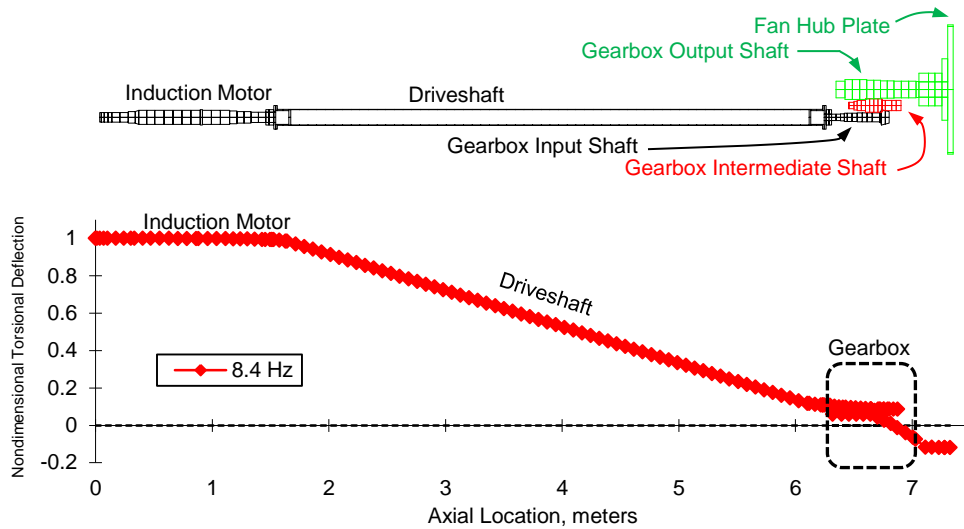
The calculated first torsional natural frequency is 8.4 Hz. The mode shape appears in Figure 6 with the entire train referenced to the motor speed. In this first torsional mode, twisting motion of the driveshaft is the primary region of deformation, which makes sense because driveshaft is the torsionally softest component of the train.

The moment of inertia of the fan is by far the largest in the system. It is 1323 times larger than that of the induction motor, and when referenced to motor speed is 8.4 times larger. The large difference in inertia is reflected in the mode shape, with motion at the motor being about eight times larger than at the fan. As will be seen later, this large difference is a key factor in the instability.

Figure 6. Torsional Analysis Model (above) and Calculated First Torsional Mode (below)

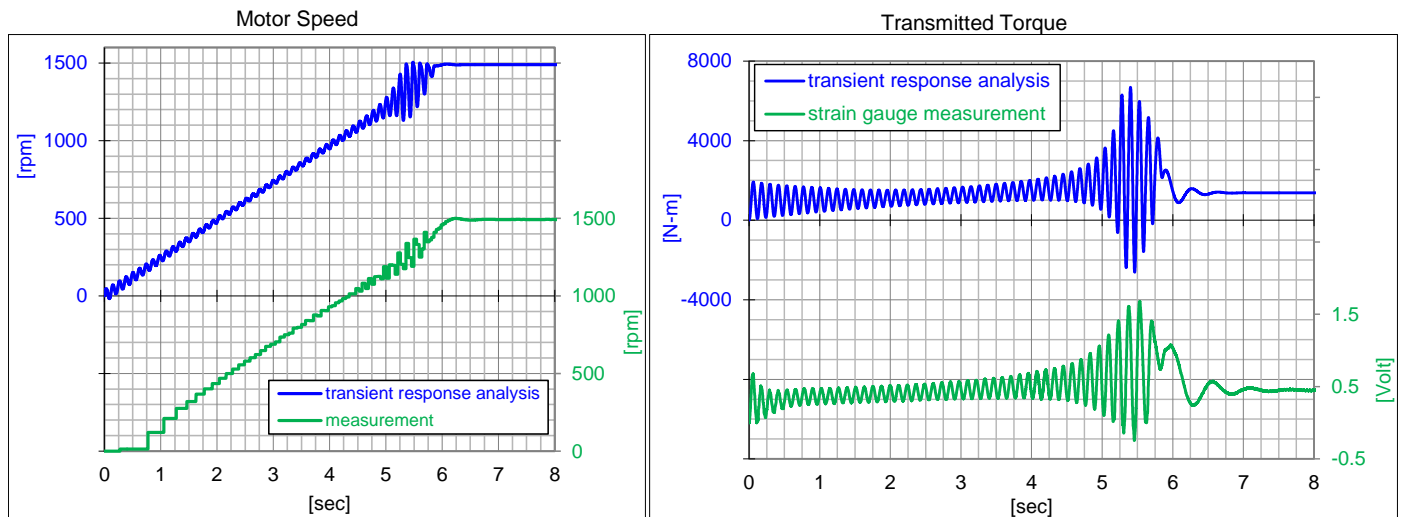
The analytical results of Figure 9 show that the measured torque and speed transient simulated by the transient response analysis has remarkable fidelity compared to the measurements. It should be noted that no excitation forces were applied in the transient analysis (only motor torque and fan load torque were applied without any other forced excitations). Abrupt powering on of the motor at standstill rings the fundamental mode, which is normal. Nevertheless, the transient simulation clearly indicates torsional vibration at the rotor system's natural frequency is growing instead of decaying during acceleration. From this simulation, it became evident that the large amplitude torsional oscillations measured during startup were caused by an instability, and not resonance (i.e. self-excitation instead of forced excitation at the train's natural frequency).

Figure 9. Comparison of Transient Response Analysis (blue) and Field Measurement (green)  
 Left: Speed; Right: Transmitted Torque

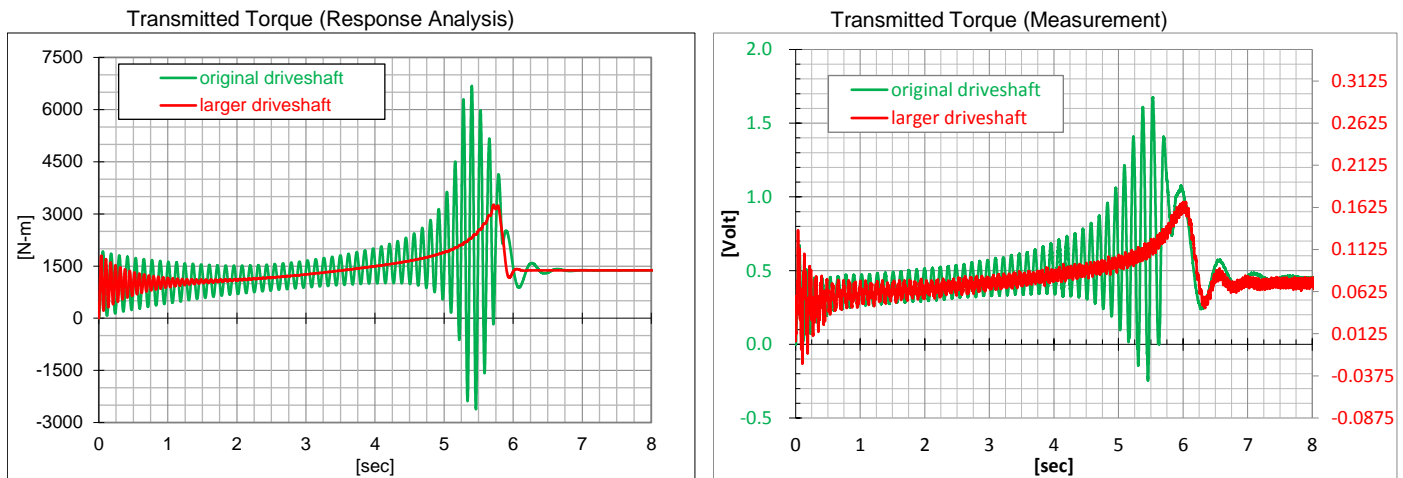
**Figure 13.** Comparison of Original and Larger Driveshafts (left: torsional analysis, right: field measurement)

It was therefore concluded that application of larger diameter driveshaft was entirely effective in suppressing the torsional instability in this train. After implementation of this countermeasure, no other problems have been observed.

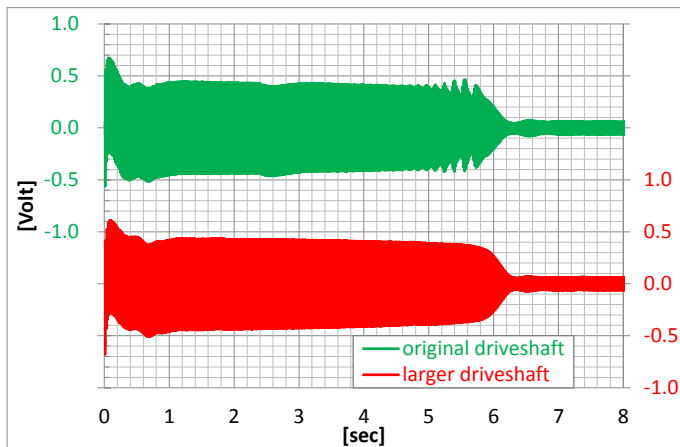
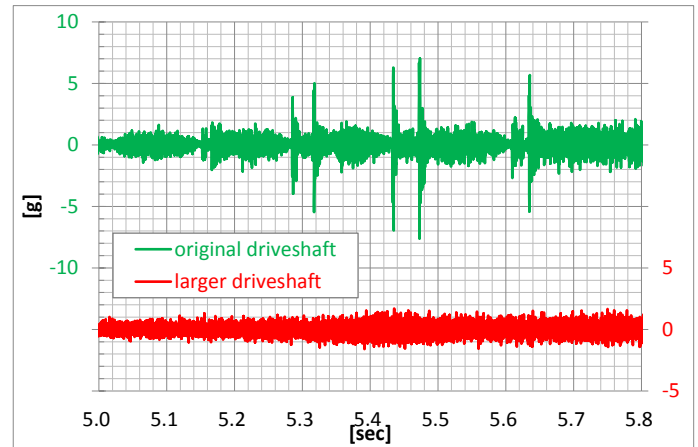
Field measurements of electrical current and gearbox vibration also confirmed that motor current pulsation and gearbox impulsive vibration right before reaching the rated speed successfully disappeared with the larger diameter driveshaft (Figure 14 & Figure 15).

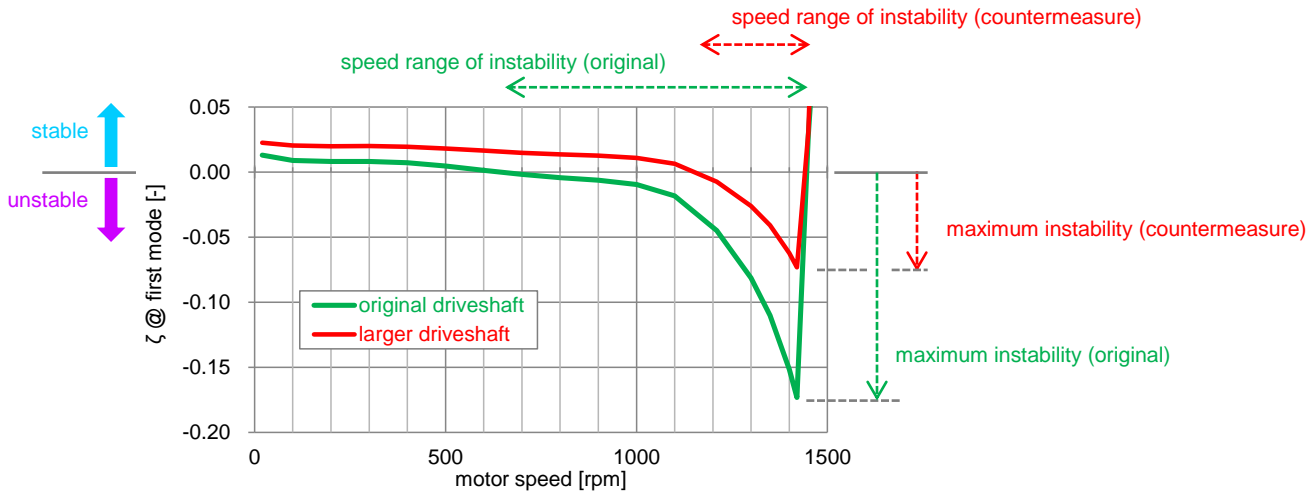
Figure 18 is a plot of the torsional damping ratio. With the original driveshaft, the damping ratio  $\zeta$  becomes negative (i.e. unstable) above 600 rpm motor speed, and peaks at 1420 rpm with a damping ratio of -0.17. In contrast, with the stiffer driveshaft the rotor system is stable up to 1150 rpm, and its peak negative value is down to -0.07. From this torsional stability analysis, it is clearly shown that the larger diameter driveshaft indeed contributes to stabilize the rotor system against torsional vibration. Greater stability by the stiffer driveshaft is essentially attributable to the increased elastic twist throughout the drive train instead of being concentrated in the driveshaft (i.e. other parts of the rotor system also participate to dissipate the energy in case of the stiffer driveshaft via the 1.3% proportional damping matrix described earlier). Dissipation by fan load torque was found to be negligible. See Figure 19 for the comparison of the mode shapes.

**Figure 18.** Calculated Torsional Damping Ratio  $\zeta$  (green: original, red: countermeasure)
