Investigation of process gas compressor shaft vibration phenomena

Investigation for Process Gas HP Compressor (PGC) Shaft Vibration Phenomena

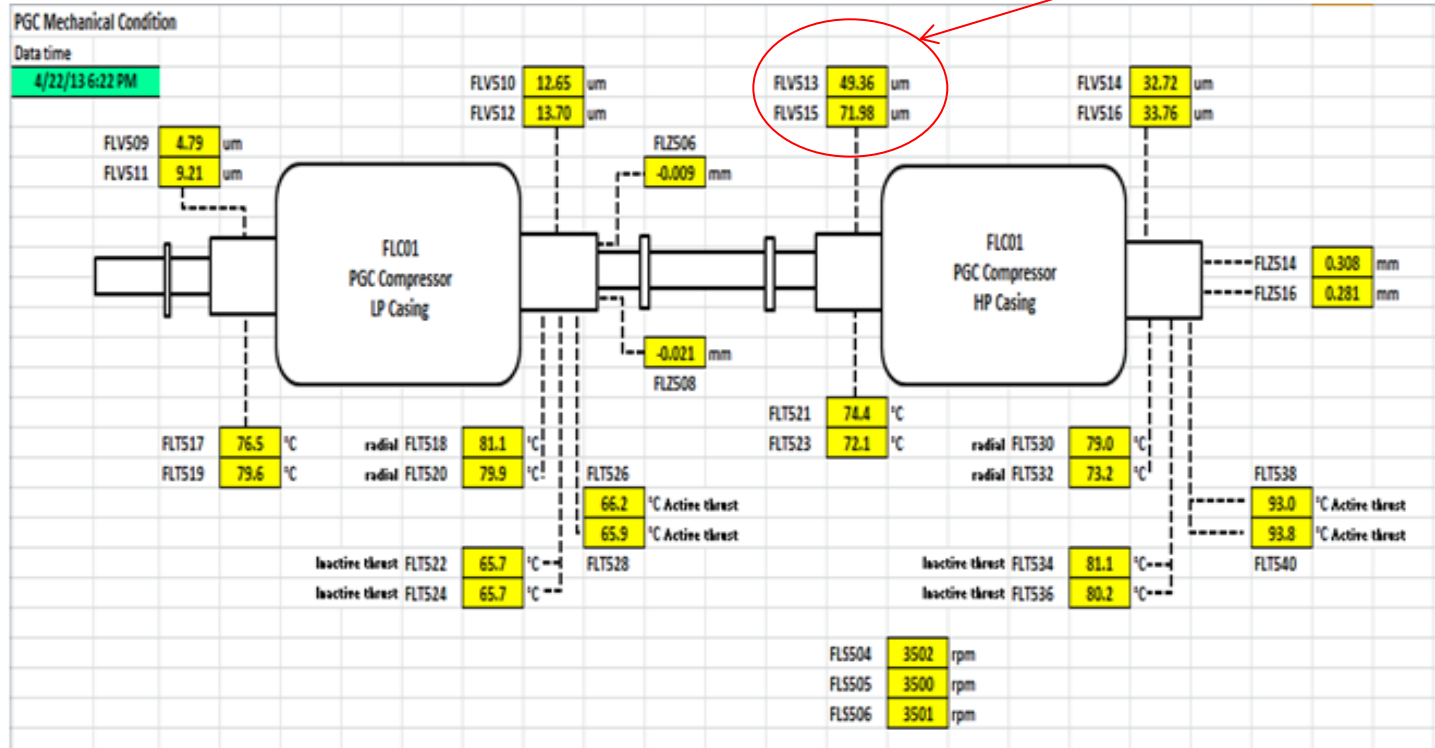
April 22nd 2013: Working rotor

DE side vibration is higher than NDE side vibration

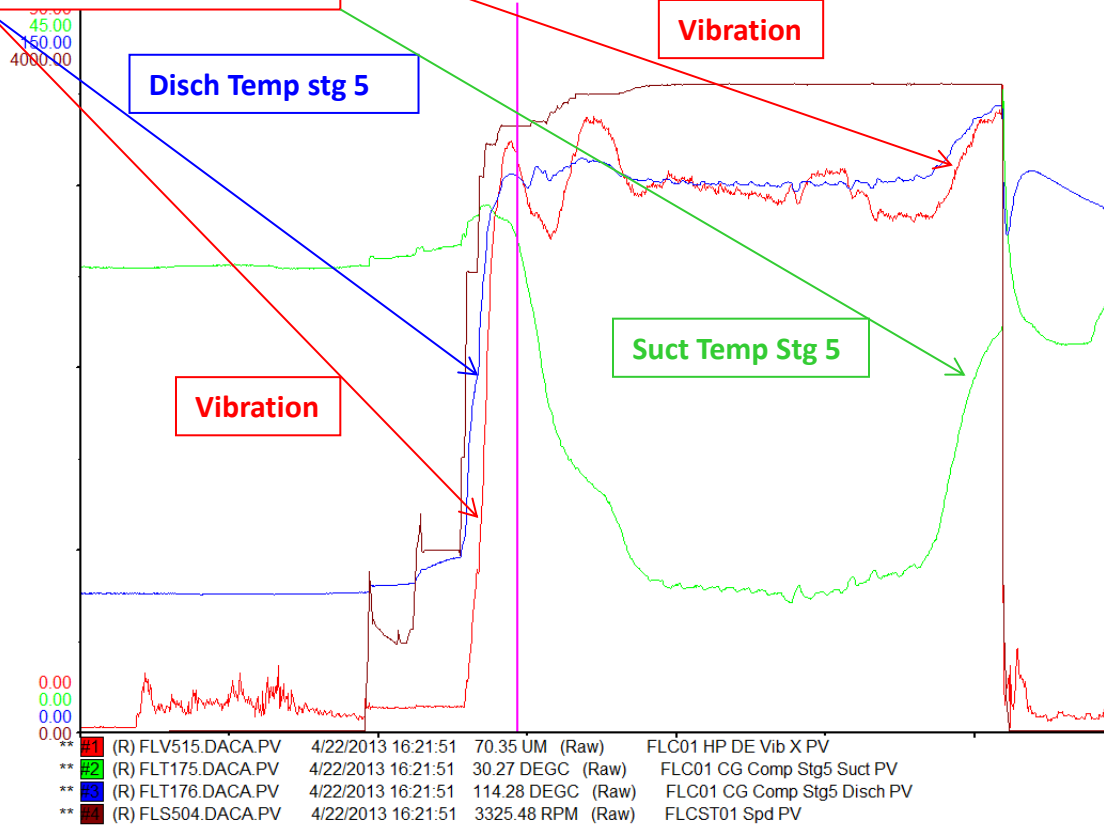
Trend data of working rotor – N2 run

Strong correlation between vibration and stage 5 suction and discharge temperature

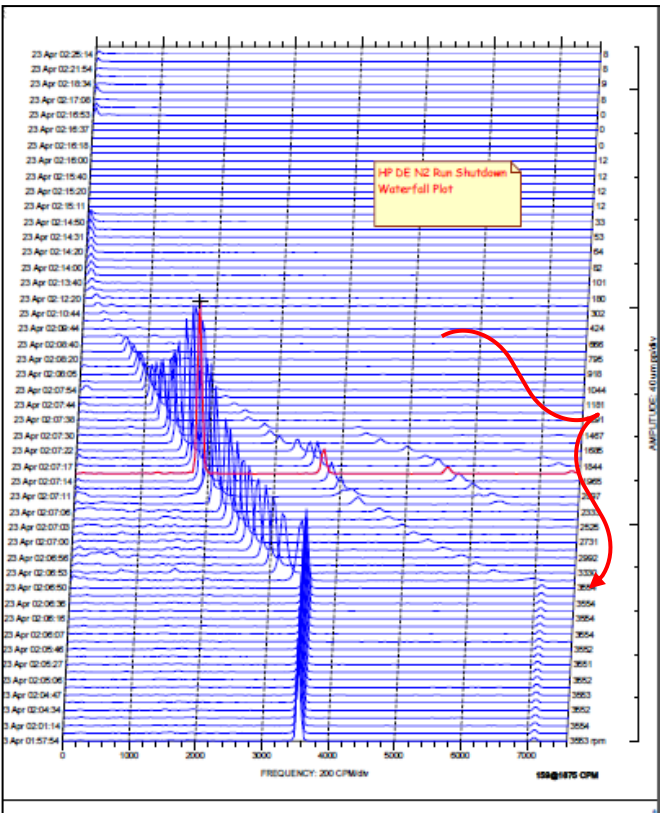
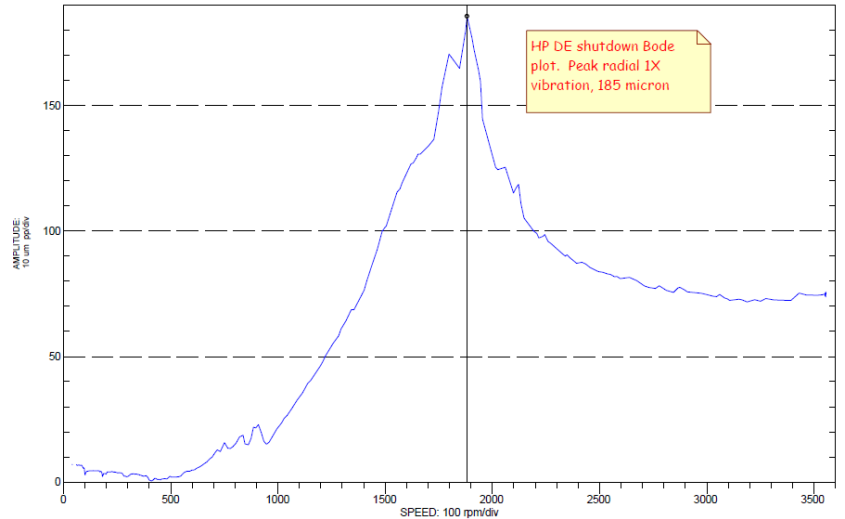
Shutdown waterfall plot of working rotor – N2 run

Abnormal waterfall plot for shutdown
– Vibrations up to 185 microns observed during shutdown

Rotor replacement initiated

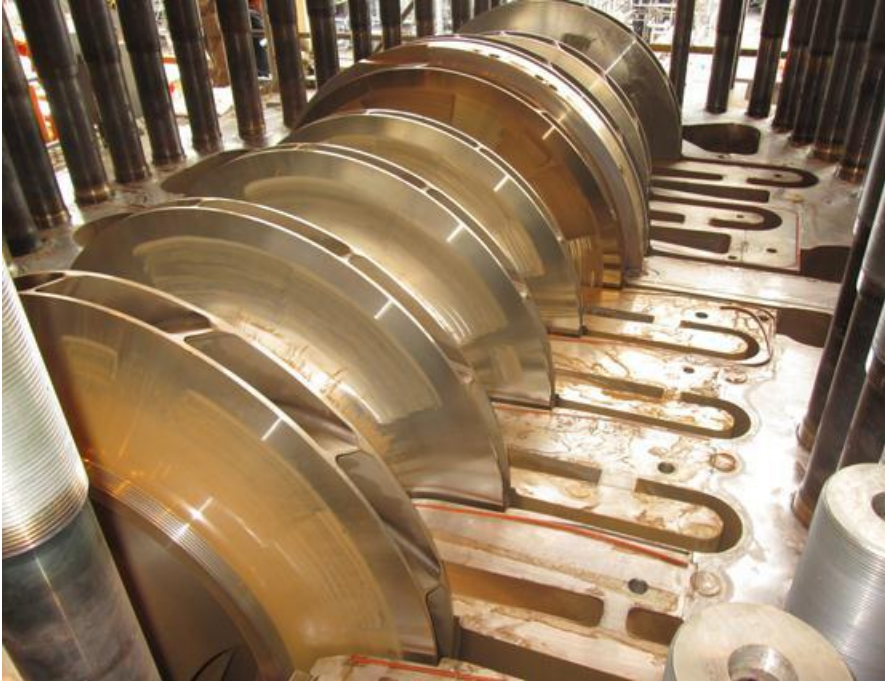
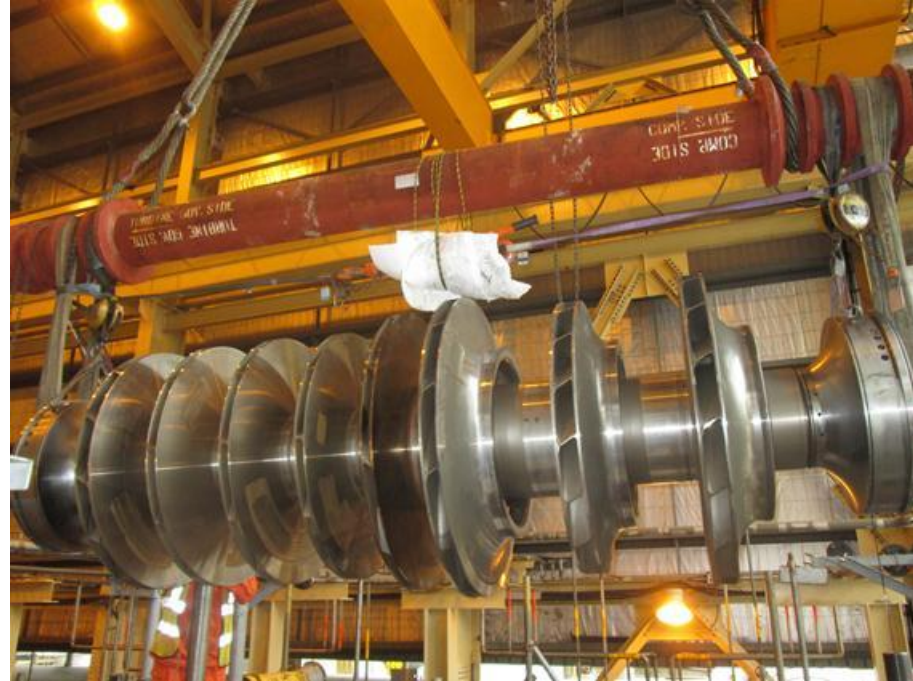
Onsite as-found conditions

- Slight rust observed on rotor; otherwise rotor still looked good from outside

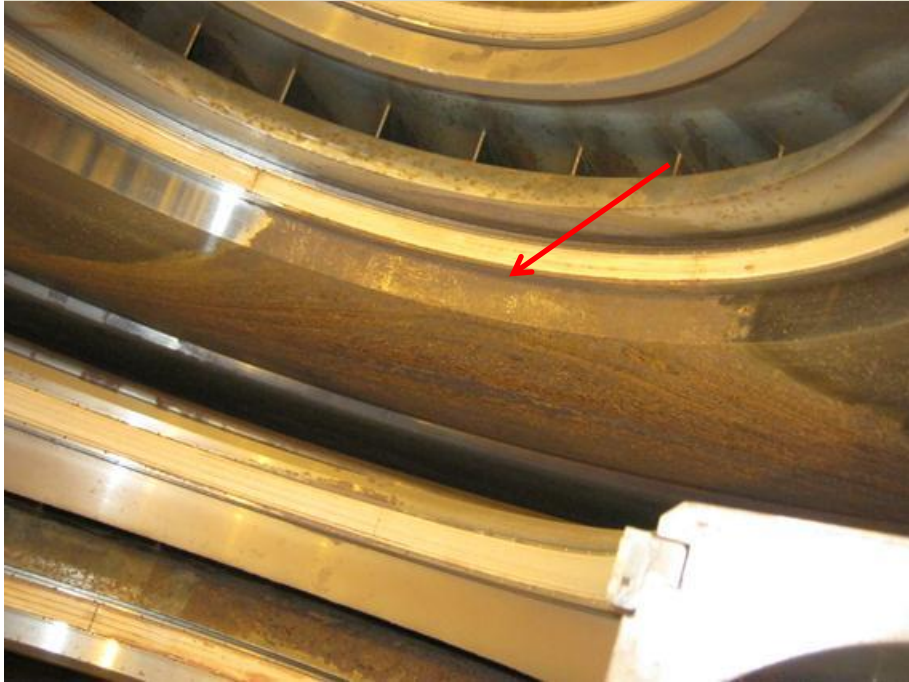
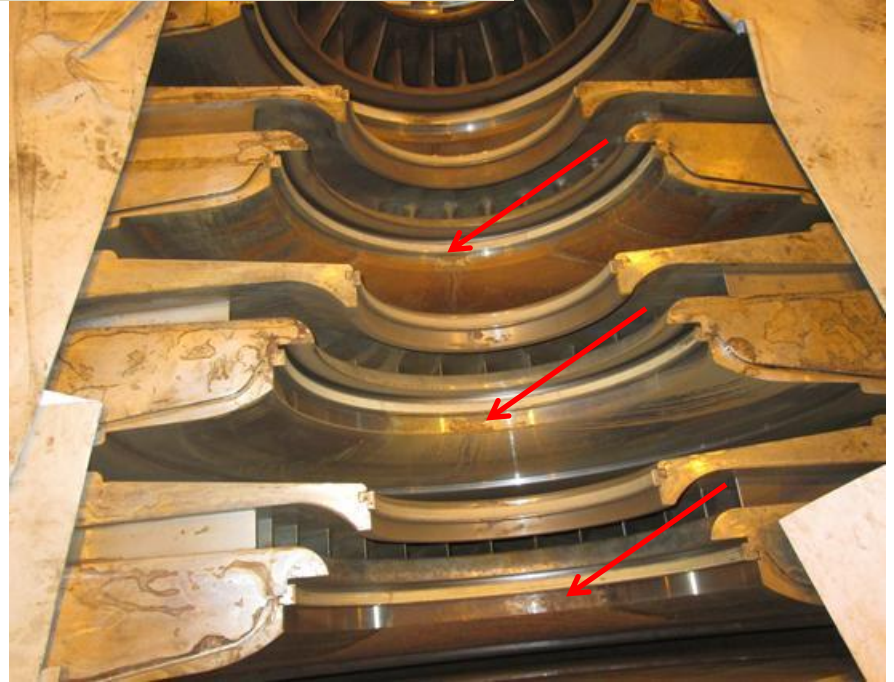
Onsite as-found conditions

- Significant rust observed on stationary diaphragms
- Water mark visible and indicated water accumulation to shaft centerline at 5th stage section

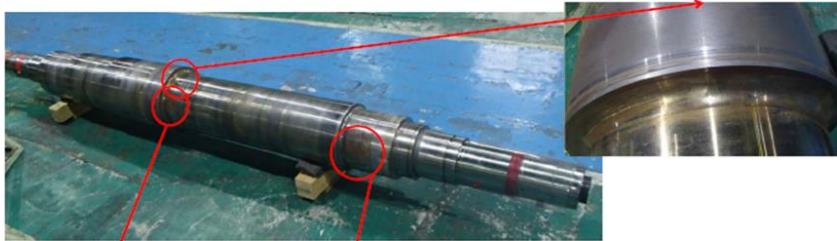
Compressor shaft

- **Heavy rust** observed around HP section (4th to 8th impeller) mainly. (Stage 1-3 is Stainless steel. Stage 4-8 is Carbon steel.)

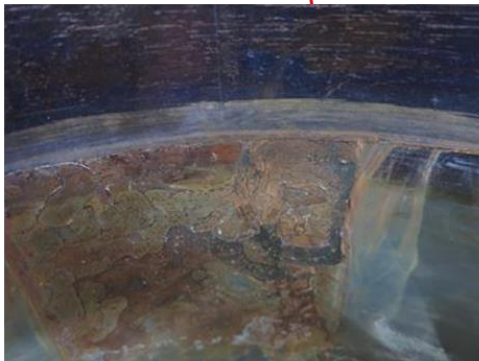
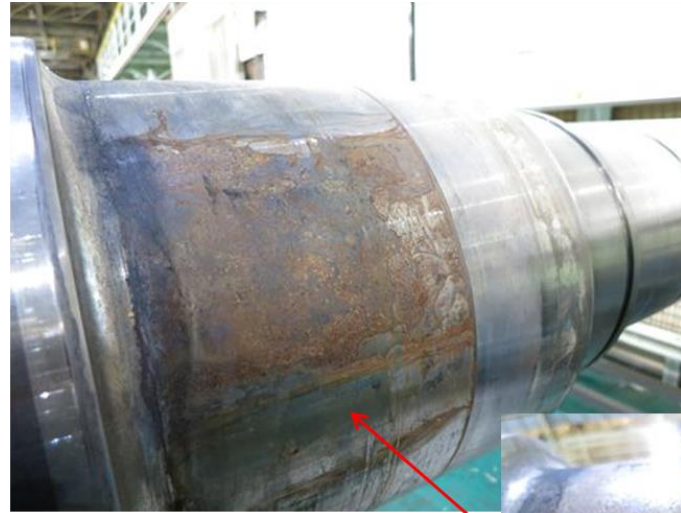
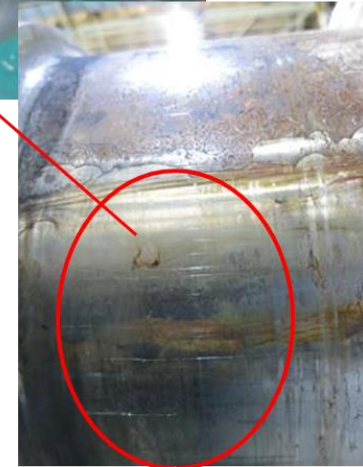
Under 4th impeller

Deep scratch marks across the width of the impeller created during impeller removal. This indicated the presence of hard particles within the clearances between the shaft and impeller

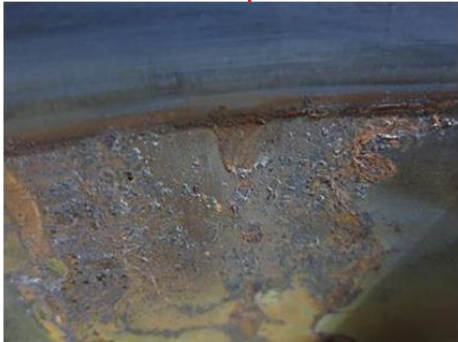
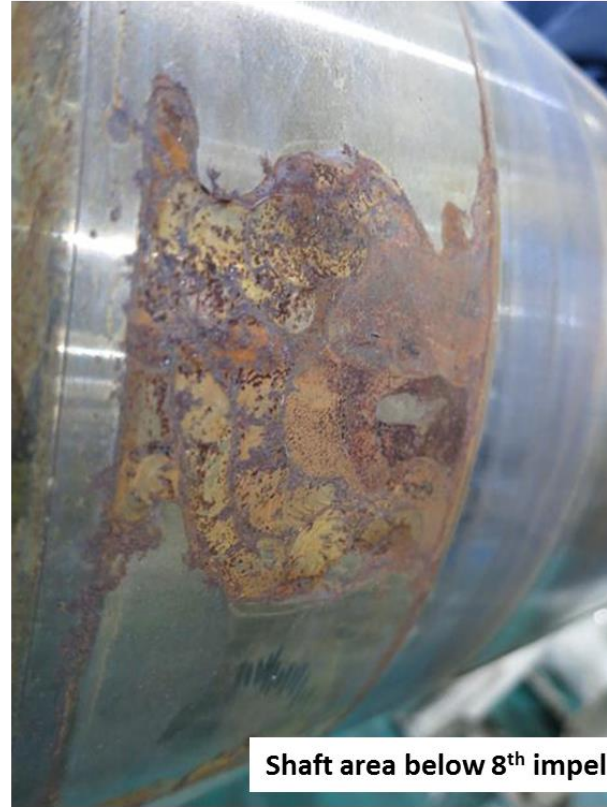
Under 8th impeller

Shaft area below 8th impeller

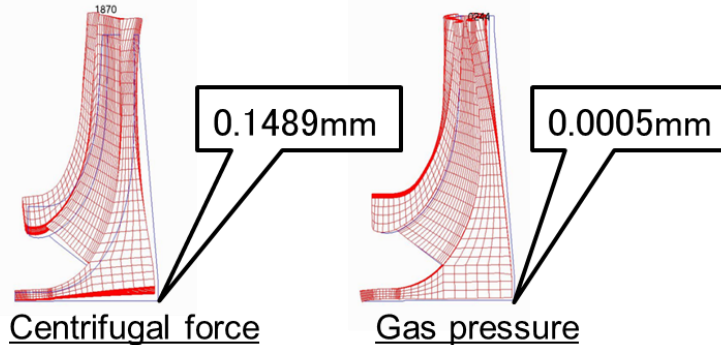
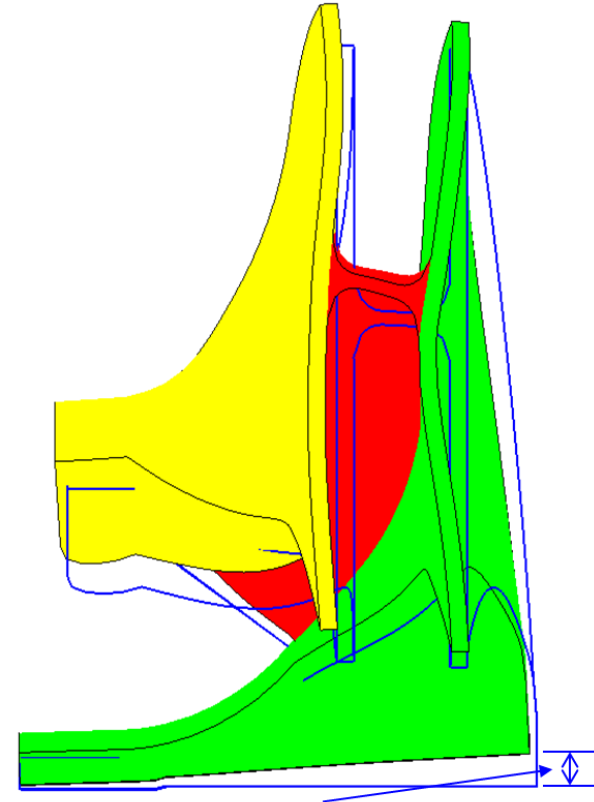
Impeller deformation (at MCR)

- 0.0005mm of deformation at impeller inside edge was caused by gas pressure.
- The impeller deformation by gas pressure was very small comparing to the deformation by centrifugal force.

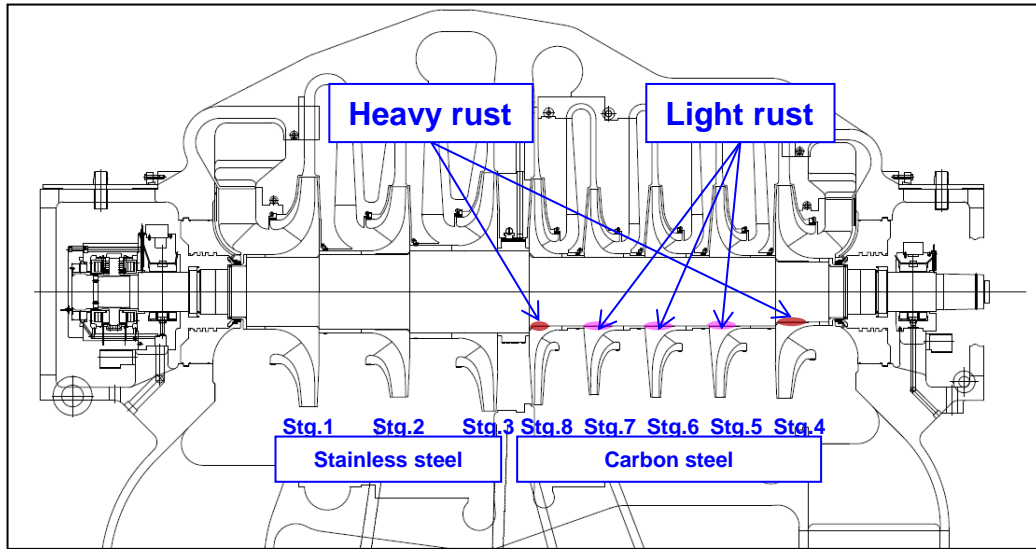
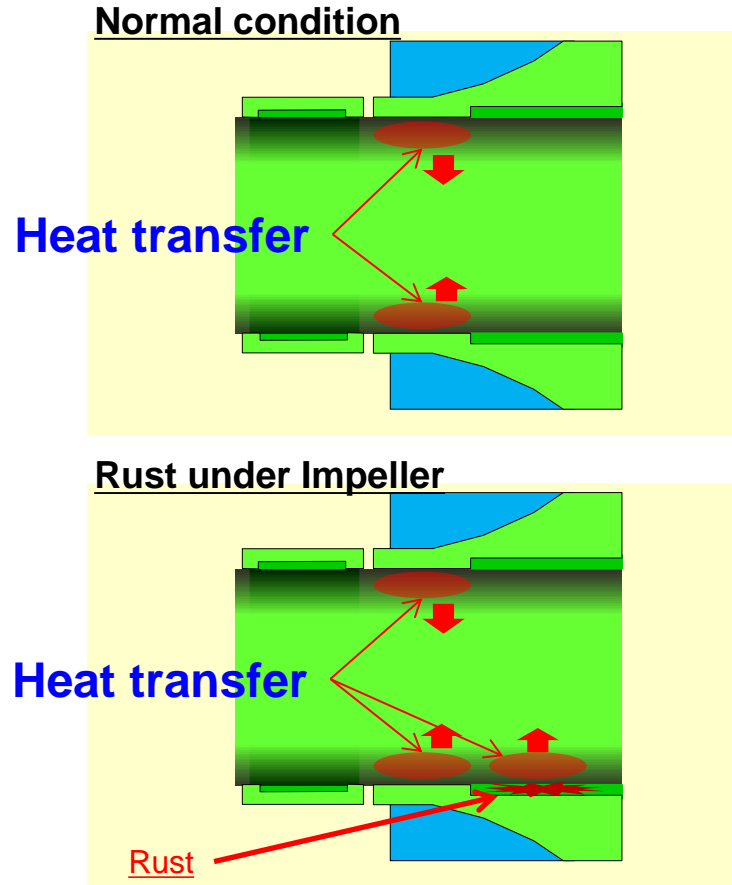
Thermal bending of the rotor could be caused by the rust, due to the uneven heat transfer from impeller.

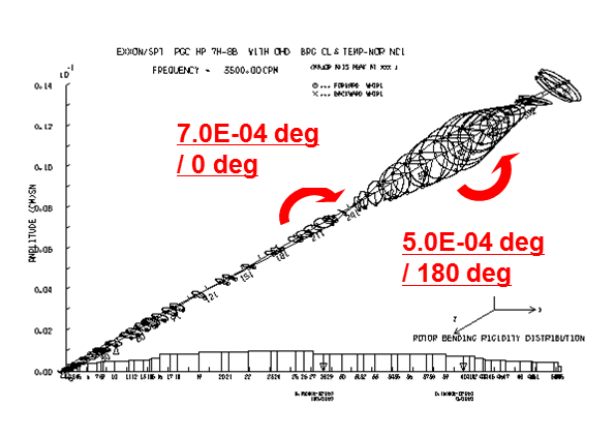
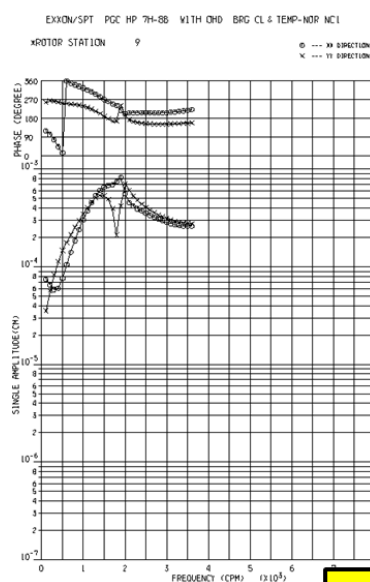
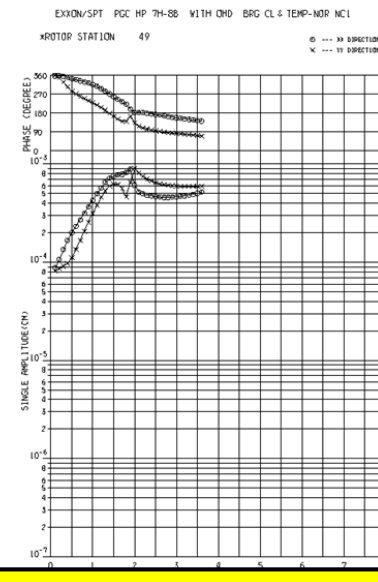
Only rotor thermal bending is considered in this analysis.

Magnification factor of almost 2 between DE and NDE, almost matched with site observation

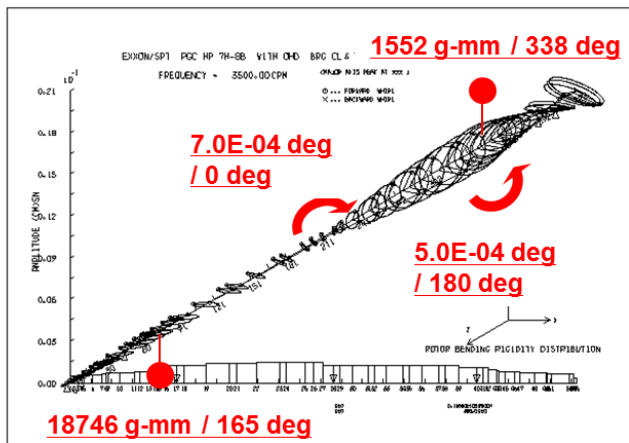
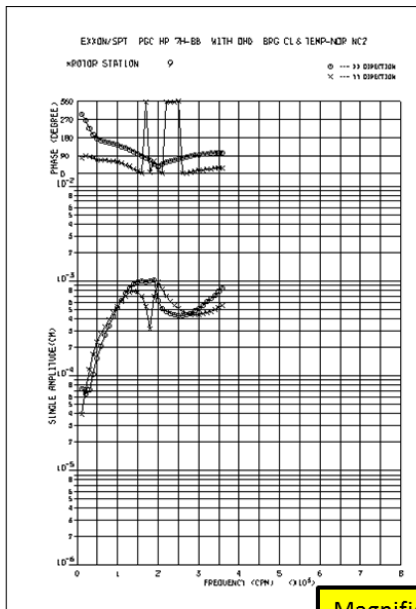
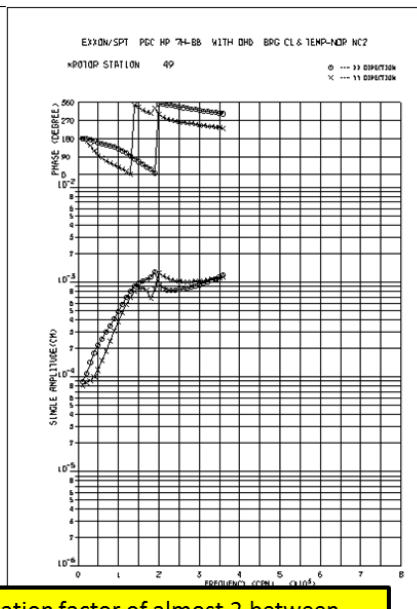
Thermal bending and residual unbalance were considered in this analysis.

Magnification factor of almost 2 between DE and NDE, almost matched with site observation
