# TURBINE FAILURE AND RECONSTRUCTION

**Charles. R. Rutan**

**Lyondell Chemical Company**

## ABSTRACT

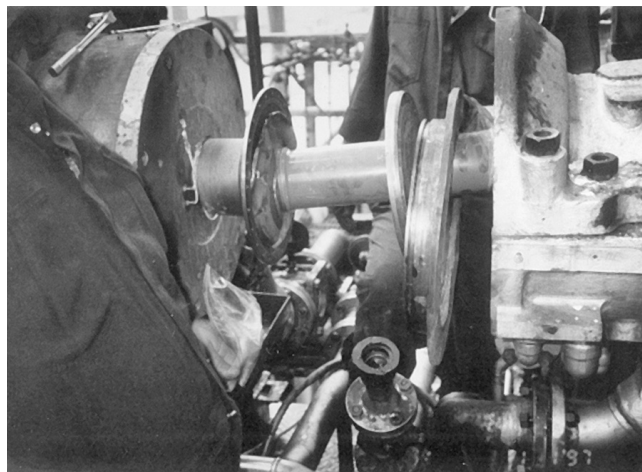
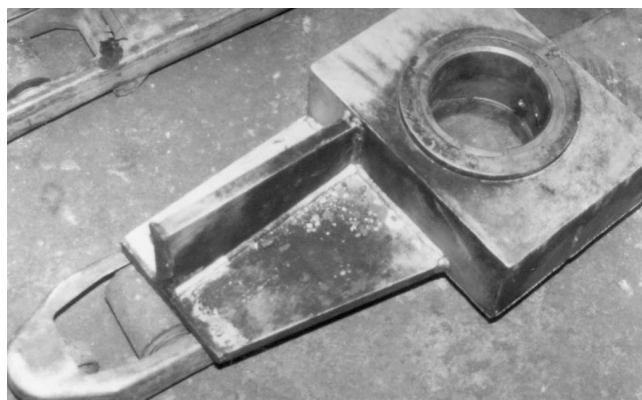
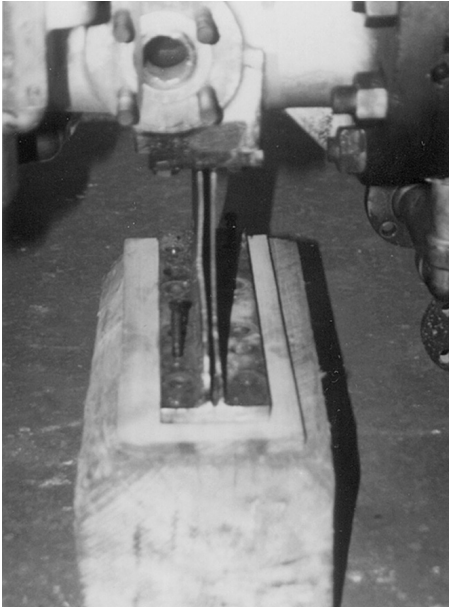
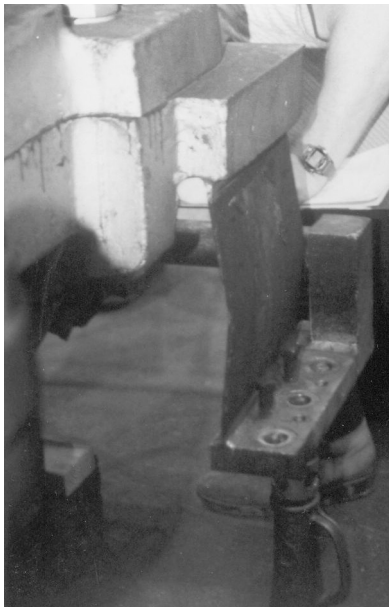
When the turbine failed (Figures 3, 4, 5, and 6), the inboard bearing cover split into two pieces (Figure 7) and the outboard bearing cover rolled to one side of the turbine (Figure 8). Oil began spewing out all over the platform and the atomized oil ignited. The ignition source was the molten metal caused by the heat generated from the metal-to-metal contact rub in the bearing areas. The platform was engulfed in flames burning all the instrumentation, electrical wiring, and the foul weather building. The conduit melted and the electrical insulation melted away exposing the wire that came in contact with other wiring and the metal structure (Figure 9). At this point, the production operator arrived on the scene and was about to turn on the firewater monitor, located at grade level on the platform. However, when he saw all the electrical arcing he decided that it would be unsafe and elected to let the fire burn itself out, which occurred when all the lube oil had been consumed. This was not a good idea. The compressor mechanical water end seals did not fail and the trip throttle valves located at the inlet and inner stage admission did close, but the motor continued to turn at-speed until the motor current overloads tripped.

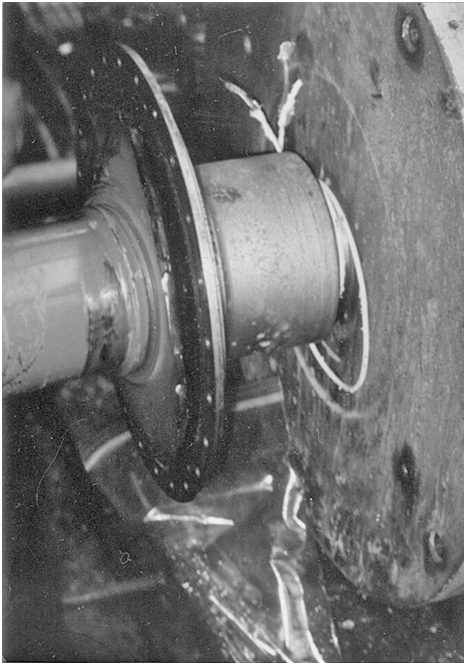
Figure 10. Compressor End.

On the morning of January 3, 1997, the compressor platform was released to maintenance to begin the job of damage assessment and repair. Structural consultants, piping experts, instrumentation, electrical, piping, and rotating equipment engineers were brought in to see what could be salvaged and what items had to be replaced. The motor, gearbox, and compressor case (with rotor) were returned to the original manufacturers for inspection. The compressor rotor, turbine end, was severely damaged (Figure 10).

Bearing journal, labyrinth oil seals, and coupling areas would require submerge arc welding and machining to bring these areas back to the original specified tolerances. Additionally, the rotor had

a 5 mil kink, turbine side, starting at the compressor end seal area extending to the shaft end. A decision was made that no effort would be made to repair the compressor shaft at this time because a new spare compressor rotor was available; so all the attention was focused on the turbine repairs.

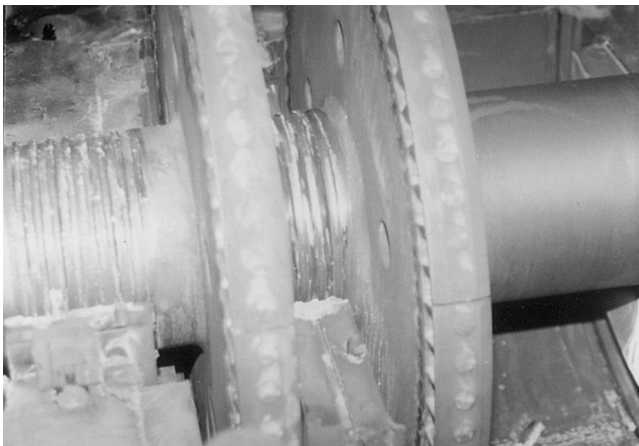
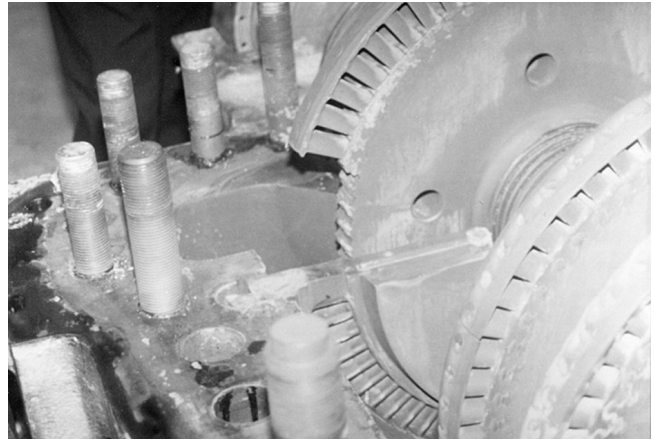
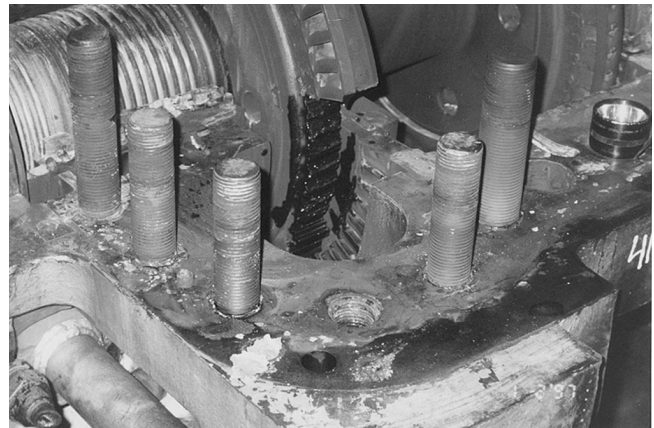
While the above was transpiring, the decision was made that repairing the turbine rotor was more expedient than waiting for a new forging. A detailed list of all the components that could be repaired, replaced with stock inventory, and fabricated was developed. An outside consultant was contacted to determine what caused the turbine failure. The first two wheels suffered severe damage. It was learned that one complete segment of the third wheel was missing (Figures 11, 12 and 13).

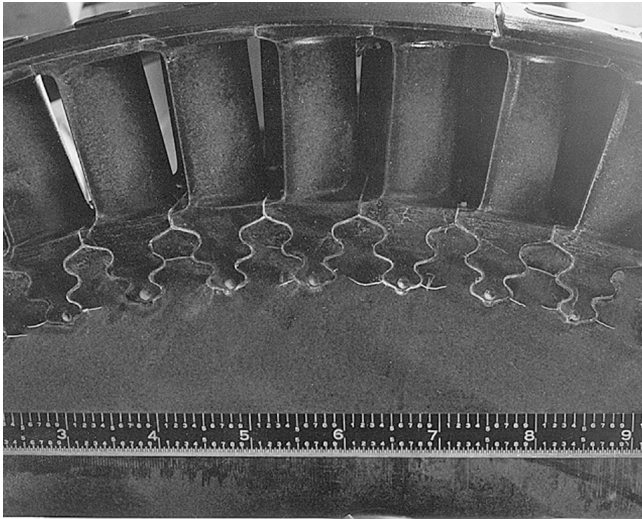
Figure 14. Third Stage Sectioned.

When the remainder of the turbine rotor was magnetic particle inspected the Christmas trees (bucket tenons) of the third wheel looked like they had grown hair (Figure 14). The cracks were sectioned and inspected. Caustic was present and the wheel had failed due to stress corrosion cracking. A section of the wheel, identical to the section that had failed (an eight-bucket packet), was removed and weighed. A quick calculation with this weight, radius from the center of the rotor and speed, was performed. It was determined that when the section came off the rotor, the turbine experienced an unbalanced force of 160,000 lb. If any of the shutdowns had been activated, and the compressor train had automatically been shut down, then the damage would have been bad, but not catastrophic. Fortunately, the compressor mechanical water end seals did not leak and remained intact. If these seals had failed and the ethylene oxide gas had been released to the atmosphere, there was a very high probability that an additional event would have occurred.

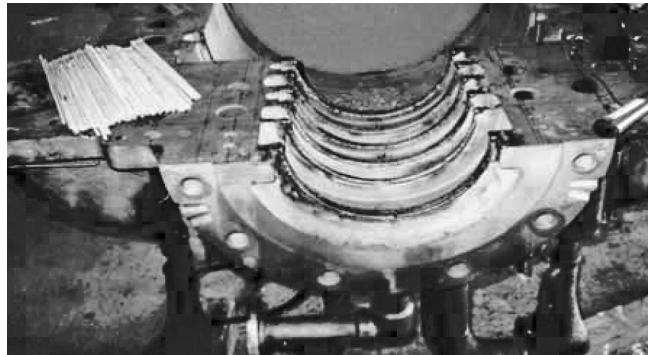
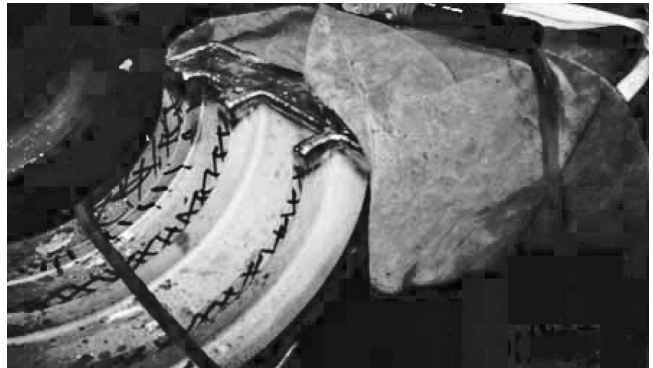
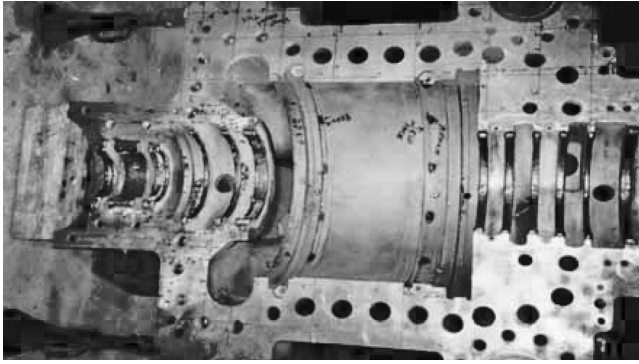
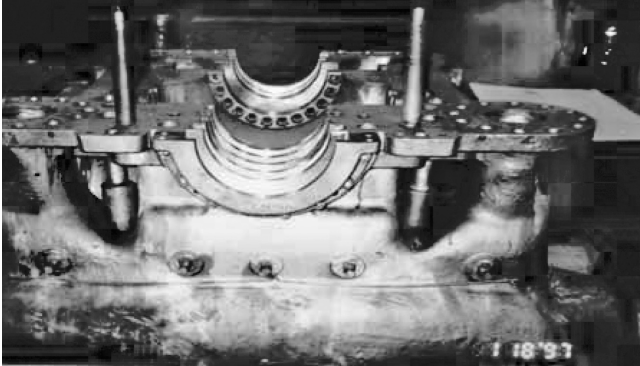
As the rotor work was proceeding, the turbine case was being weld repaired. As can be seen this was not an easy matter (Figures 23 through 26). First, the split lines of the upper and lower halves were weld repaired and rough machined. Then, the register fit areas were weld repaired and rough machined. The turbine case halves were then sent to stress relieving. Once this operation was completed, the case was returned to the machine shop and final machining was completed and the case was dimensionally checked.

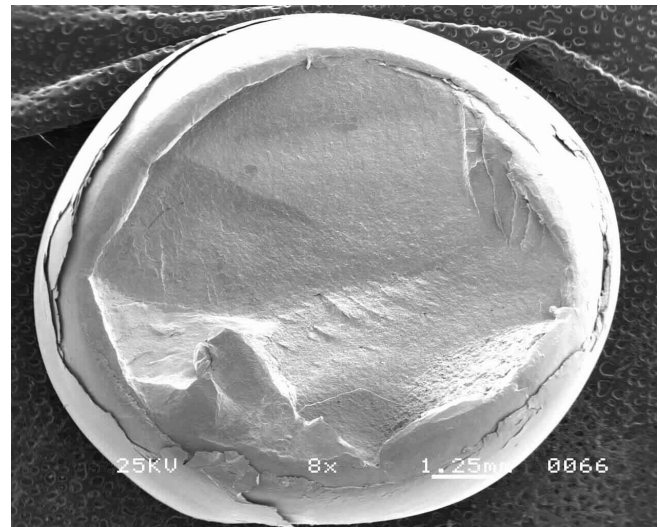
Figure 28. Bucket Tenon.

- *Tenon (or nipple) piece*—It was quite fortunate that the fracture surface was mostly undamaged except in areas near the circumference of the tenon (Figure 28). However, the fracture surface is severely oxidized, which masked out the fine details on the surface. Still, it could be determined to be a fatigue failure (Figure 29) with the typical feature of fatigue striations (Figure 30).

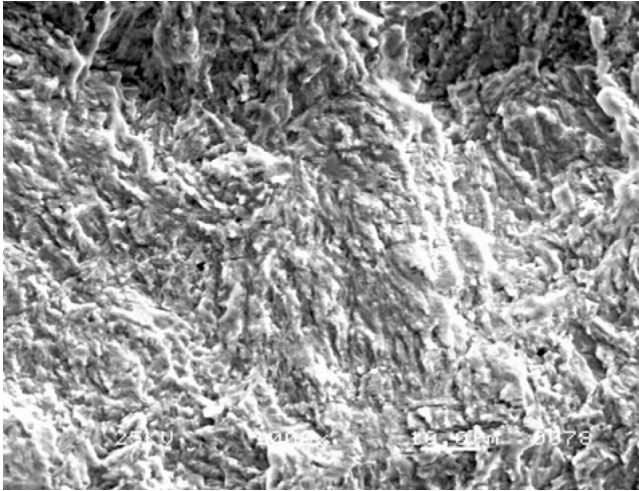
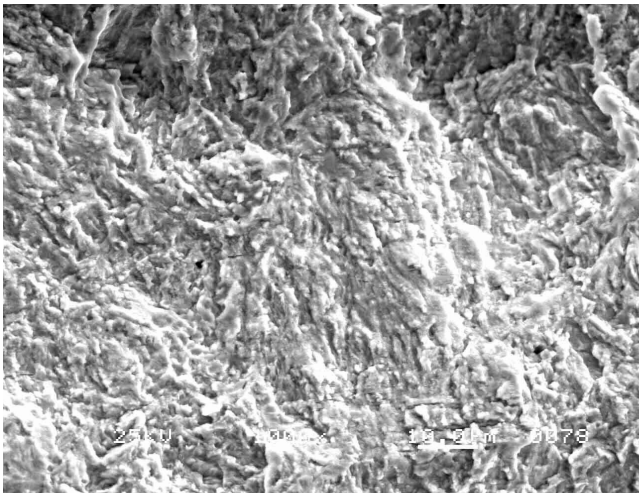
The failure of the tenon has been confirmed by SEM fractographs as fatigue, or more precisely corrosion assisted fatigue. It is also likely a high cycle (or low stress) fatigue failure because:

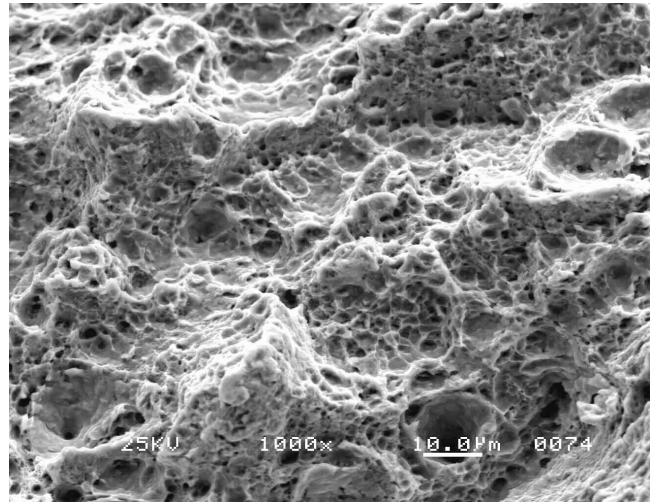
Figure 31. Ductile Overload Failure.

On one end of the fracture, there was clear sign of final ductile overload fracture (Figure 31). Also known as microvoid coalescence (MVC). Another final fracture area is found about 90 degrees to the first one. Here the microvoids appeared to be distorted or elongated (Figure 32), which indicates the fracture is at a different orientation. Efforts to locate the crack initiation site by tracing back from the final fracture areas to the opposite end of the fracture surface were not successful, as the area was too damaged to be recognizable (Figure 33).

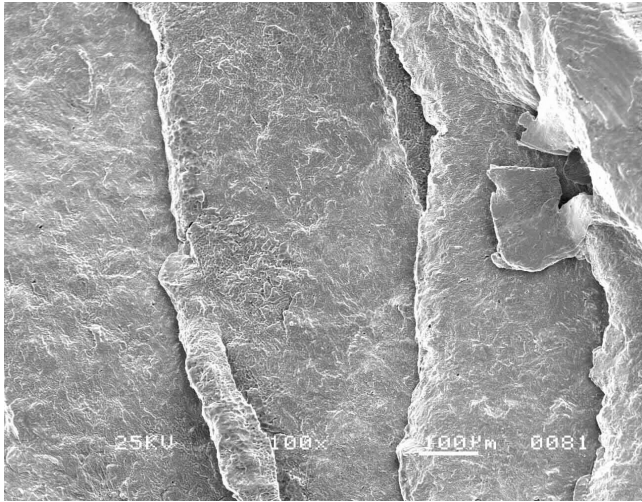
Figure 34. Feathery Area.

A feathery area (Figure 34) across from the second final fracture area was determined to be a fatigue area (Figure 35). When viewed at higher magnification, all in all, the fatigue area was estimated to cover over 70 percent of the fracture surface.

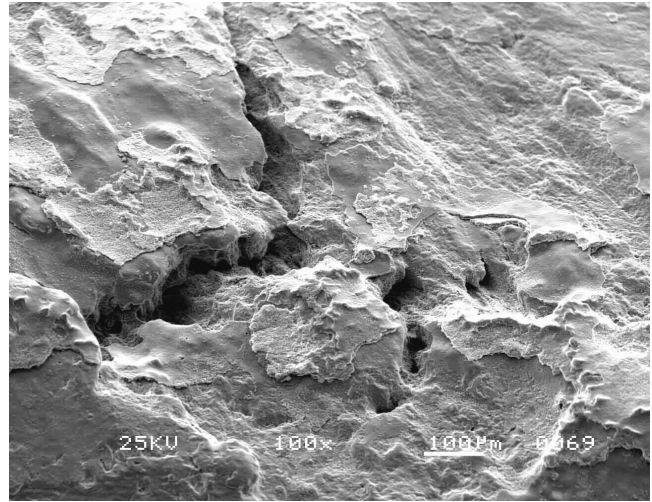
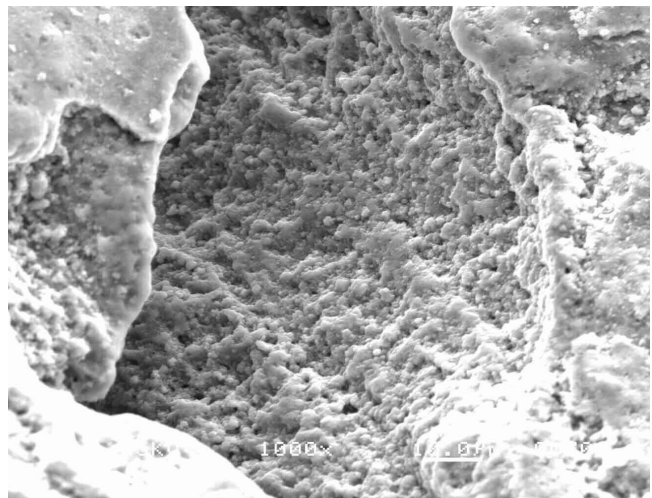
- *Shroud piece*—There was not much to look at, because the “fracture surface” had been damaged (rubbed) and also heavily oxidized (Figure 36). In a cracked area, near one end of the surface, it was also damaged, but it had some scale attached to it (Figure 37). Even the surface inside the crack was found to be severely oxidized (Figure 38). Heavy scaling was also found on the side surface of the shroud piece (Figure 39).

The severe oxidation and scaling on the failed pieces are not believed to be beneficial to the service life of the turbine components. It was believed that the steam is of poor quality and is corrosive to 422 SS. The steam also contains a high amount of impurities. The elements found in the scales like calcium, phosphorus, silicon, and vanadium are believed to be water treatment chemicals, while the zinc, copper, and aluminum are likely to be corrosion products that were carried over by the steam. Since steam is water vapor, it is not supposed to carry many impurities. The steam used in the turbine is thus believed to be very wet and contained liquid entrainment. Besides oxidation, there was no other sign of environmental degradation like localized corrosion, stress corrosion cracking, or caustic embrittlement on the failed pieces.
