47<sup>TH</sup> TURBOMACHINERY & 34<sup>TH</sup> PUMP SYMPOSIA  
HOUSTON, TEXAS | SEPTEMBER 17-20, 2018  
GEORGE R. BROWN CONVENTION CENTER

# Resolving High Vibration On a Vertical Pump

Baker Hughes, a GE Company

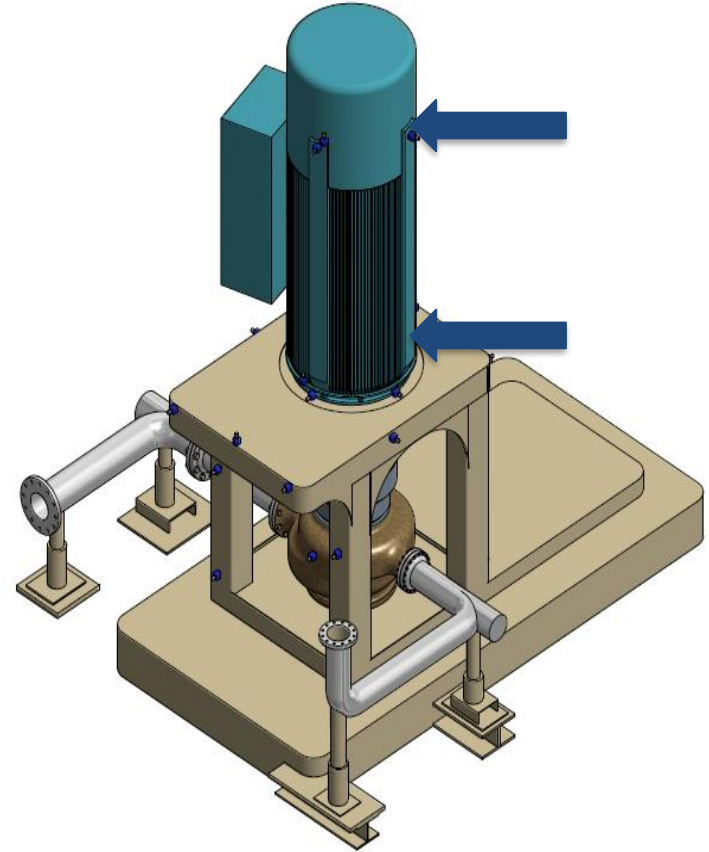
- High vibration at same locations as in coupled run
- **High residual unbalance response on the motor while passing 2<sup>nd</sup> critical frequency**
- **Bode & polar plots confirmed the residual unbalance response**

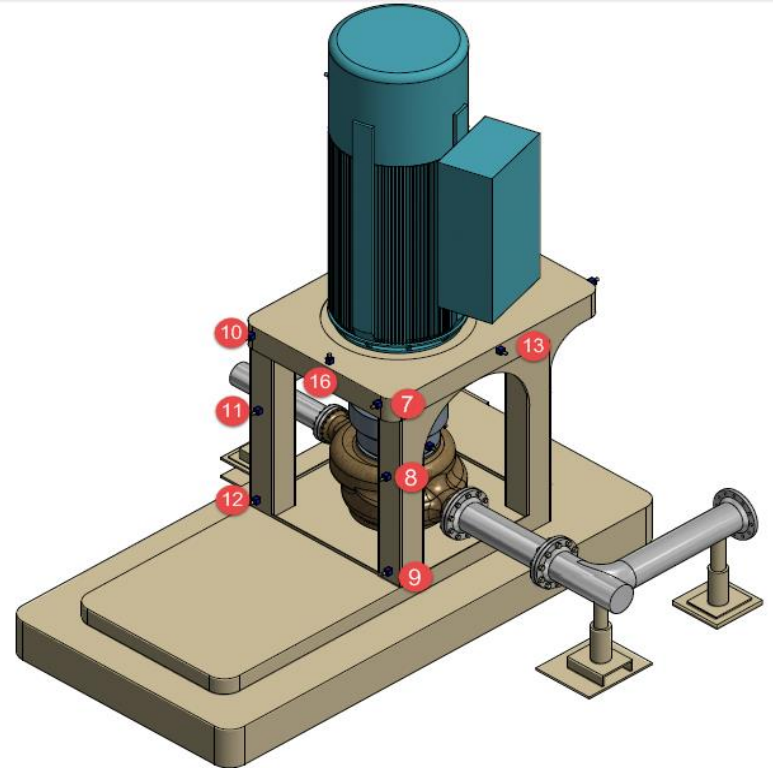
mm/sec Peak	Coupled Run		Solo Run	
	Overall	1X <sub>motor</sub>	Overall	1X <sub>motor</sub>
Str#7	13.7	12.4	12.6	12.4
Str#8	9.8	7.3	7.8	7.3
Str#9	1.4	0.7	1	0.7
Str#10	12.7	11.5	11.9	11.5
Str#11	10.2	6.8	7.3	6.8
Str#12	1.6	0.7	0.9	0.7
Str#13	10.1	10.1	10.4	10.3
Str#16	4.1	0.9	2.4	1.2

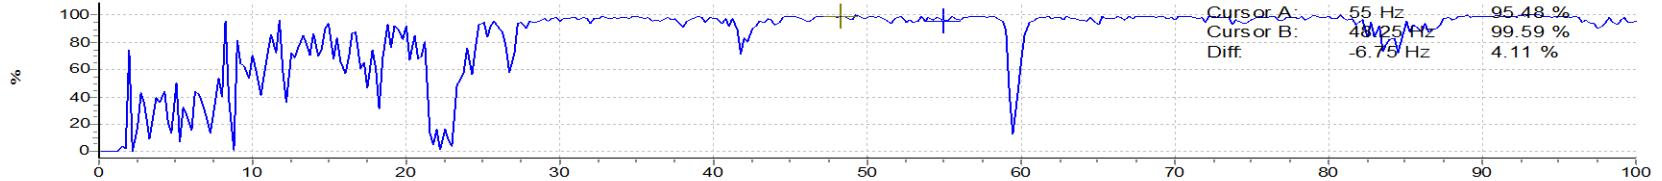
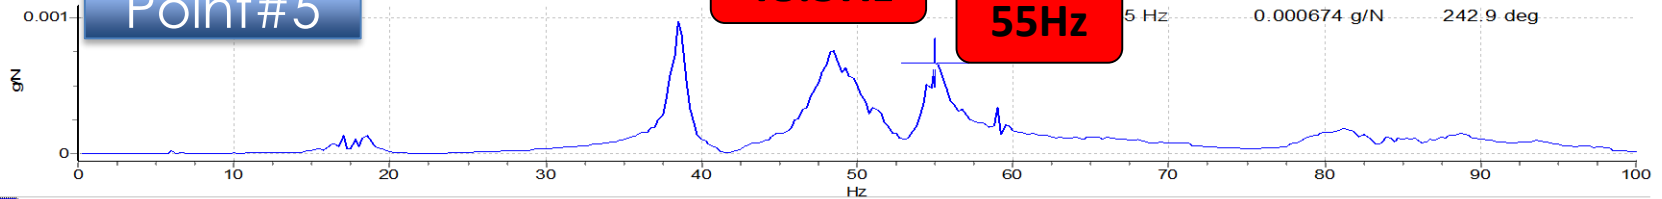
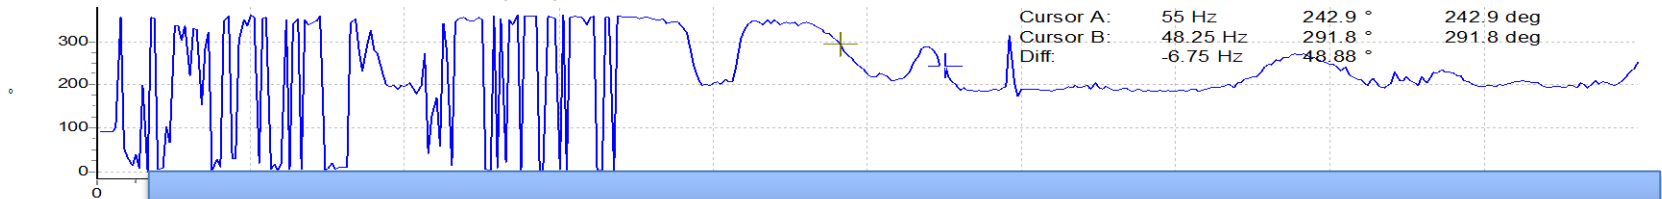
Point#5 Showed Natural Frequency Close to The Running Speed

Other Points Showed Natural Frequency BUT Away from The Forcing Frequencies

- The extremely high vibration levels on the motor, pump and structure -mainly due to motor rotor residual unbalance.
- ODS showed circular motion due to unbalance response.
- In-situ balancing reduced vibration levels to acceptable values.
- After balancing, the twisting motion remained due to the natural frequency of 55 Hz.
- Structure design to be reviewed with the OEM to shift the natural frequency above 20% operating speed.

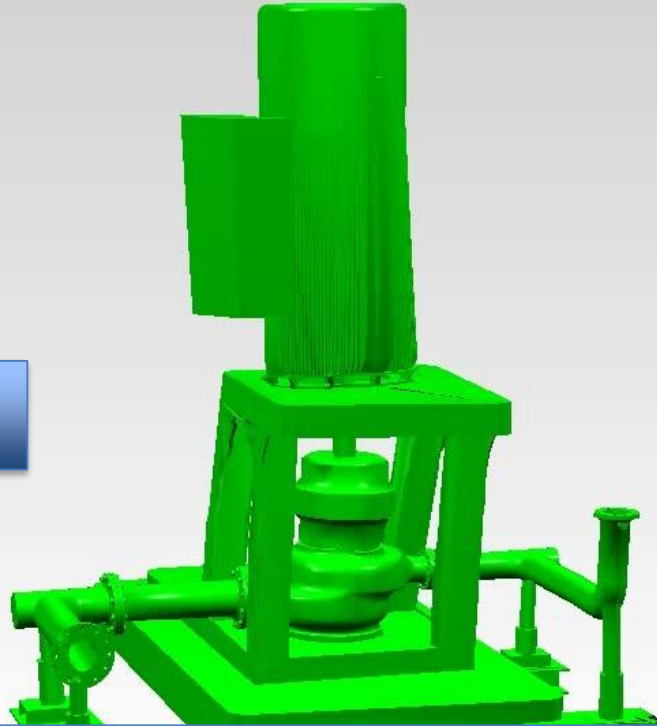
BLK Coupled Run\_Before  
Freq: 59.4 Hz, Damp: 0%  
Complex Shape

Circular Motion

Solo Run also showed the similar circular motion

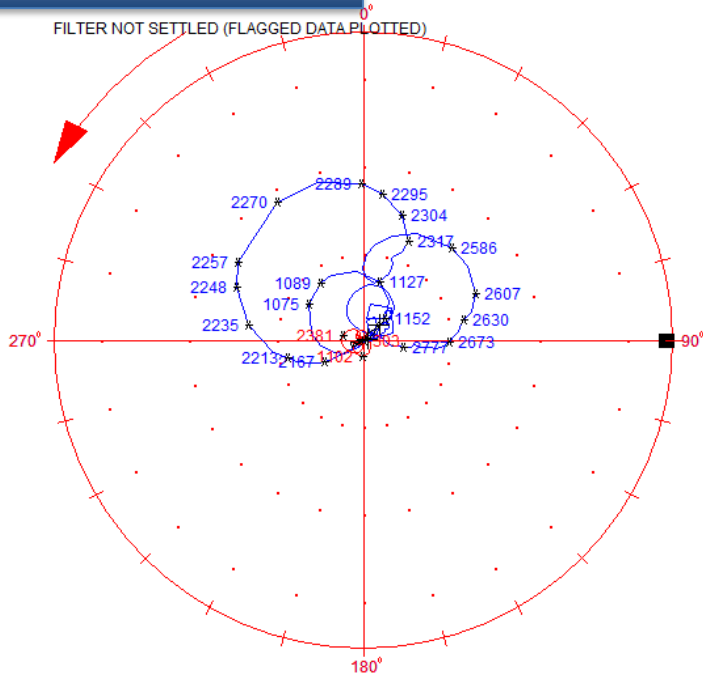
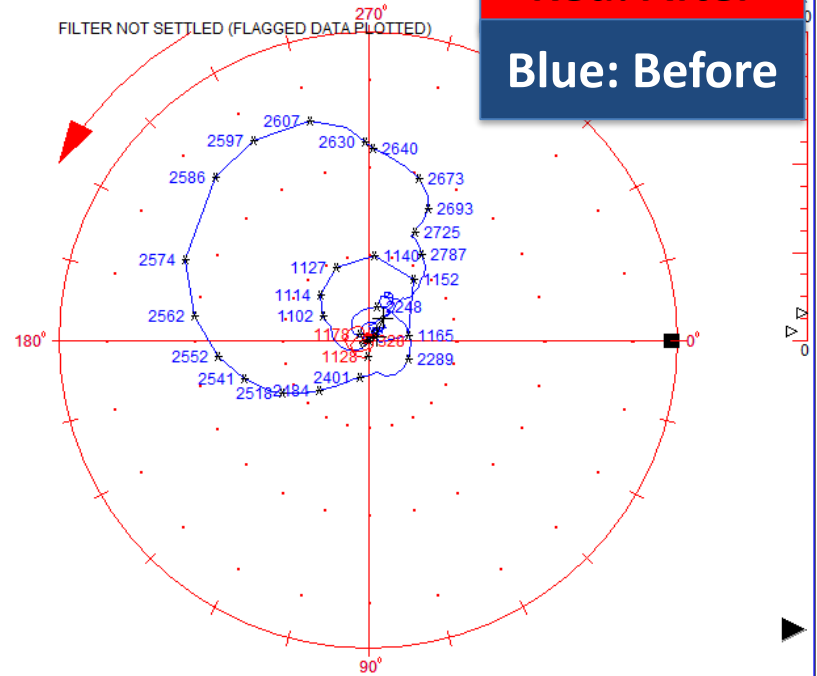
## Coupled Run

MOBV —  $\angle 90^\circ$  Right 6.213 mm/s pk  $\angle 303^\circ$  3582 rpm  
 MOBV —  $\angle 90^\circ$  Right 1.939 mm/s pk  $\angle 335^\circ$  3584 rpm

Red: After

Blue: Before

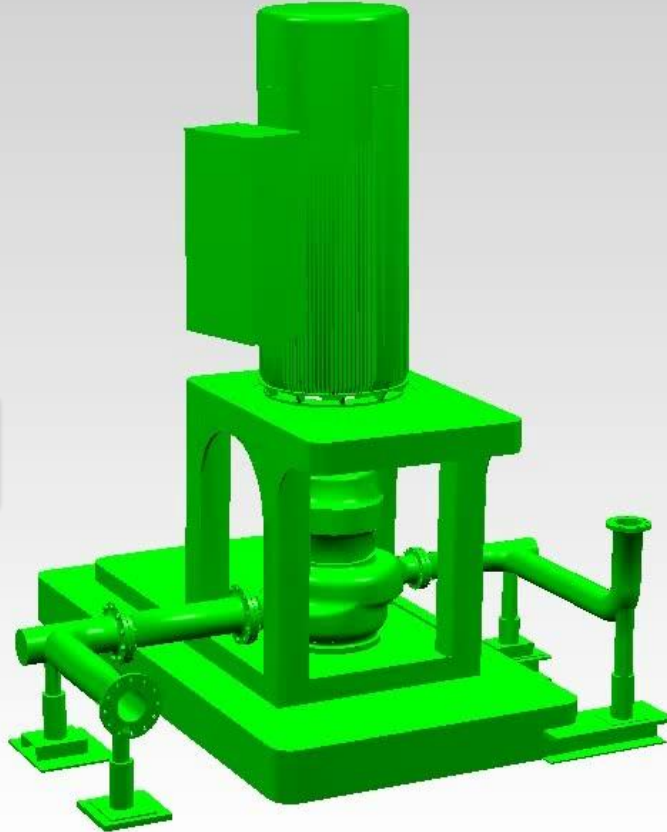
BLK: Coupled\_Run\_After  
Freq: 59.4 Hz, Damp: 0%  
Normal Shape

Twisting Motion
