Chronic high vibration issue of a Condensate Pump

ASIA TURBOMACHINERY & PUMP SYMPOSIUM

**AMM2 - Process Condensate Pump
MP-2508 -POH Pump Outboard Horizontal**

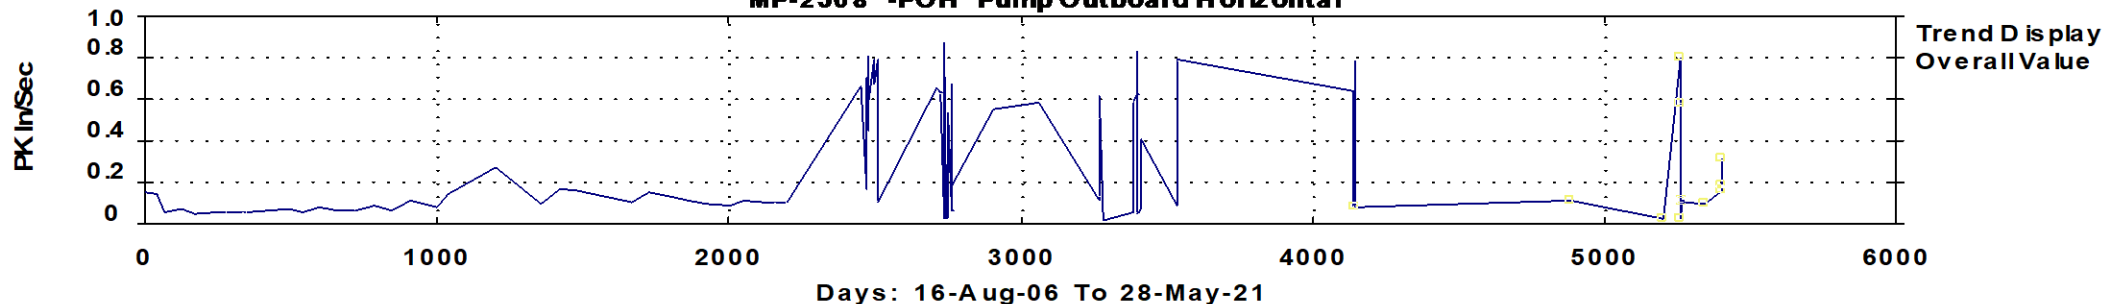
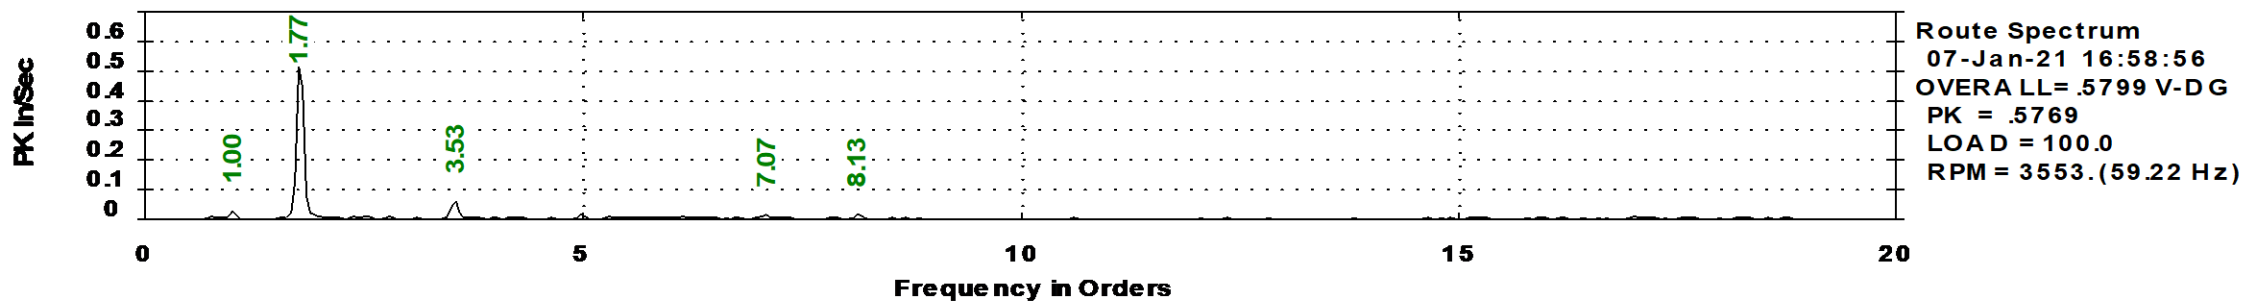
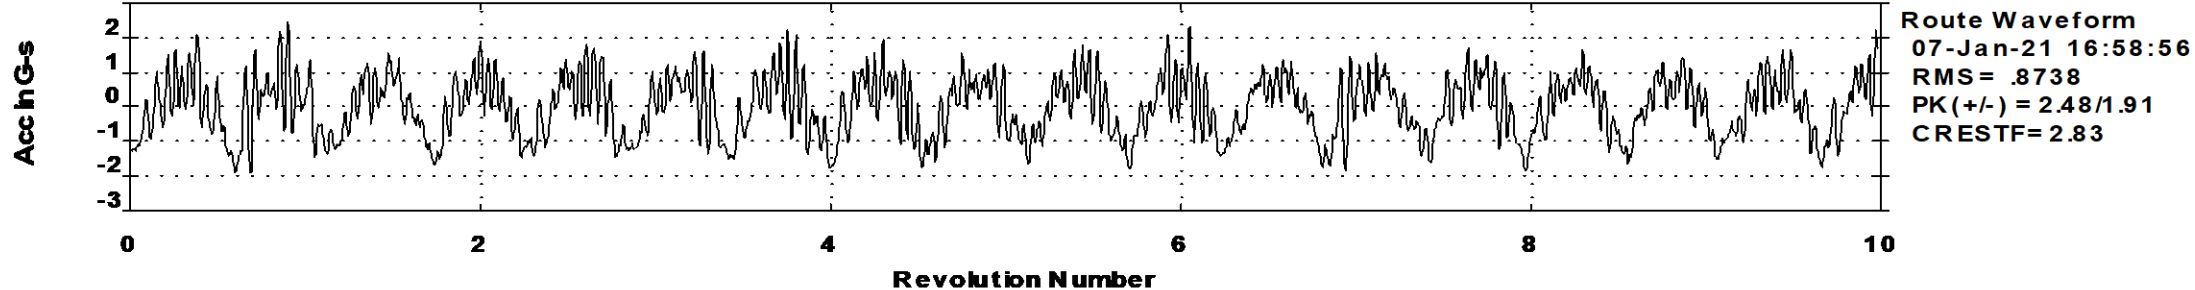
Vibrational analysis of was carried out using Emerson CSI 2140 to identify the root cause of the issue. The Spectrum revealed peak vibrations at 1.7X (Spectrum is appended below). Based on this analysis, the pump was overhauled **03 times in past 10 years** however there were no abnormalities observed and the high vibration issue remained as such. A lot of efforts were put in, like piping supports modifications, installation of stiffeners but the issue persisted.

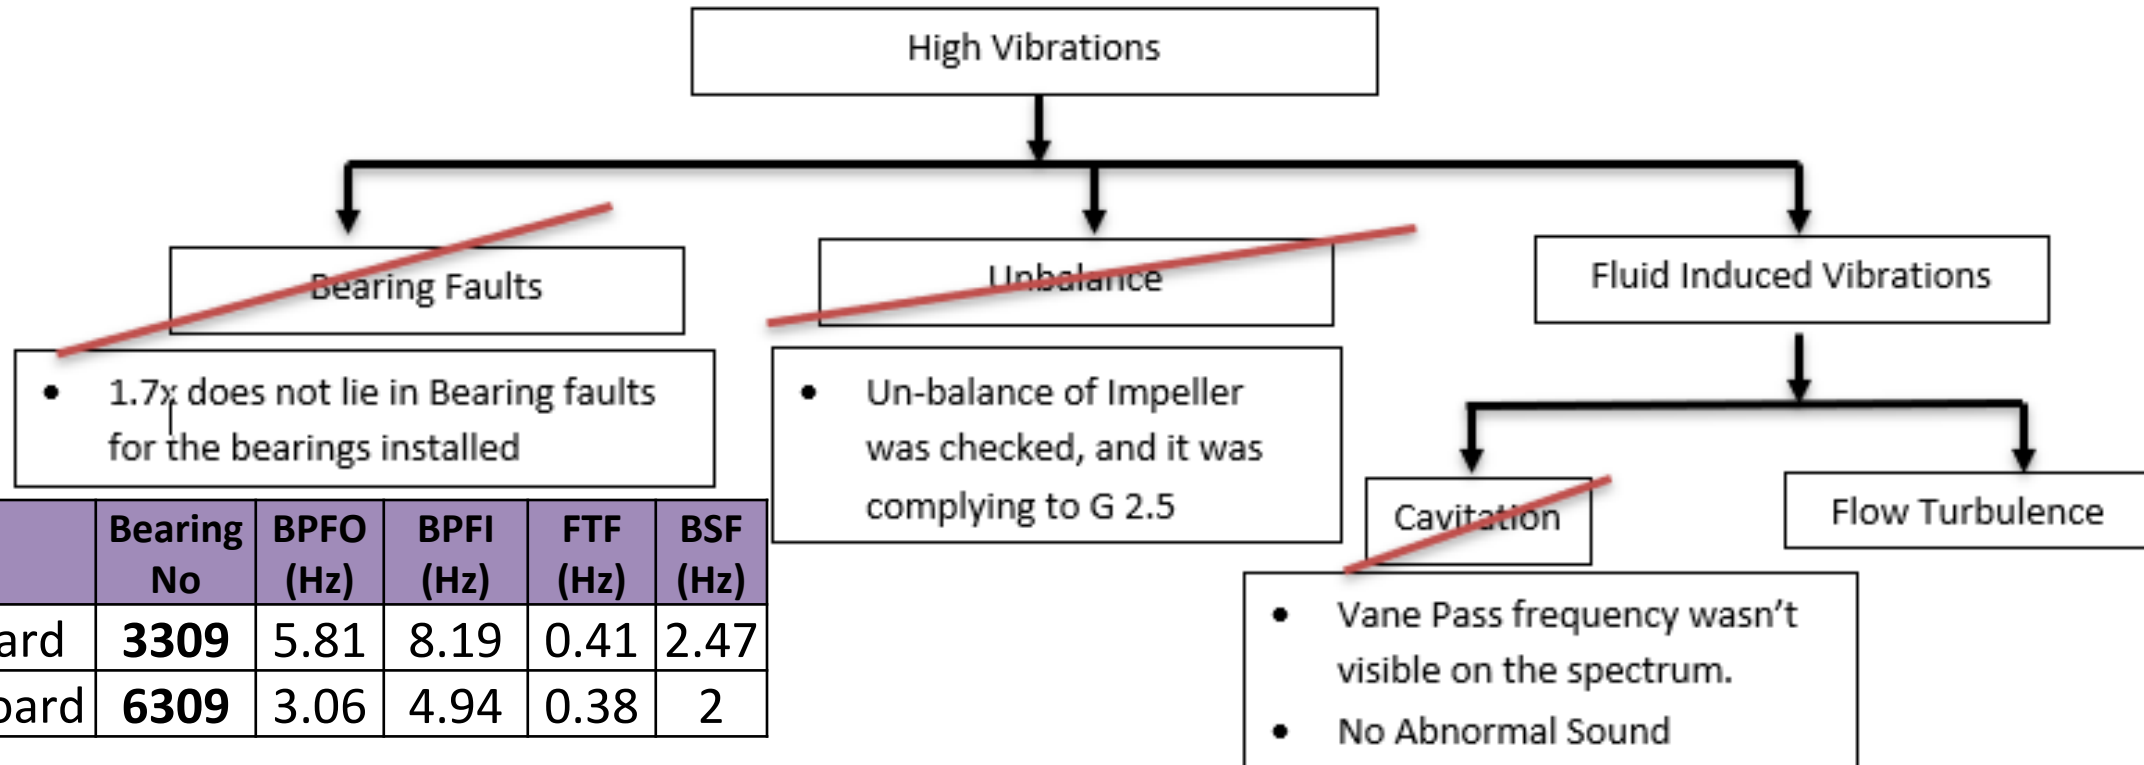
Fault Tree Analysis (FTA):

It was decided to overhaul this pump again to identify and resolve the issue. Based on the vibration data, following course of action was taken to identify the root cause. Once observations were taken, the below Fault Tree Analysis was carried out to narrow down the issue,

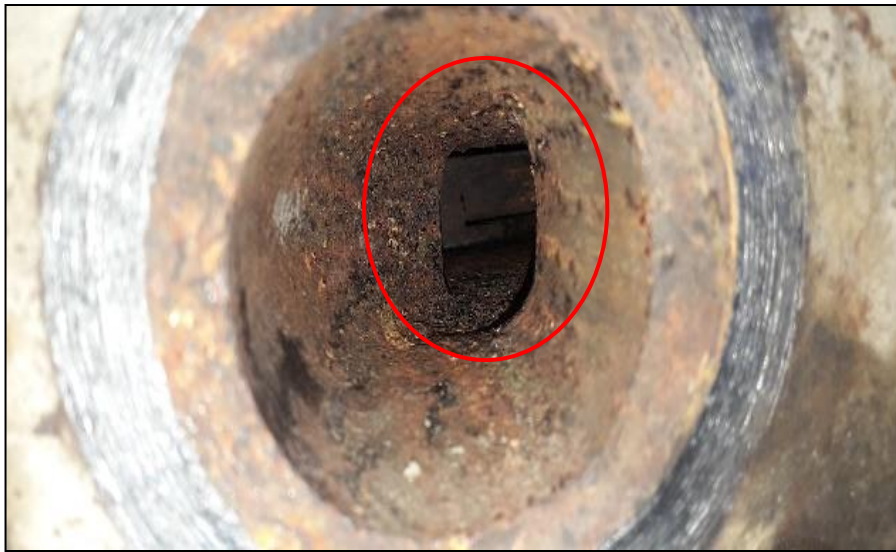
View from Discharge Nozzle: Impeller not centered in the opening

Based on the issues observed in this overhaul, further investigation was done internally, maintenance personals of 2007-2008 timeframe were reached out (since problem was suspected to be initiated at that time). The interviews revealed that, owing to erosion on the casing a new casing was locally cast and machined and replaced in that time frame. This fact positively concluded that the issue was caused due to locally casted & Machined pump casing.

Sr. No	Issue	Rectification
1	The impeller was not aligned with the discharge nozzle which could have caused hydraulic imbalance .	The impeller eye was aligned with the outlet nozzle by machining the face of gasket seating area of the adaptor
2	The suction eye of impeller & casing inlet was not concentric; a portion of the impeller was facing the casing wall causing flow restriction .	Casing was fixed on 4 jaw chuck lathe machine and casing was centered w.r.t to adaptor guide collar. Machining of inlet nozzle bore was carried out so that the impeller eye is not blocked by the portion of the casing.

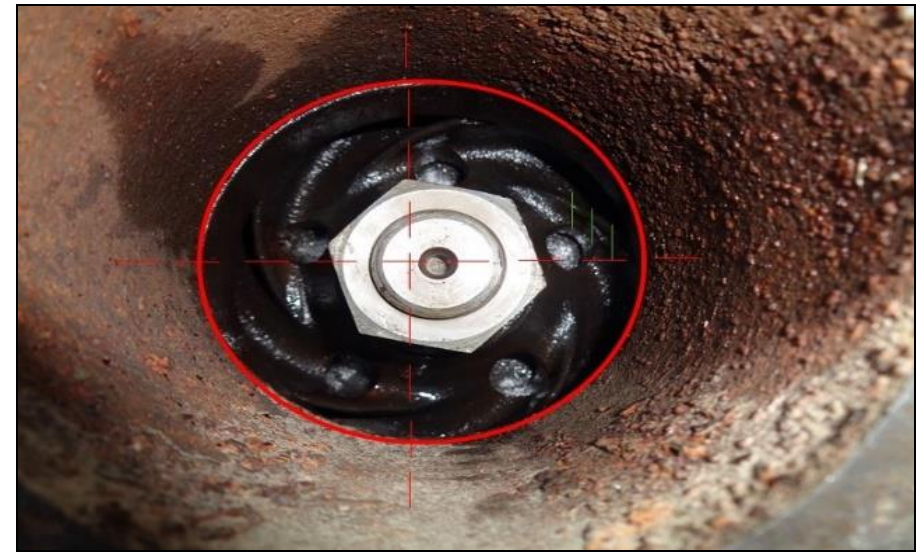
View from Inlet of the Pump: Impeller eye and Nozzle are not concentric

Upon deeper investigation of all assembly based on general installation guidelines of pump we found that pump impeller non- concentricity with casing center resulted in flow induced vibration

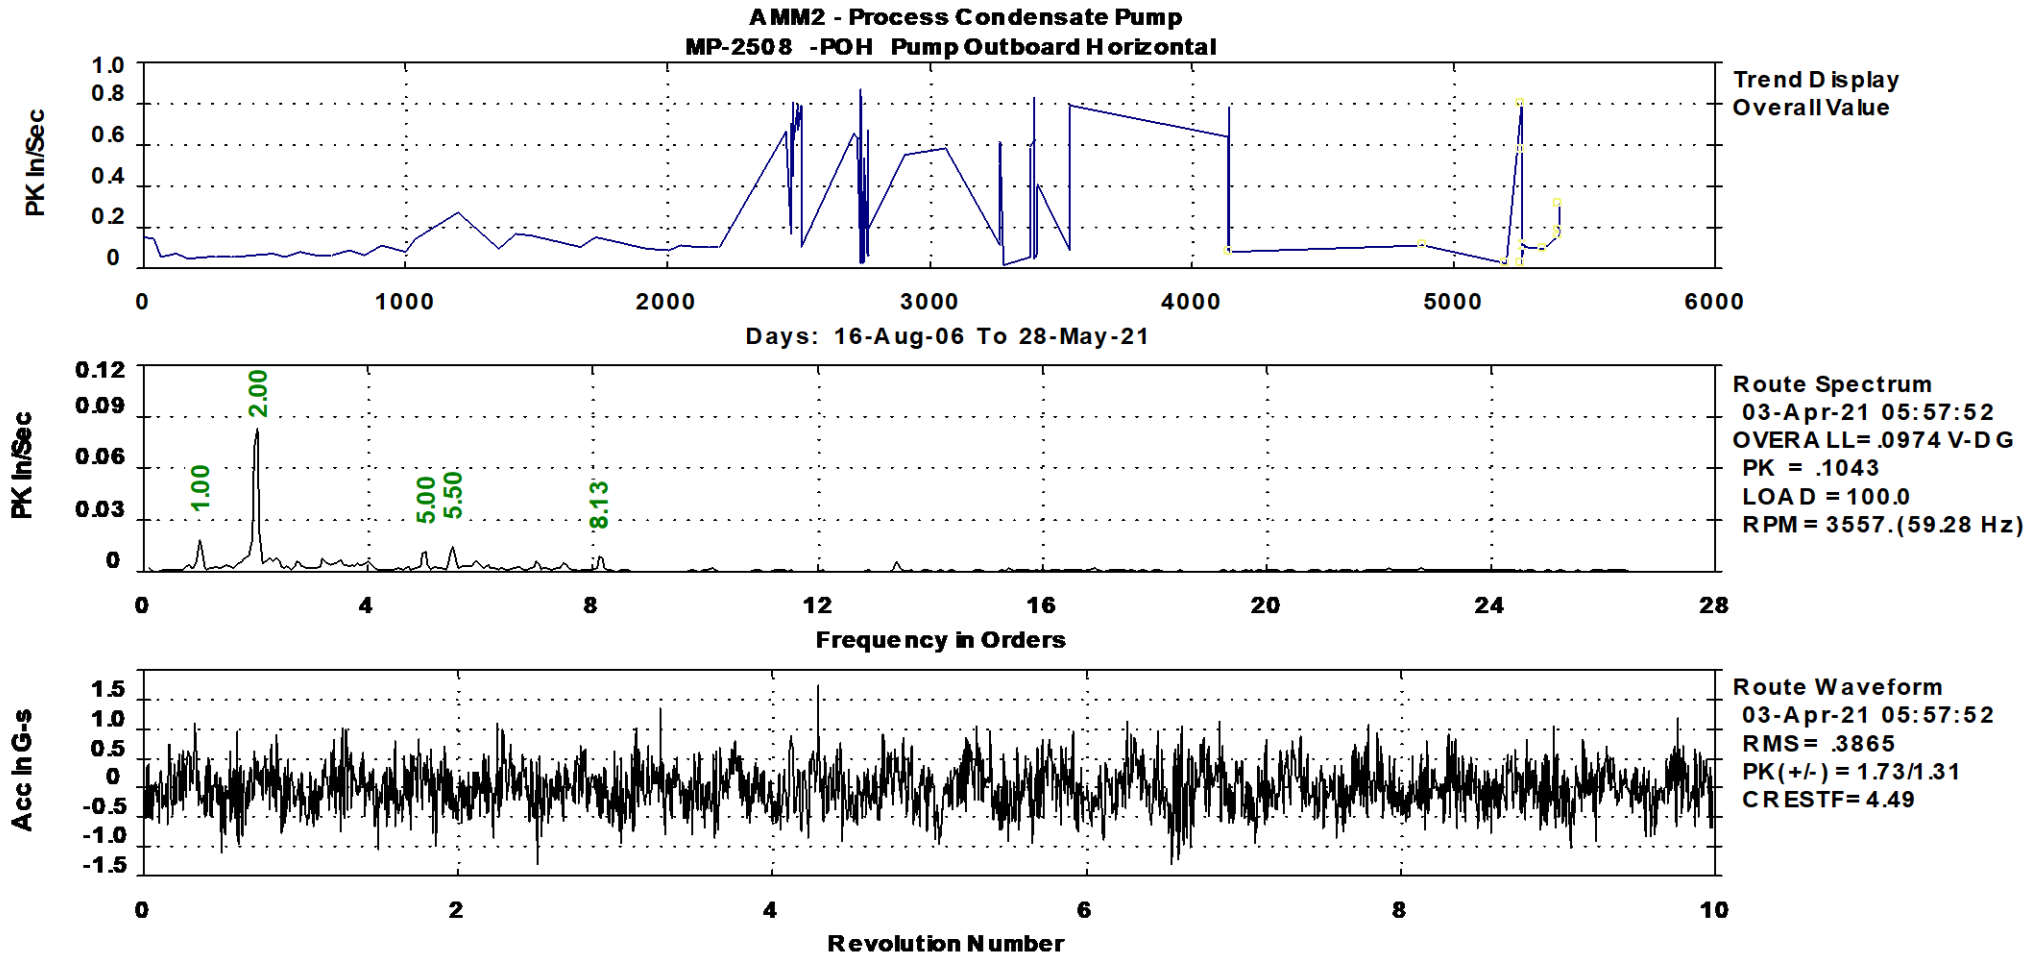
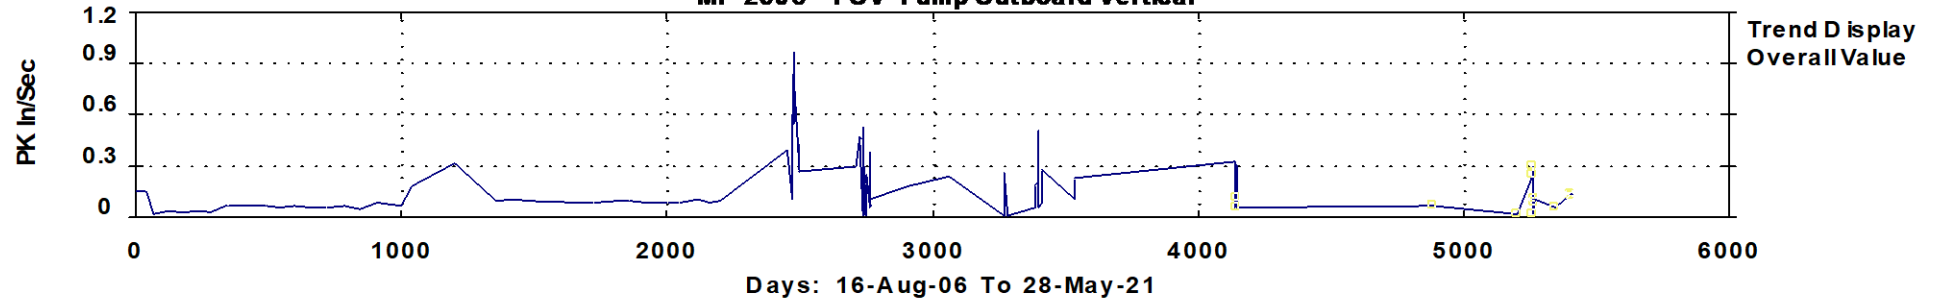
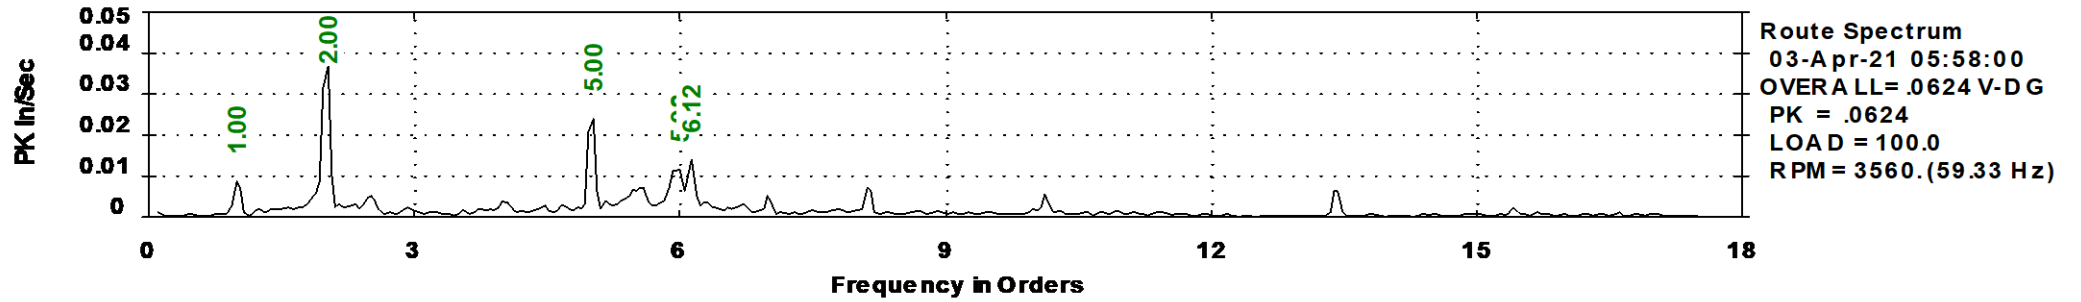
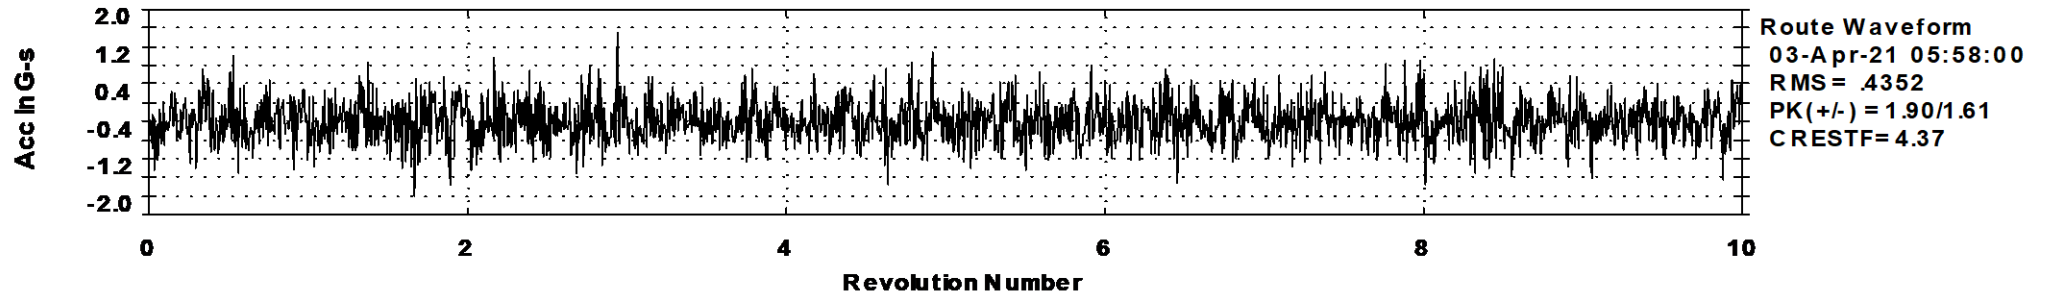
**AMM2 - Process Condensate Pump
MP-2508 -POV Pump Outboard Vertical**

The pump was started post the overhaul and the earlier mentioned rectifications. The high vibration issue was resolved and the 1.7x component of the spectrum was also not there anymore.
