SHELBURNE SHIPYARD STEAMBOAT GRAVEYARD: ARCHAEOLOGICAL  
INVESTIGATION OF FOUR STEAMBOAT WRECKS

A Thesis

August 2015

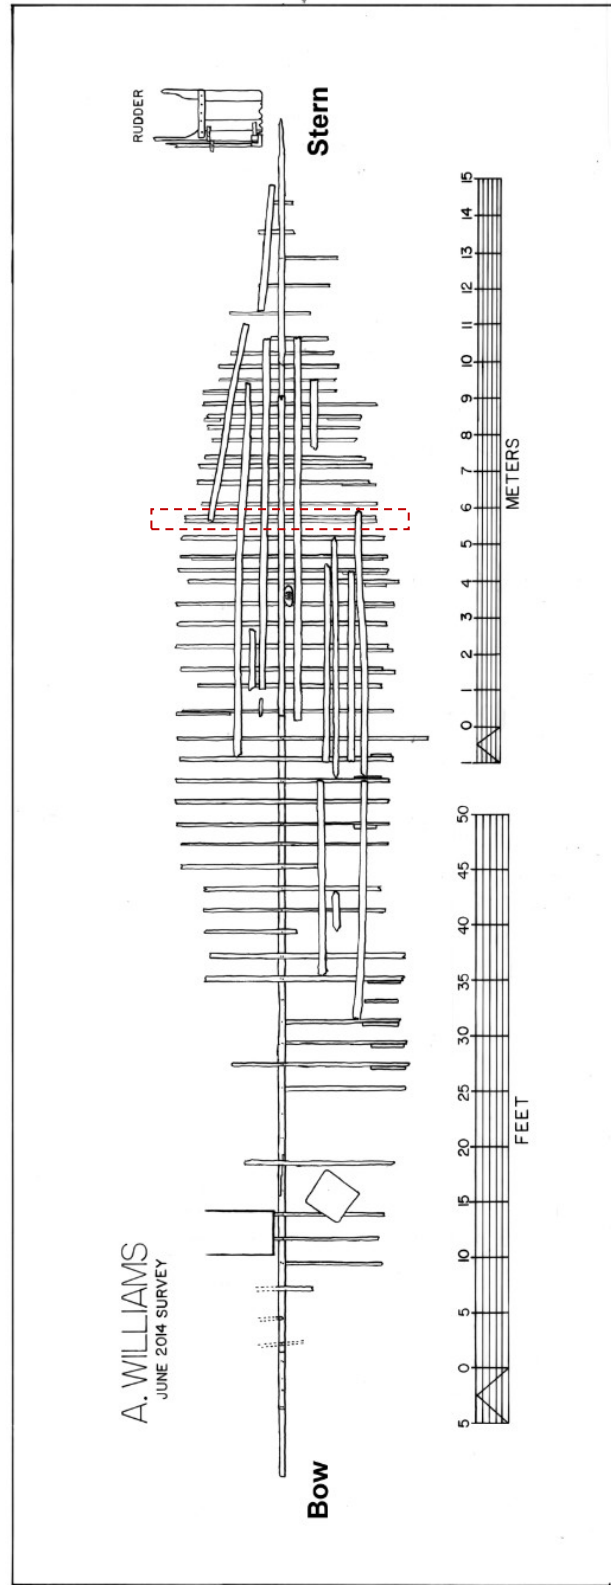
The hull remains were a total of 123 ft. 2 in. (37.5 m) long from stem to stern. The wreck was fairly complete, and even its rudder lay nearby, still attached to the sternpost that had broken off from the keel. The biggest challenge with recording Wreck 1 was due to its proximity to shore and location below the overhanging branches of several large oak trees. A thick layer of leaves from the oak trees had covered portions of the hull and therefore much time was spent clearing the debris. Wreck 1 had a large concrete mooring block on its frames 22 ft. 10 in. (7 m) abaft the stem. The dock adjacent to the wreck served as our dive entry and exit point. This meant that some care was required to avoid stirring up the silt and blinding the dive team studying Wreck 1. Also because of its very shallow location, Wreck 1 was heavily eroded and broken up.

Figure 16. Preliminary site plan of Wreck 1. Frame 42 is a double-floored frame and is outlined in red. (Drawn by Stephanie Koenig, Varvara Marmarinou and Christopher Sabick; inked by Nathan Gallagher.)

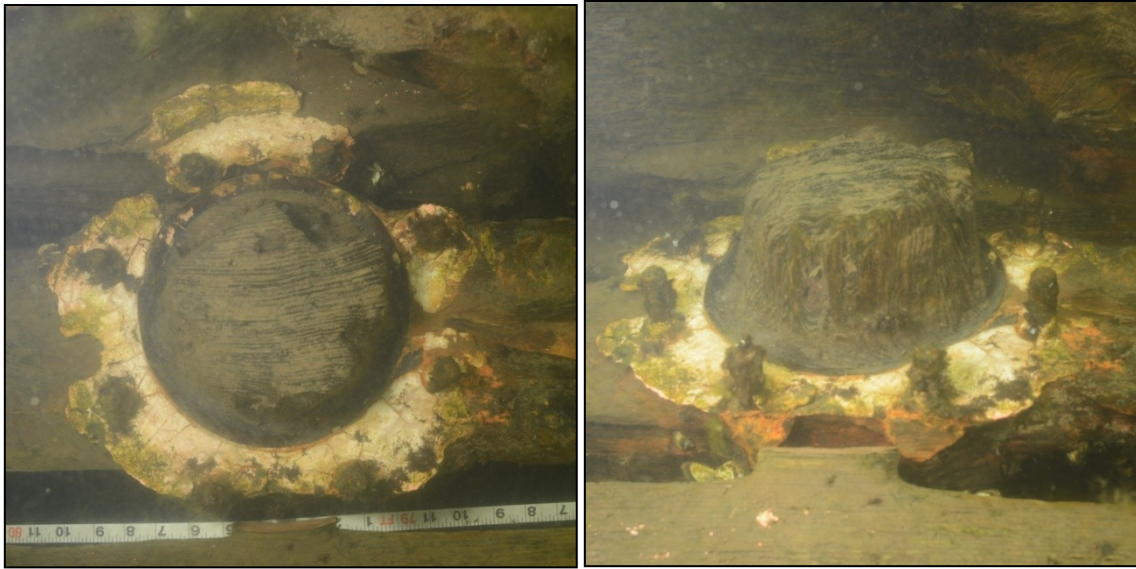
Another feature that divers noted and recorded was a lead collar found at 78 ft. 7 in. to 80 ft. 6 in. (24 m to 24.5 m) along the main baseline (MBL), in between the keelson and first port bed timber. The lead was identifiable due to its white corrosion product and pliability (Figure 17). This collar likely represented either a seal placed between iron water-intake pipes for the boiler, or one for an overflow drain from the engine's condenser. The opening in the hull planking for the collar was plugged with a large wooden stopper.

Figure 17. Lead collar found on Wreck 1. Top view (left) shows location along the center baseline and perspective view (right) shows wooden stopper. (Photographs by Stephanie Koenig.)

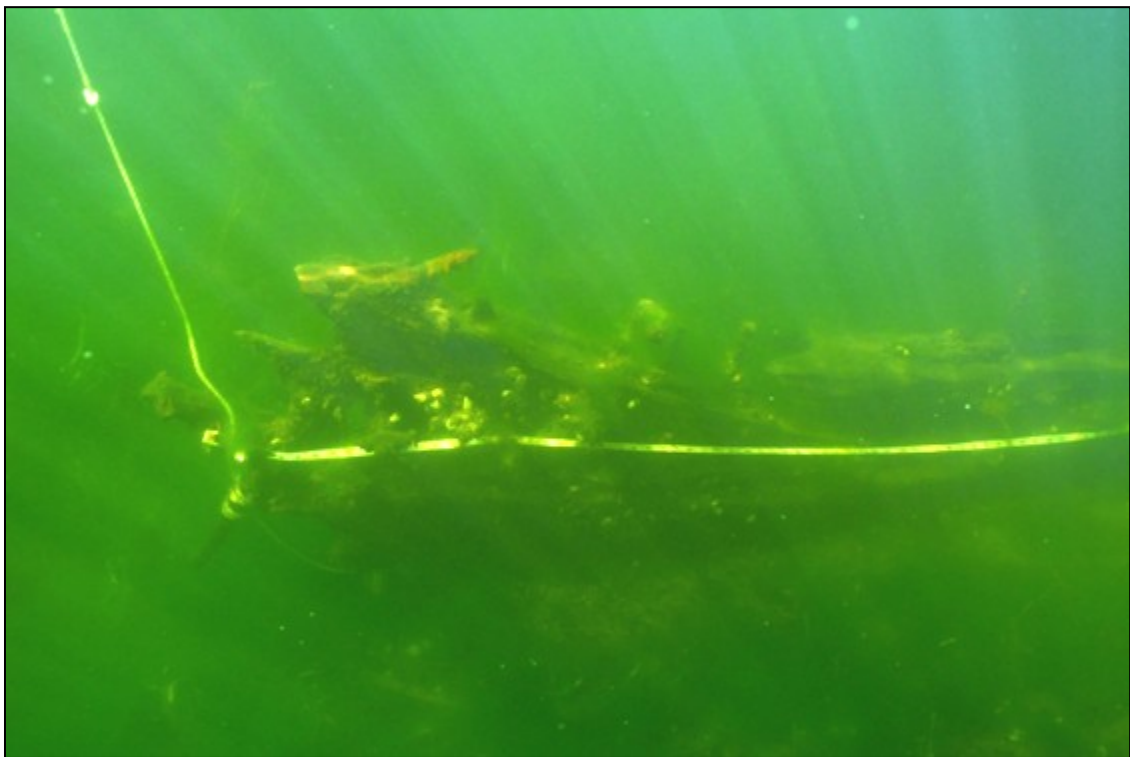
Wreck 1's lower stem assembly was partially preserved, and its after end overlapped the keel by 4 in. (10.2 cm). The keel appeared to be broken off at its forward end. A bolt extending down from the stem 7 in. (17.8 cm) forward of the end of the keel confirmed this theory, as it had nowhere to go except into the keel. This bolt likely marked the original forward end of the keel. The bolt head was located at the level of the keel's underside, and the bolt itself extended up and aft approximately sixty degrees from horizontal (the angle was measured from digital camera images), through the widest remaining part of the inner stem, and the tip was bent aft (Figure 18).

Figure 18. Photograph of bow assembly on Wreck 1. A buoy is tied to the forward end. Note the bolt that exits the topmost timber and angles aft. (Photo by Paul Gates.)

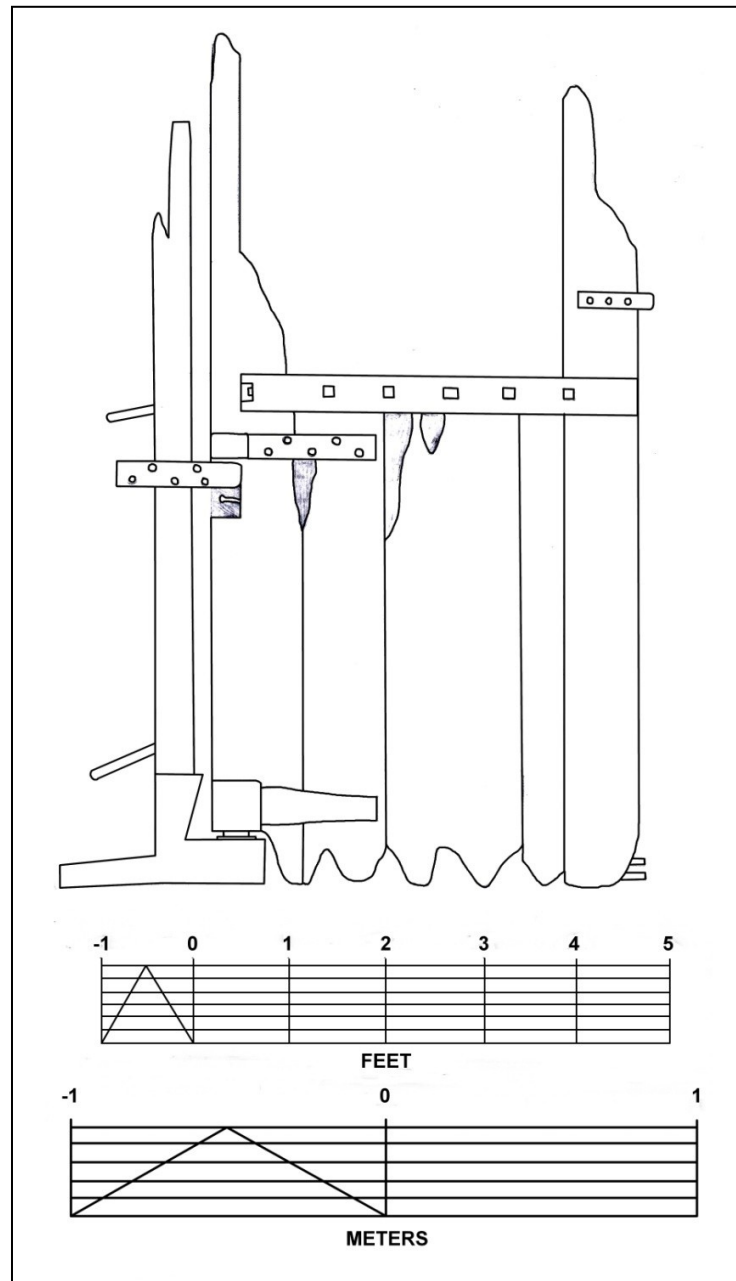
The rudder was a typical steamboat "barn-door-style rudder," measuring 5 ft. 4 in. (1.63 m) fore-and-aft, 5 ft. 10 in. (1.78 m) tall, and 6 in. (15.2 cm) thick (Figure 19). It was made up of five vertical timbers with a range of widths. The first vertical timber was the rudder post to which were attached two pintles. The rudder post was taller than the succeeding timbers, with a height of 7 ft. 2.5 in. (2.20 m); it was clearly broken at the top. The adjacent three timbers measured 1 ft., 1 ft. 9.5 in. and 6 in. (30.5 cm, 54.6 cm and 15.2 cm) in width. The fifth and furthest-aft timber measured 1 ft. (30.5 cm) fore-

Figure 19. Rudder from Wreck 1 drawn to scale. (Drawing by Stephanie Koenig and Varvara Marmarinou.)

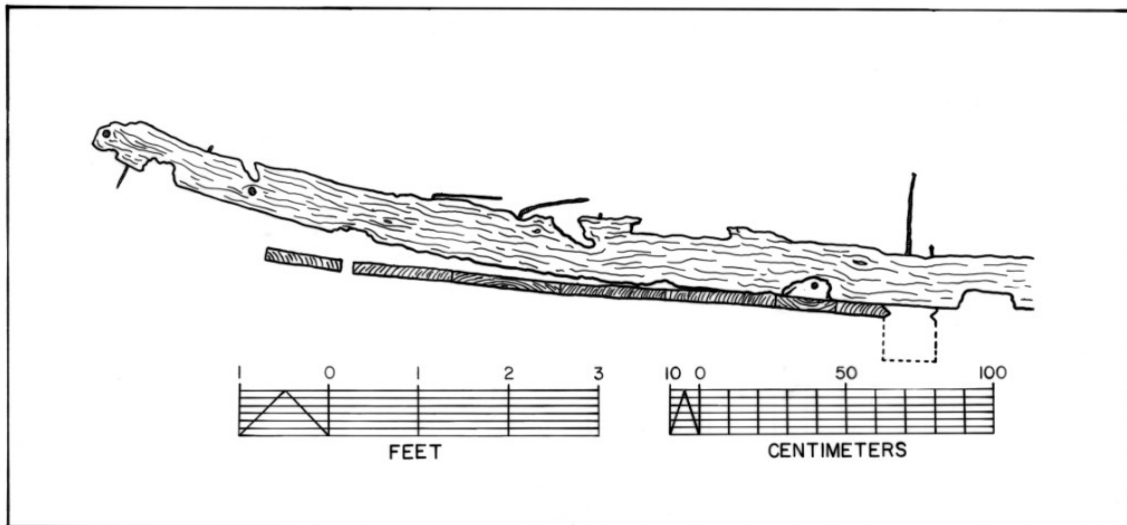
Figure 21. Cross section of starboard side frame 29 facing aft on Wreck 1. (Drawing by Chris Sabick; inked by Nathan Gallagher.)

Considering the level of erosion present, an average of 9 in. (22.9 cm) molded was likely the original size. These measurements represent deep but narrow frames. Similar frames were found on Wrecks 3 and 4 as well. One hypothesis is that this shape was employed in order to reduce the weight of the hull, while not sacrificing any of the structural stability of larger frames. Long, narrow steamboats with heavy square frames would have had problems with hogging or sagging. Employing narrower frames reduced the total weight, while keeping them deep retained their strength. Even though *A. Williams* was a relatively short boat, at 132 ft. (40.2 m), this method was likely standard for all steamboats by the time it was built in 1870. For example, *Champlain II* (1868) exhibited similarly rectangular sections in its frames, with average sided dimensions of 4 in. (10.16 cm) and molded dimensions of 16 in. (40.64 cm). The much larger steamer (original length of 244 ft. [74.4 m]) would have benefited from the reduced weight this style of frame allowed for, much more even than *A. Williams*.<sup>55</sup>

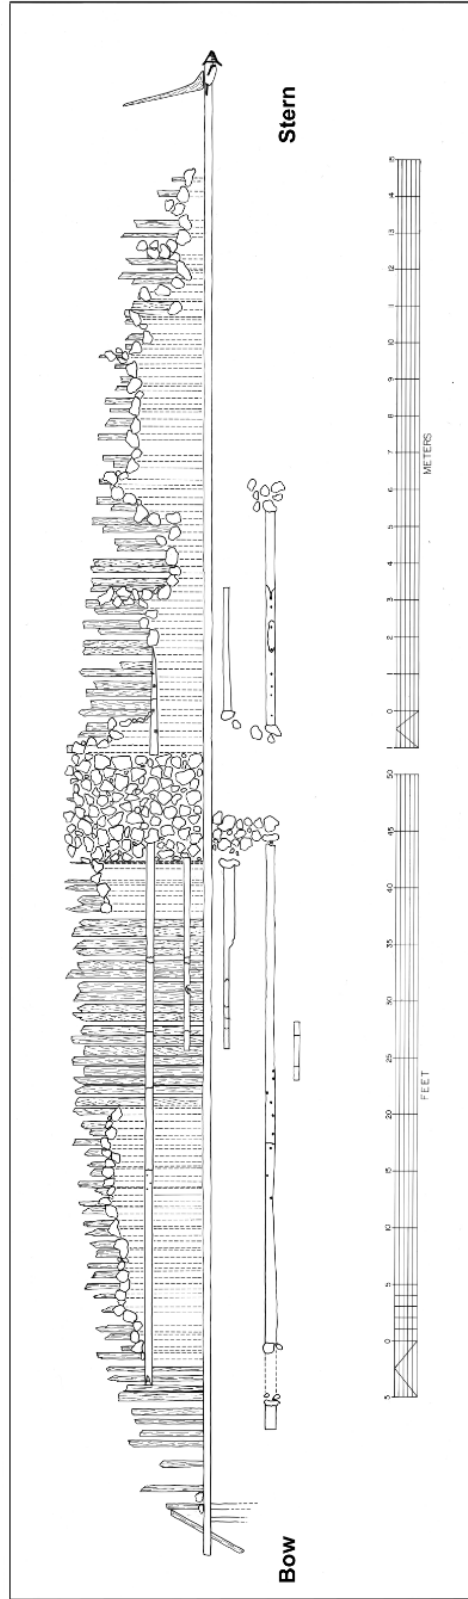
Figure 22. Preliminary site plan of Wreck 2. Where the frame timbers were covered by rocks is represented by dashed lines. The outline of the rock pile is drawn in. (Drawing by Carolyn Kennedy; inked by Nathan Gallagher.)

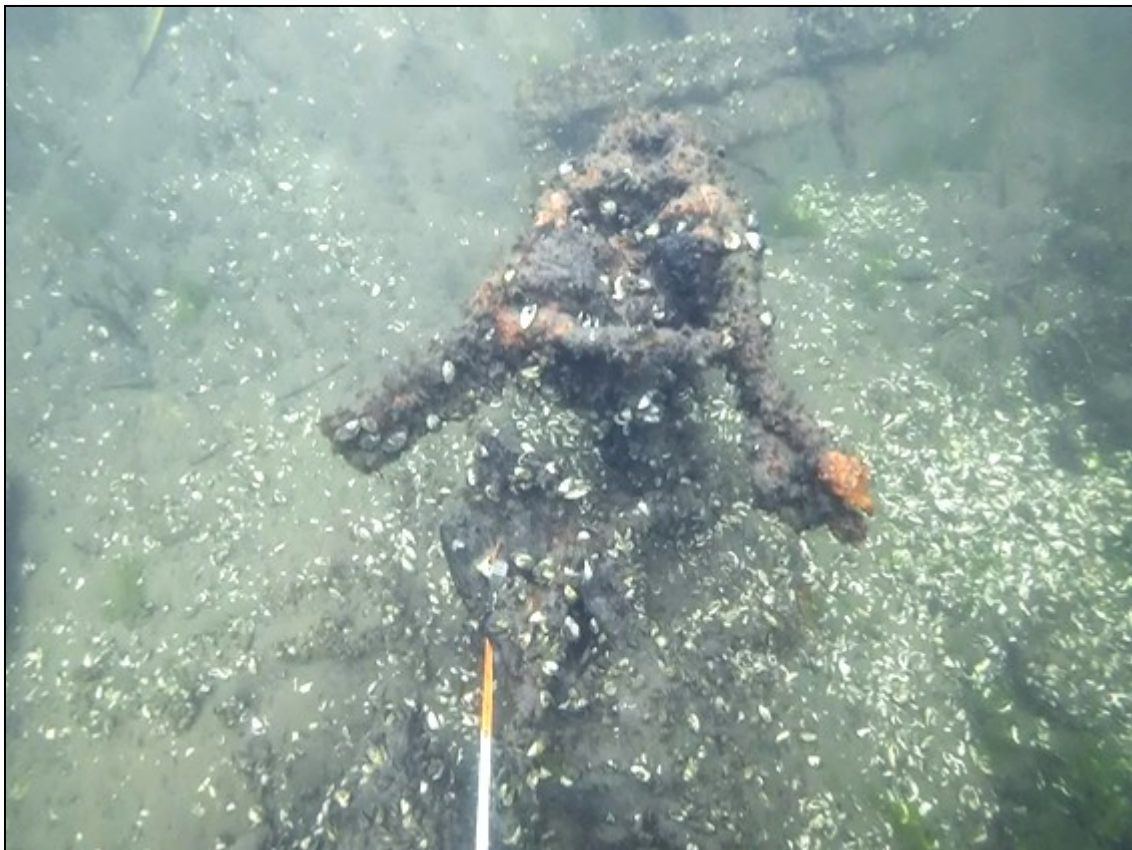
stern shape (Figure 25). Each strap measured 18 in. (45.7 cm) in length, and 3 in. (7.6 cm) in height. The distance between the forward ends of the straps was 18 in. (45.7 cm). The pintle hole in the gudgeon was 2 in. (5.1 cm) in diameter. There is likely another gudgeon attached to the sternpost beneath the exposed example.

Figure 25. Iron gudgeon attached to Wreck 2's sternpost. The basic shape is triangular, but the forward ends flare out to accommodate the shape of the missing stern. The rudder is visible in the background. (Photo by Carolyn Kennedy.)

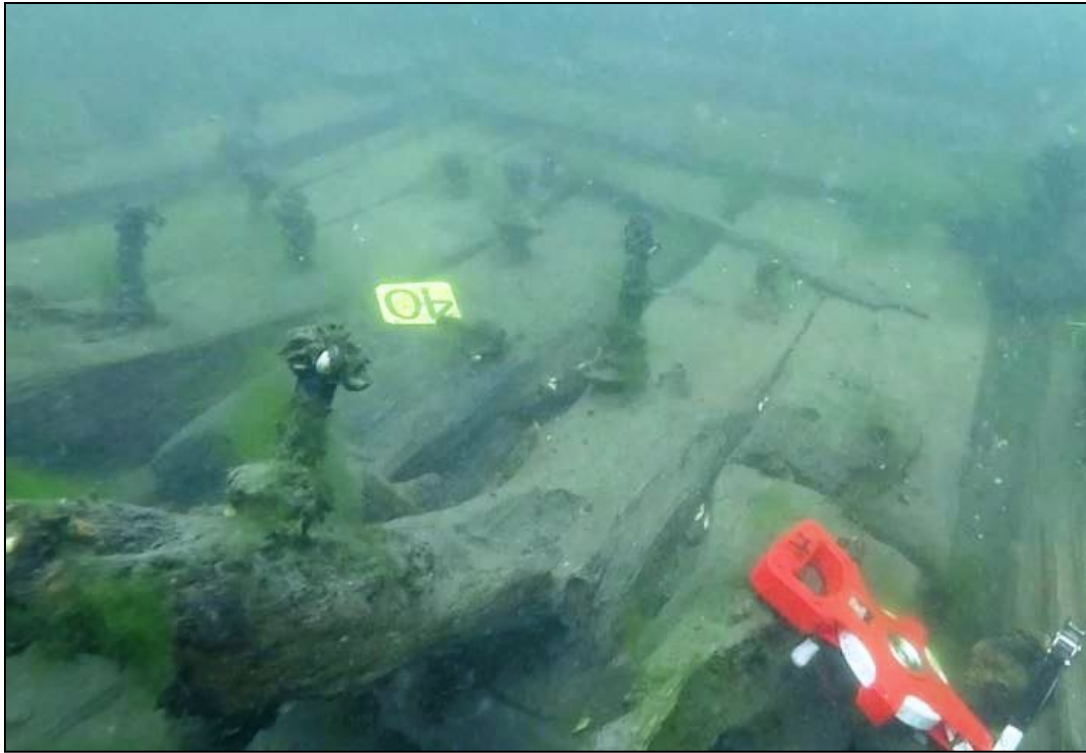
Figure 26. Wreck 2 midship timber (tagged frame 40) is darker and larger than the adjacent frames. Also note the compass timber on frame 39. (Photo by Carolyn Kennedy.)

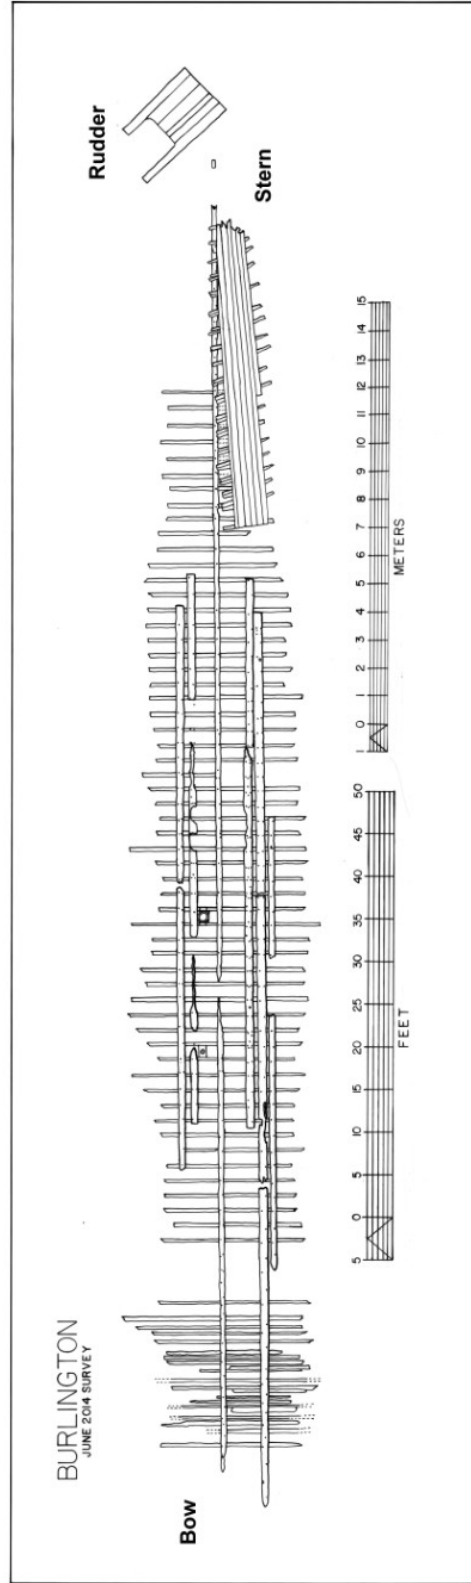
Wreck 3 was the second longest of the four wrecks examined in 2014, with an overall length of 158 ft. 1 in. (48.2 m). According to contemporary accounts *Burlington* was originally 185 ft. (56.4 m) in length, indicating that about 27 ft. (8.22 m) of the hull's forward end is gone. During the 2014 survey the zero point on the main base line (MBL) was fixed at the forward end of the broken-off keelson (the tip of the keel extended 20 in. [50.8 cm] forward of the MBL's zero point, and the second port-side engine bed timber [P2] extended 5 ft. 6 in. [1.7 m] forward of the MBL). The overall length of the MBL, from the forward end of the existing keelson to the after end of the sternpost, was 152 ft. 7 in. (46.5 m) (Figure 27).

Figure 27. Preliminary site plan of Wreck 3. (Drawing by Rebecca Ingram and Dan Bishop; inked by Nathan Gallagher.)

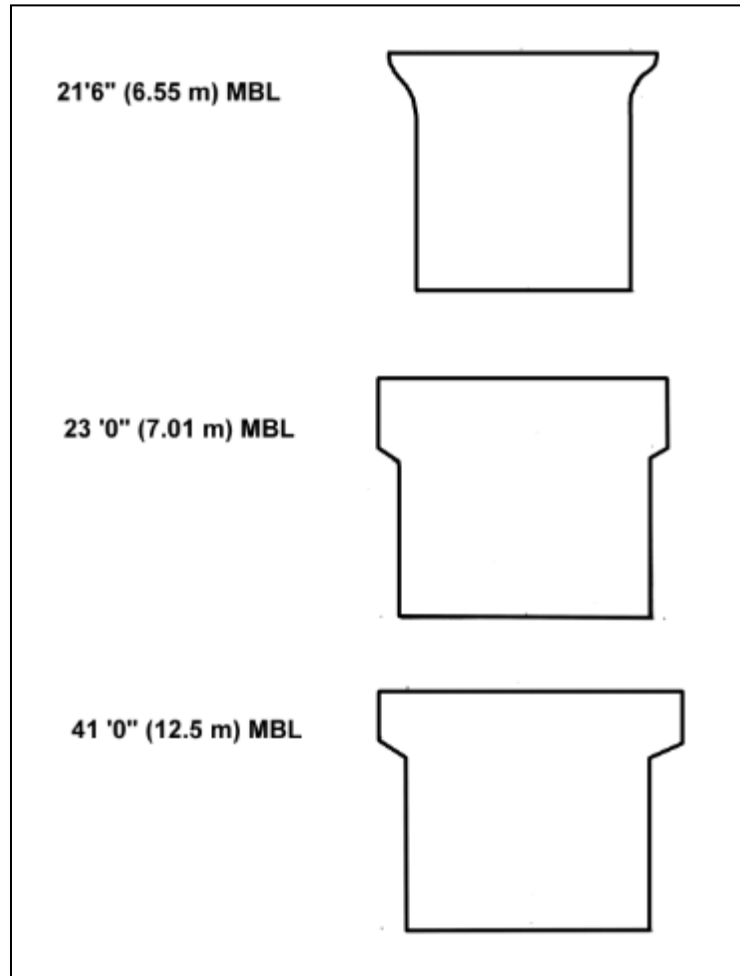
the hull planking would have met the keel below the arms. The arms were on average 1 ½ in. (3.8 cm) molded and ½ in. (1.3 cm) sided on both sides, making the lower part of the keel on average 7 ¾ in. (19.7 cm) sided (Figure 28).

Figure 28. T-Shaped section of Wreck 3 keel. Most likely the first section view is eroded. (Drawing by Dan Bishop and Rebecca Ingram.)

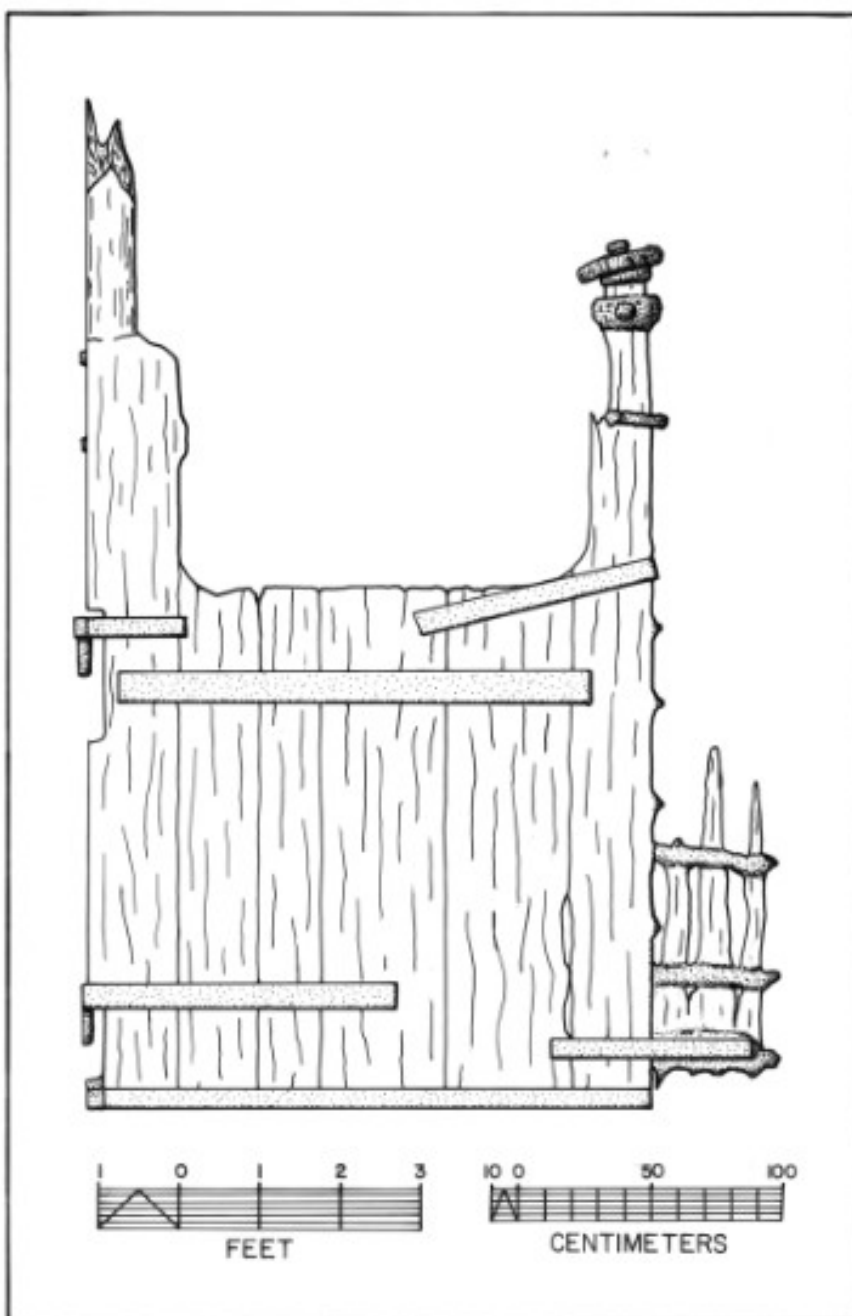
The upward projection of the aftermost rudder timber included metal hardware fitted to the top 12 in. (30.5 cm) of the piece. The fittings included two metal rings encircling the wooden post, and a topmost ring that had fore-and-aft projections of approximately 3 in. (7.6 cm) each. The purpose of all of these pieces is unknown, and was not found on any of the other rudders. The most likely explanation for their presence is for control over the rudder, as steamboat rudders were often controlled by a block-and-tackle system attached to this after extremity. These may have acted as fastening points for the block and tackle. Two feet three inches (68.6 cm) below the top of the upward projection was a D-shaped metal ring, whose flat side connected through the wooden timber. This piece was 9 in. (22.3 cm) in thickness, and was about halfway between the base and the top of the upward projection. It is possible this piece also allowed for further control of the rudder (Figure 29).

Figure 29. Rudder from Wreck 3. Note the extension on the right-hand side (aft). (Drawing by Dan Bishop; inked by Nathan Gallagher.)

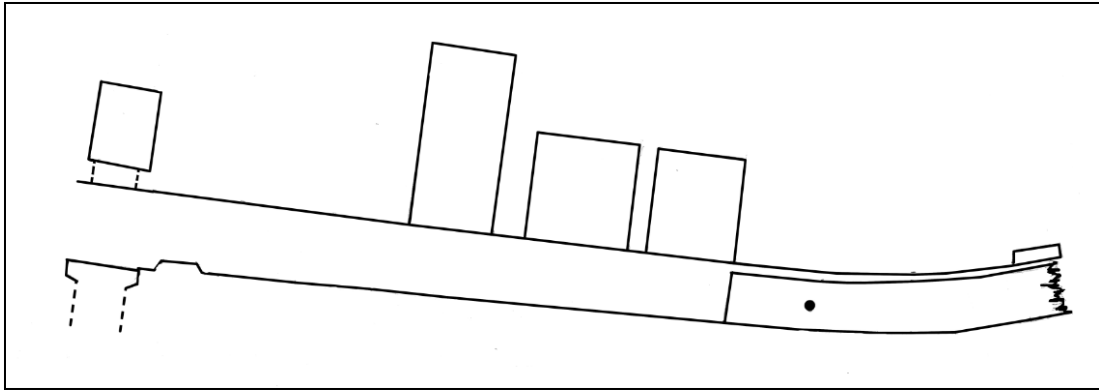
Figure 31. Cross section of frame 45 looking aft. Note limber hole adjacent to T-shaped keel. (Drawing by Carrie Sowden.)

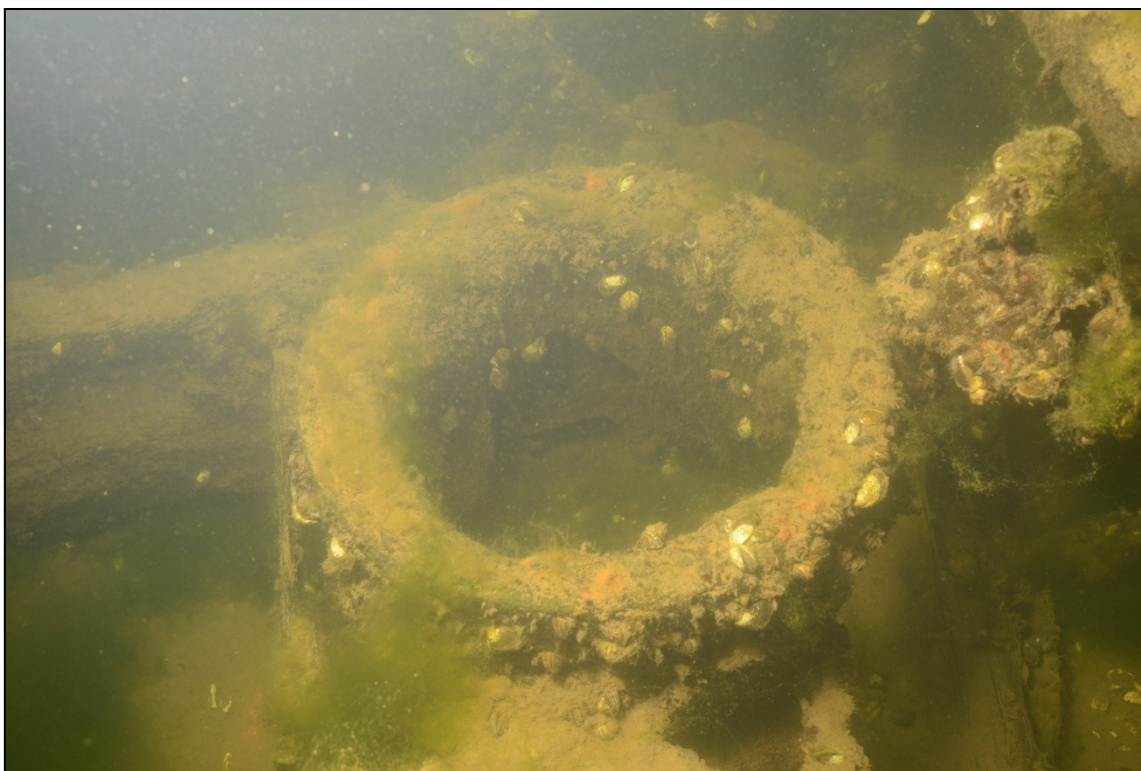
Figure 33. Metal cylinder or pipe found on Wreck 3. (Photo by Paul Gates.)

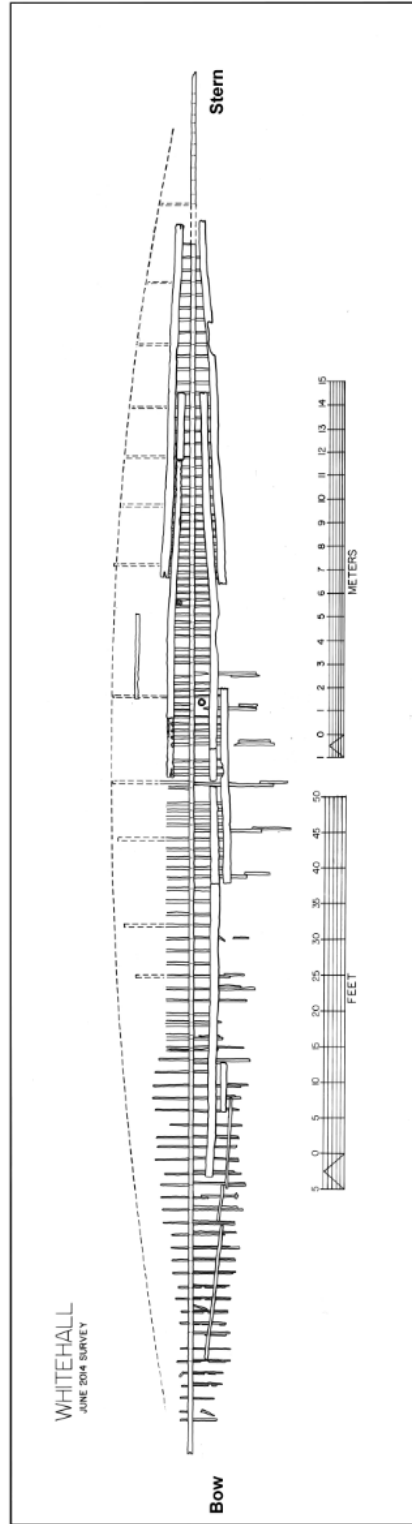
Figure 34. Preliminary site plan of Wreck 4. (Drawing by Nathan Gallagher, Kevin Crisman and Grace Tsai.)

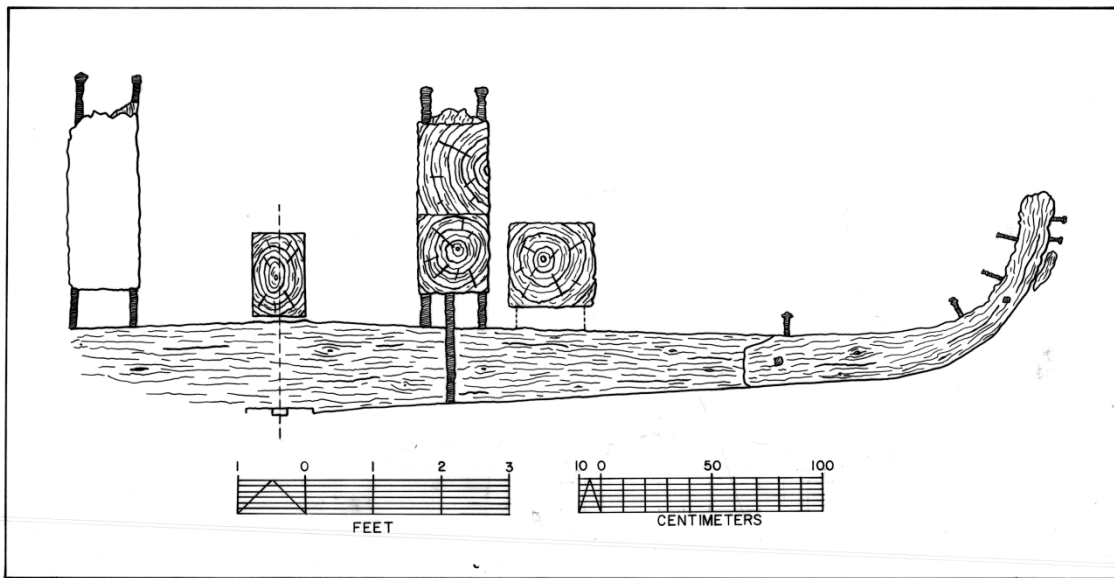
Figure 35. Section at frame 86, port side looking aft. Planking and keel not shown. (Drawing by Kevin Crisman; inked by Nathan Gallagher.)

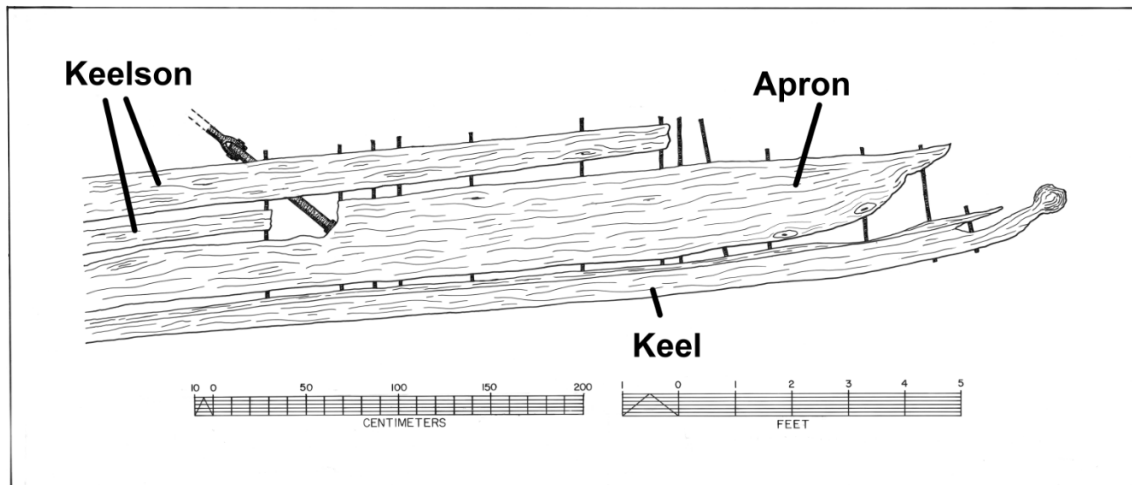
Figure 37. Bow section of Wreck 4. Note the attachment of the hog chain through the keelson. (Drawing by Kevin Crisman and Nathan Gallagher.)

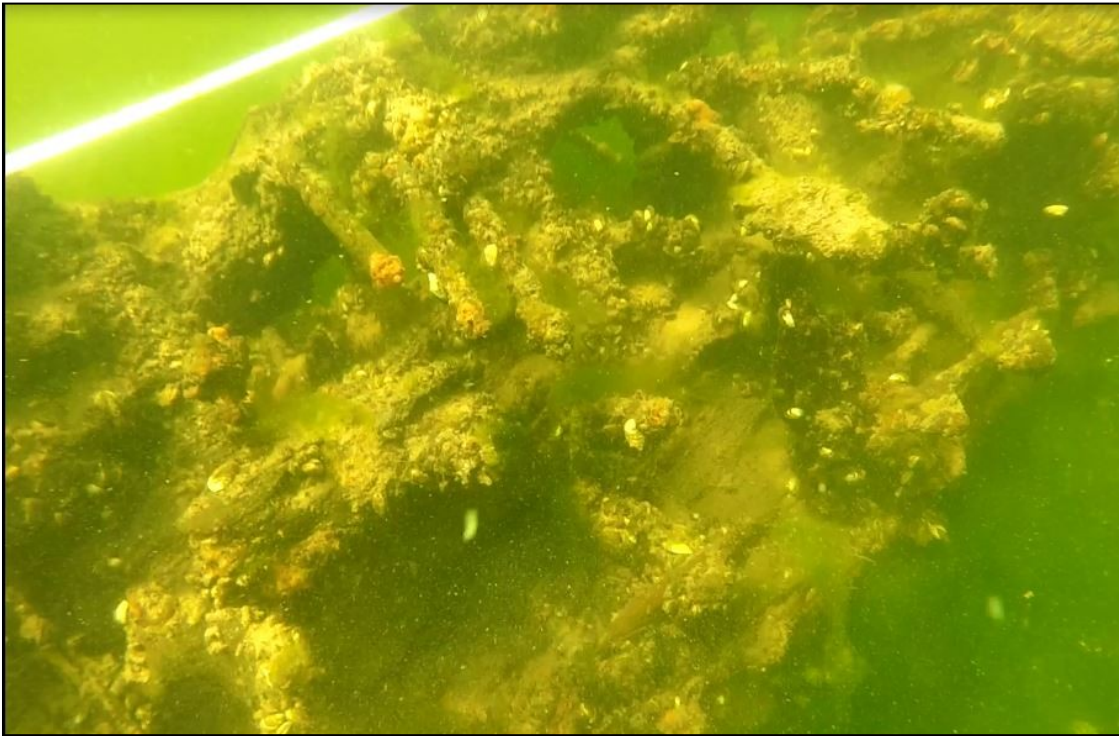
Figure 38. Bolts around frame 130, presumably to hold deadwood in place. (Photo by Kevin Crisman.)

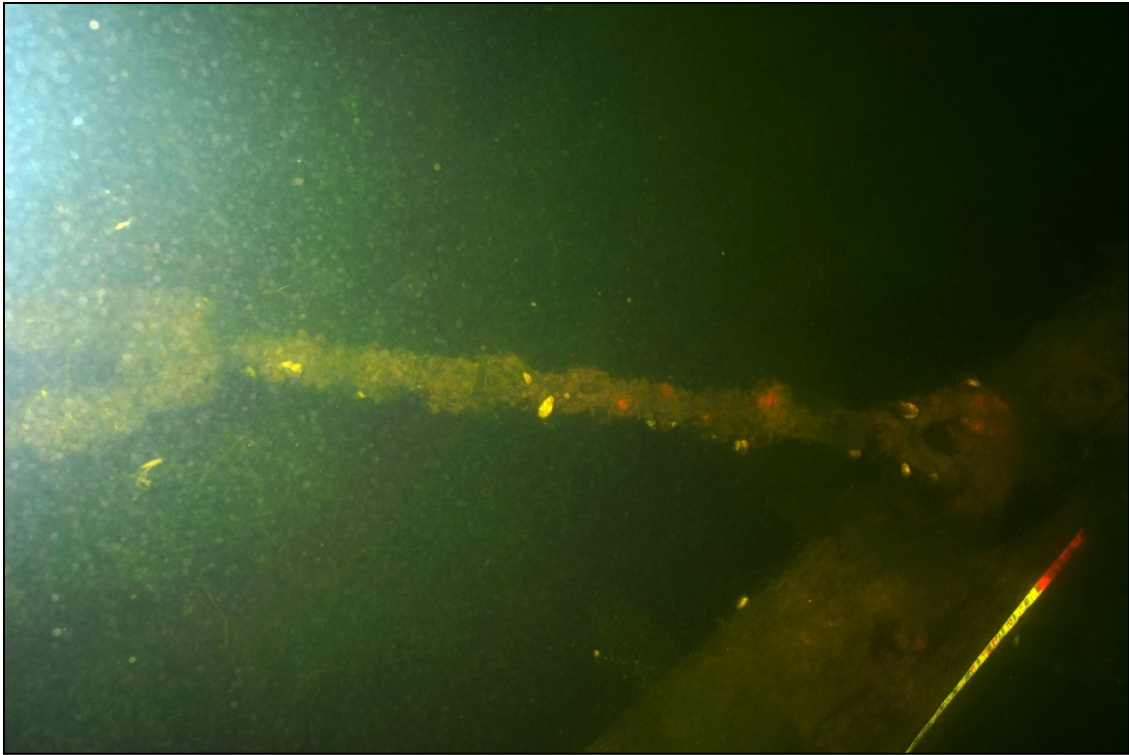
Figure 39. The remains of the hog chain above the keelson. The tum buckle is not fully included in this photograph. (Photo by Paul Gates.)
