45<sup>TH</sup> **TURBOMACHINERY** & 32<sup>ND</sup> **PUMP SYMPOSIA**  
HOUSTON, TEXAS | SEPTEMBER 12 – 15, 2016  
GEORGE R. BROWN CONVENTION CENTER

Potassium Carbonate Pump Failure – High Axial Movement due to Uncontrolled (unbalanced) forces.

Ibrahim AbdAl-Wahab  
Ammonia Sector Head  
Misr Fertilizer Production Company

Hatem AbdelRahman  
Machinery Section Head  
Misr Fertilizer Production Company

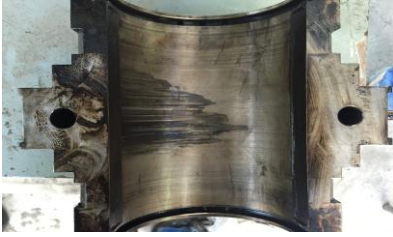
Huge rub for hydrodynamic journal bearing for DE /NDE  
Plus black color in oil for NDE bearing

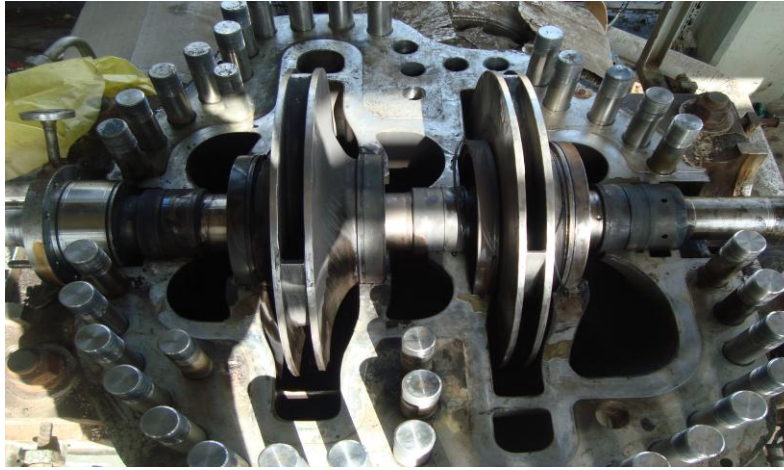
Inner side casing wear ring of first stage impeller

- All new casing wear rings machined in our work shop to get the optimum size
- The pump casing was deformed in lower and upper parts in two locations. Some machining activity was done for the new DE throat bushing also for inner casing wear ring for first stage impeller. Some lapping was done to get the optimum surfaces established for these items with casing and shaft to get the optimum clearance

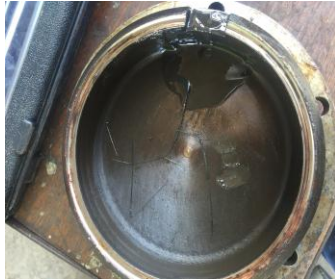
Wear in thrust bearings end cover by about 3 mm

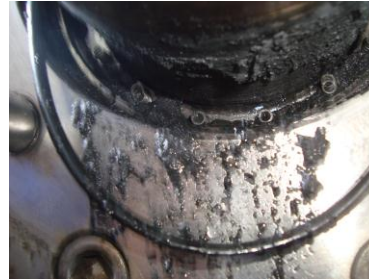
Damage of DE Mechanical seal

The pump stopped and the seal flow was isolated, so due to pump not drained the potassium carbonate solutions entered the seal faces area of DE mechanical seal and solidified inside causing seal faces damage. After running the pump again mechanical contact occurred for mechanical seal parts leads to melting between DE throat bushing and rotary sleeve of mechanical seal as we discover powder of silicon carbide between them which comes from seal faces damage

- Assembling the rotor complete with all parts with measuring all clearances , it was all after machining according to standard
- Assembly a new mechanical seal for both DE and NDE according to optimum dimensions

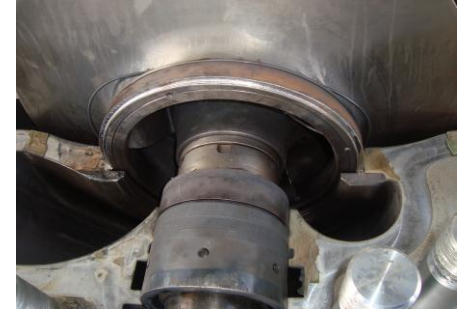
Deformation in casing housing for DE throat bushing first stage Casing Wear ring inside

Huge rub for casing wear ring of outside second stage impeller with pump casing due rotation for half cycle

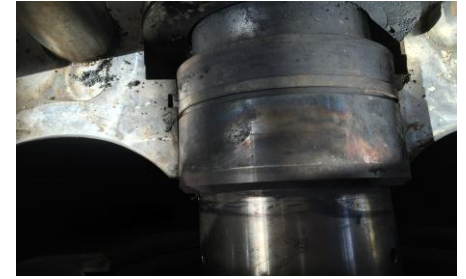
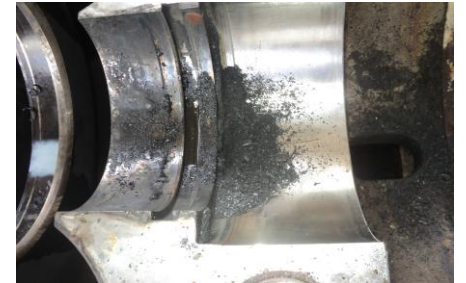
DE throat bushing stuck on shaft

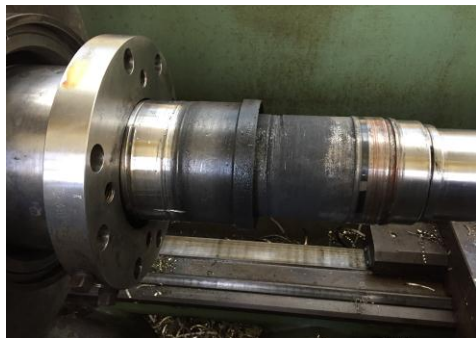
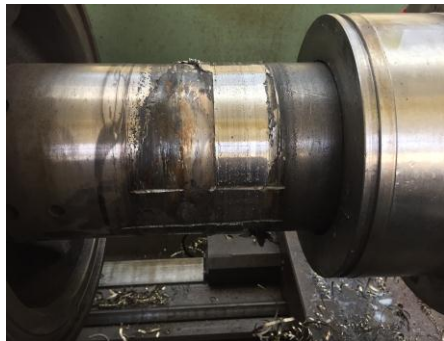
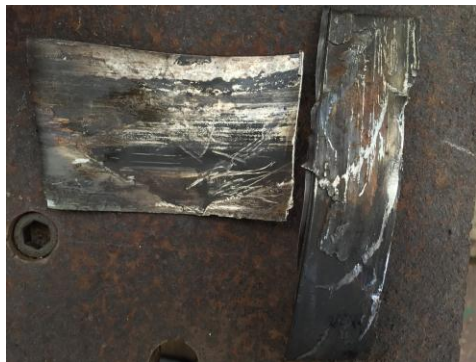
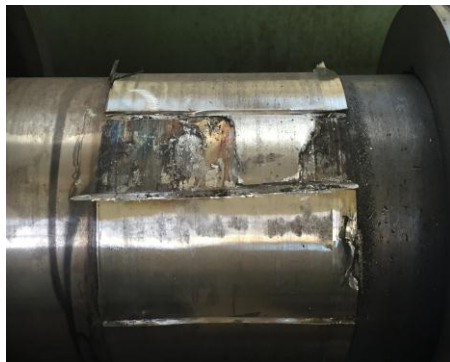
The multi stage pump sudden failure occurred due to high axial movement from axial thrust. These are typical effects of Benfield process; it has been proven that uncontrolled forces occur in second stage impellers of solution pumps, due to liquid instability in high pressure environment (gasification, foaming and solidification). The pump used for Potassium Carbonate is very sensitive to temperature as it should be monitored during stagnant periods. The fact that the pump was not drained completely, lead to forming Potassium Carbonate solidification, i.e. when the pump operate again it leads to high axial movement as the fluid pressure established in first and second stage impellers and couldn't out from the pump diffuser due to solidification i.e. unbalance forces acted on rotor, this causes mechanical seal failure and DE throat Bushing stuck with mechanical seal rotary sleeve because of the powder result in failure of silicon carbide face . It also caused wear and damage of casing wear rings and first stage inside impeller wear ring

DE Throat Bushing stuck with M/C rotary sleeve

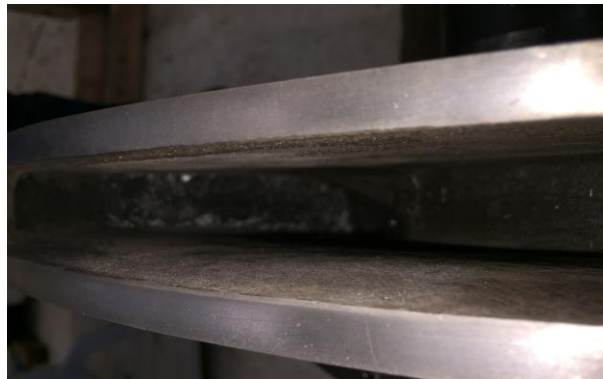
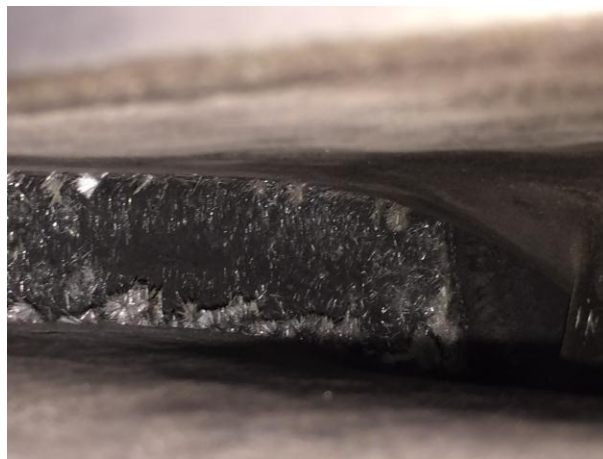
1- The pump was not completely drained before the stand still period since it stopped last time , i.e. formation of potassium carbonate solidification was present.

Potassium Carbonate solidification inside impeller

Always ensure draining the pump from potassium carbonate solution
