# Thermal Load Effect on Vibration on a Reactor Feed Water Pump (FWP)

Nine Mile Point Nuclear Station (NMPNS) Unit 2 – 1150 MW (Oswego, NY)

Application:	Reactor Feed Water Pump (FWP)
Type:	20x20x22 – 2 Stage (barrel type radial split)
Capacity:	8,000 gpm (min flow) to 22,870 gpm (max flow) Normal operation steady slightly above BEP
Suction Press.:	550 psig
Discharge Press.:	1,200 psig
Speed:	3,339 rpm (55.7 Hz)
Temperature:	382 °F
Normal Load:	10,500 to 11,500 BHP
Driver:	Induction Motor (16,500 HP @ 1785 rpm (29.8 Hz))
Gearbox:	Speed Increaser (Gear ratio 1:1.87)

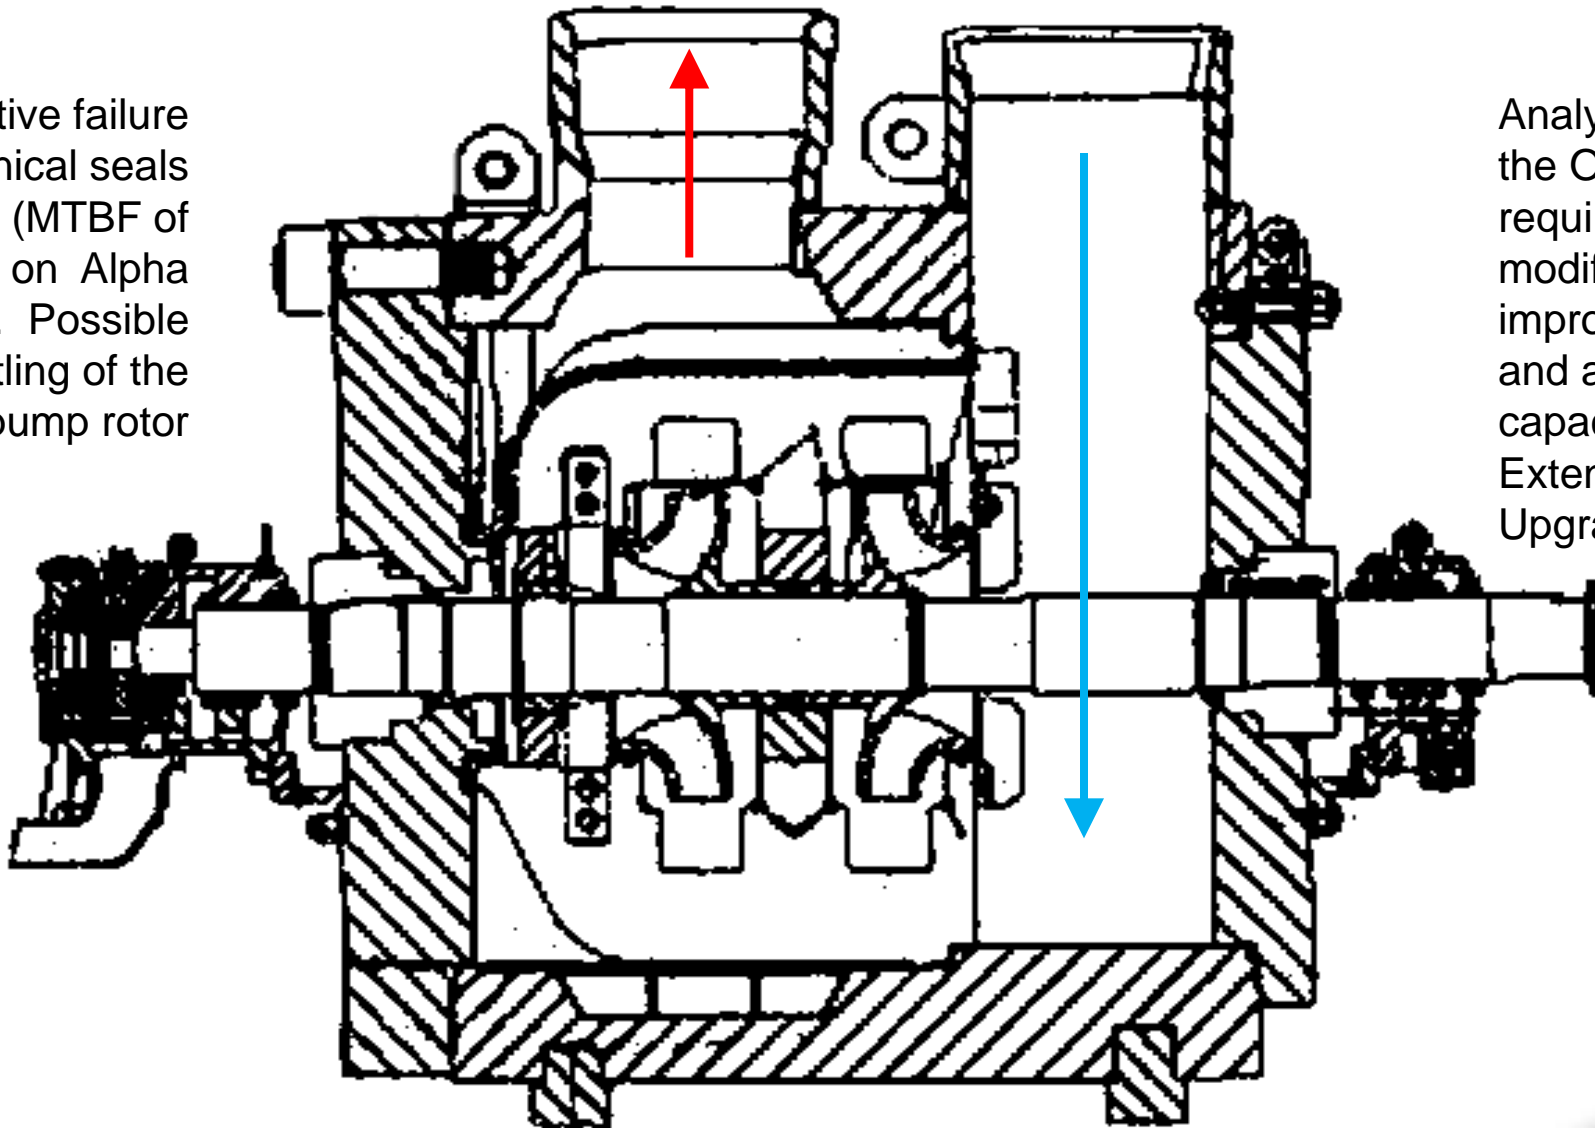
Former Design Cross Section  
20x20x22 – 2 Stage

Repetitive failure mechanical seals since 1987 (MTBF of 6 months on Alpha FWP). Possible axial shuttling of the pump rotor

Analysis performed by the OEM, the pumps required a series of modifications to improve seal reliability and also increase plant capacity by 15% Extended Power Upgrade (EPU)

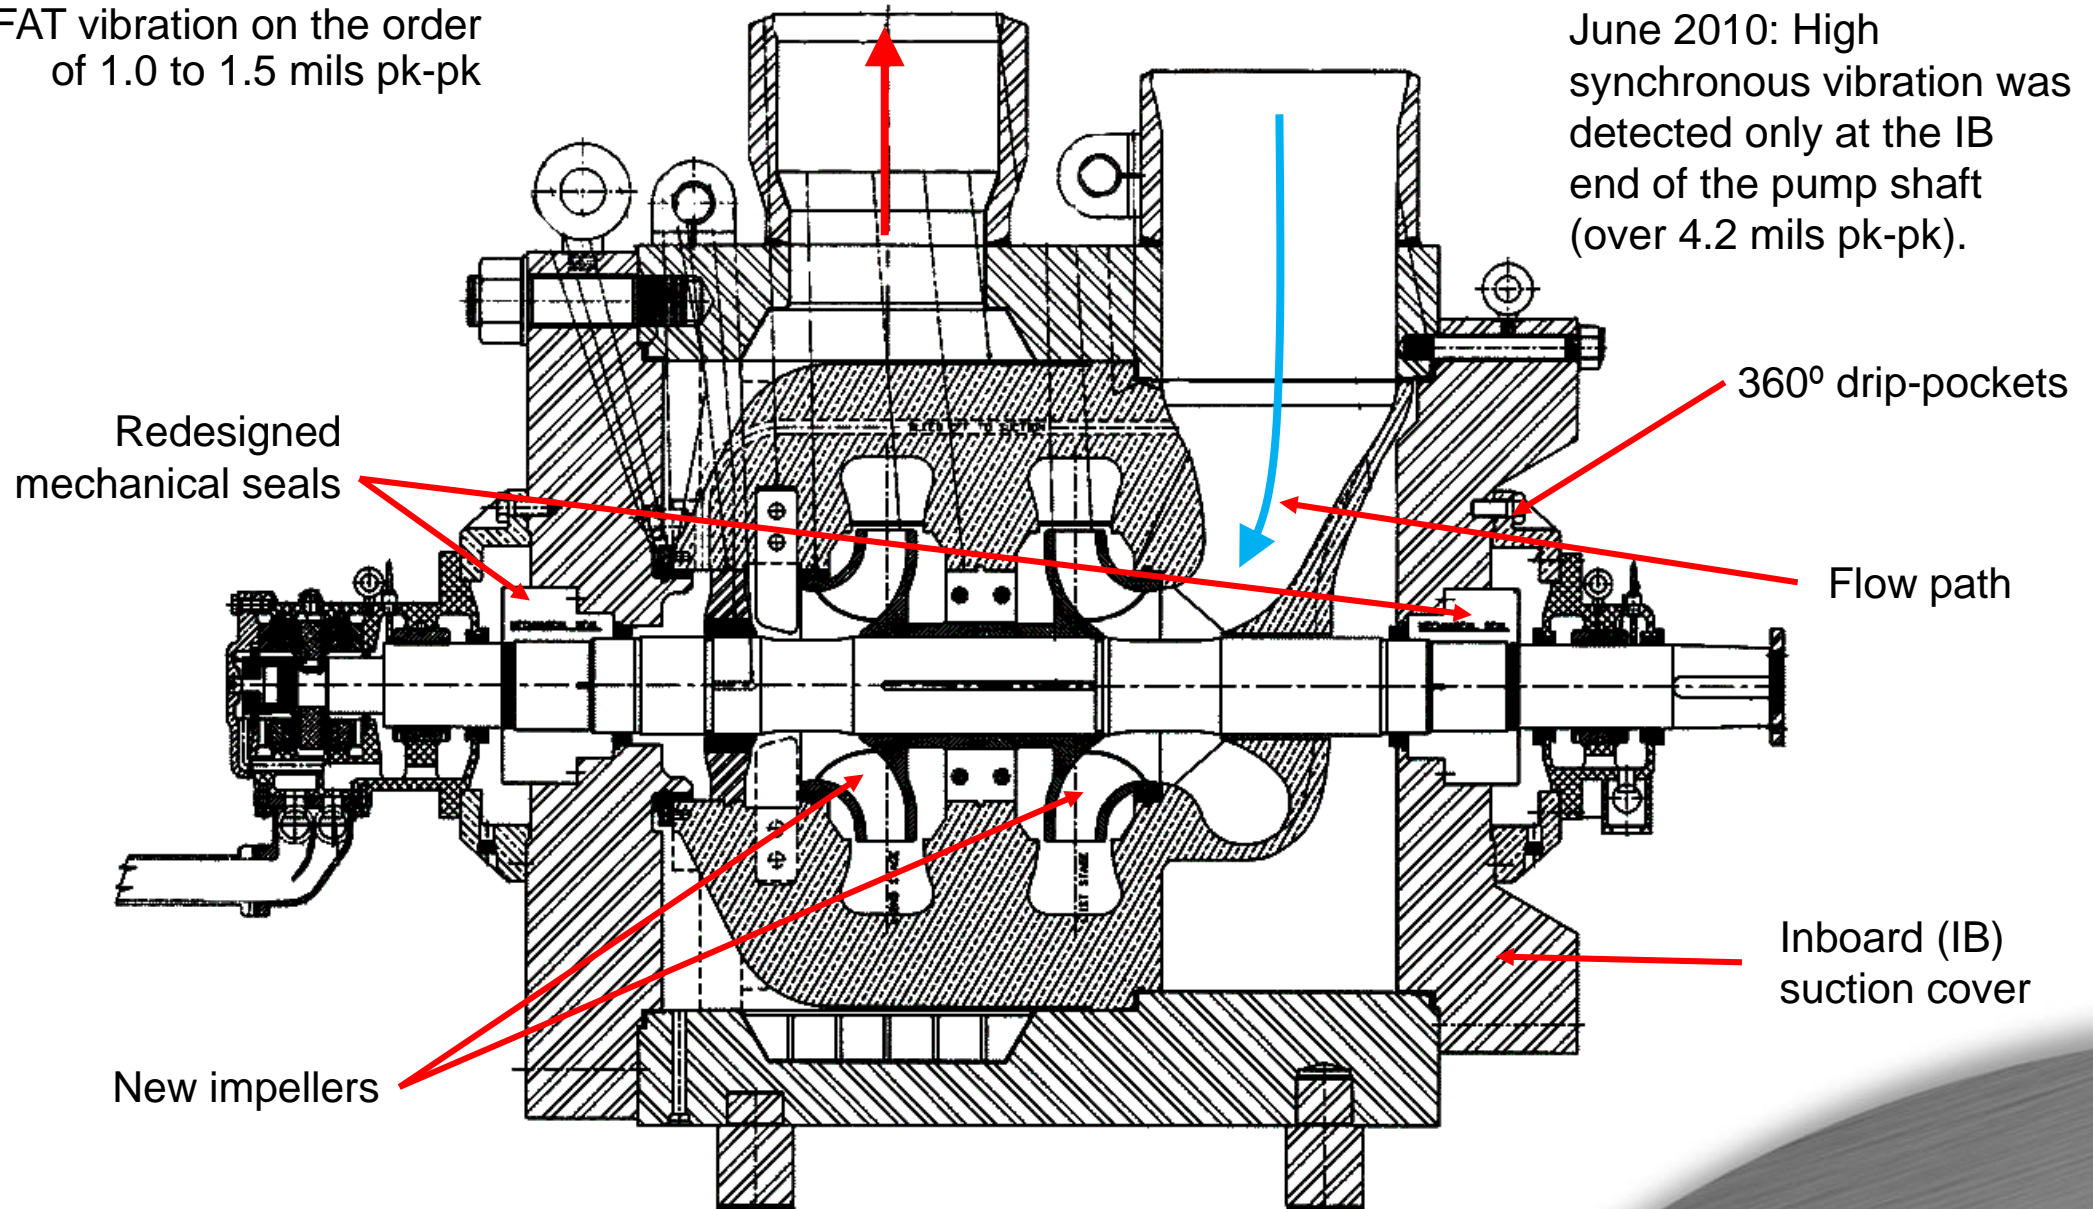
Modified in Spring 2010

FAT vibration on the order of 1.0 to 1.5 mils pk-pk

June 2010: High synchronous vibration was detected only at the IB end of the pump shaft (over 4.2 mils pk-pk).

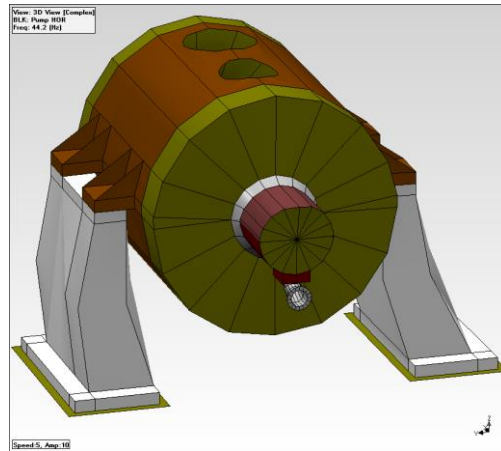
Lateral Rocking Mode @ 44 Hz

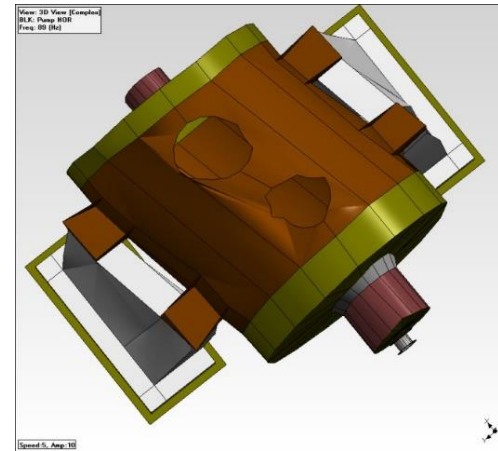
Twist Mode @ 89 Hz

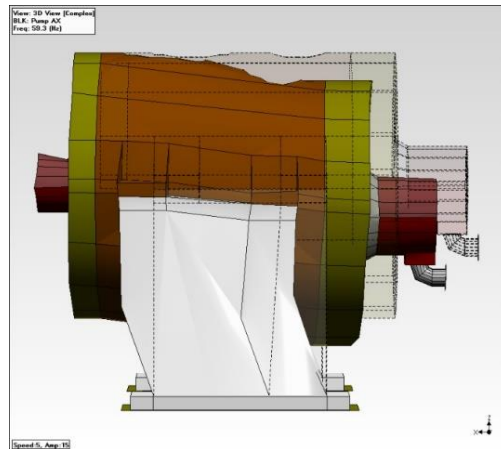
Axial Rocking Mode @ 59.3 Hz

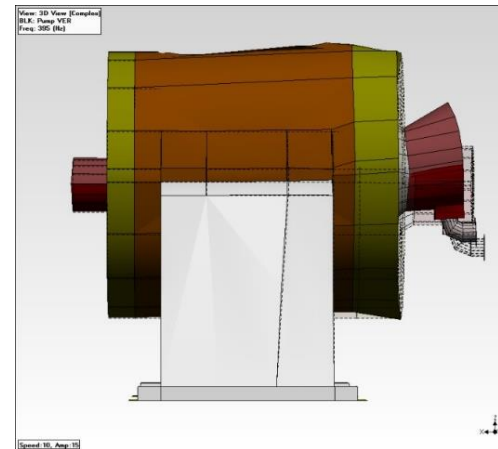
OBB Vertical Mode @ 395 Hz

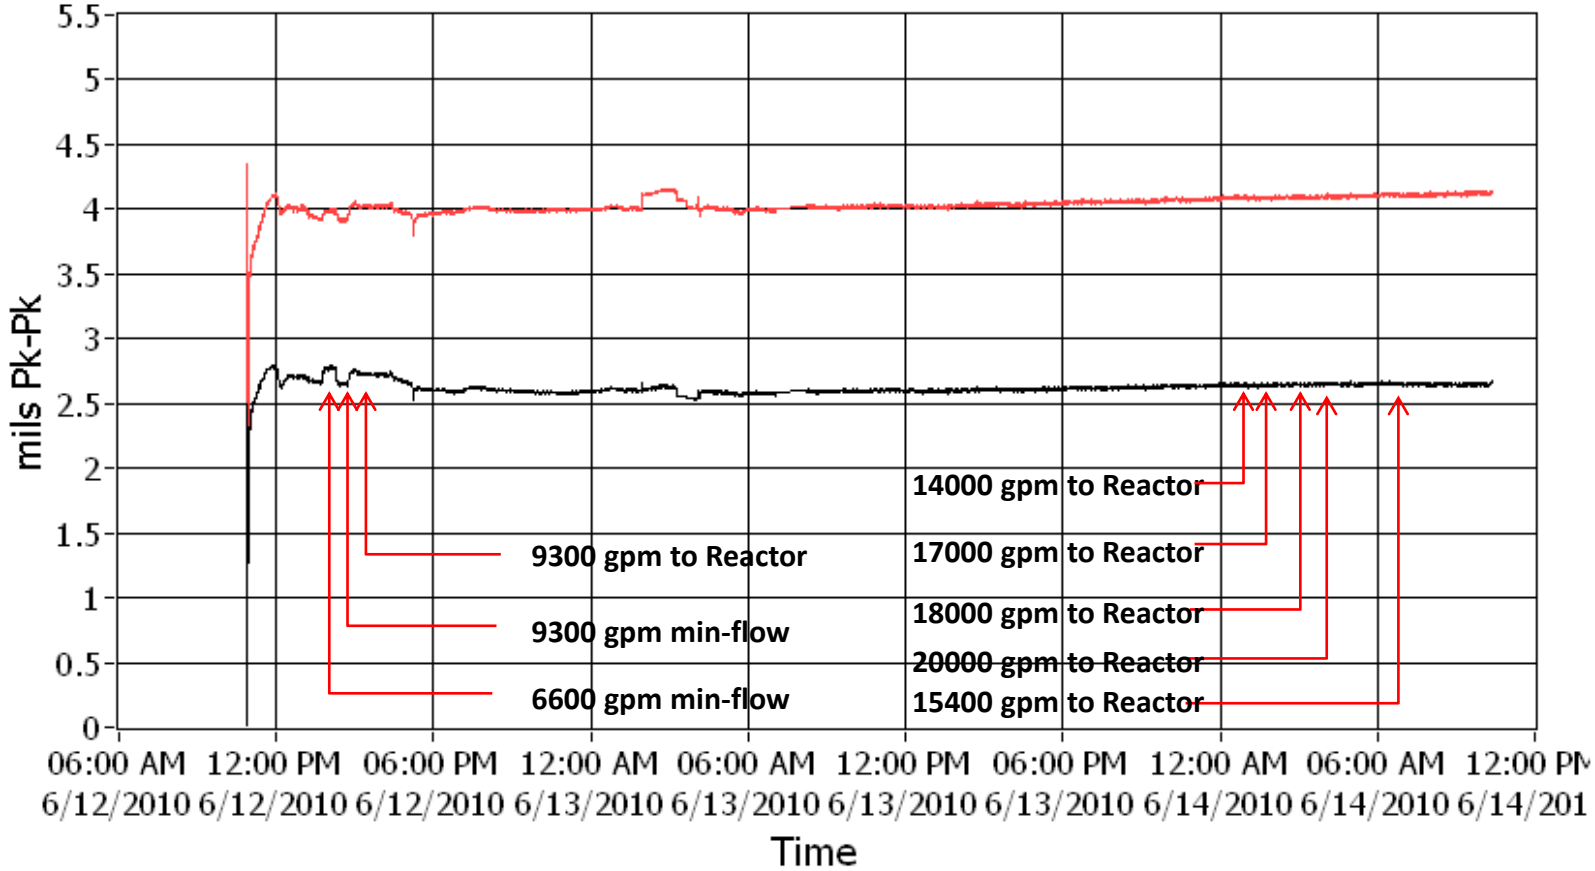
Pump IBB Radial Proximity Probes Overall Pk-Pk Vibration

Shaft vibration mostly at 1x rpm  
 Bearing housing vibration was acceptable

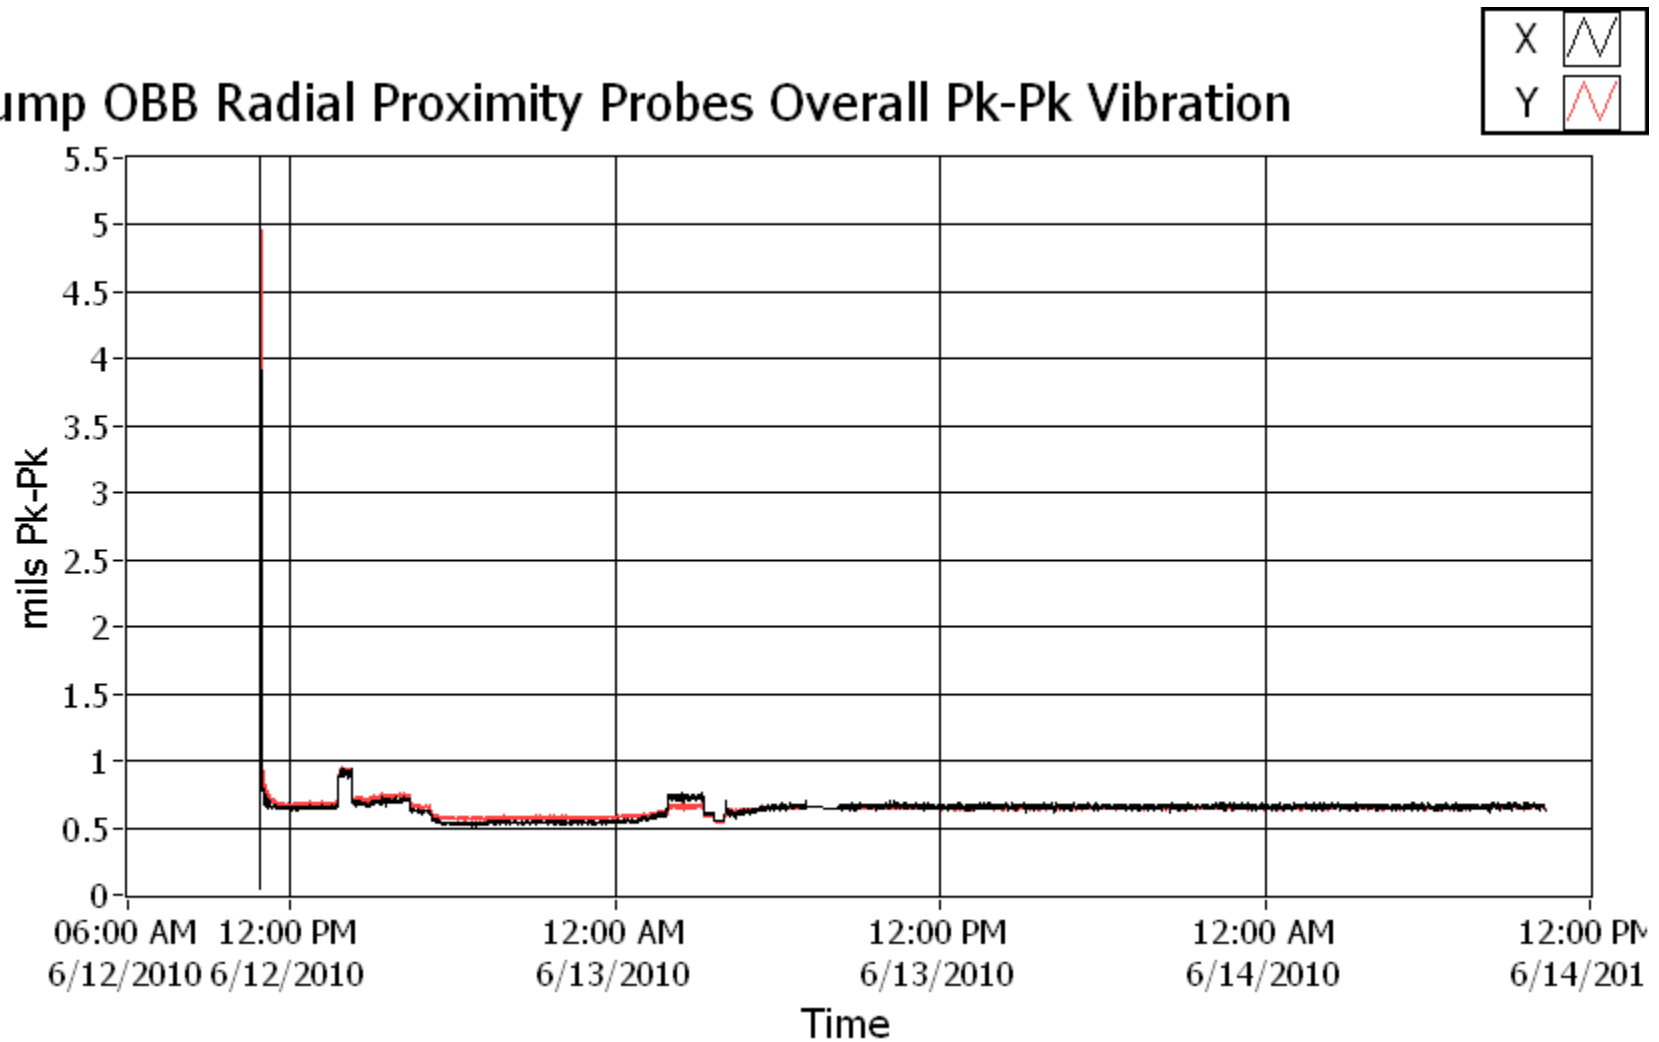
Pump OBB Radial Proximity Probes Overall Pk-Pk Vibration

Shaft vibration mostly at 1x rpm  
Bearing housing vibration was acceptable

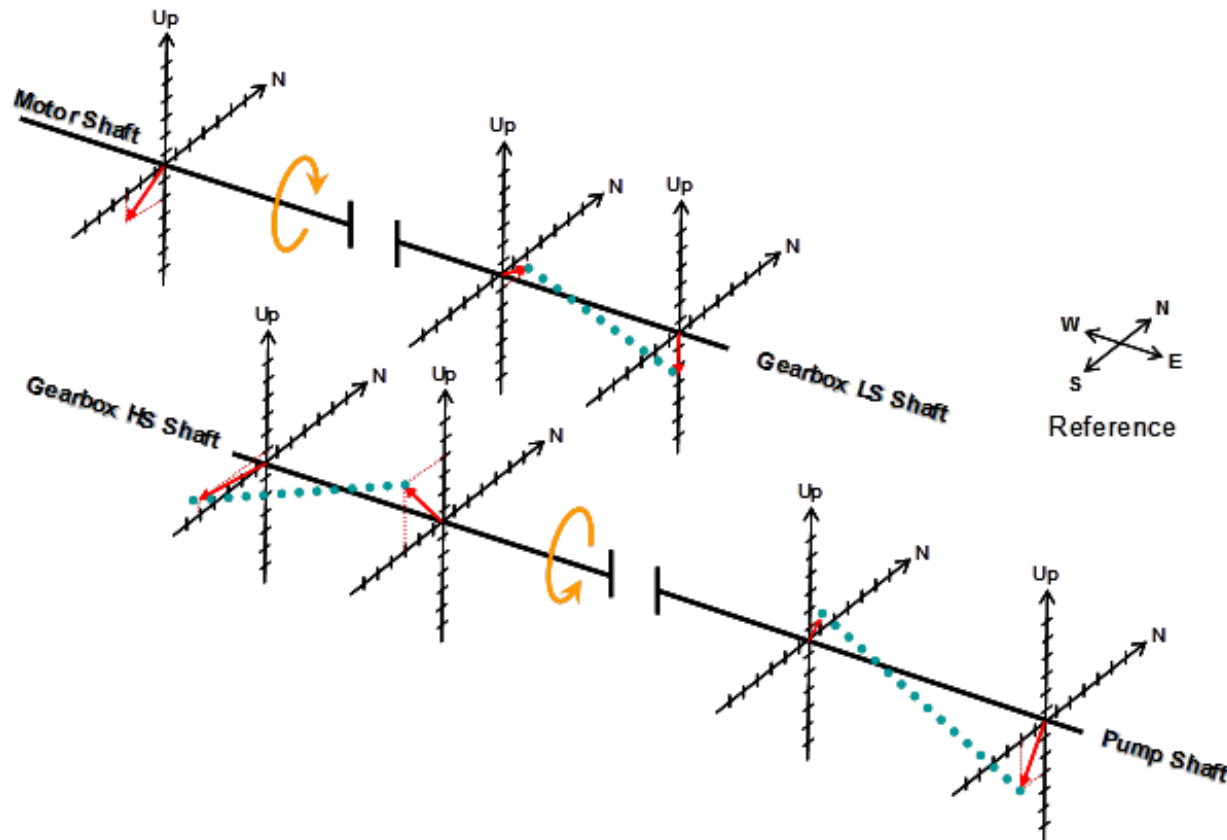
- Misalignment: Severe offset misalignment between the HS gearbox pinion shaft and the pump. Modify the cold alignment.
- Coupling Imbalance: Eccentricity of the coupling spacer from the coupling mounting center line.
- Thermal growth between the pump shaft and the HS gearbox pinion.
- Verify the radial position of the coupling spacer for potential eccentricity that could lead to imbalance forces.

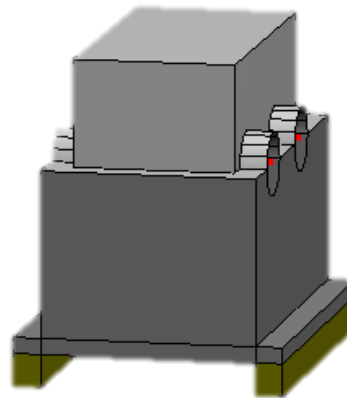
Tri-land bearings (7 mils diametral clearance)

Verified/ corrected the misalignment of the entire train

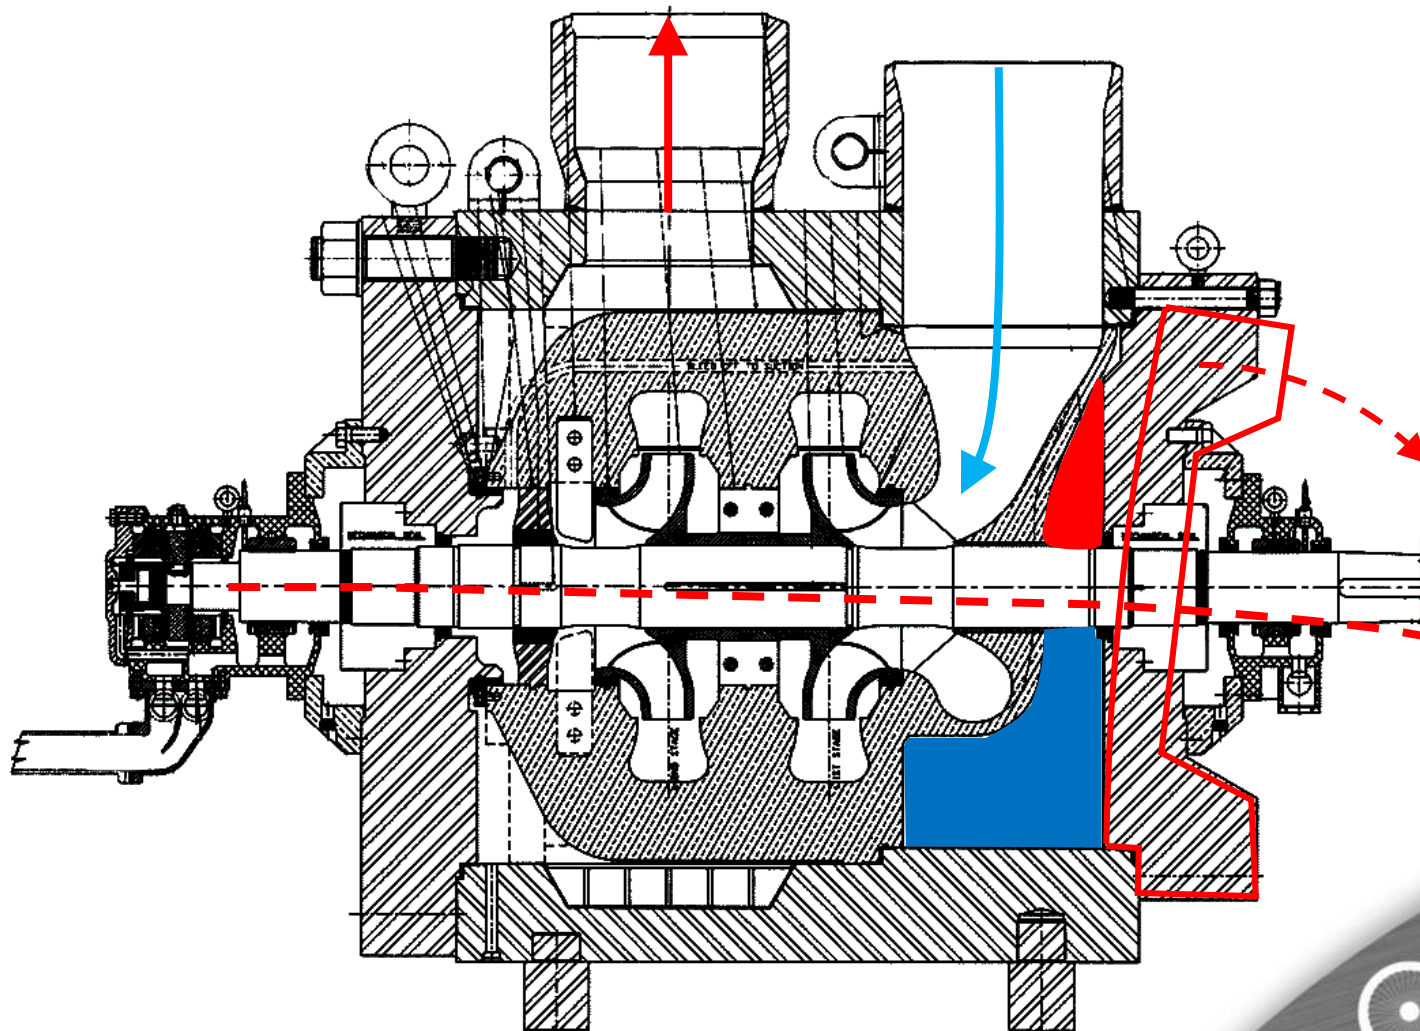
1<sup>st</sup> stage flow path did not allow uniform thermal expansion of the pump casing at the IB end cover. Former seal injection design allowed accumulation of condensate seal water at the bottom of the pump casing with lower temperature than the reactor feed water. This was causing distortion of the inboard cover plate and therefore internal misalignment at the IBB.

1. Modifications implemented on these pumps during the outage (i.e. seal injection API plan 23) eliminated the thermal distortion effect that was causing deformation of the inboard end cover of the pump.
2. Previous seal injection design allowed accumulation of condensate seal water at the bottom of the pump casing with lower temperature than the reactor feed water. This was causing distortion of the inboard cover plate and therefore internal misalignment at the IBB.
3. The shaft vibration at the IBB used to be approximately 4.5 mils pk-pk, while the vibration at the OBB was approximately 1.0 mil pk-pk. Vibration data gathered after the outage indicated significant improvement at the IBB (2x reduction).
4. Radial proximity probe GAP voltage readings were not changing over time during the warm-up or cool-down processes, versus such changes that had been identified in previous tests.
