45TH TURBOMACHINERY & 32ND PUMP SYMPOSIA
HOUSTON, TEXAS | SEPTEMBER 12 – 15, 2016
GEORGE R. BROWN CONVENTION CENTER

Integral Gear Compressor Gearbox Flooding Issue

Daryl Callan

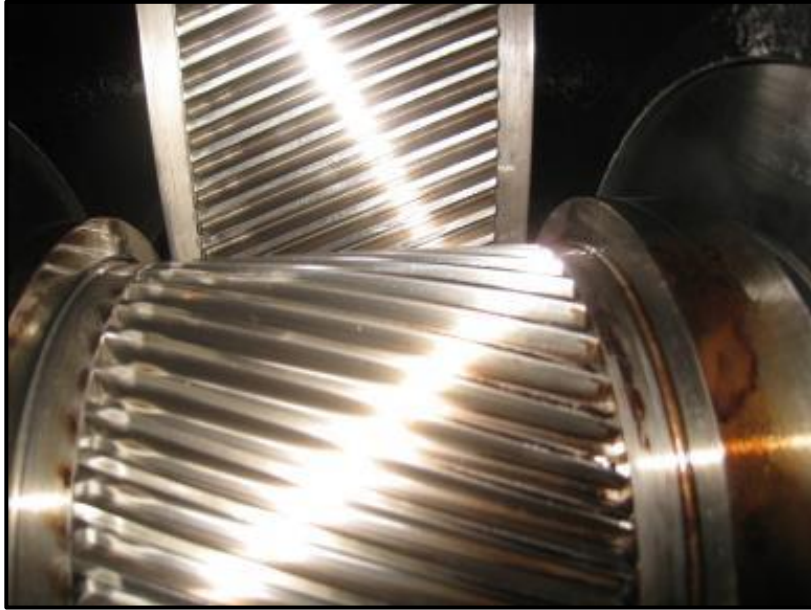
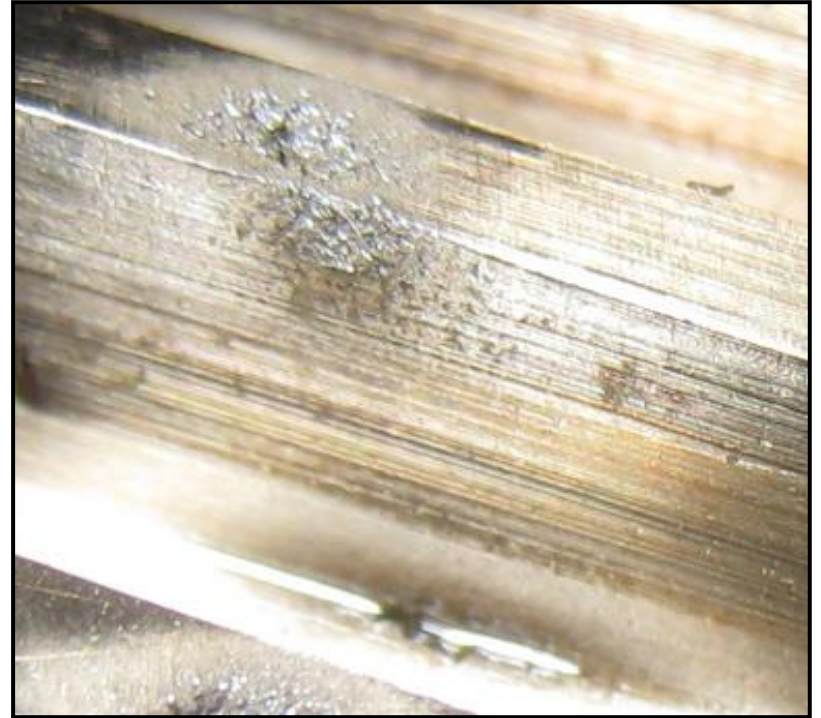
Gearing Damage

- ▶ Three “identical” compressors located at an owned and operated facility have experienced trips related to high motor power that are unrelated to process conditions
- ▶ Events have resulted plant trips and damage to gearing components and replacement components
- ▶ Compressors unable to keep operating if main oil pump and aux oil pump operating.

- ▶ No apparent process or lube oil related instigation of event
- ▶ Gearbox vacuum is lost on the cover pinion but not on the high speed pinion area or on the reservoir
- ▶ Process pressures and lube oil pressure drops as amps increase
- ▶ Oil forced through gaskets around cover pinion and low speed pinion inspection covers
- ▶ Trip events can be forced by running auxiliary oil pump

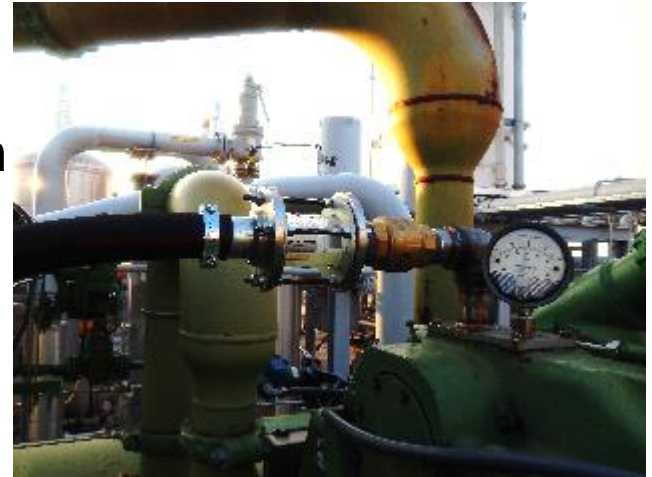
Modification Testing

- ▶ On compressor start oil seen flowing from side drain and low speed drain
- ▶ Side and low speed drains closed, oil begins to flow out of cover pinion drain
- ▶ Oil no longer flows from low speed drain through remainder of testing
- ▶ All drains closed except side drain and AOP started, no trip characteristics seen in 15 minutes of operation
