45TH **TURBOMACHINERY** & 32ND **PUMP SYMPOSIA**
HOUSTON, TEXAS | SEPTEMBER 12 – 15, 2016
GEORGE R. BROWN CONVENTION CENTER

Sub-Synchronous Vibration on Centrifugal Compressor with Tilt-Pad Bearings

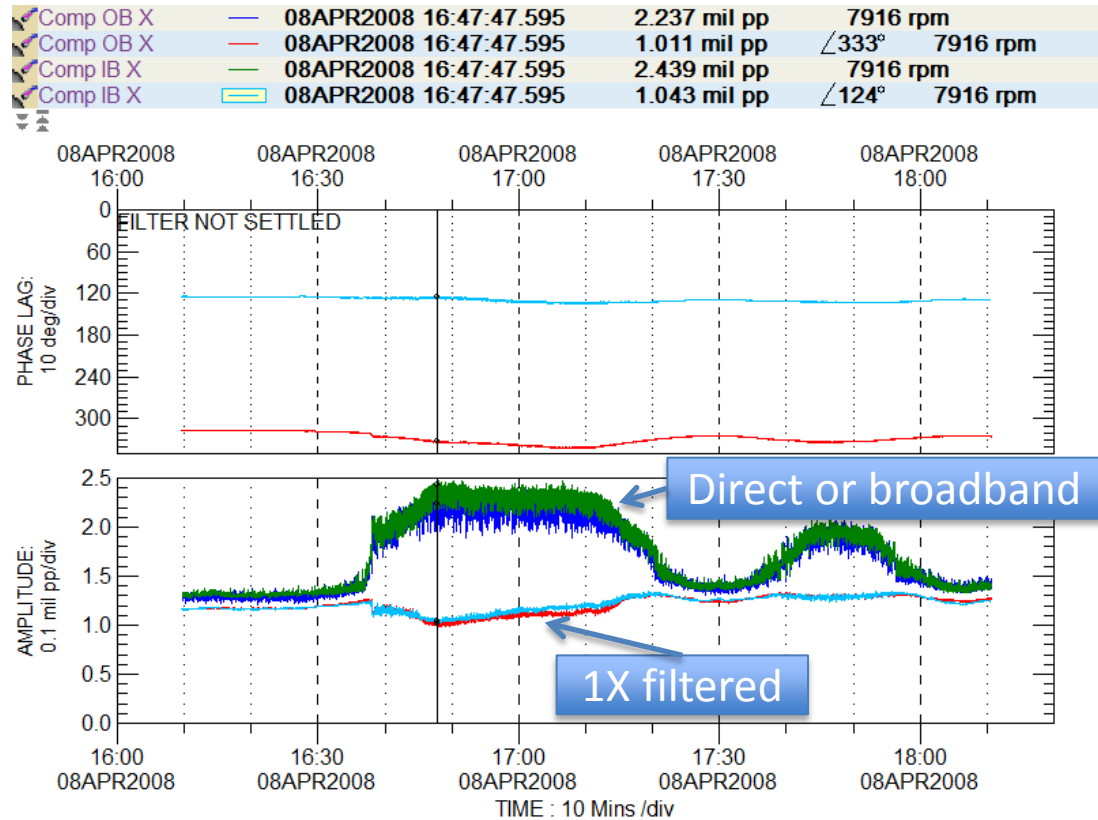
- The compressor experienced high vibration of ~ 2.5 mil pp with **Sub-Synchronous Vibration (SSV)** amplitude of ~ 1.5 mil pp at frequency of ~ 3000 cpm, at both inboard and outboard bearings.
- Very trivial level of **SSV** from steam turbine bearings.

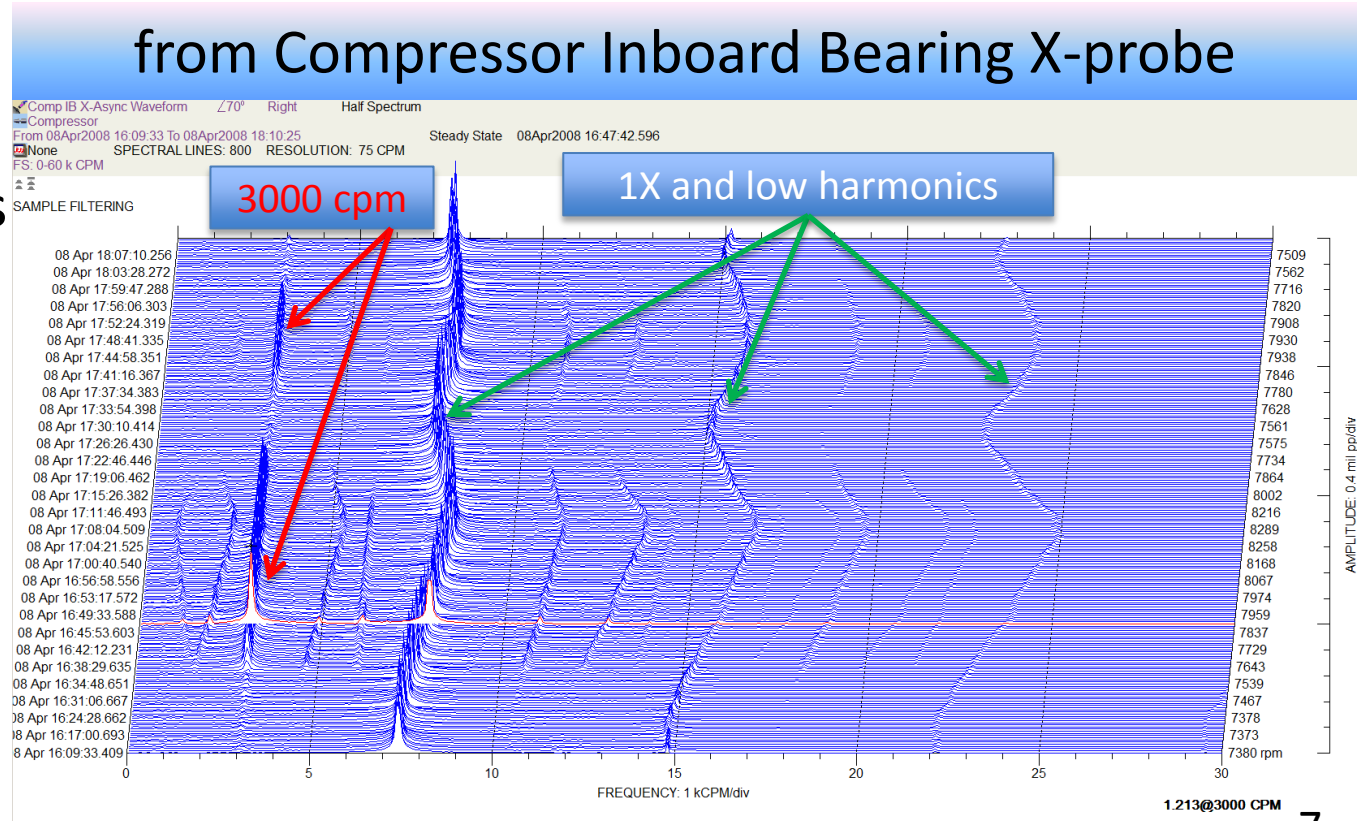
3.1 Vibration Data Review – Waterfall plot

- 1X and harmonics – normal
- SSV at 3000 cpm – abnormal

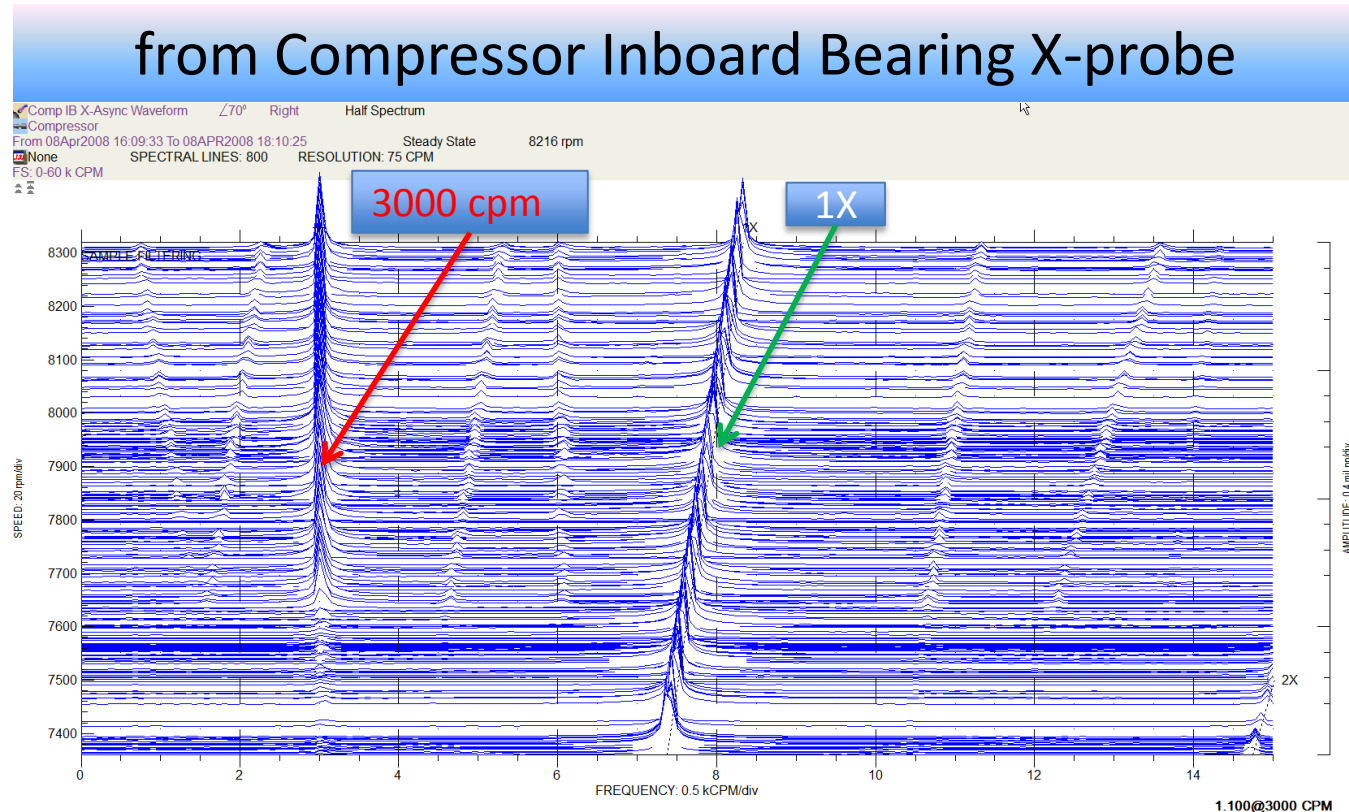
3.2 Vibration Data Review – Cascade plot

- Not tracking with speed.
- Almost constant frequency of ~ 3000 cpm, likely the lowest natural frequency.

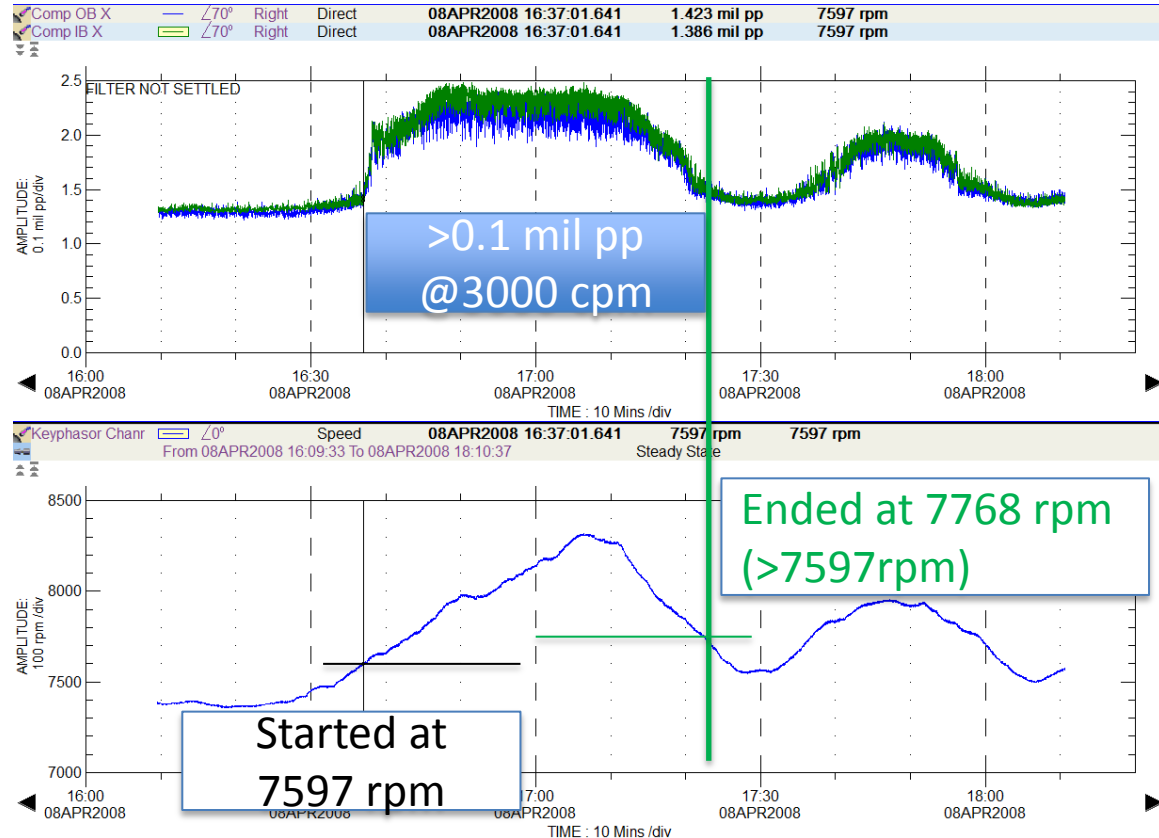
3.3 Vibration Data Review – Operation condition

- At high speed that is also related to high horsepower.
- SSV was able to disappear at speed even higher than the onset speed.
- Molecular weight decreased after SSV lasted for a while but before reducing speed.

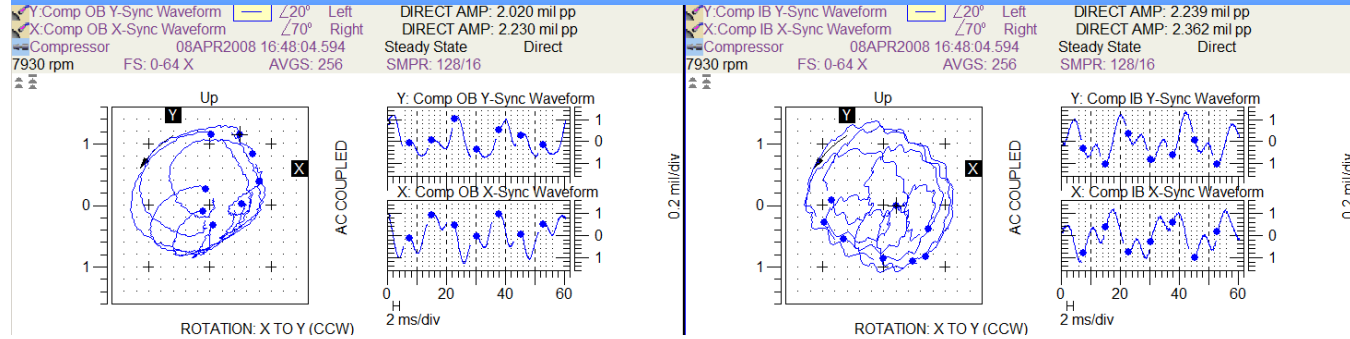
Orbits at OB & IB Bearings

- Varying orbit shapes due to combined SSV and 1X, etc.
- SSV level even higher than 1X as shown in spectrum plots

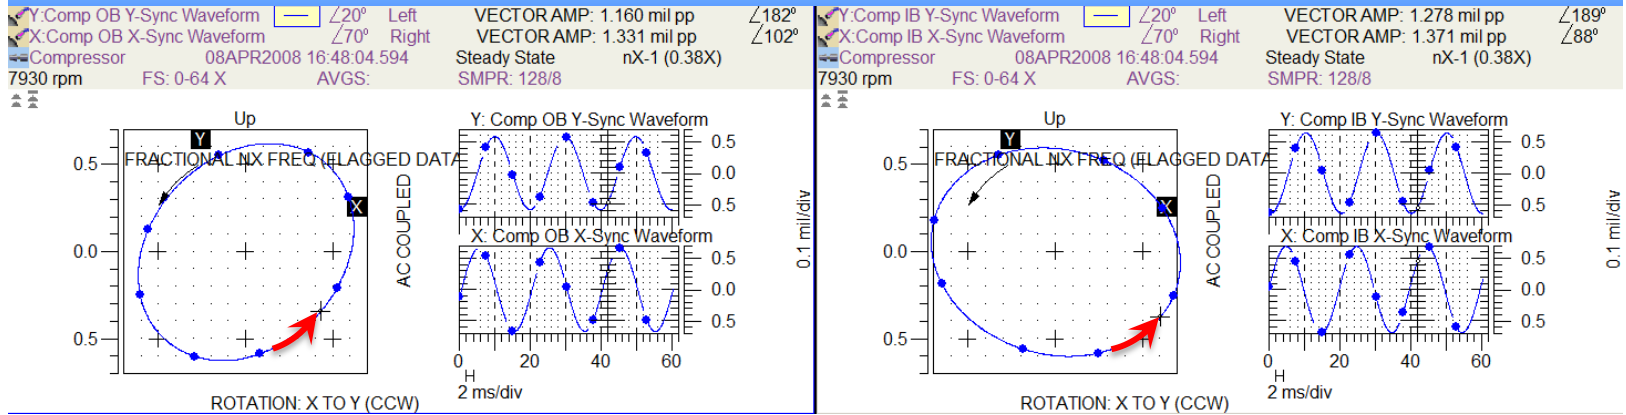
SSV (~ 0.38X filtered at 7930 rpm) orbits at OB & IB Bearings

- Fairly circular orbits with forward precession.
- In-phase between IB and OB, indicative of the self-excited vibration with the 1st mode.

Therefore, the source of the instability might have come from the seals and impellers, not from the tilt-pad bearings. However, the current higher bearing clearance might have reduced stability margin of the whole compressor-bearing system. A recommendation was made to reduce the bearing clearance.

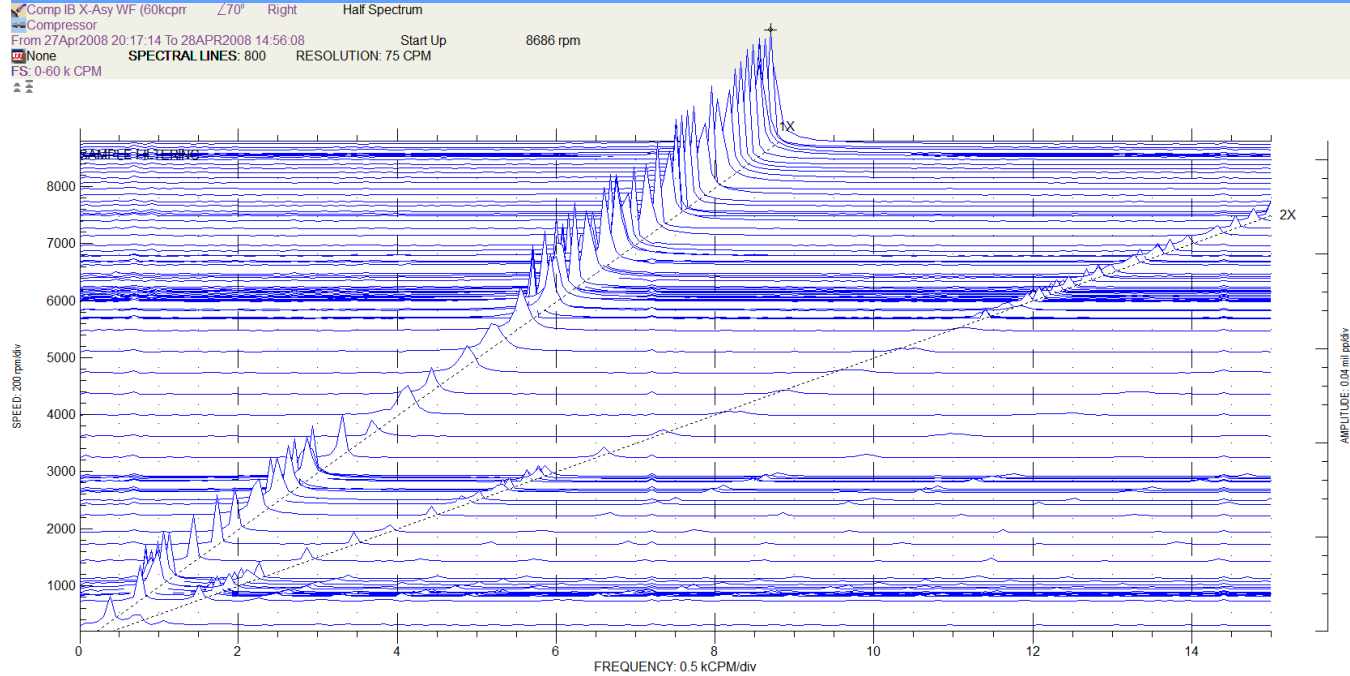
Cascade plot from Compressor IB X-probe

SSV virtually suppressed to zero at all operational conditions

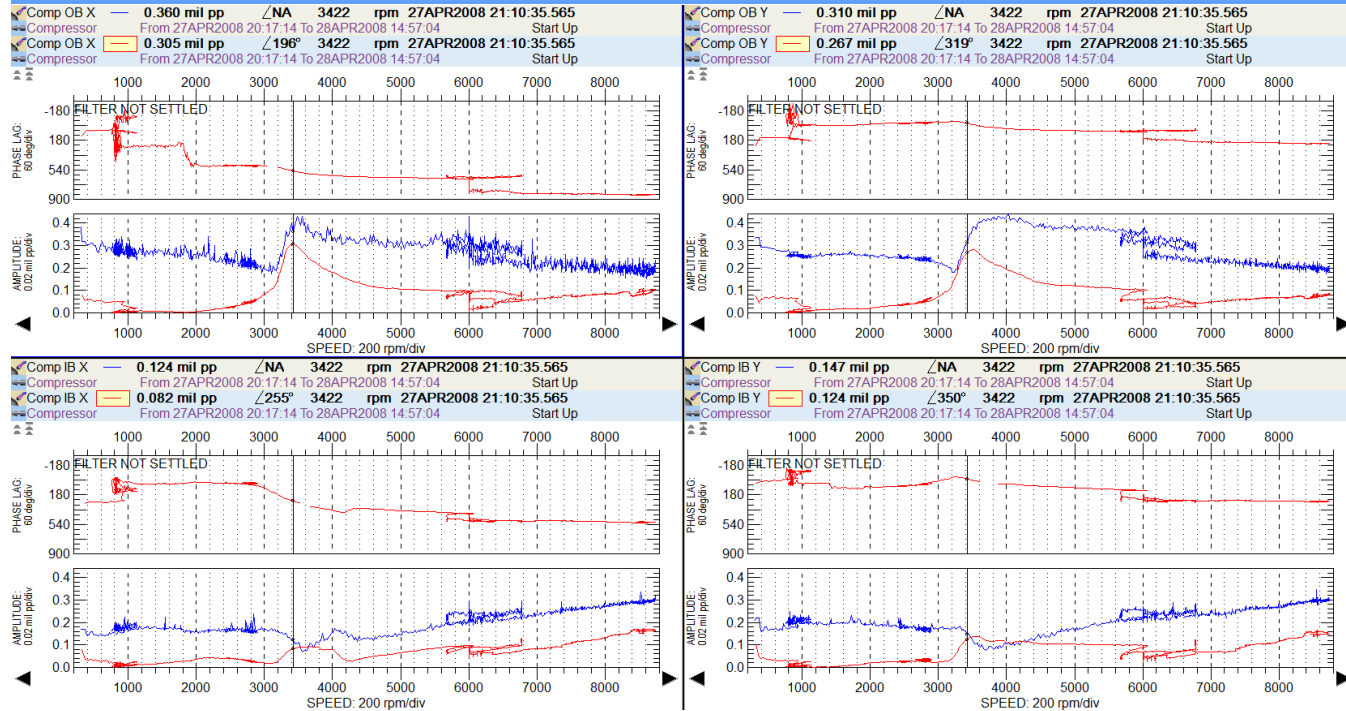
Bode plots from compressor bearings

The 1st resonance increased from ~ 3000 rpm to ~ 3400 rpm

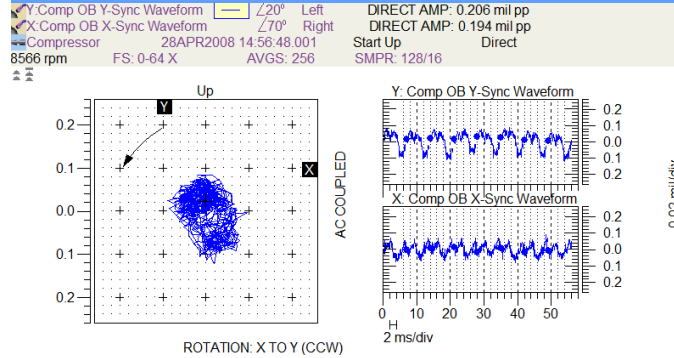
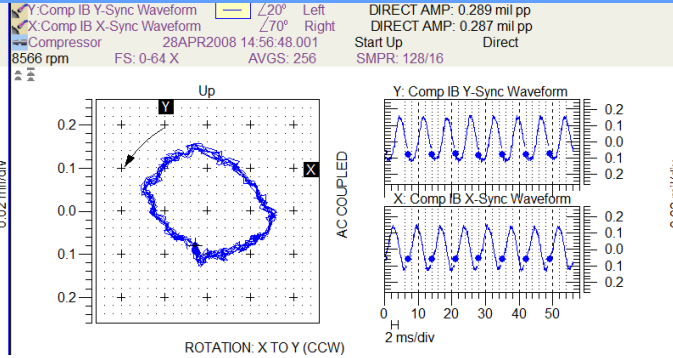
Orbits at OB & IB Bearings

At 8566 rpm, overall vibration amplitude became < 0.3 mil pp at both IB and OB bearings, as the unit was operating near the anti-resonance point.

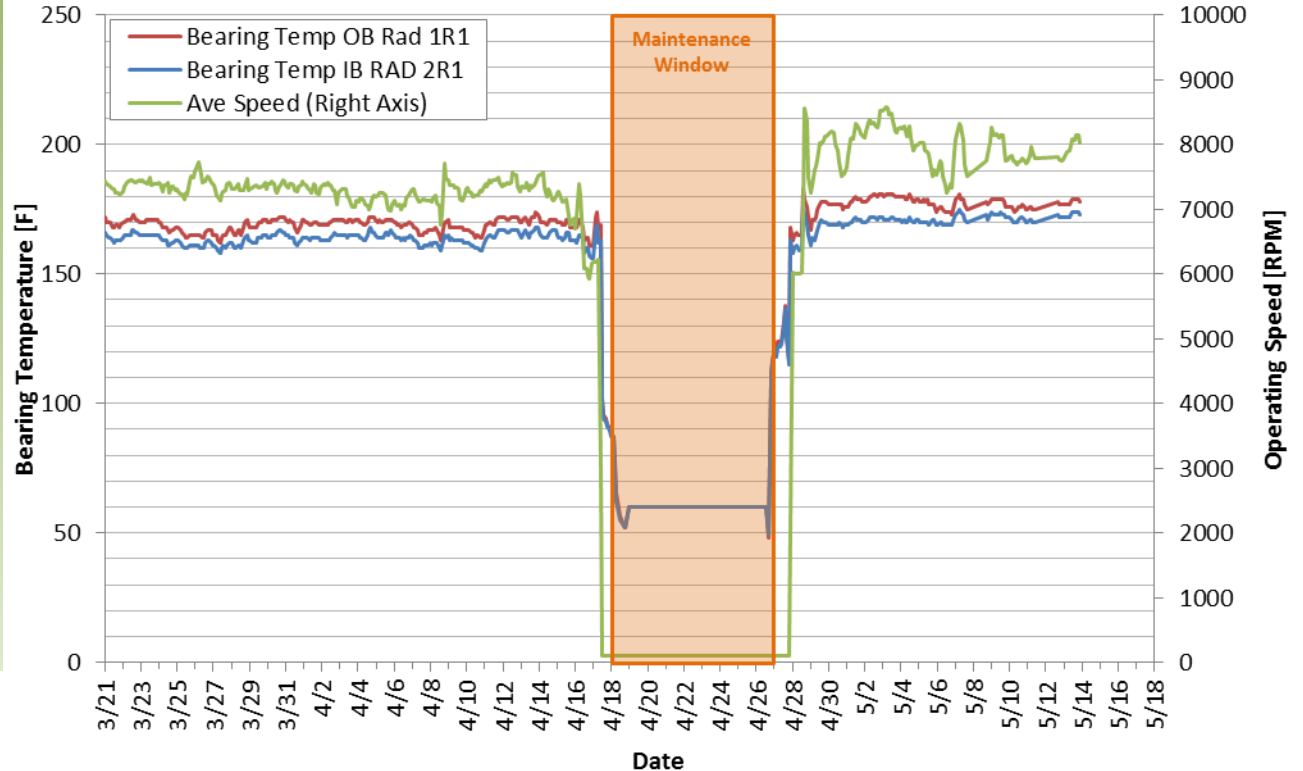
Compressor Bearing Temperature *Before and After Clearance Change*

Bearing metal temperatures increased slightly ($<10^{\circ}\text{F}$) due to reduction in bearing clearance, but not exceeding 180°F (alert limit being 240°F).
