ASIA TURBOMACHINERY & PUMP SYMPOSIUM  
SINGAPORE | 22 - 25 FEBRUARY 2016  
M A R I N A B A Y S A N D S

# Steam Turbine Vibration Resonance of Pedestal, Vibration Investigation with Countermeasures in Singapore

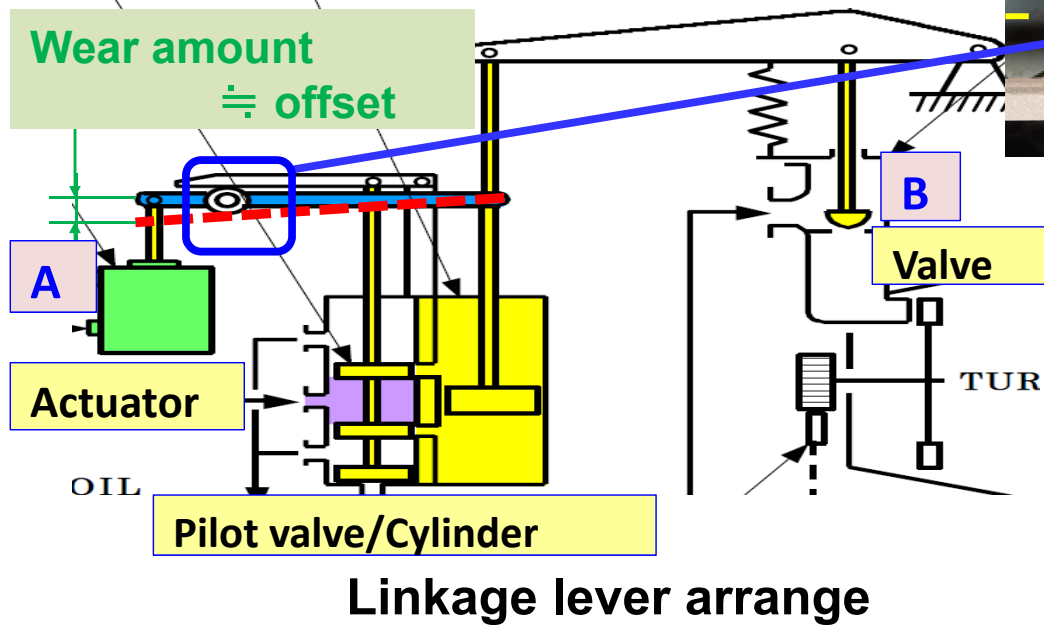
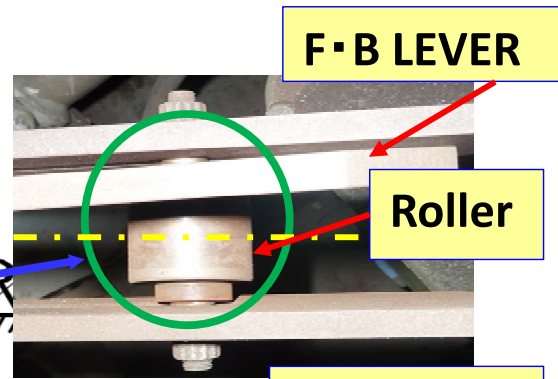
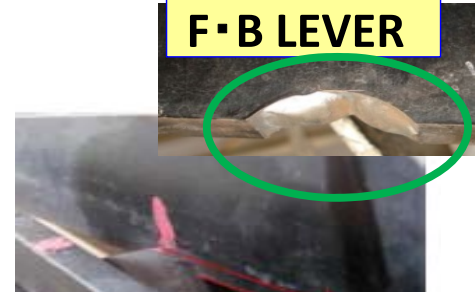
Impact of lever wear damage;  
Offset the neutral point of pilot valve

Wear amount  
≡ offset

F-B LEVER moved  
from center, and  
heavily worn

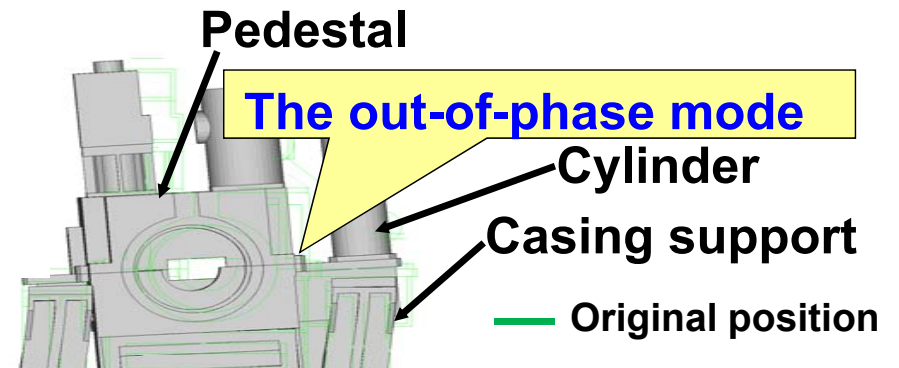
Measured vibration mode at 3850 rpm (59Hz)

The main characteristic of the vibration mode is an out-of-phase (counter-motion) mode between main pedestal and casing support

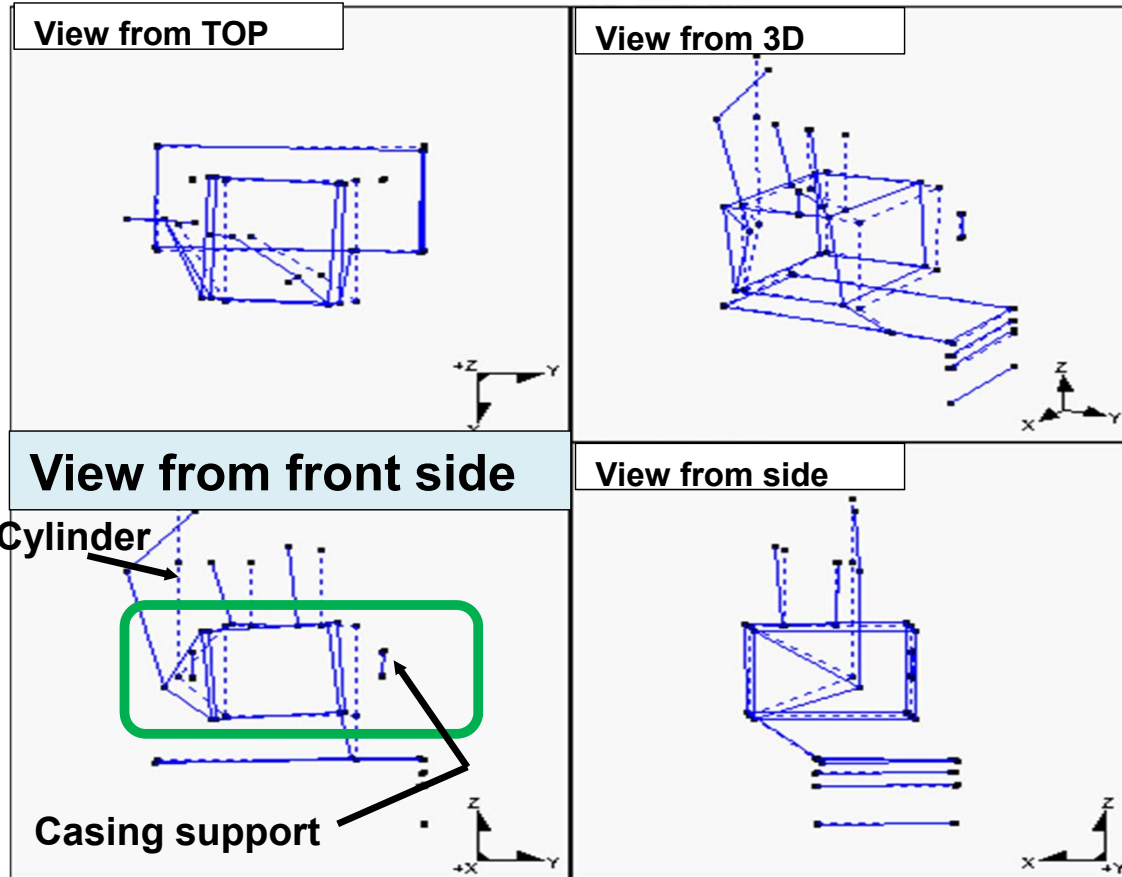
Measured vibration mode at site

- Well matched in both results.
- High responded Out-of-Phase mode between main pedestal and casing support.

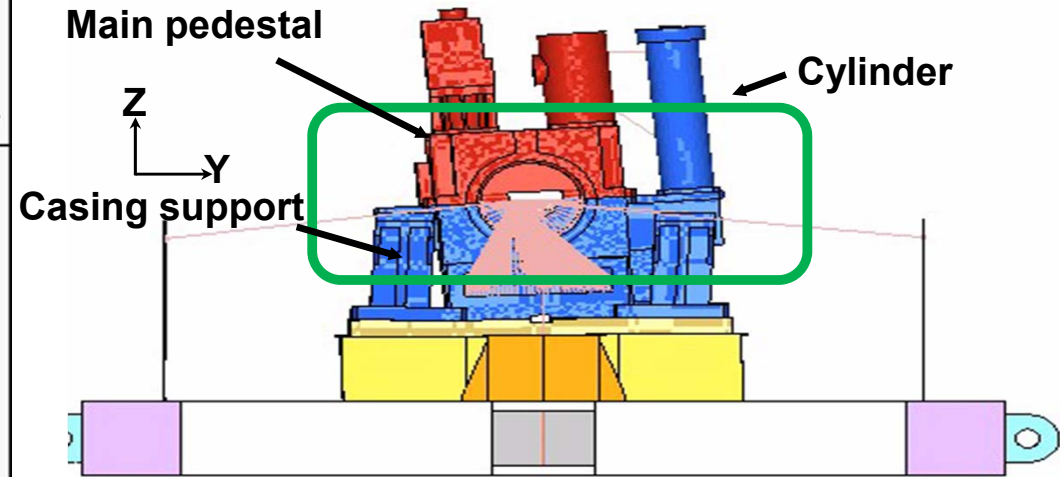
Analysis vibration mode result  
(View from Exh, side)

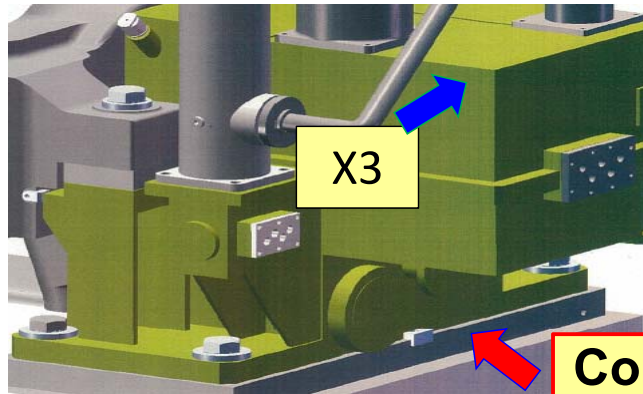
- Natural frequency 74 Hz is close to the turbine operating speed range at hot condition.
- Vibration level in analysis is from 2 to 10 mm/s 0-P around normal to maximum speed as same as site vibration level.

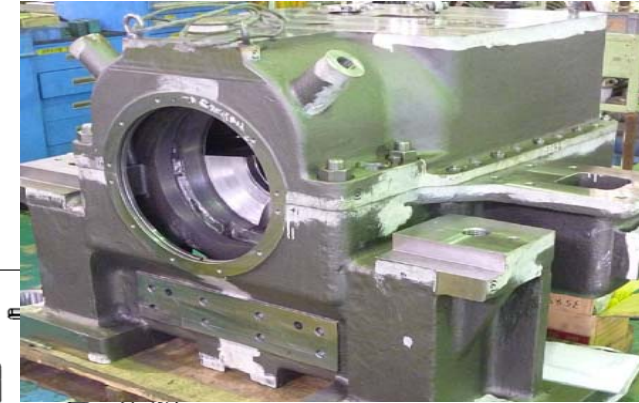
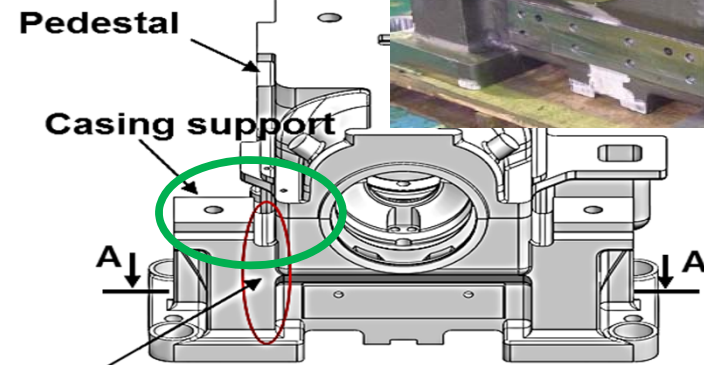
Integration between pedestal and casing support

Free standing of pedestal and casing support

- 1) Full contact condition of pedestal surface.
- 2) Rigidly connection between pedestal body and casing support without freestanding.

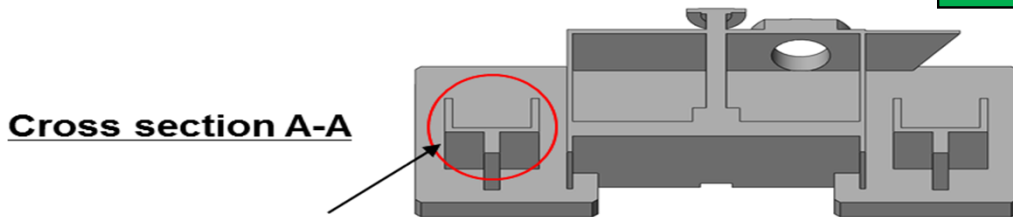
Old fabricated type

Optimized thickness support

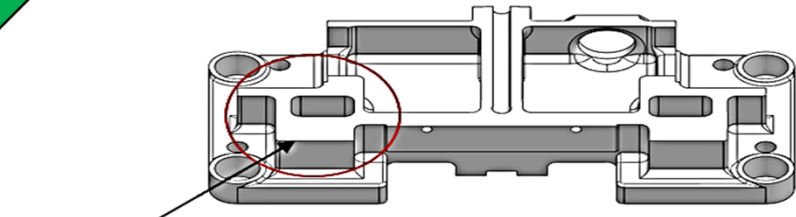
New casting type

Robust support

**Casting pedestal type has more high stiffness than original type**

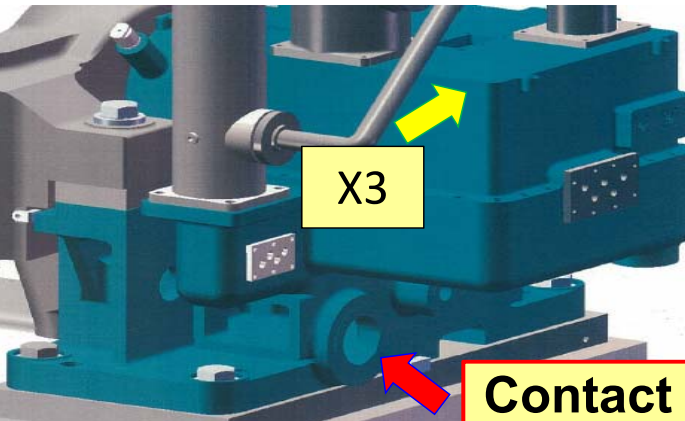
**Result;**  
a) Natural frequency 41.0Hz to be out of operation range, and satisfied with API standard (less than 48Hz).  
b) Vibration level in operation to be much lower at 0.2 to 0.4 mm/s 0-P even by 5-times of API unbalanced limit

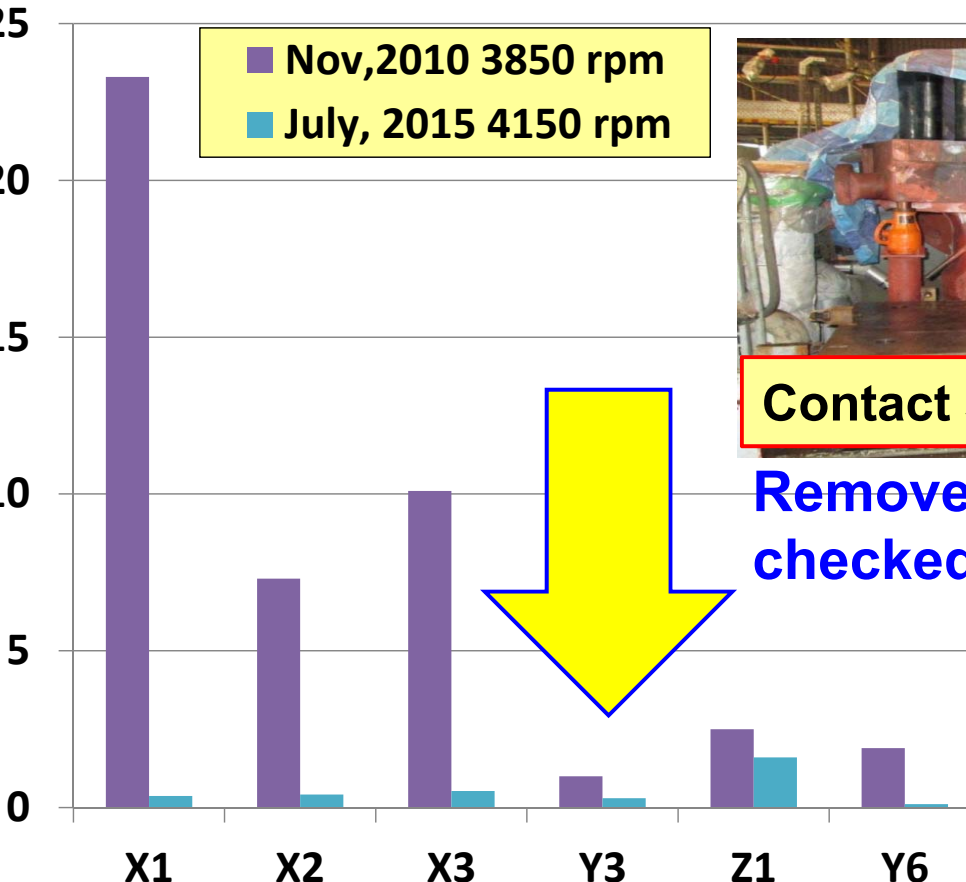
Vibration record improved pedestal in 2015

**Result ;**  
Vibration level in rotating speed to be much reduced, which means reduction of 1/10 (one-tenth) over compared with the existing pedestal vibration level.

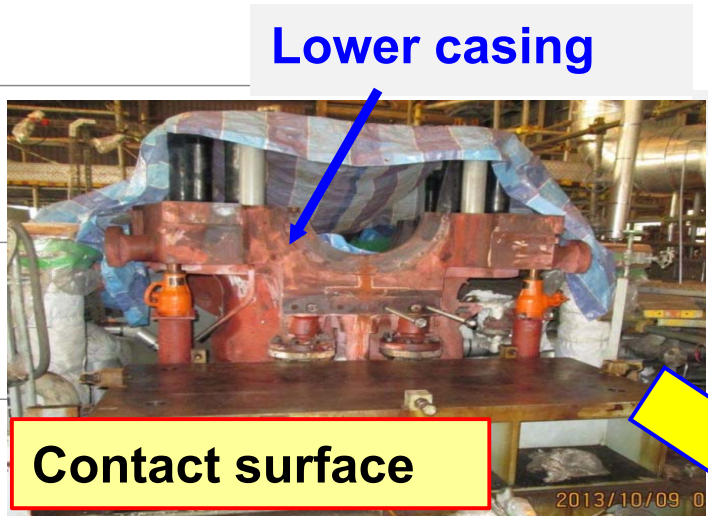
Removed old pedestal, checked alignment

Improved pedestal with cover
