ASIA TURBOMACHINERY & PUMP SYMPOSIUM  
SINGAPORE | 22 - 25 FEBRUARY 2016  
M A R I N A B A Y S A N D S

# Investigation of Process Gas compressor shaft vibration phenomena

## Investigation for Process Gas HP compressor shaft vibration phenomena

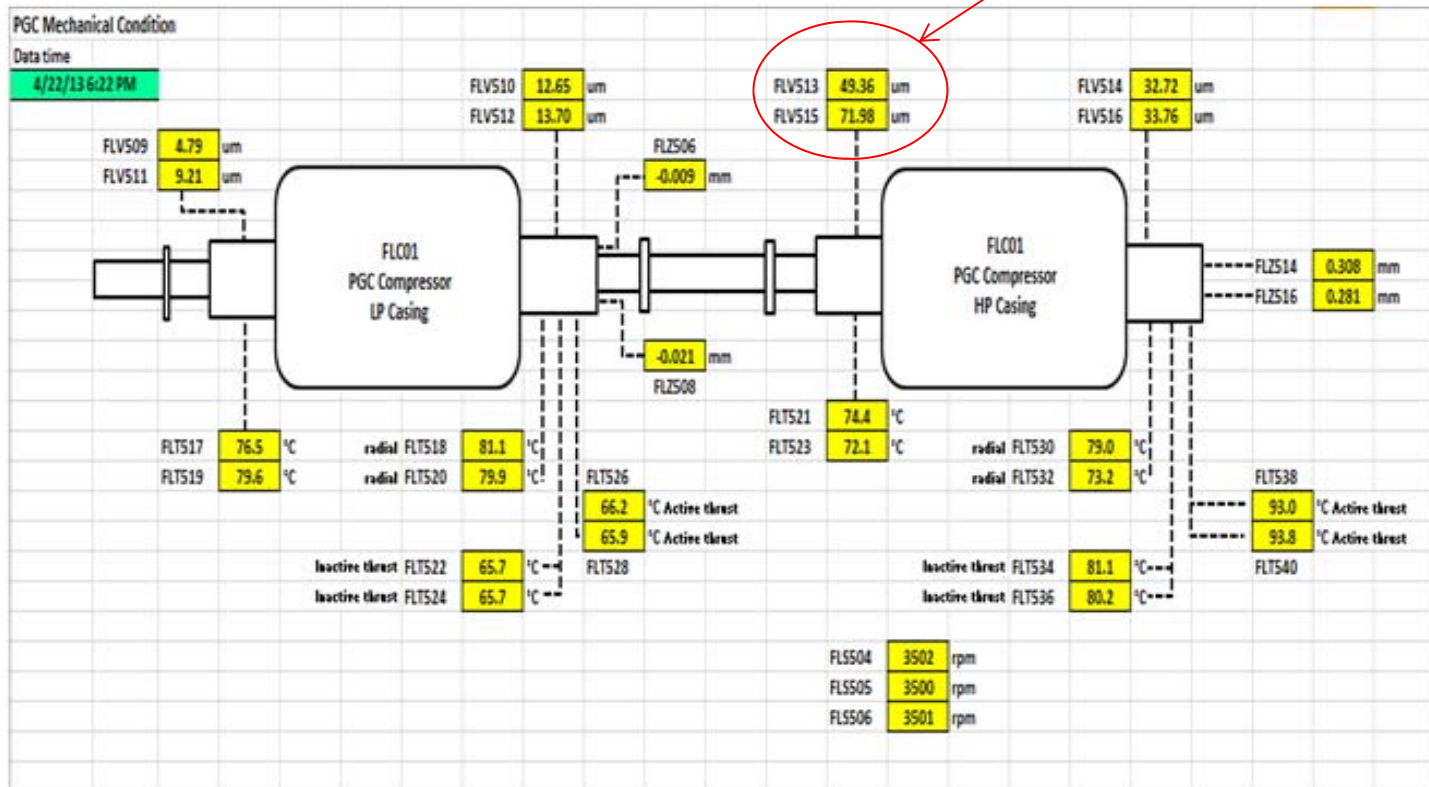
April 22<sup>nd</sup>. 2013:  
Working rotor

DE side vibration is higher than NDE side vibration for both rotors (working and spare rotors).

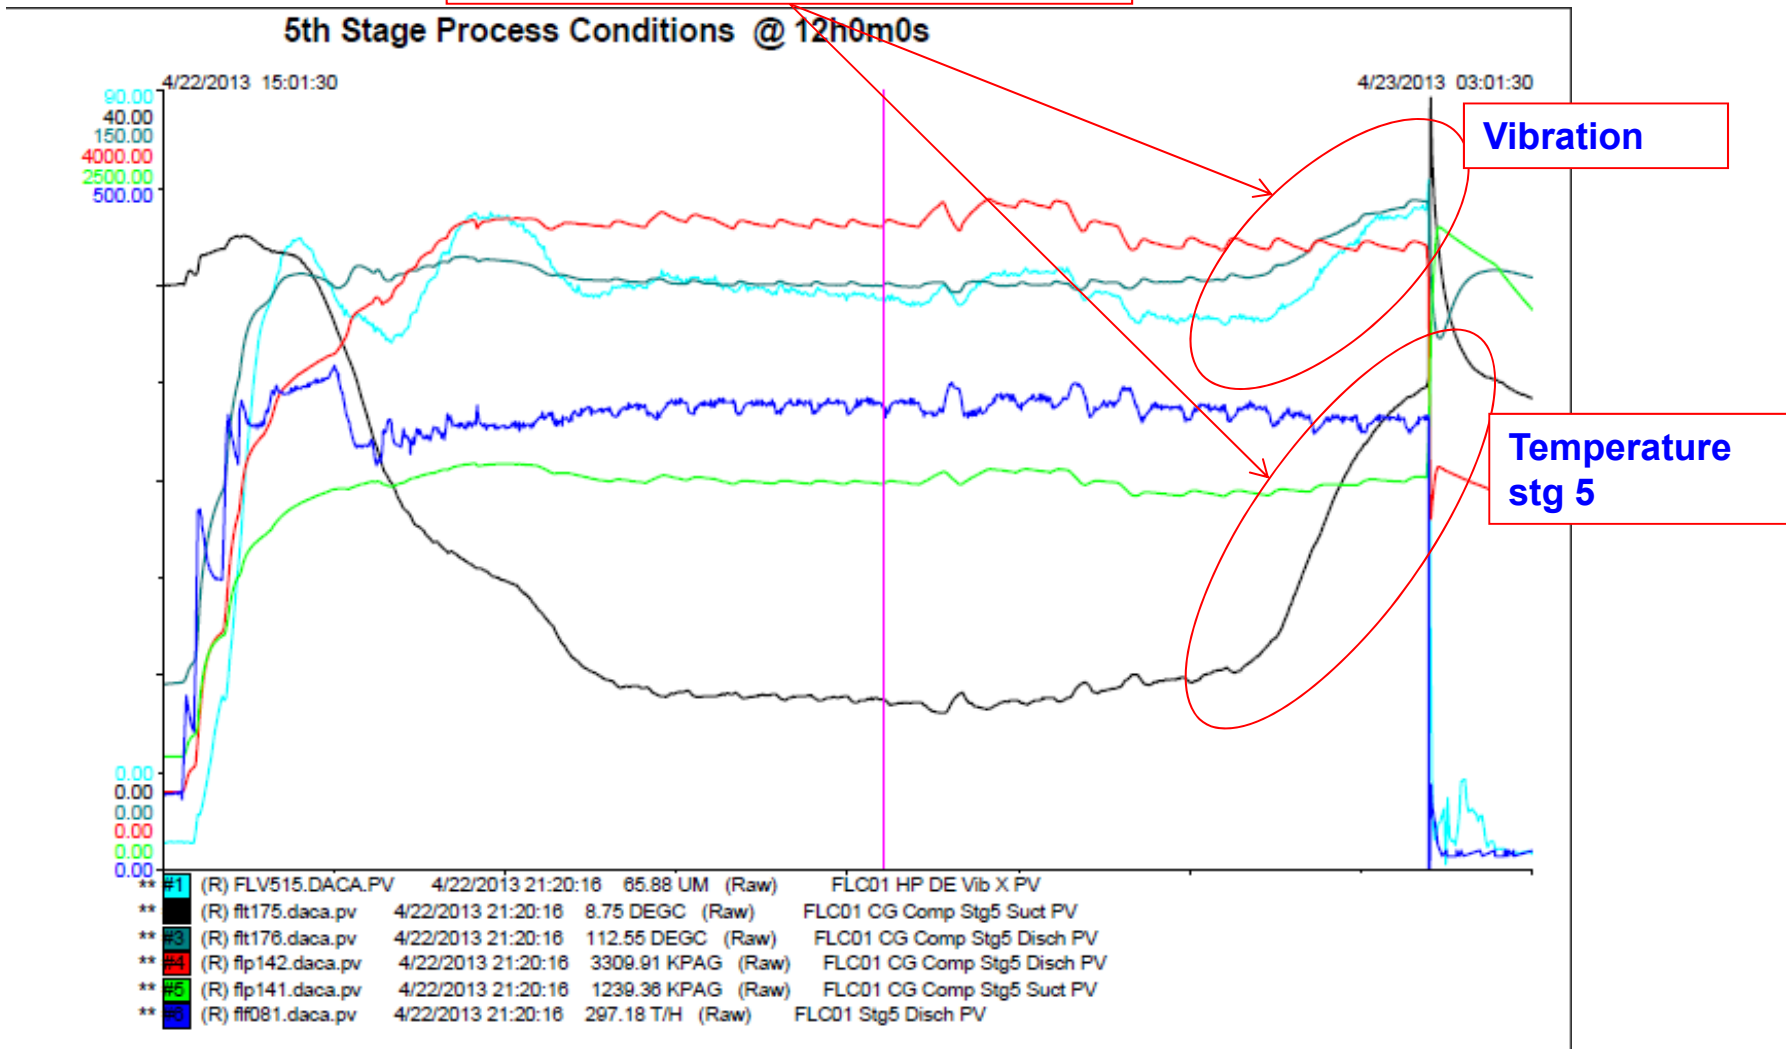
Strong correlation between vibration and section 5 suction and discharge temperature

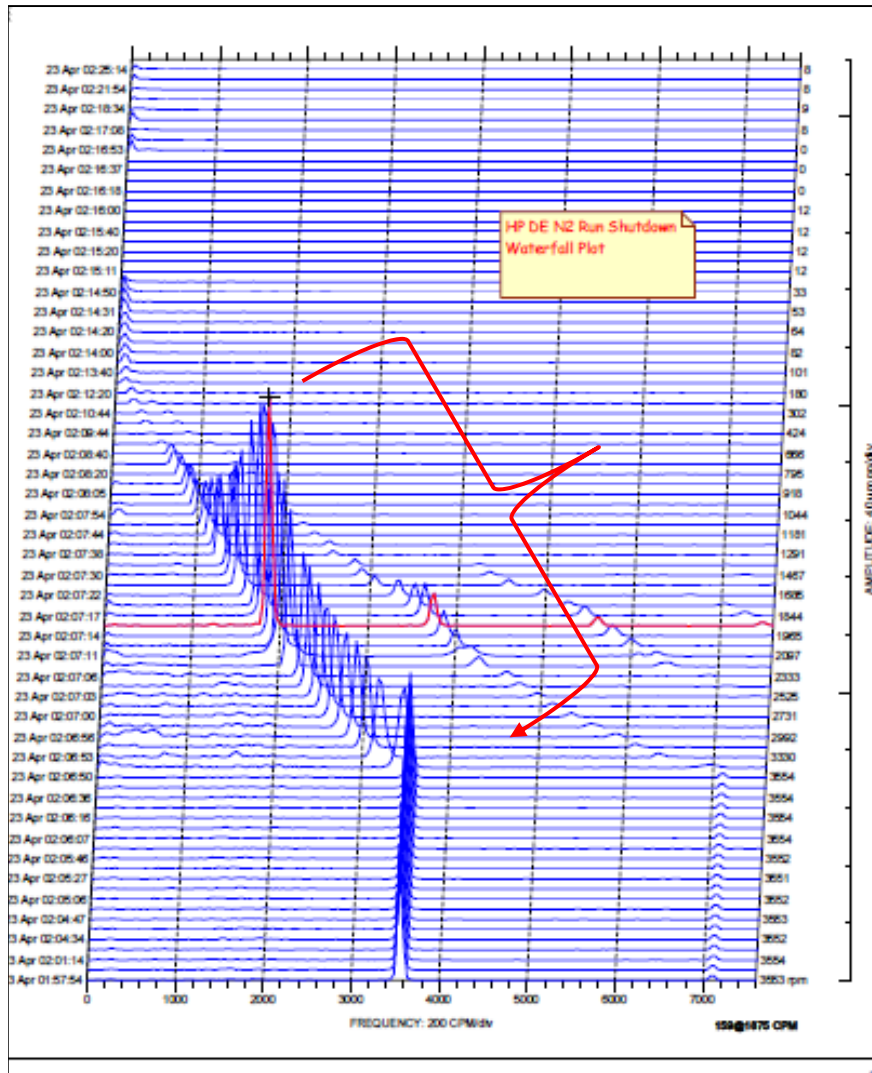
## Shutdown plot of working rotor – N2 run

Abnormal waterfall plot for shutdown  
– Vibrations up to 140 microns  
observed during shutdown

Rotor replacement initiated

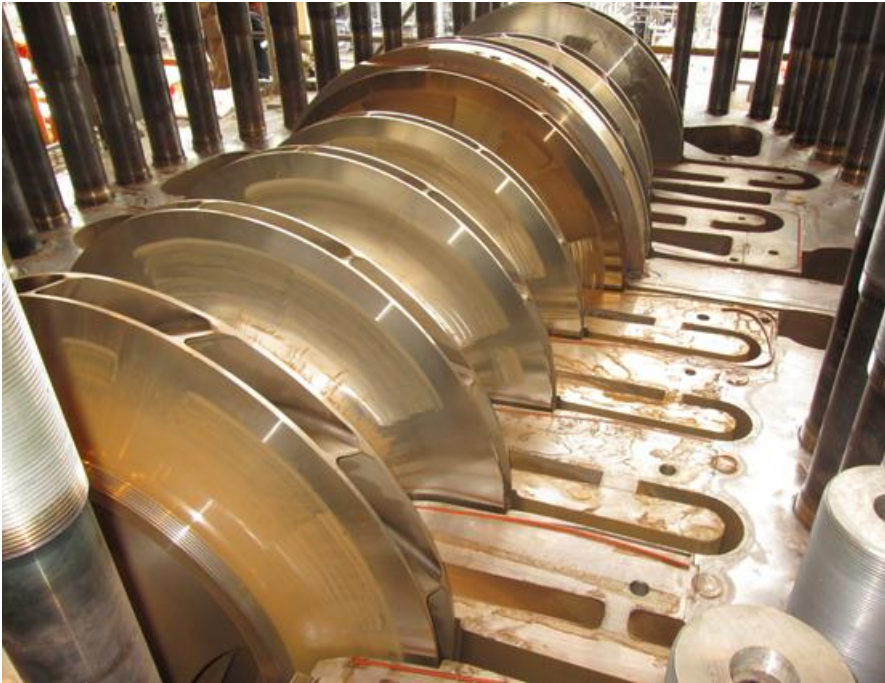
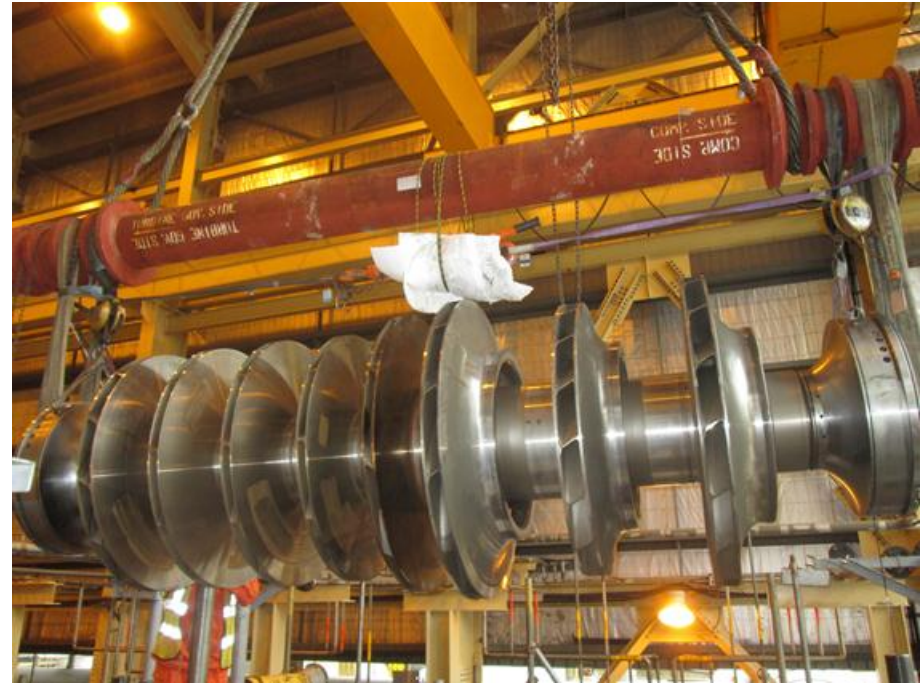
### Onsite as-found conditions

- Slight rust observed on rotor; otherwise rotor still looked good from outside

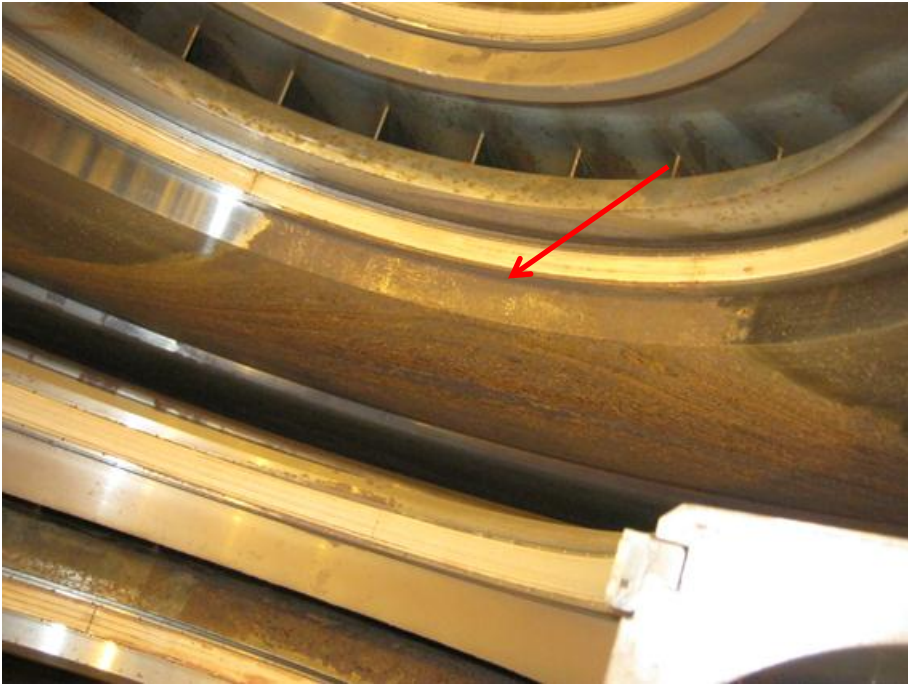
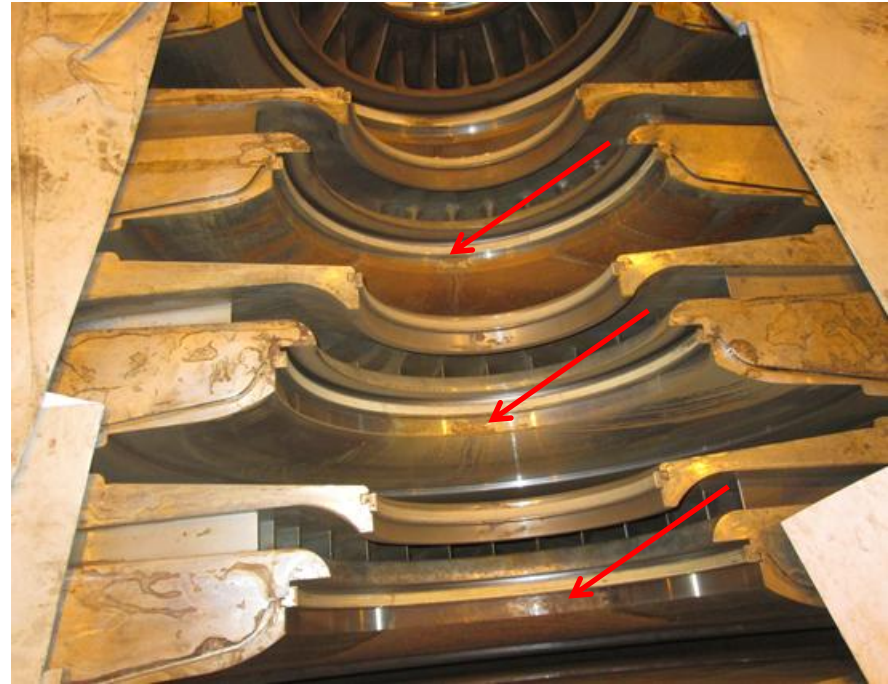
### Onsite as-found conditions

- Compressor casing was opened for inspection and some rusts on the rotor and casing was found. Rotor residual unbalance check was performed at local workshop. The residual unbalance was found higher but it was not adequately high to cause higher vibration level and also did not explain reason for high vibrations during coast down of the machine. Root cause of rusts was established as exposure to hydrotest water during piping hydro test at site.

- Significant rust observed on stationary diaphragms
- Water mark visible and indicated water accumulation to shaft centerline at 5<sup>th</sup> stage section

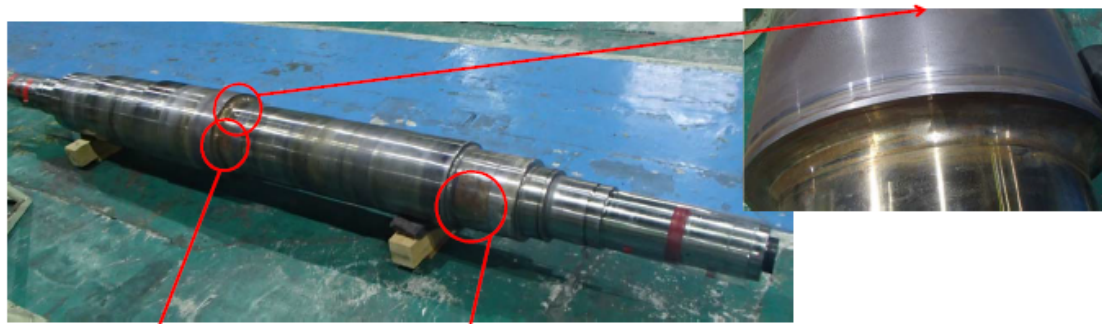
Compressor shaft

- ✓ Heavy rust was observed around HP section (4th to 8th impeller) mainly. (Stage 1-3 is 17-4PH. Stage 4-8 is SNCM 431.)

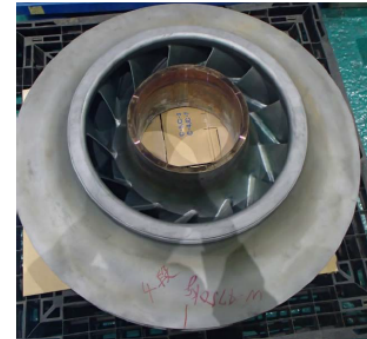
4th impeller

- ▶ 4<sup>th</sup> and 8<sup>th</sup> impeller had most severe rust accumulation
  - ▶ Process stage 4 (1<sup>st</sup> to 3<sup>rd</sup> impellers on the rotor) impellers were found to be in good condition

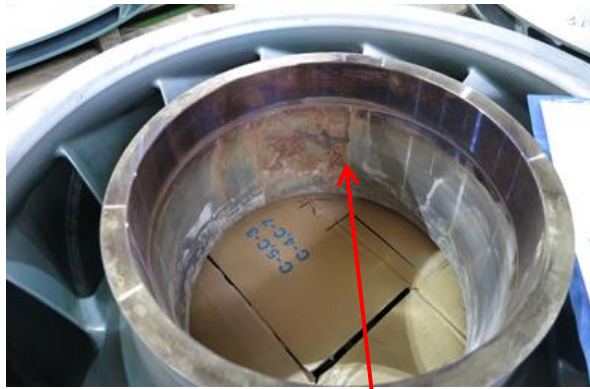
Rotor as-found condition after disassemble 4<sup>th</sup> Impeller and shaft

- Impellers were de-stacked for detailed inspection
  - ▶ Rust sediments were observed accumulated within the clearances under the 4<sup>th</sup> to 8<sup>th</sup> impellers.

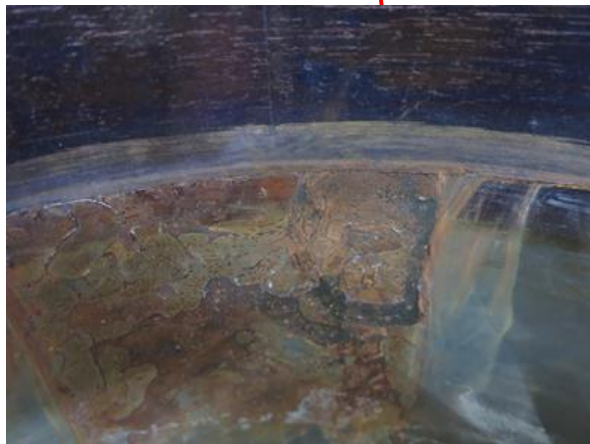
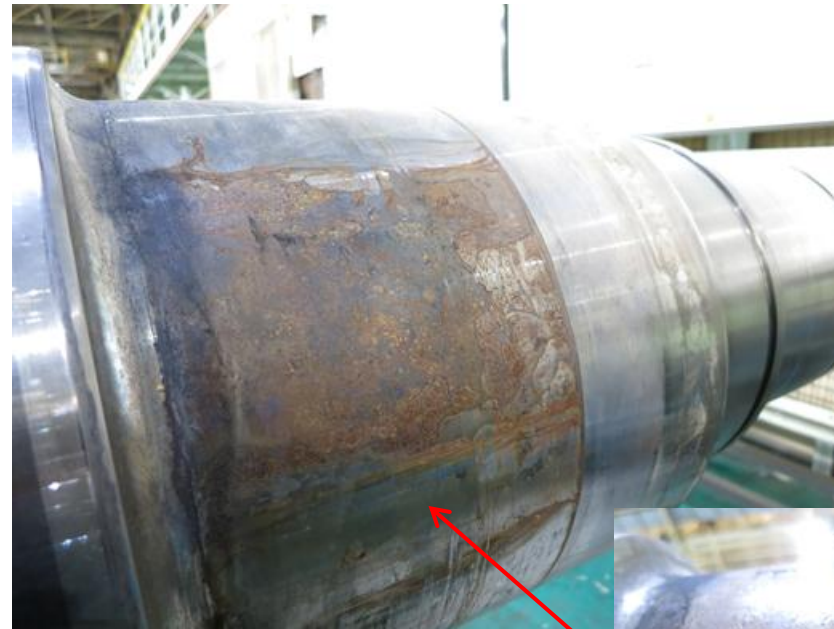
Under 4<sup>th</sup> impeller

Deep scratch marks across the width of the impeller created during impeller removal. This indicated the presence of hard particles within the clearances between the shaft and impeller

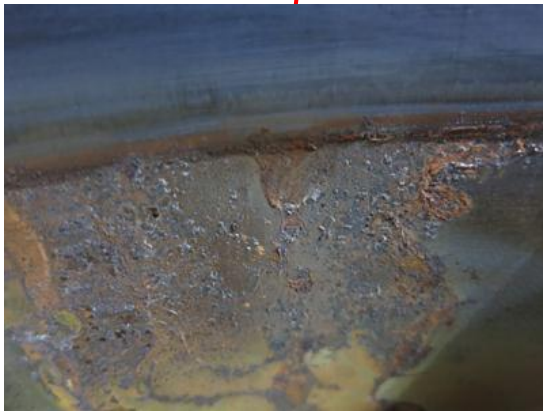
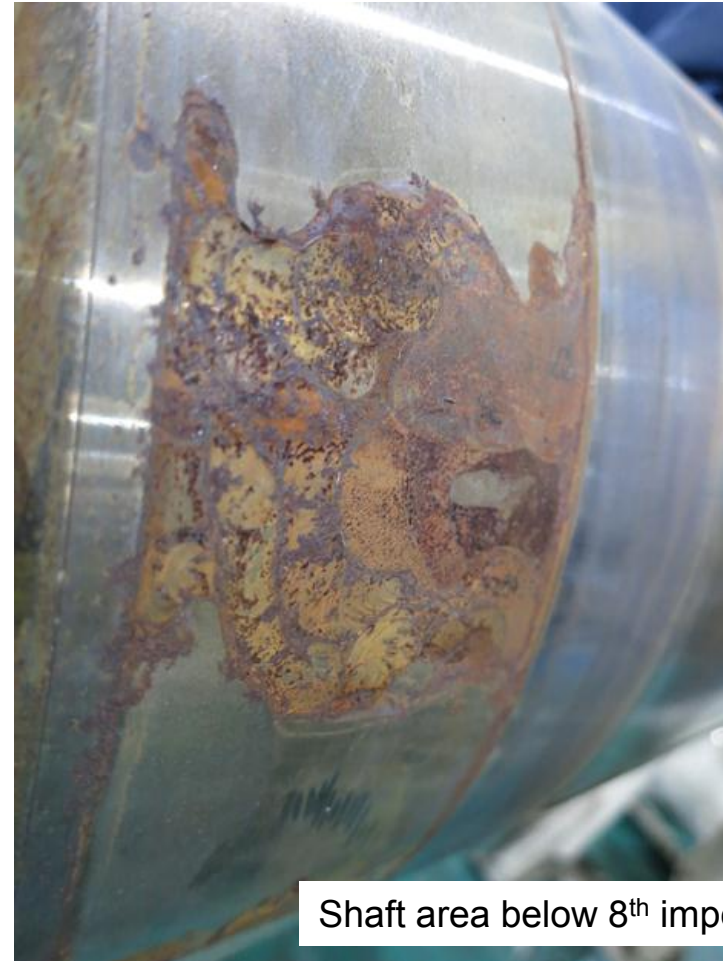
Under 8<sup>th</sup> impeller

Shaft area below 8<sup>th</sup> impeller

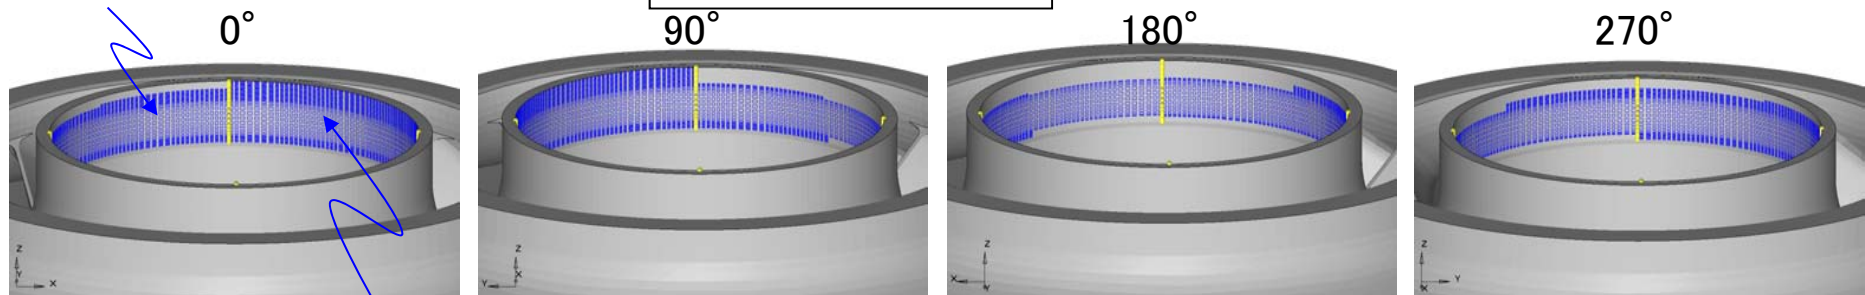
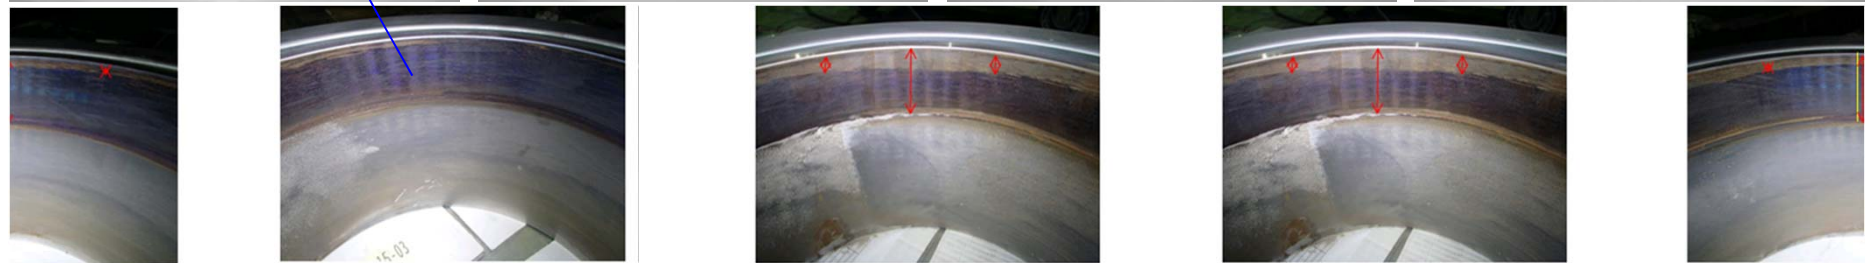
**As found condition of contact area**

Item	Analysis condition
Objects	Shaft and 5 <sup>th</sup> Impeller
Speed	3982rpm(MCR)
Load	Centrifugal force + Shrink fit pressure
Assumptions	<ul style="list-style-type: none"> <li>▪ Recorded dimension was used.</li> <li>▪ Color distribution was considered as contact area. (Area is 76.6% of design.)</li> <li>▪ Thermal expansion was not considered.</li> </ul>

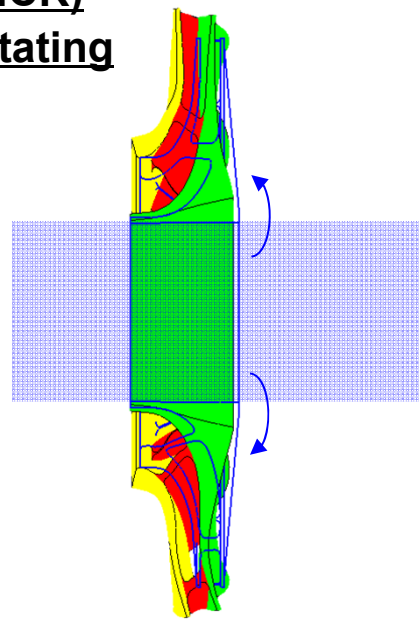
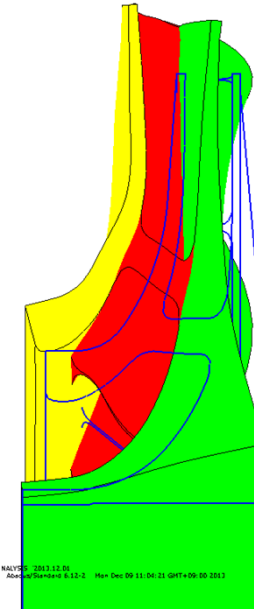
Rotating

The gap between impeller and shaft is increased by impeller centrifugal deformation.

(0.1489mm / on radius)

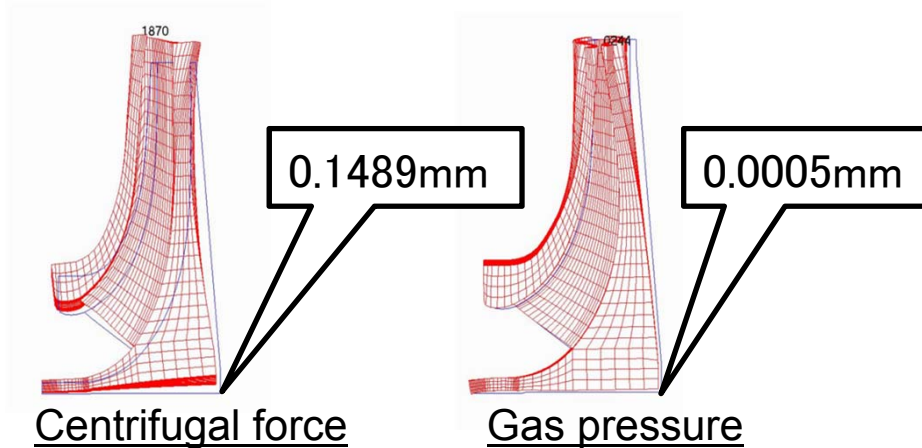
- 0.0005mm of deformation at impeller inside edge was caused by gas pressure.
- The impeller deformation by gas pressure was very small comparing to the deformation by centrifugal force.

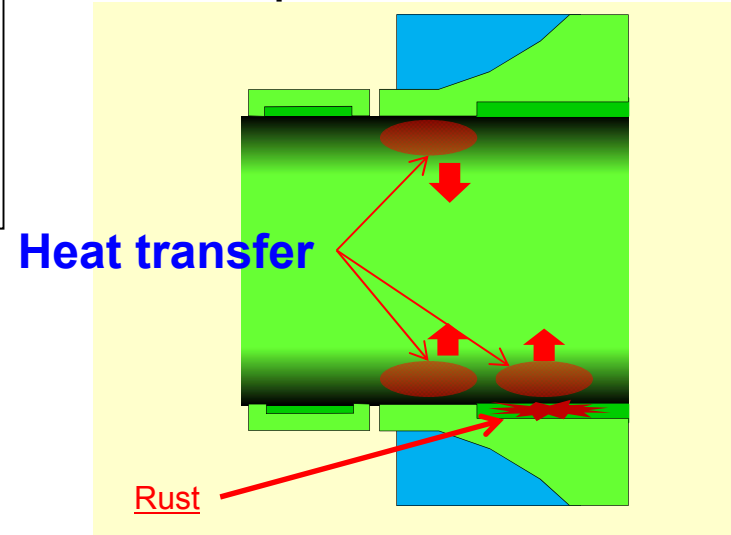
PGC HP spare rotor

<p><b>Thermal bending of shaft</b></p>	<ul style="list-style-type: none"> <li>• The heavy rust was observed around HP section (4th to 8th impeller)</li> </ul> <p>⇒ Thermal bending of the rotor might be caused by the rust, due to the no uniform heat transfer.</p>	<p><b>Possible.</b></p> <p>FEM analysis shows the possibility. (P.21-24)</p>

Thermal bending of the rotor could be caused by the rust, due to the uneven heat transfer from impeller.

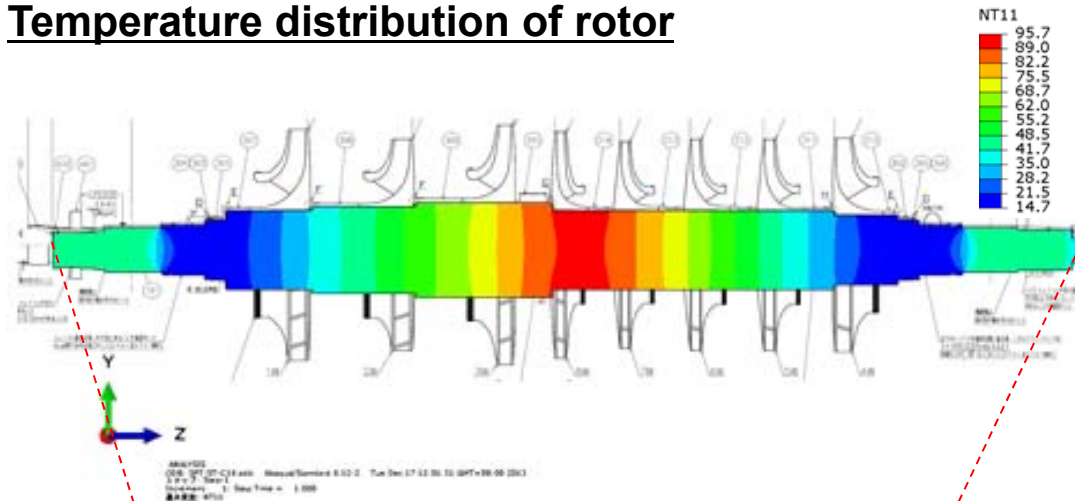
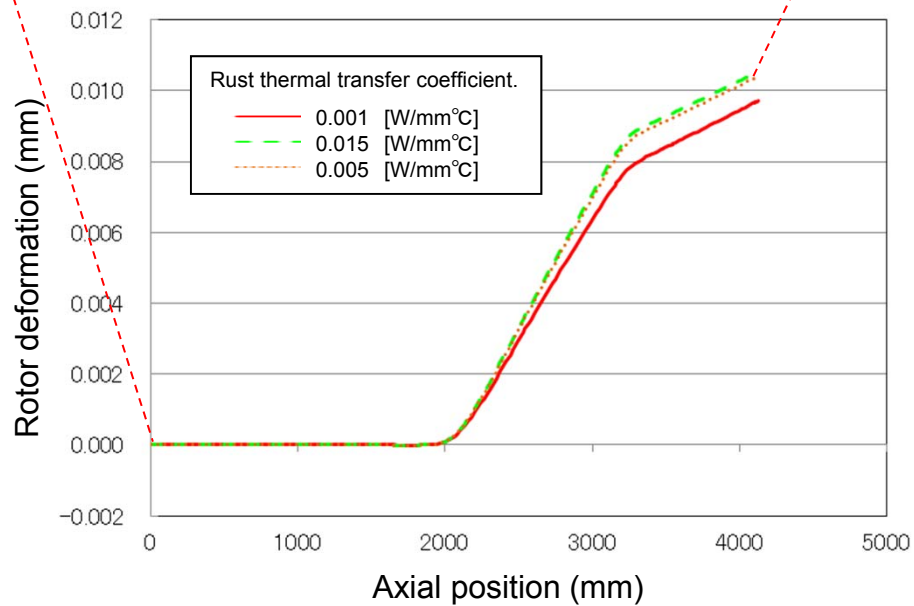
## Temperature distribution of rotor

Rotor thermal bending analysis was performed based on N2 operating condition.

Small effect of rust thermal transfer coefficient difference was confirmed by the analysis.

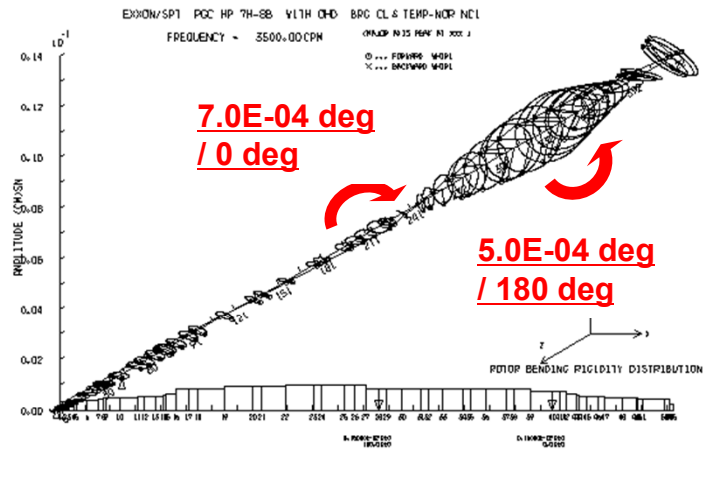
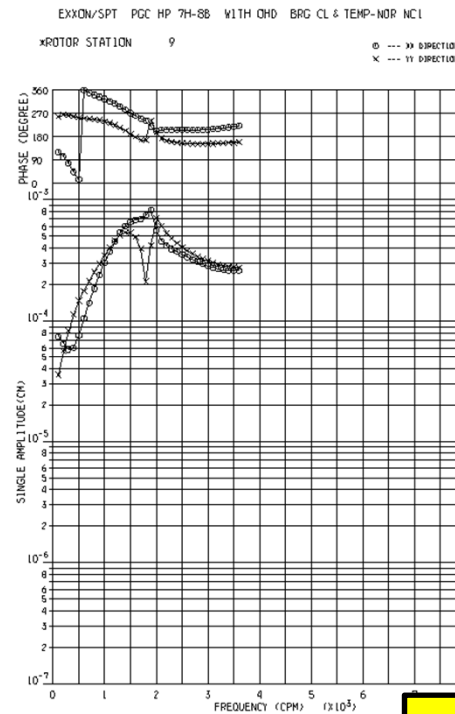
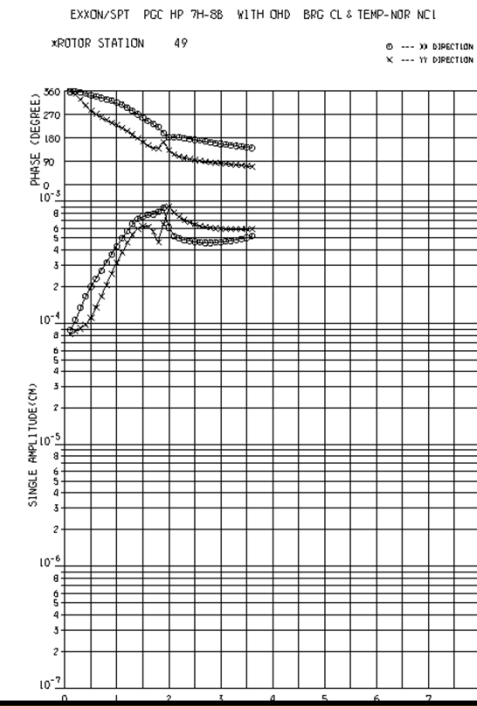
## Case study

TH side H [μm <sup>p-p</sup> ]	TH side V [μm <sup>p-p</sup> ]	N-TH side H [μm <sup>p-p</sup> ]	N-TH side V [μm <sup>p-p</sup> ]
Site operation	34	33	72	49
Analysis considering rotor bending due to the rust	6	6	12	10

Magnification factor of almost 2 between DE and NDE, almost matched with site observation
