44<sup>TH</sup> **TURBOMACHINERY** & 31<sup>ST</sup> **PUMP** SYMPOSIA  
HOUSTON, TEXAS | SEPTEMBER 14 – 17 2015  
GEORGE R. BROWN CONVENTION CENTER

# Pipe Vibration Caused by Aero Excitation Resulted from a Foreign Object Lodged Inside an Impeller Passage

Dr. Zheji Liu  
Mark J. Kuzdzal  
Scott D. Wisler  
September 17<sup>th</sup> 2015

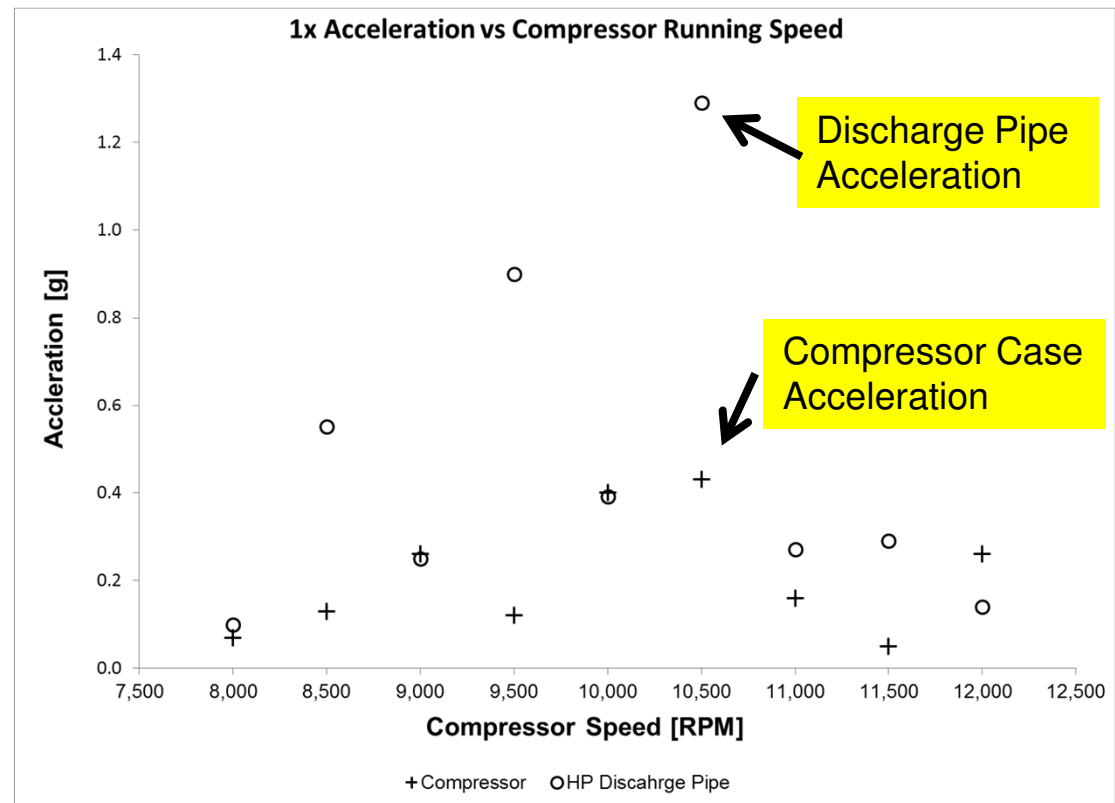
- ◆ One of the three compressor trains was observed with high discharge pipe vibration.
- ◆ High acceleration (g's) was reported on the discharge pipe of unit # 1
- ◆ Highest amplitude occurs at 1x rotor speed

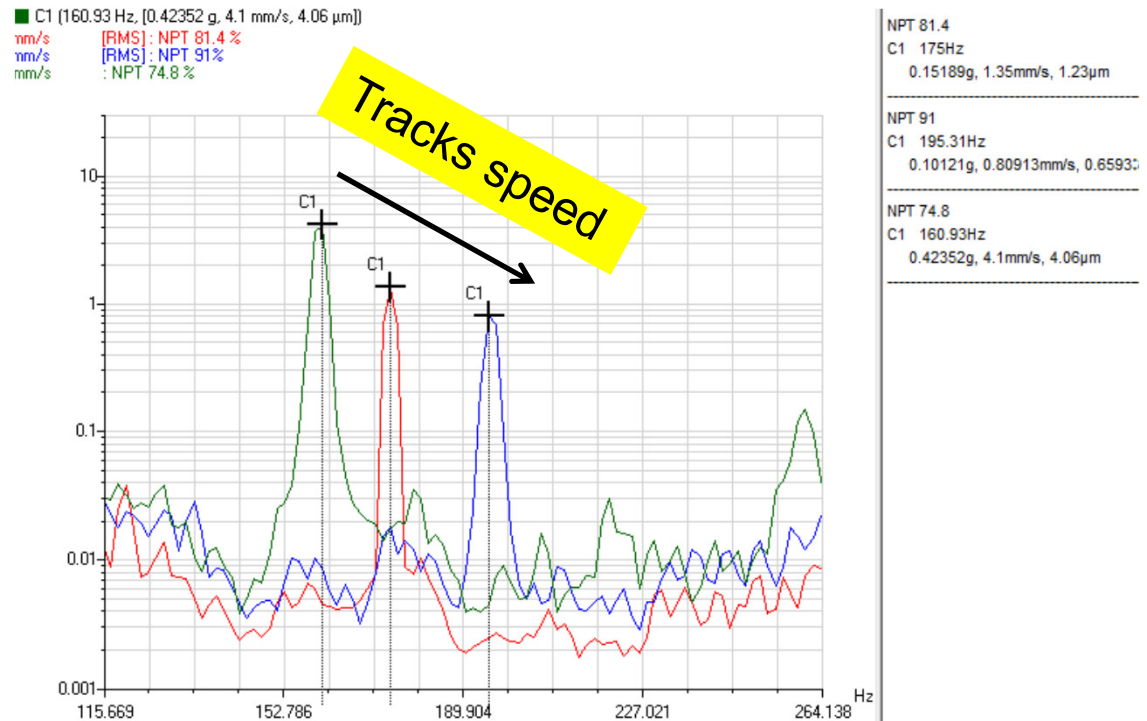
- ◆ Pipe peak vibration frequency occurs at 1x and tracks with speed

Mechanical and acoustical resonance is ruled out

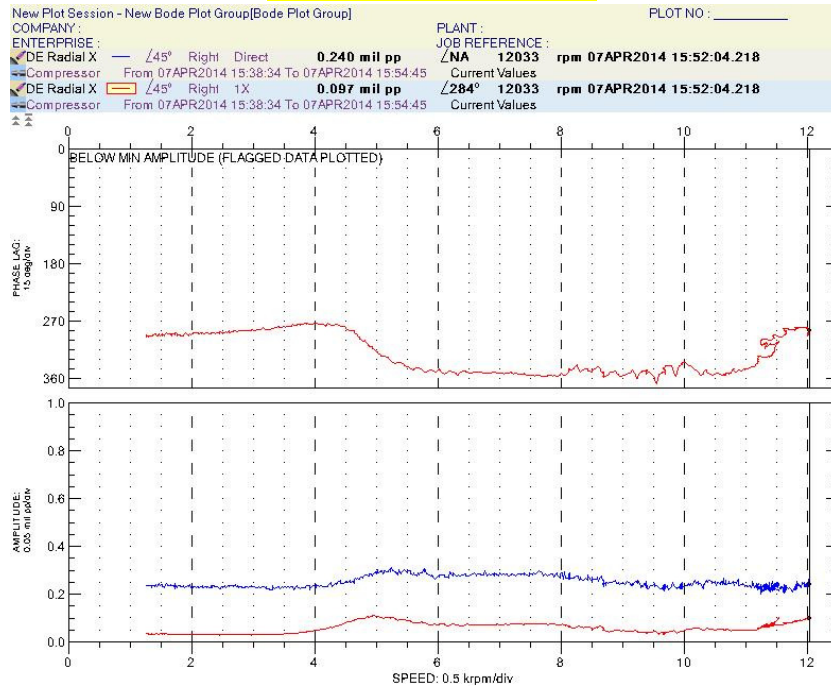
Unit # 1- High Pipe Vibration

Unit # 1 high pipe vibration has lower shaft vibration

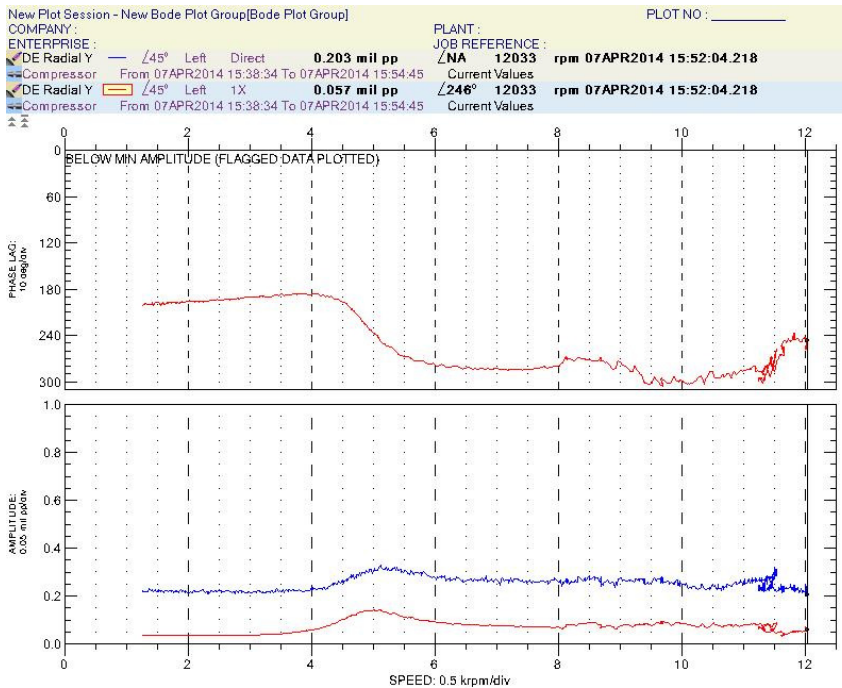
Unit # 1- High Pipe Vibration

Unit # 1 high pipe vibration has lower shaft vibration

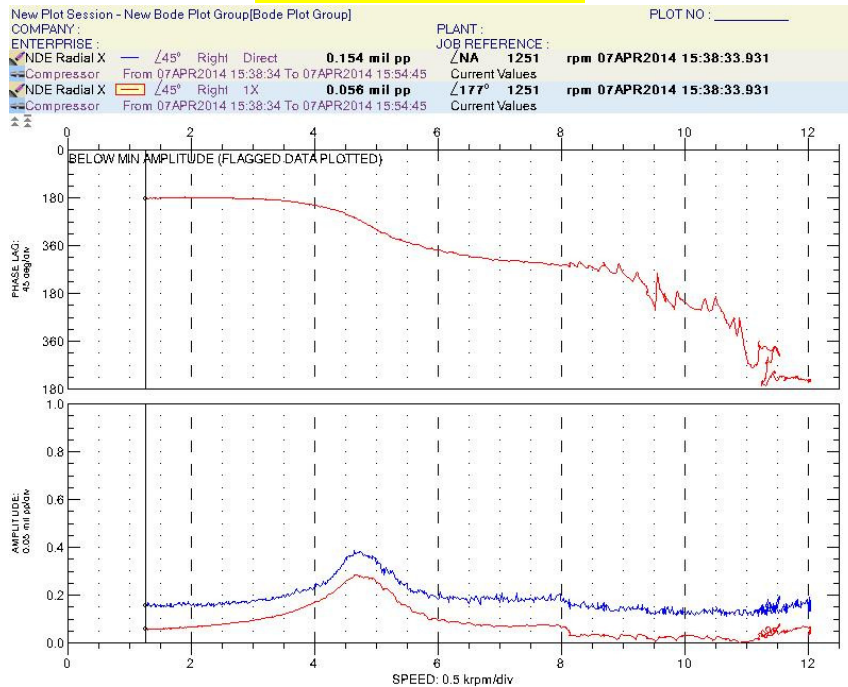
Unit # 1- High Pipe Vibration

Unit # 1 high pipe vibration has lower shaft vibration

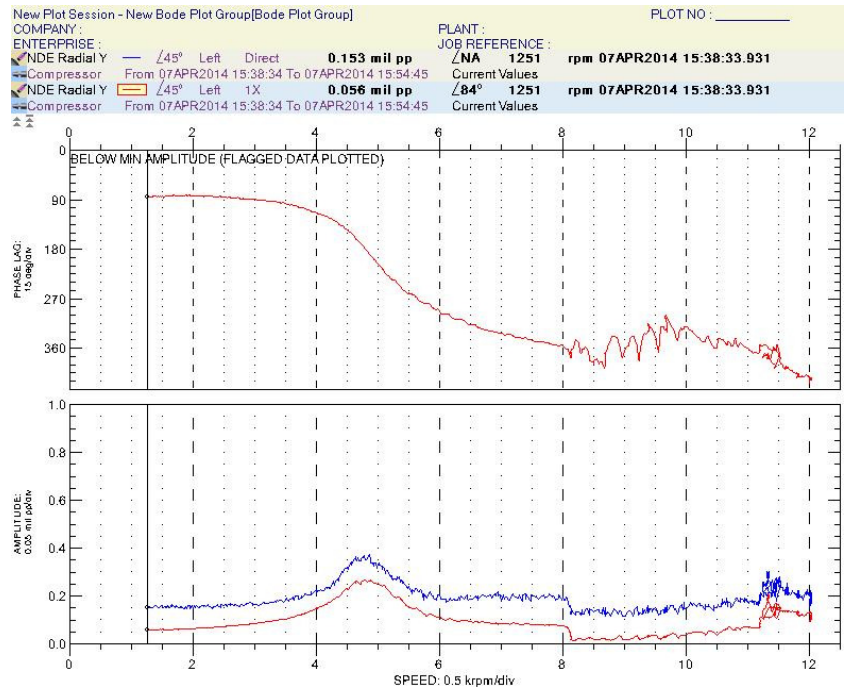
Unit # 1- High Pipe Vibration

Unit # 1 high pipe vibration has lower shaft vibration

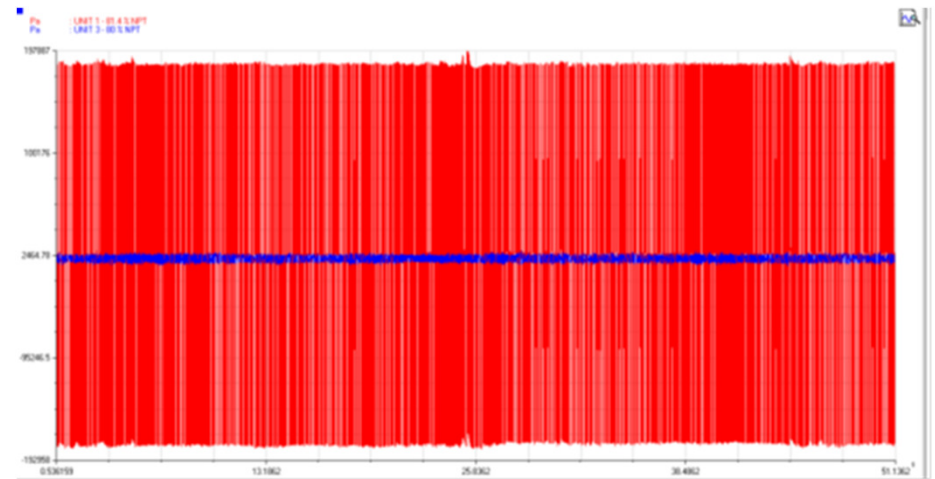
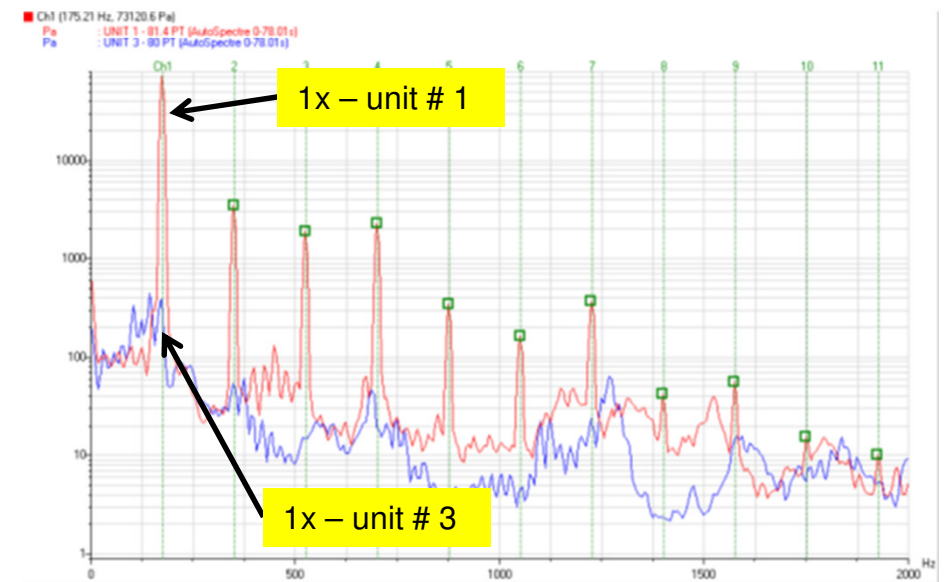
- ◆ Time domain pressure fluctuation of Unit #1 is 100 times higher than that of Unit #3
- ◆ Frequency domain spectrum comparison shows the same higher amplitudes in Unit # 1

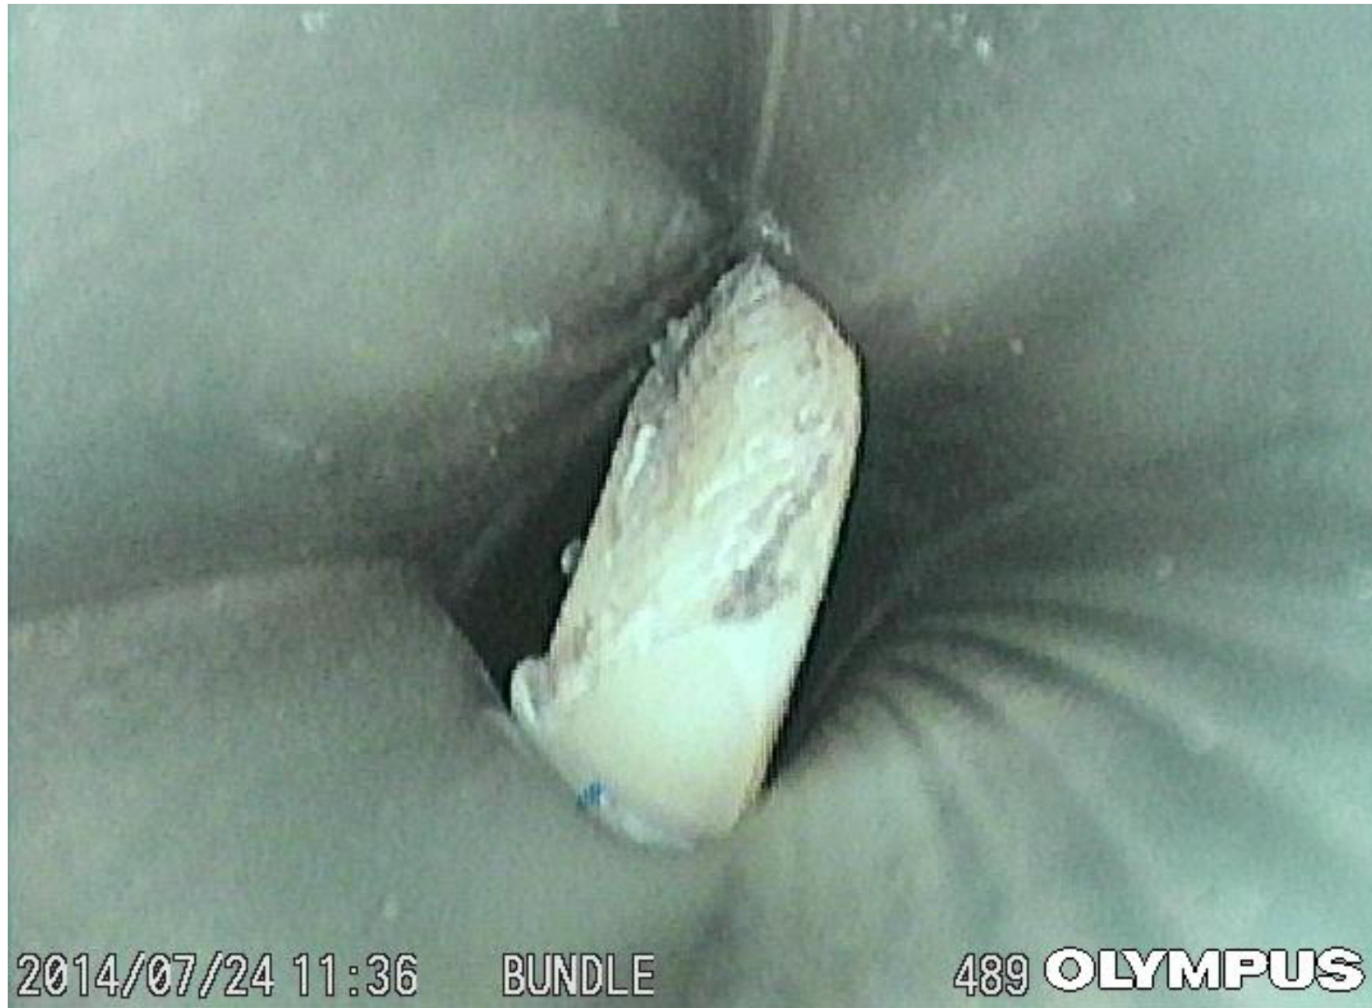
Disassembly of the compressor revealed about 50% of one impeller passage was blocked

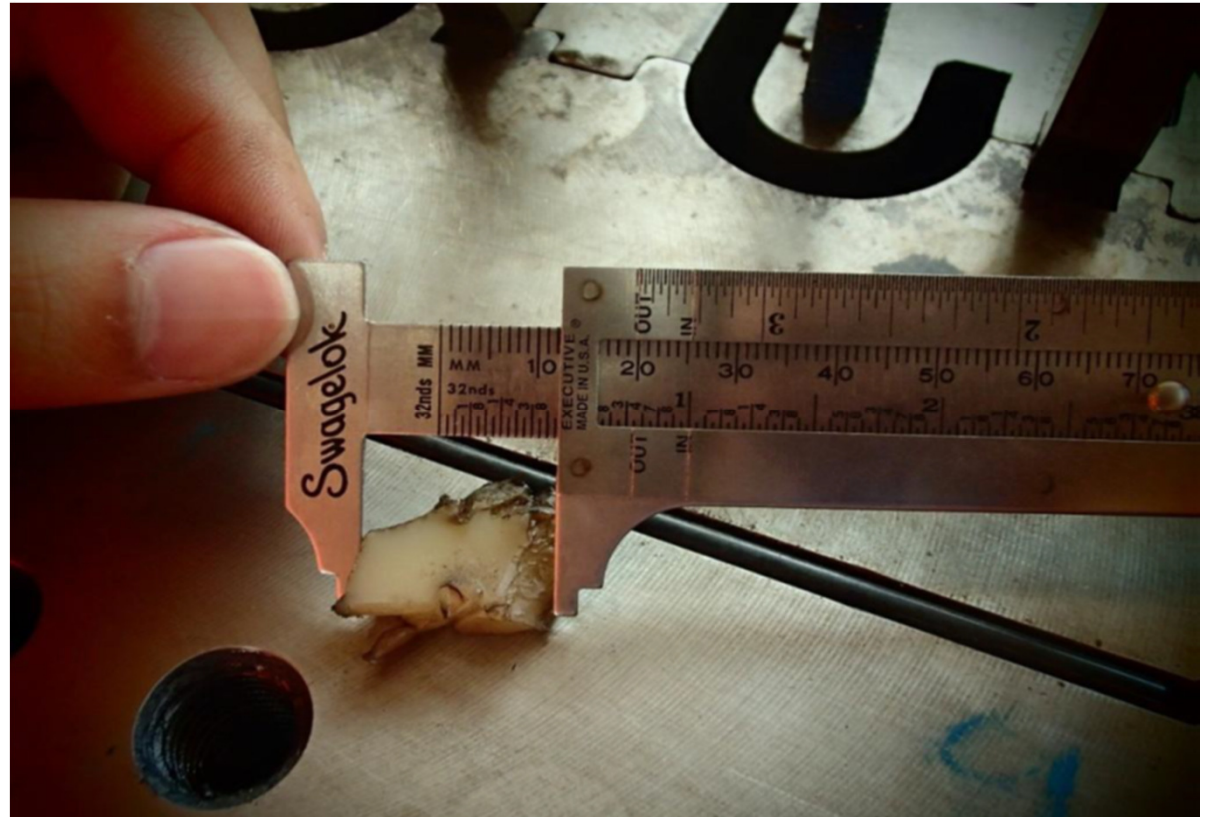
- ◆ Teflon like material was lodged in a blade passage of the last stage impeller.

Approximately 12 mm or 0.5 inches

- ◆ The foreign object lodged in a blade passage of the last stage impeller restricted flow and made that passage work significantly less than the other 16 passages.
- ◆ This uneven mass flow distribution at the impeller exit generated a 1x aero-acoustic excitation.
- ◆ The high vibration and noise on the discharge pipe was in response to this 1x aero excitation.
- ◆ Removal of the foreign object from the impeller passage resolved this field pipe vibration problem.
- ◆ Since the foreign object found lodged in the last stage impeller passage was Teflon and light in density, it did not contribute enough unbalance weight to make the rotor vibration noticeably different.

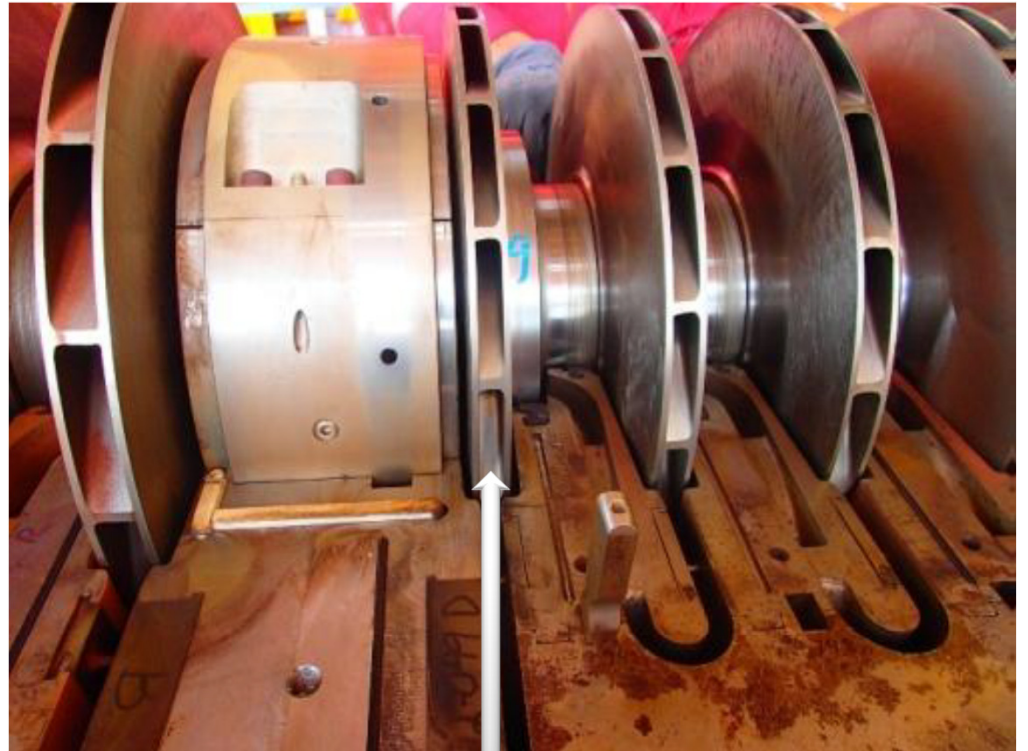
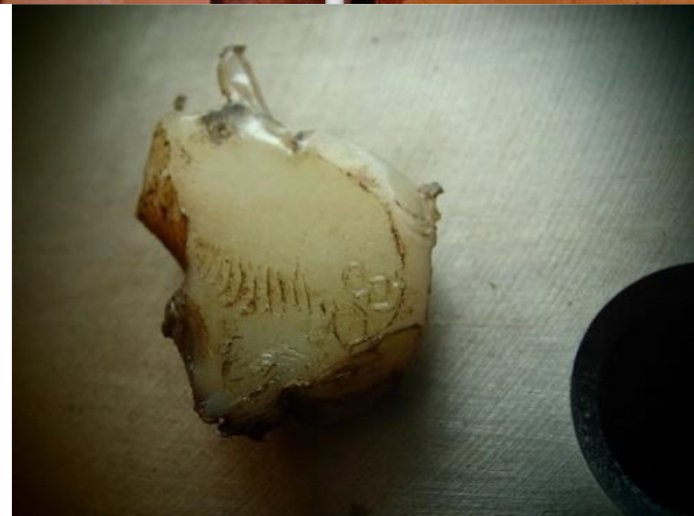
- ◆ The last stage impeller typically has the narrowest passage width and was small enough to catch the Teflon.
