44<sup>TH</sup> **TURBOMACHINERY** & 31<sup>ST</sup> **PUMP SYMPOSIA**  
HOUSTON, TEXAS | SEPTEMBER 14 – 17 2015  
GEORGE R. BROWN CONVENTION CENTER

# ELIMINATING DAMAGE BY USING ANTI-VORTEX VANES

- Damage to the end head was observed on boiler feed pumps that were running for up to 20 years with reliable service.
- These boiler feed pumps are high speed, high pressure pumps that supply water to the boilers of power plants of 500 to 800 megawatts.
- The damage prevented accurate assembly of the seal housing to the end head.
- The method applied to prevent this damage is the subject of this case study.

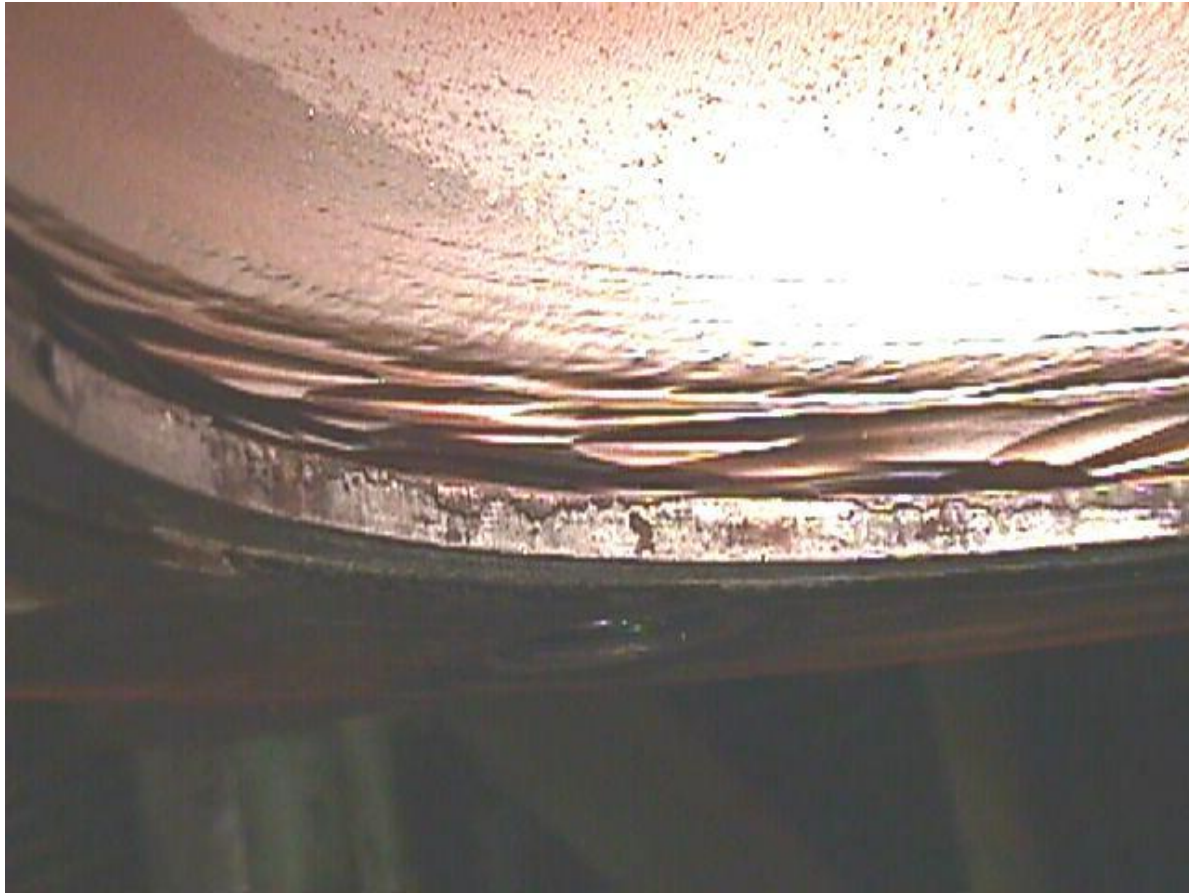
# Example of the Damage Observed (Water Wash and Erosion)

- Using the anti-vortex vanes eliminated the water wash and erosion damage.

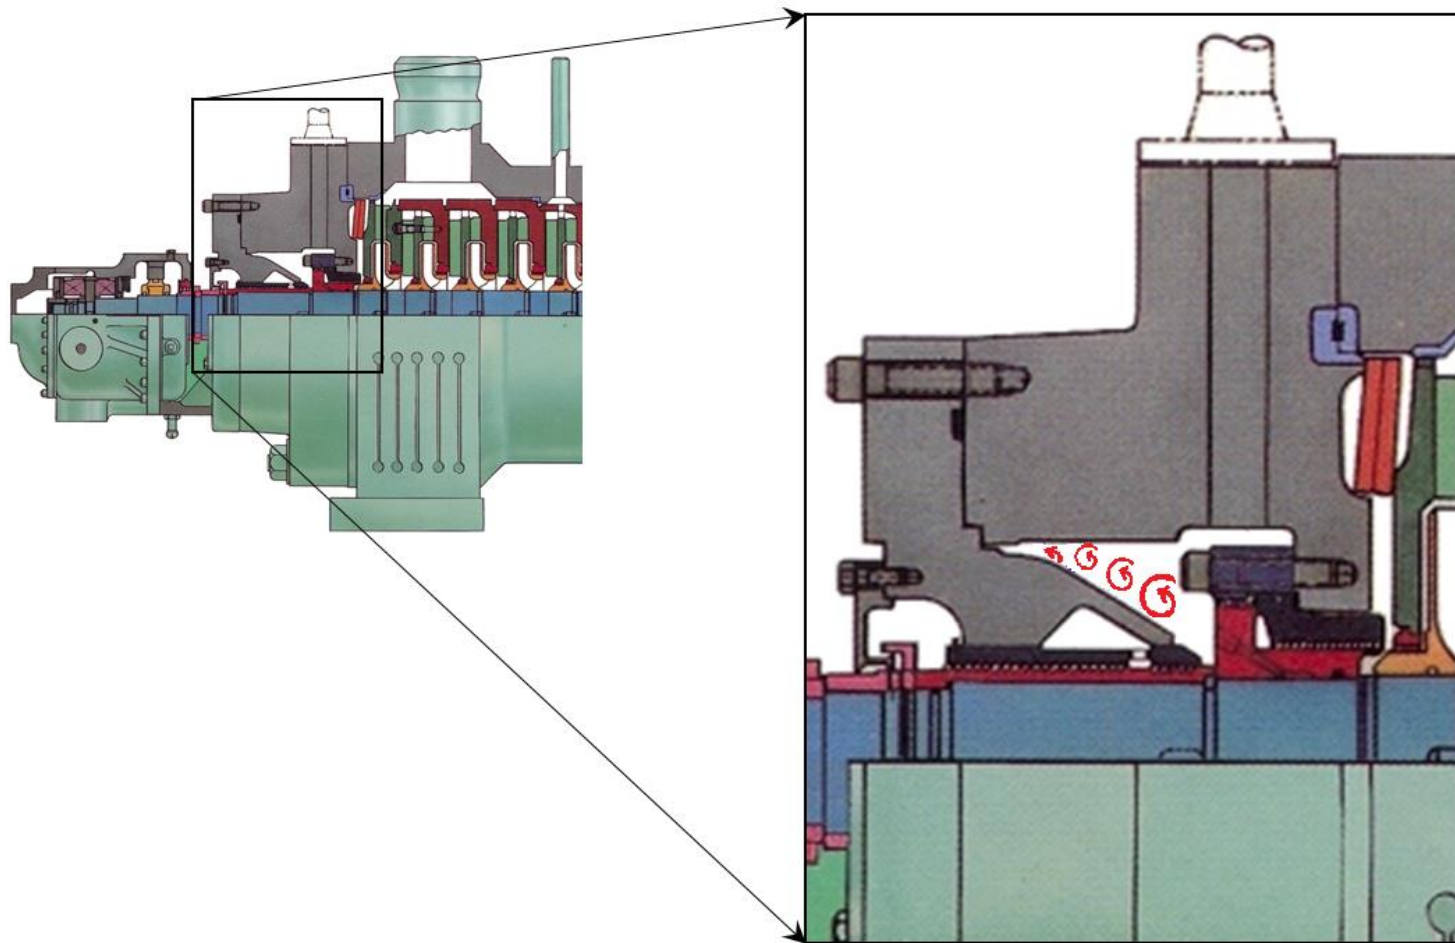
# Hypothesis of the Root Cause of the Damage
