Circulating Water Pump Resonance

Monroe Voyles, Solutions Engineer

ITT Goulds Pumps
Seneca Falls, NY

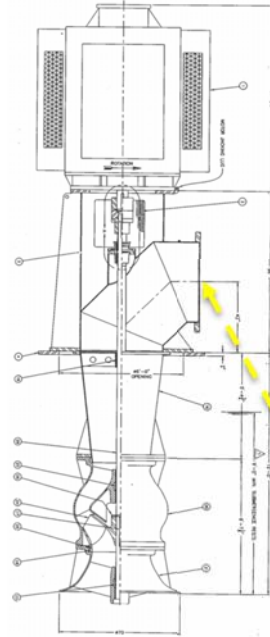
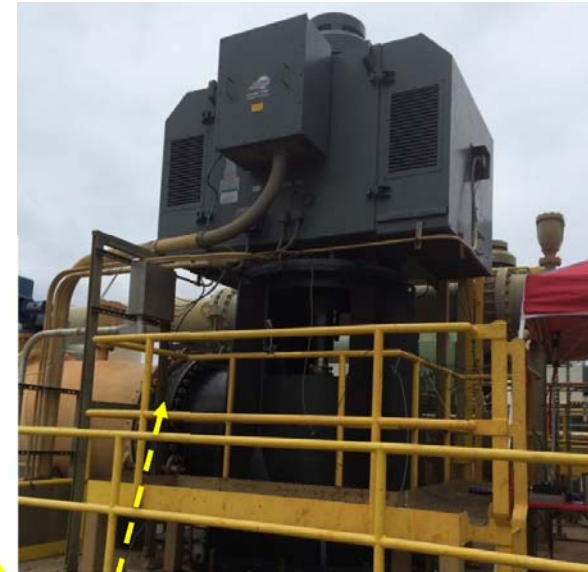
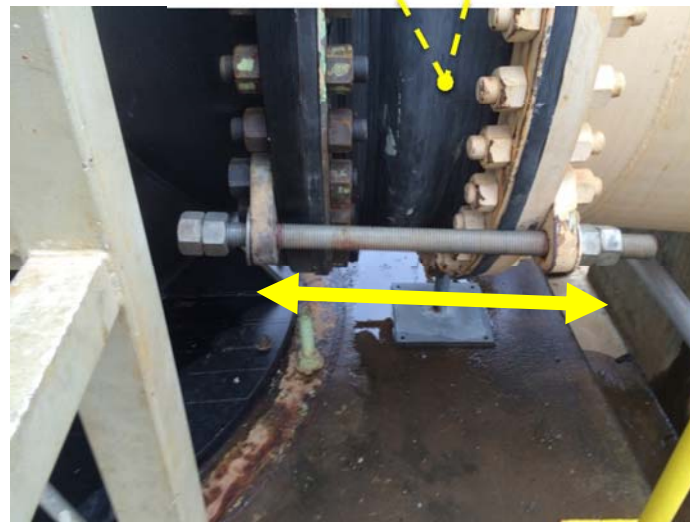
Discharge Expansion Joint

- The tie bolts were initially loose.
- Loose tie bolts allow hydraulic separation forces to be applied to the pump discharge head.
- Significant vibration changes were observed when the spare pump was started in parallel (higher discharge pressure/force)

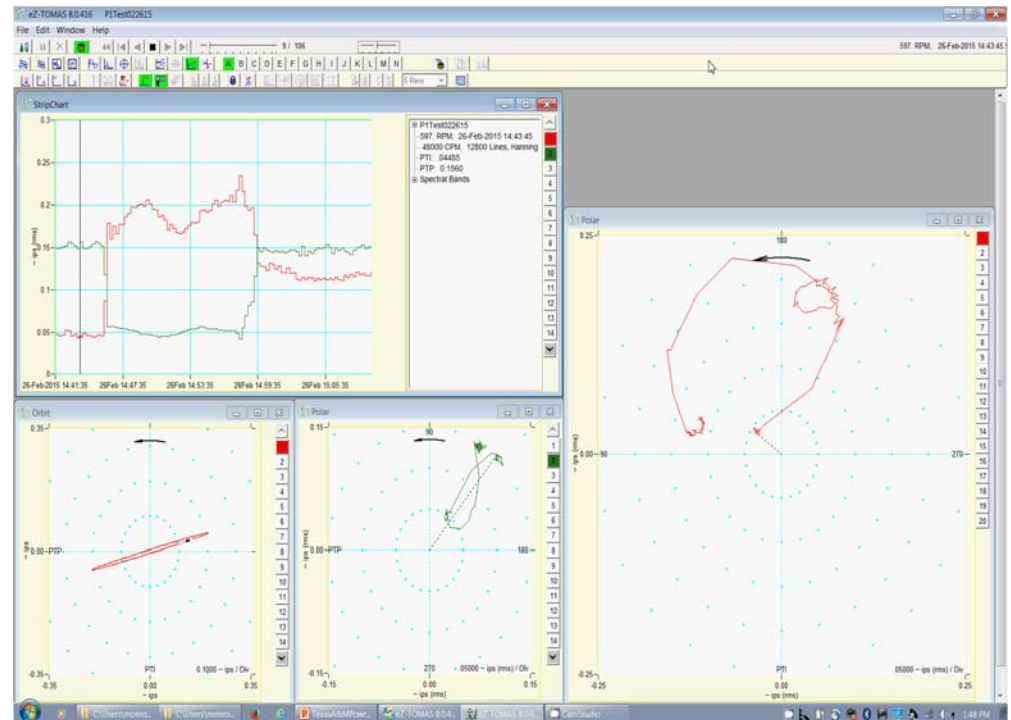
Operating Condition Changes (animation)

- 1- Solo operation (tie bolts loose)
- 2- Start spare CWP in parallel operation; nat. freq. increased into operating speed. (note beat pattern)
- 3- While still in parallel operation the tie bolts were tightened; lower thrust force; nat. freq. lowered back below operating speed

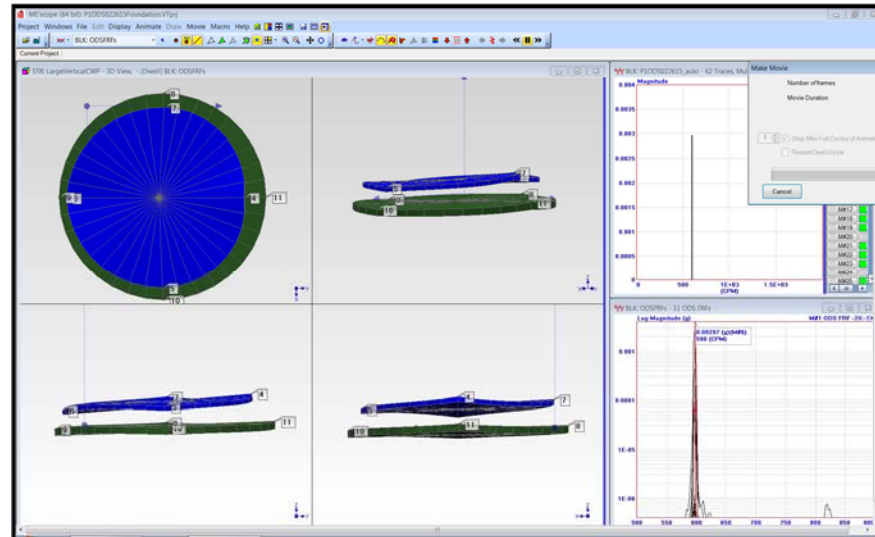
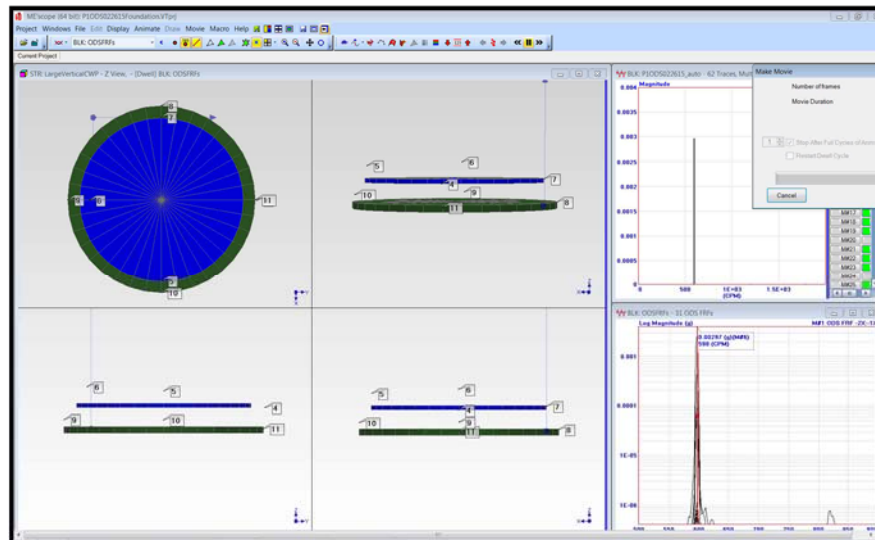
Pump Flange and Soleplate ODS (animation)

- Soleplate and pump flange are essentially moving together.
- Stations 7 & 8 have little relative movement. Motion in the other 3 quadrants is higher than if properly grouted.
- The lower animation has no model interpolation

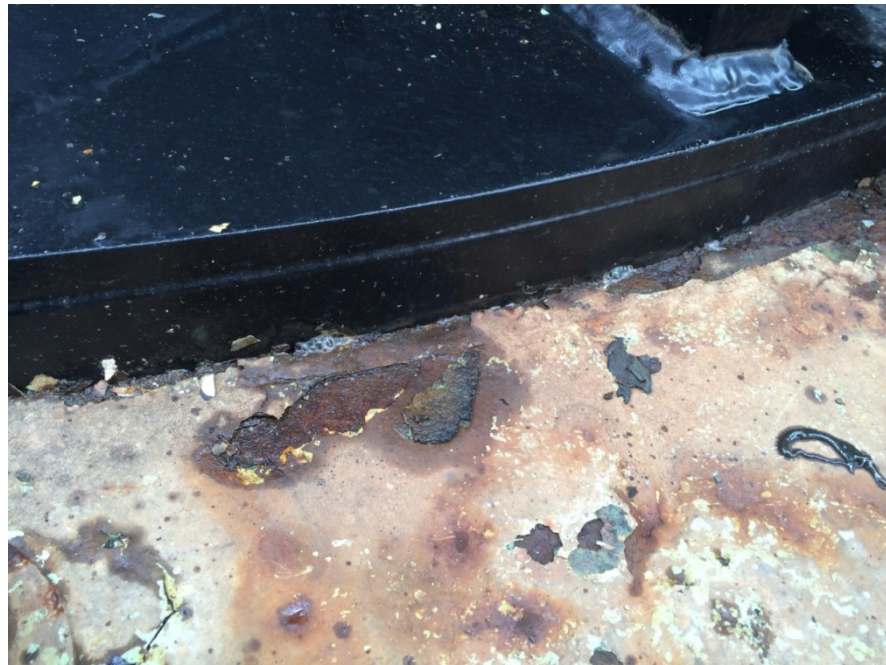
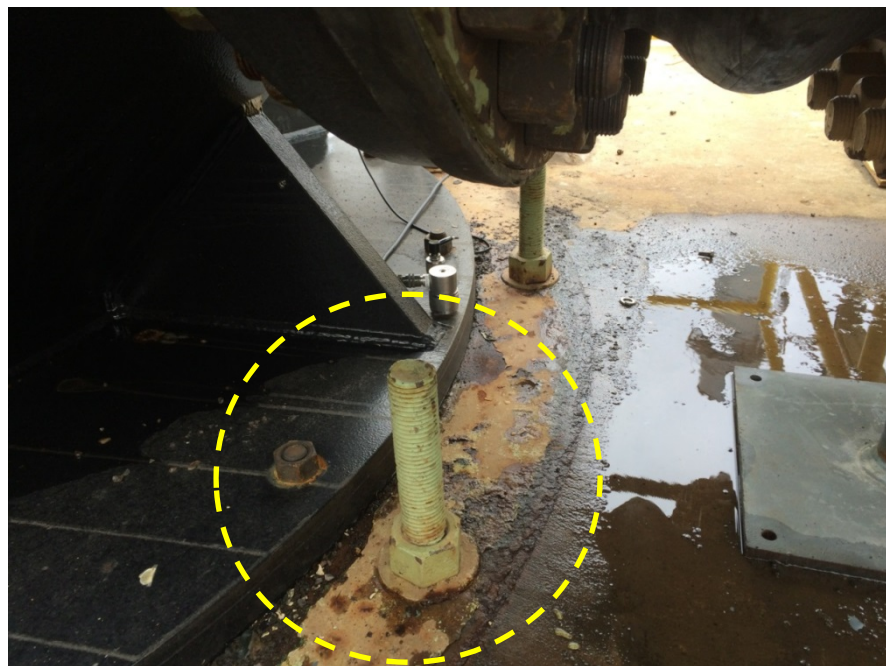
Solution

- Bubbles indicate relative movement
- Soleplate anchor studs were tightened to improve connection and increase stiffness of the pump/foundation system
- Nuts were tightened from the discharge moving CW viewed from the top down
- As studs were tightened vibration amplitude and phase changed
- Final vibration was decreased from .4ips rms to 0.08ips rms.

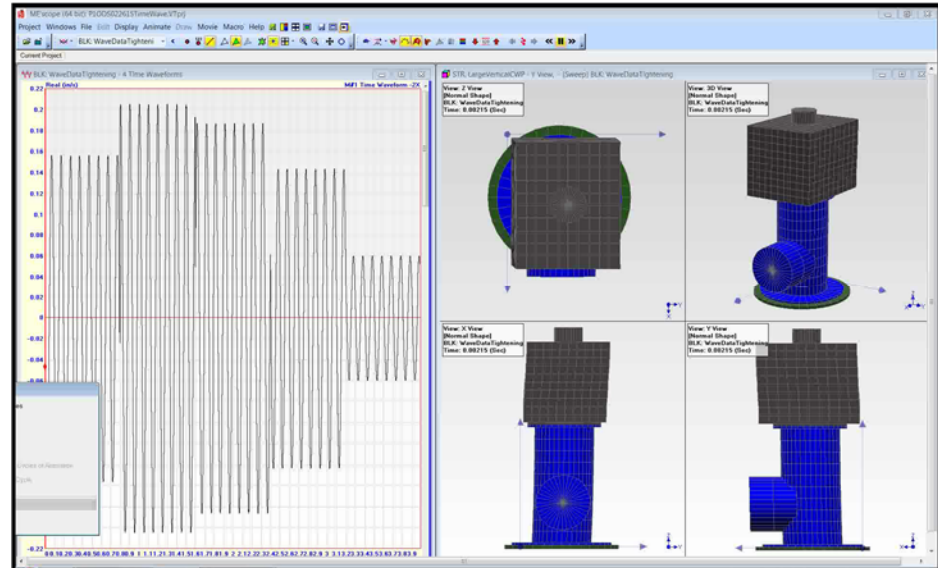
Operating Deflection Shape (TIME-BASED ANIMATION)

- Stud torqueing sequence
- Waveform(1X filtered)
- Amplitude decreased 70% after soleplate anchor studs were torqued.
- Nat. freq. was raised to and then above 1X by increasing foundation/pump stiffness.

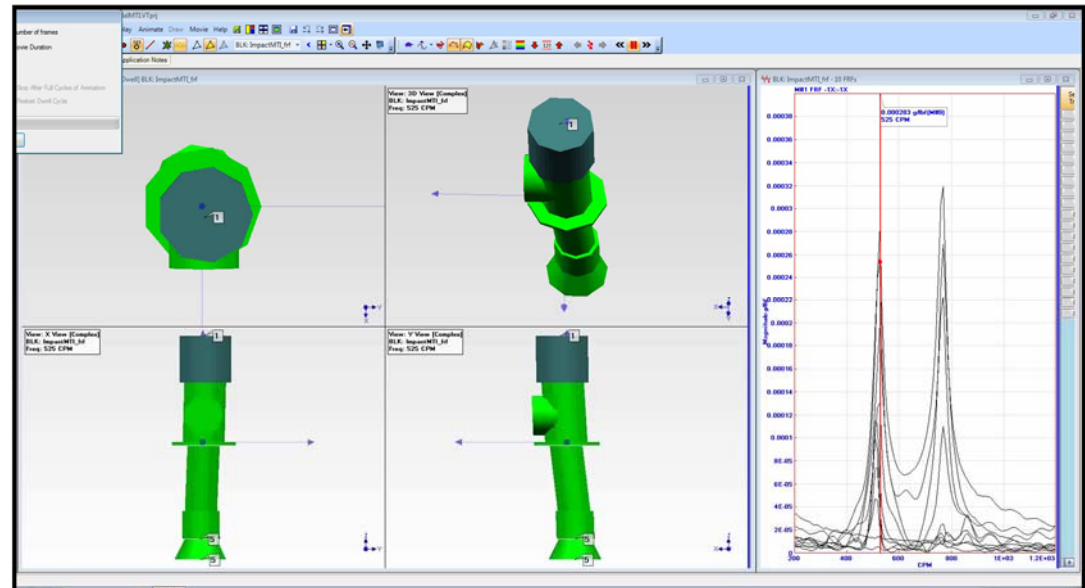
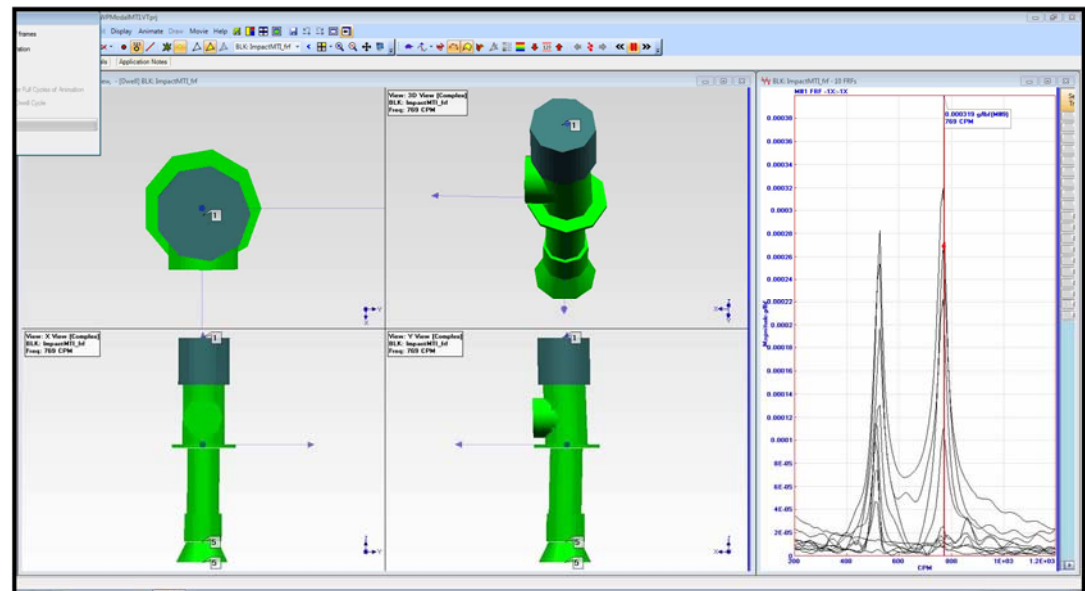
Mode Shapes (examples)

- 1st mode is the “Trunion” or pivoting mode. The column and motor are essentially a rigid body pivoting about the flange/soleplate.
- 2nd mode is a “C” shape bending mode. The column properties control the effective stiffness and natural frequency

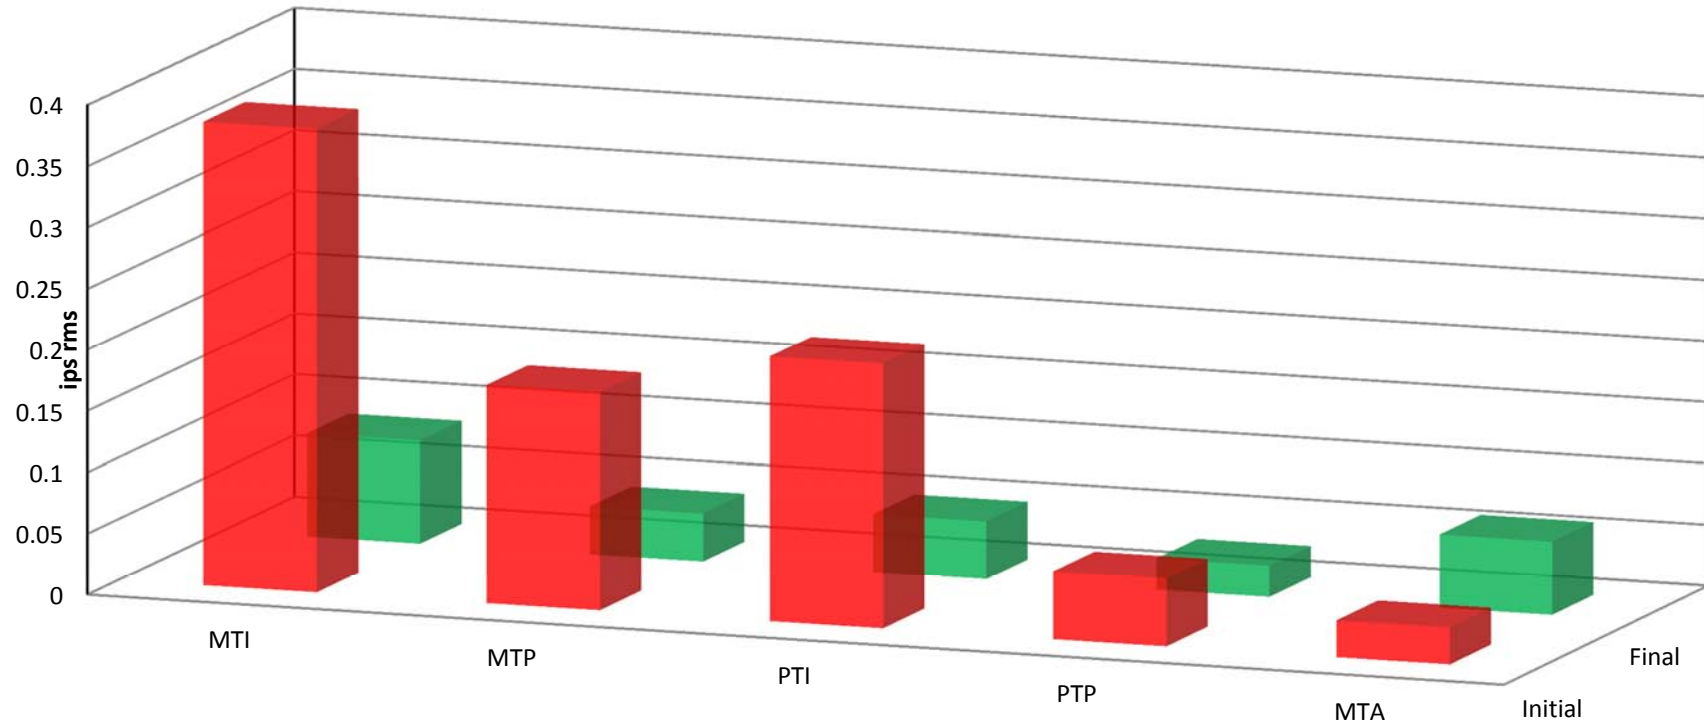
Overall Vibration Amplitudes

MTI	MTP	PTI	PTP	MTA
Initial	0.379	0.178	0.216	0.0553	0.0298
Final	0.0839	0.0393	0.0474	0.0257	0.06
