HYDRAULIC UPGRADE OF HOT WATER CIRCULATION PUMPS IN A DISTRICT HEATING SYSTEM

CSP9 – Hydraulic Upgrade of Hot Water Circulation Pumps

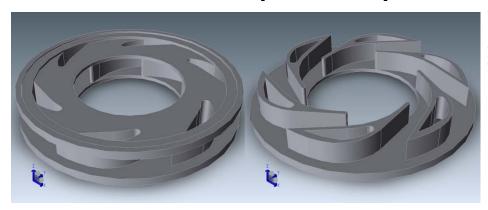
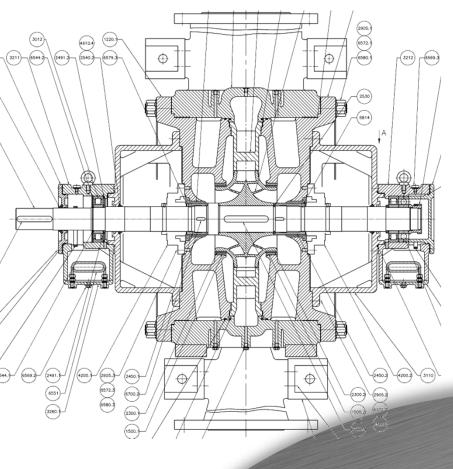
New diffuser (6 vanes)

- New high capacity impeller
 - 8 vanes
 - □ D_{2,max} 21½"

(546.1 mm)

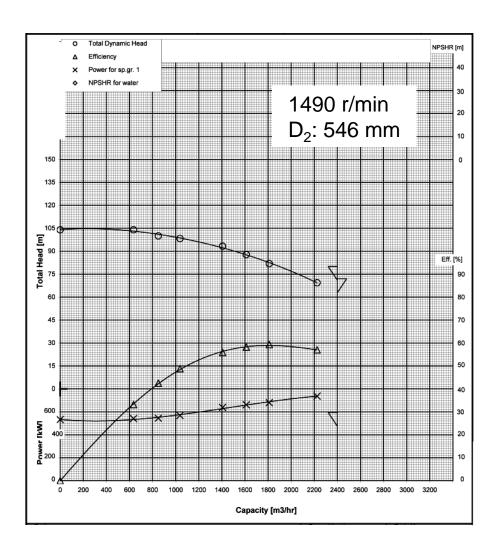
First Test Result:

- Failed to make the head
- Efficiency too low
- Power too high
- ❖ BEP at too low capacity

Suspected Cause:

Choking flow at casing outlet (narrowing throat passage)

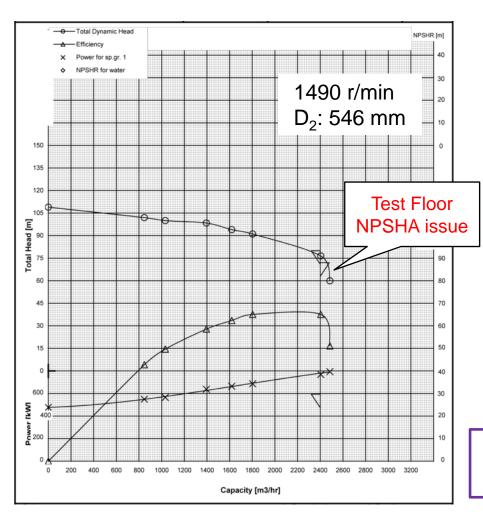
Second Test Result:

(After opening up casing area)

- Head picked-up
- Efficiency improved
- BEP shifted to higher capacity

BUT, pump still not making expected performance

Suspicion:

➤ Incorrect diffuser design?!?

Diffuser throat area laid out too small

→ <u>Second Hydraulic Option: Volute insert</u>

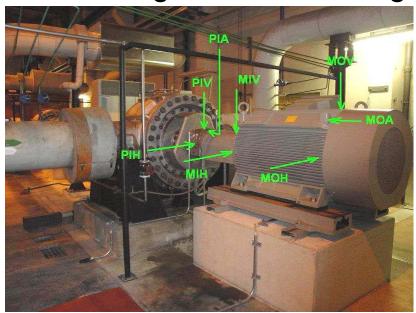
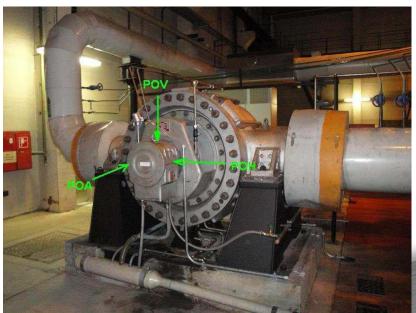
Vibration measurement locations

- While developing volute insert and manufacturing parts pump was shipped to site.
- At site an 8X vane pass vibration issue @ PIH emerged when running around 1200 r/min*.

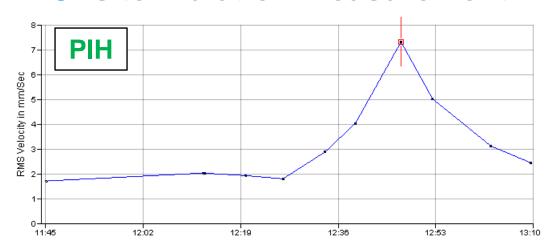
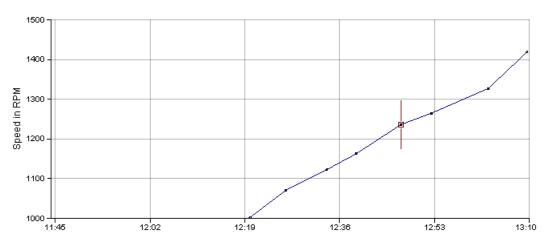
Onsite vibration measurement

PIH: 7.3 mm/s
@1236 r/min
(8X, or 165 Hz)

Bump Test:

➤ 169 Hz resonance frequency (Hor.)

Elevated vibration levels due to:

- 8X vane passing excitation forces @165 Hz
- Natural (resonance) frequency in horizontal plane
 @169 Hz.
- Very small impeller tip ("Gap B") clearance, causing strong vane passing excitation forces

$$(D_3 - D_2) / D_2 = 553 - 546 / 546$$

= 0.013 or 1.3% (!)

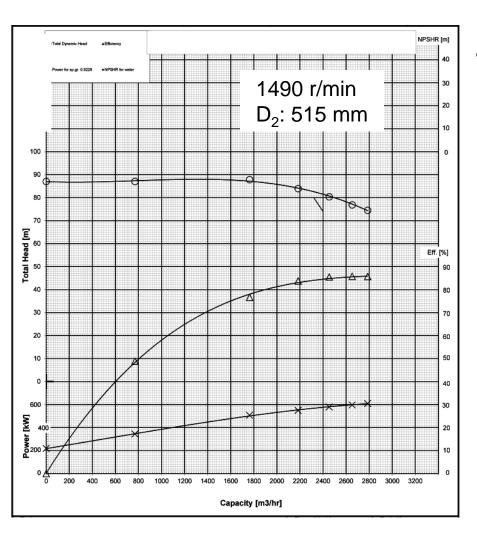
Final test result:

- ✓ Head okay
- ✓ Efficiency okay
- ✓ Power okay
- ✓ Tip clearance (Gap B) okay:

$$(D_3 - D_2) / D_2 =$$

578.2 - 515 / 515 =
0.123 or 12.3%

✓ 8X vane pass vibration issue resolved

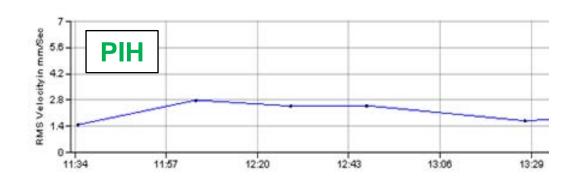
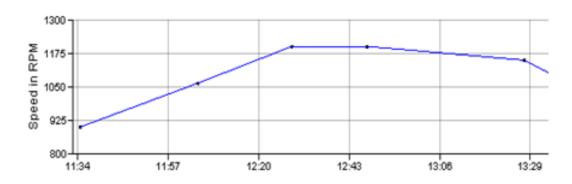
Shop test with VFD demonstrated strong reduction in vibration response.

- 8X Vibration response not peaking up anymore
- Overall vibration level below 3 mm/s (RMS)
