Corrosion and Materials Issues in Converting a Conventional Pump to a Canned Motor Pump.

By: Ron Carlson

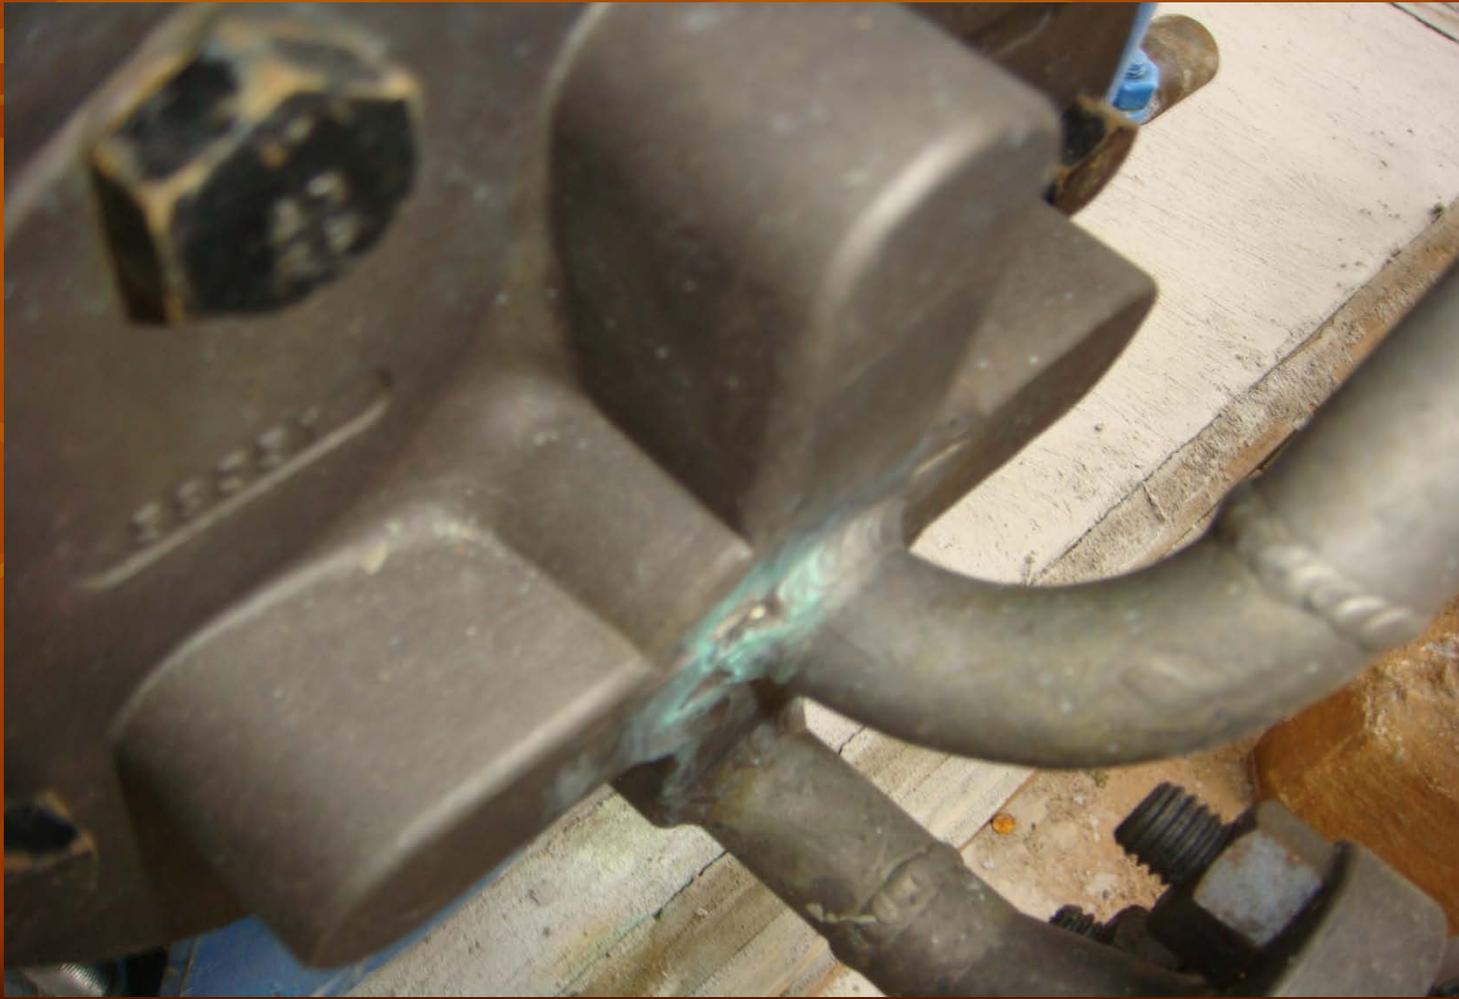
The unit ran well for two weeks. A discoloration was then observed at the weld where the flush line entered the rear bearing housing. A call to the manufacturer resulted in a rapid response of a field service representative, and a lead engineer to assist in the failure analysis and determine a path for corrective action.

- The first repair attempt involved grinding out the weld and re-welding the area. NDT (dye penetrant) did not reveal any leak paths. After reassembly, the pump was pneumatic tested to 50 PSIG with no evidence of leakage. Hydro-testing was not performed as we did not have another set of o-ring gaskets for this service.

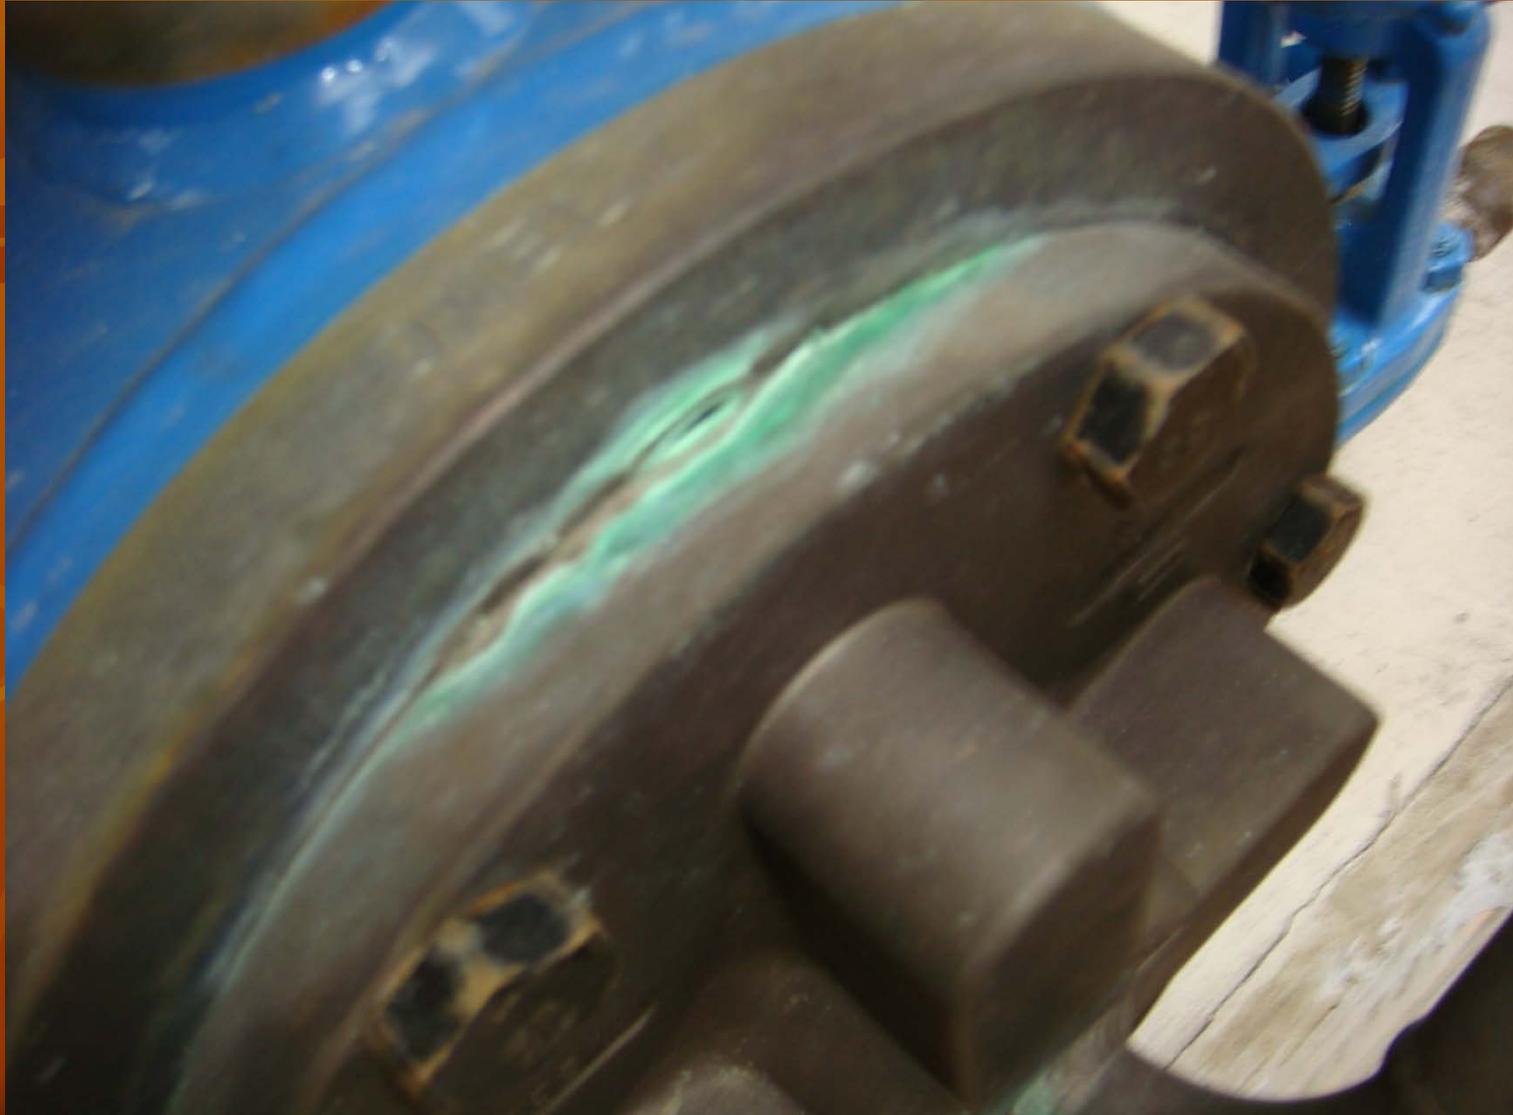
We also observed a leak with the o-ring seal of the rear bearing housing.

Over this 10 month period, a slight discoloration around a couple of the rear bearing housing bolts had been observed. LDAR and chemical sampling had not detected any sign of a leak, but the discoloration indicated a very small slow leak of the bearing housing o-ring.

While the deformity on the rotor sleeve was repaired, the case sealing areas were modified for spiral wound gaskets to eliminate any future leak issues with the o-rings.

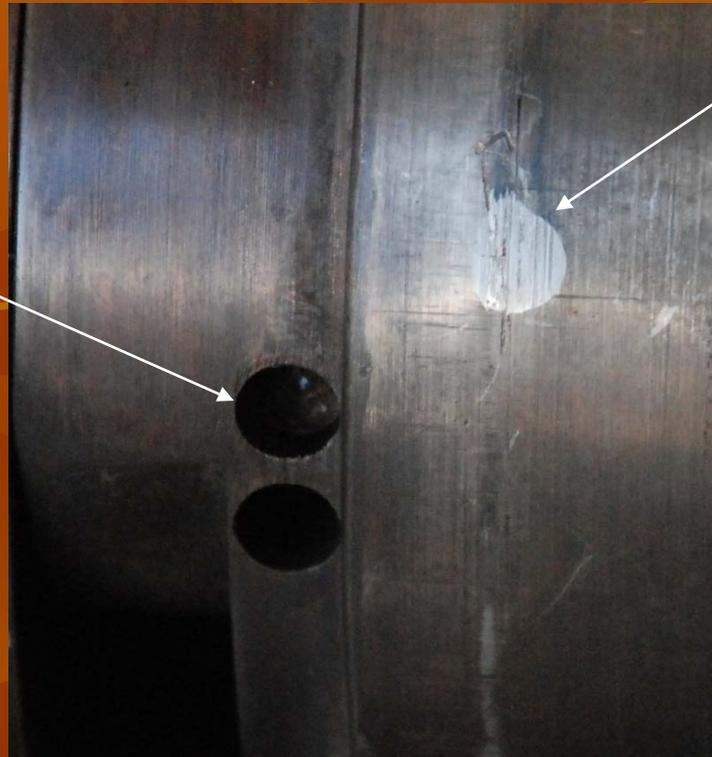
Five more months of trouble free operation ended when the motor overload tripped, again. Inspection of the electrical system showed no faults. Disassembly of the pump displayed a small pimple on the rotor sleeve which had lightly rubbed the stator liner. Speculation was that, while not correct, this would not cause enough drag (3 HP) to overload the motor.

Holes
drilled for
balancing.

“Pimple”,
0.008” high.
(0.20 mm)

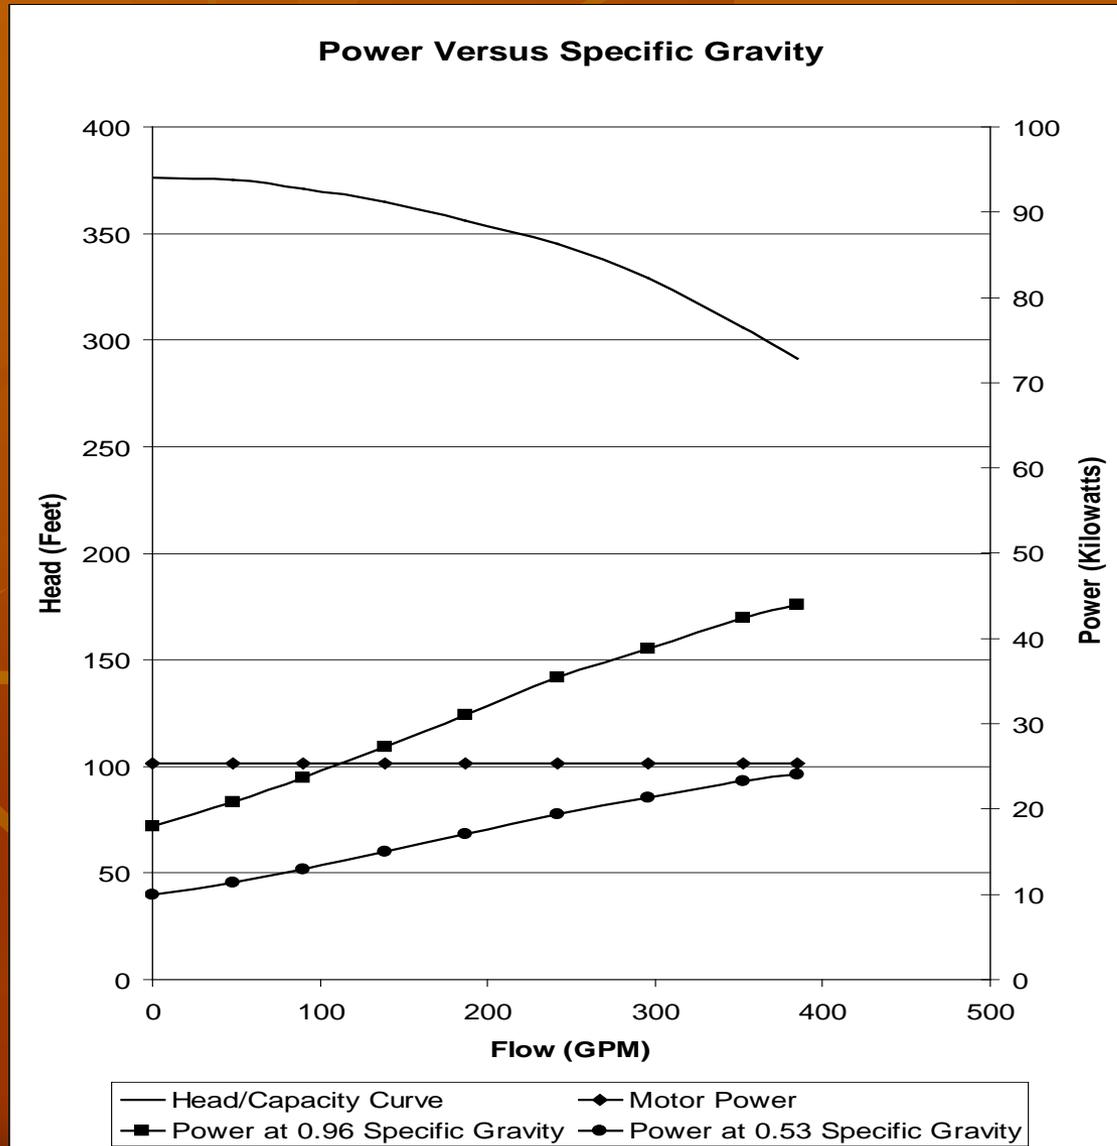
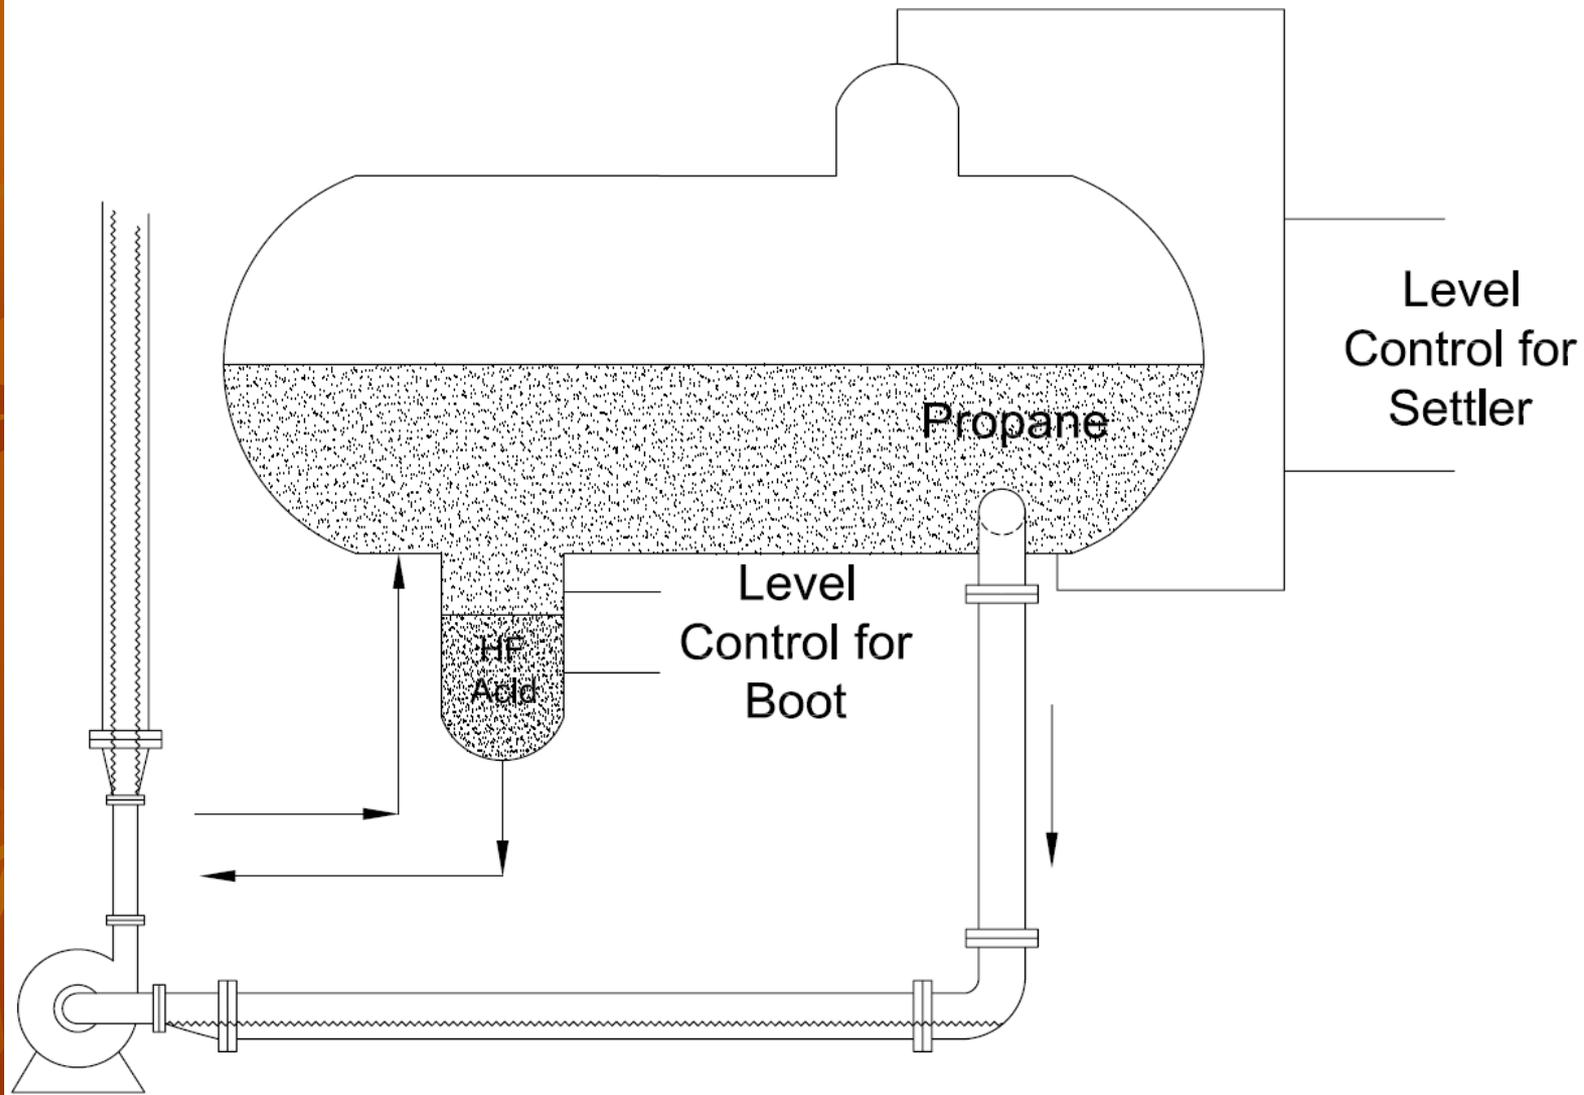
Figure 3

Another failure analysis was conducted with no clear answer to the motor trips being identified. A hypothesis was postulated that the very low velocities in the suction (<1.4 fps) and discharge (<3 fps) piping, as well as the piping arrangement, were causing HF Acid to accumulate until the concentration was high enough to overload the motor, Figure 3. Note: HF relative density is 0.96 and Propane relative density is 0.526. Power curve for HF versus Propane on the next slide.

Pump Curves Including comparison Of C3 and HF Power
