43rd **Turbomachinery 30**th **Pump** SYMPOSIA

COUPLED TORSIONAL-LATERAL ANALYSIS

STAFFAN LUNDHOLM – LLOYD'S REGISTER CONSULTING NIKLAS SEHLSTEDT – LLOYD'S REGISTER CONSULTING PER TELLEFSEN – LLOYD'S REGISTER CONSULTING CLAUS MYLLERUP – LLOYD'S REGISTER

Background

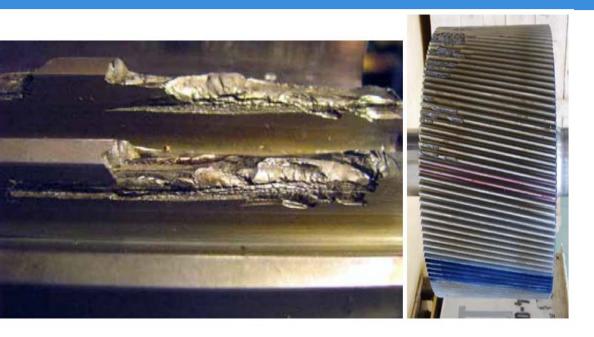
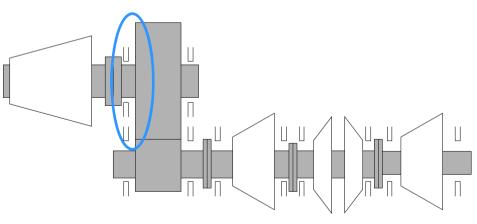
Problems encountered:

- Two consecutive gearbox failures within few weeks after commissioning
- ~ 500-1000 operating hours before failure
- Severe gearbox casing vibrations and excessive noise levels recorded
- Turbine side on bull gear experienced fractured teeth and cracks on the load surfaces

Actions taken:

- Full RCA initiated. This concluded poor final grinding as primary cause of failures
- Contributory causes had to be investigated as part of the RCA
- Torsional/Lateral vibration analysis was initiated by LRC as part of the RCA

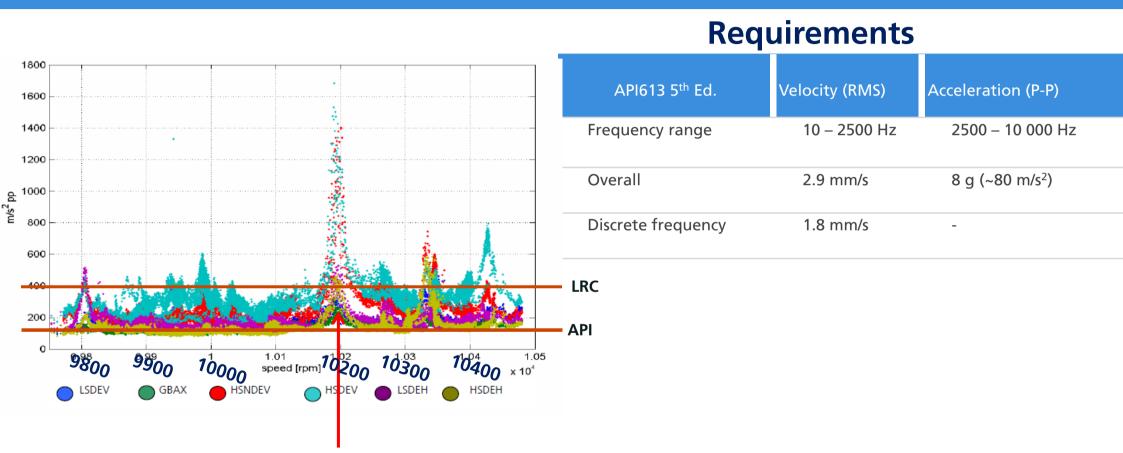
10200 rpm = GMF @ 7480 Hz Levels up to 1600 m/s² (~160 g) p-p

Amplification factor $Q \approx 700$

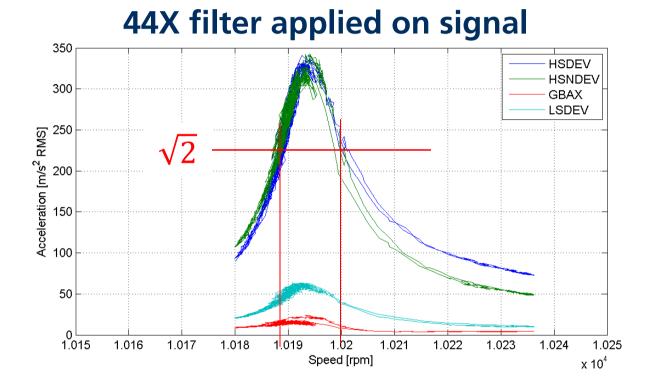
Pinion mode excitation

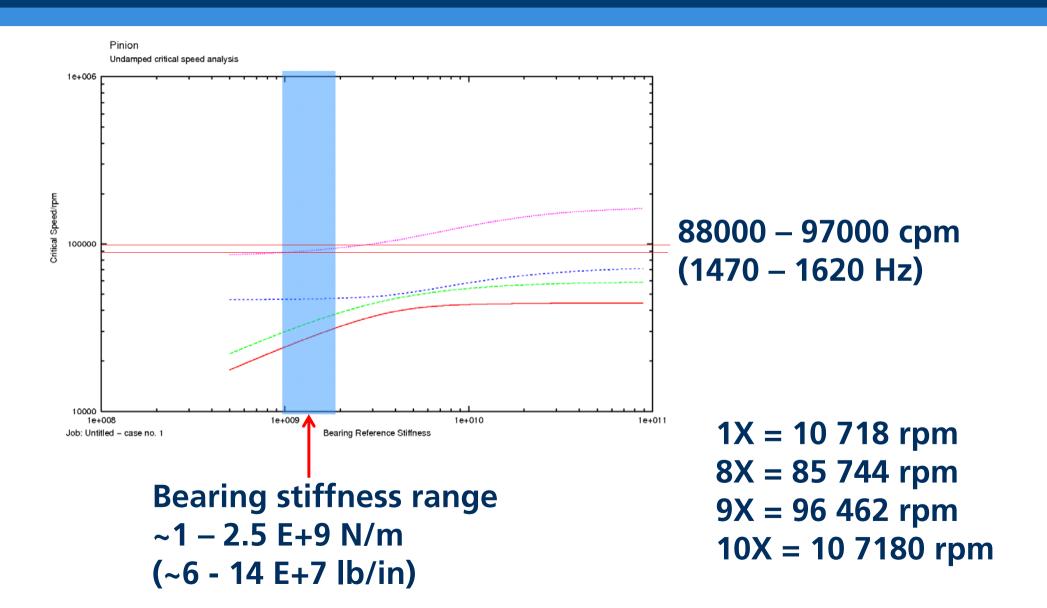
Pinion mode excitation

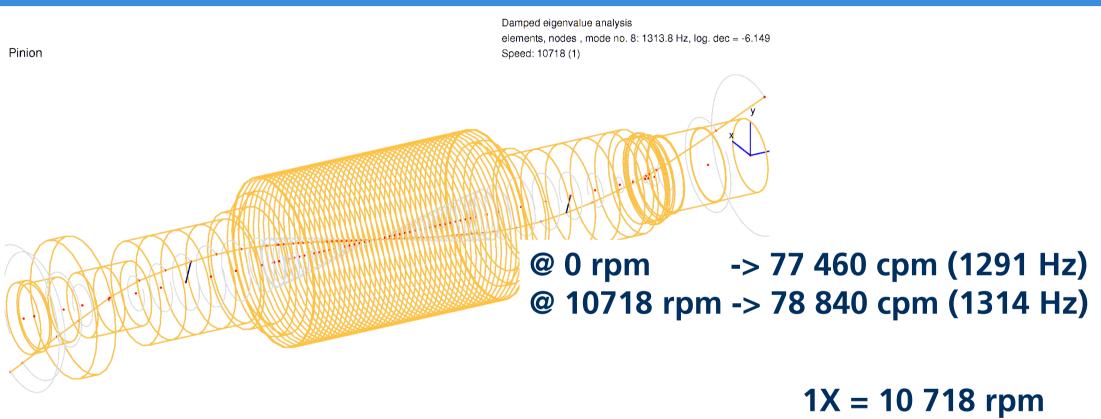
Untitled - Case no. 1

7X = 75 026 rpm 8X = 85 744 rpm 9X = 96 462 rpm 10X = 10 7180 rpm
