**43rd Turbomachinery
30th Pump SYMPOSIA**

REMOTE MONITORING & DIAGNOSTICS AS APPLIED TO A RECIPROCATING COMPRESSOR HEAD

BRUCE MCCAIN, PE
ROTATING EQUIPMENT LEAD
OXY OIL AND GAS CORPORATION

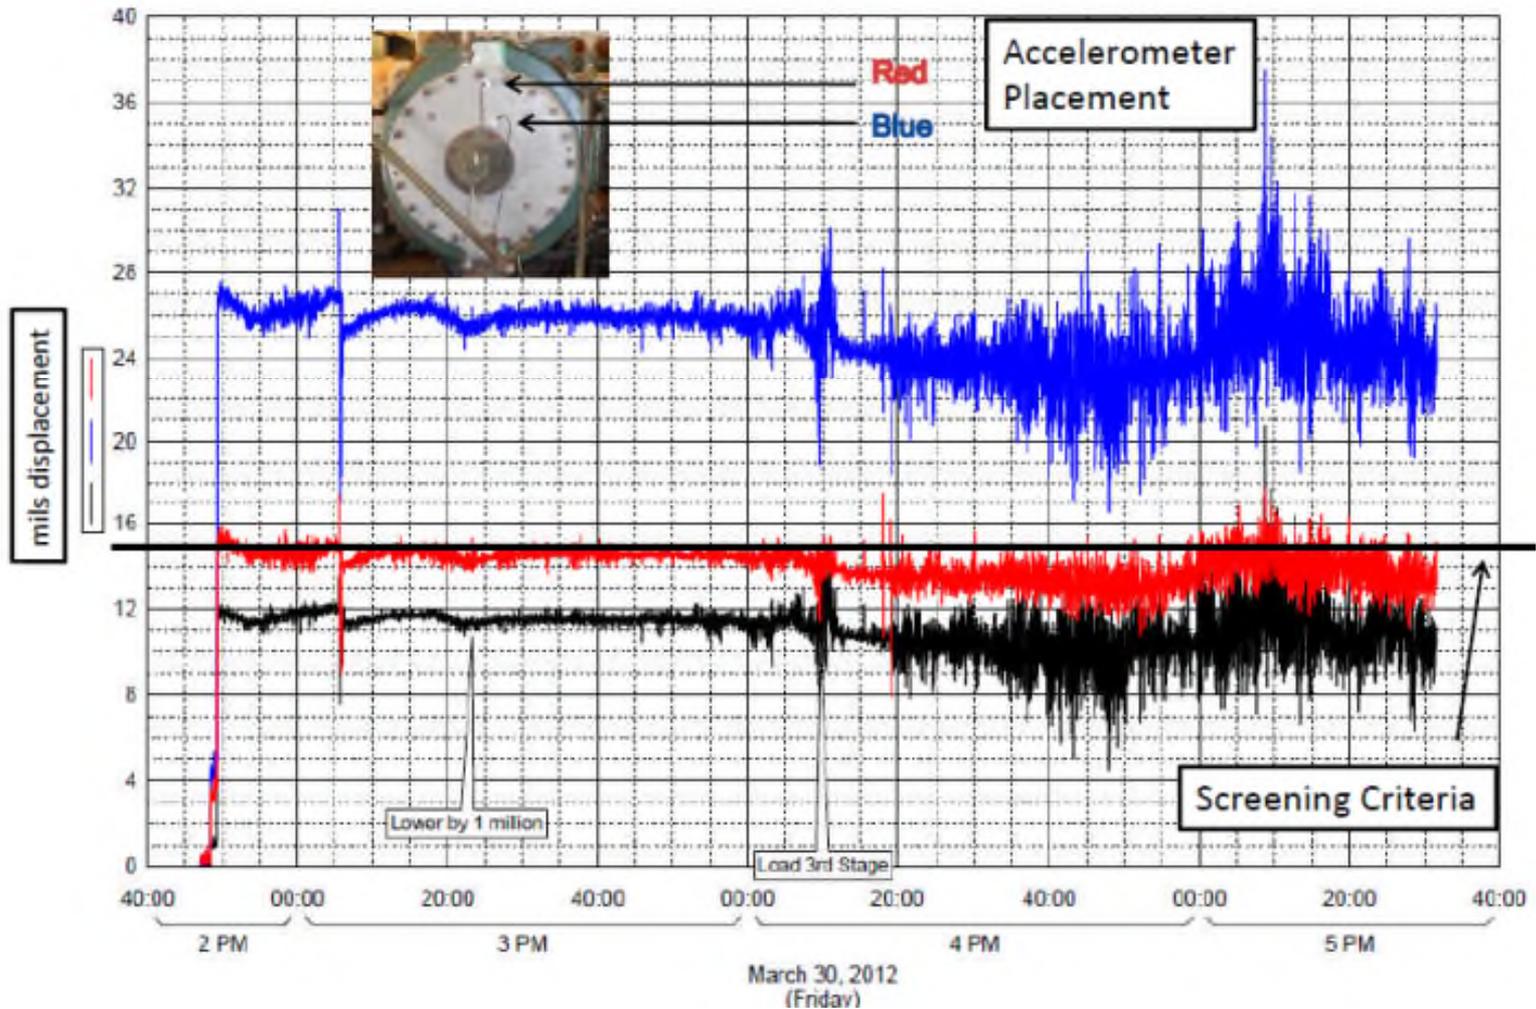
Initial Differential Vibration

- High stretch direction vibration (differential displacement) on a reciprocating compressor cylinder head indicated possible crack
- Facility requested path forward options until replacement head arrived (3 months)
- This presentation will demonstrate techniques used to quantify the component condition while providing continuous surveillance and immediate notification of any degradation

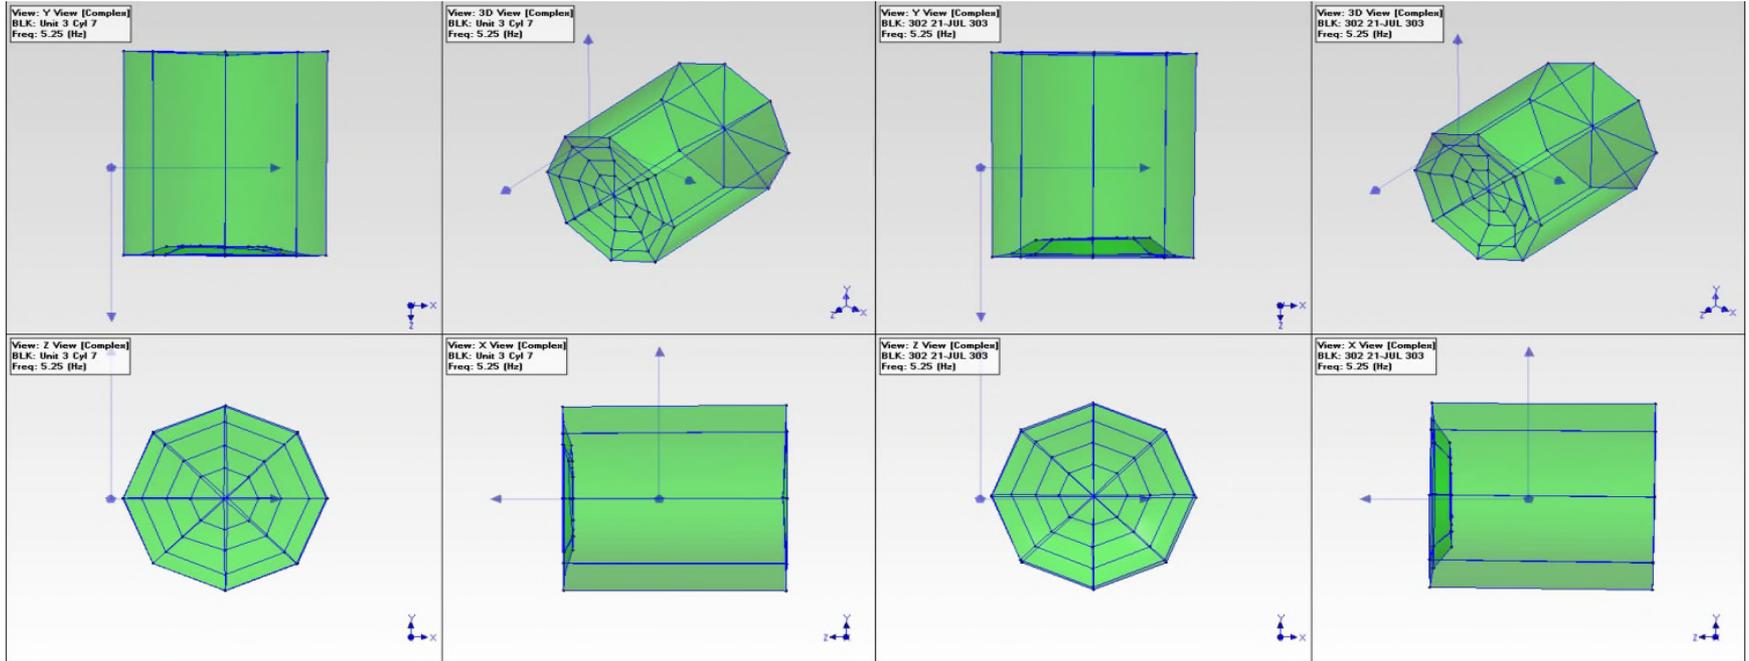
Operating Deflection Shape (ODS)

5-7 mil
differential on
“good” outer
head

11-13 mil
differential on
“bad” outer
head

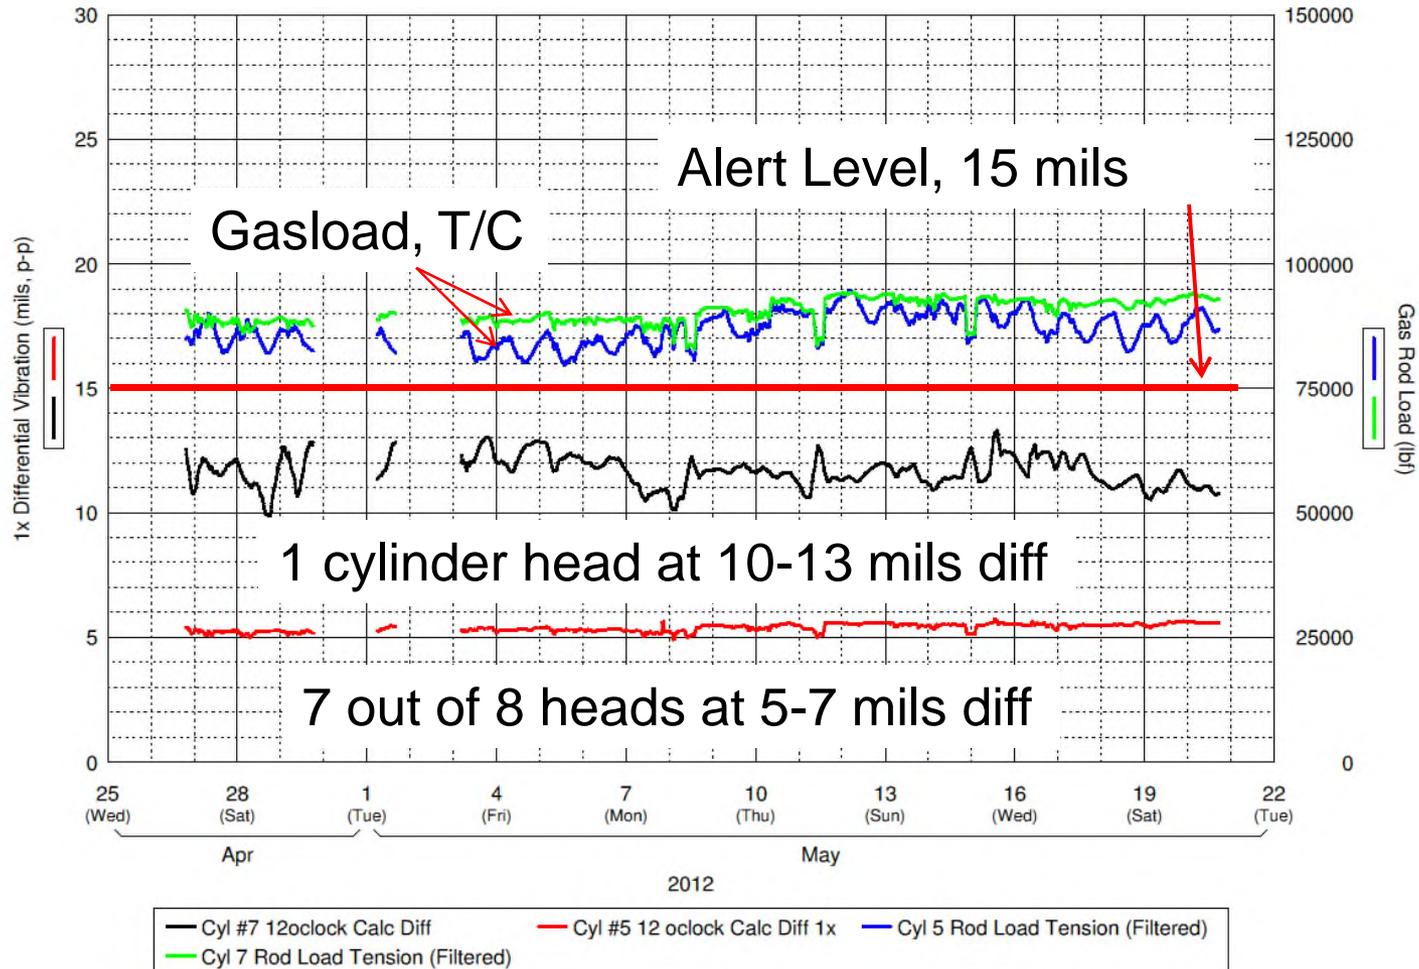
Differential Vibration and Gasload Trends

- “Normal” differential vibration across outer head face of 5-7 mils
- One “repaired” cylinder head indicated differential vibration of 10-13 mils
- An alert level was established at 15 mils differential vibration based on consistent trending
- Automated alerts were utilized to provide early warning in the event of crack propagation

- Closed 4th stage recycle and adjusted process parameters to reduce 3rd stage discharge pressure
- Subsequently shifted some compression ratio from 2nd stage to 3rd with unloader operation to reduce 2nd stage gasload
- Unloaded problematic 2nd stage on subject compressor while loading 2nd stage on other machines (incremental reduction in gasload and differential displacement)

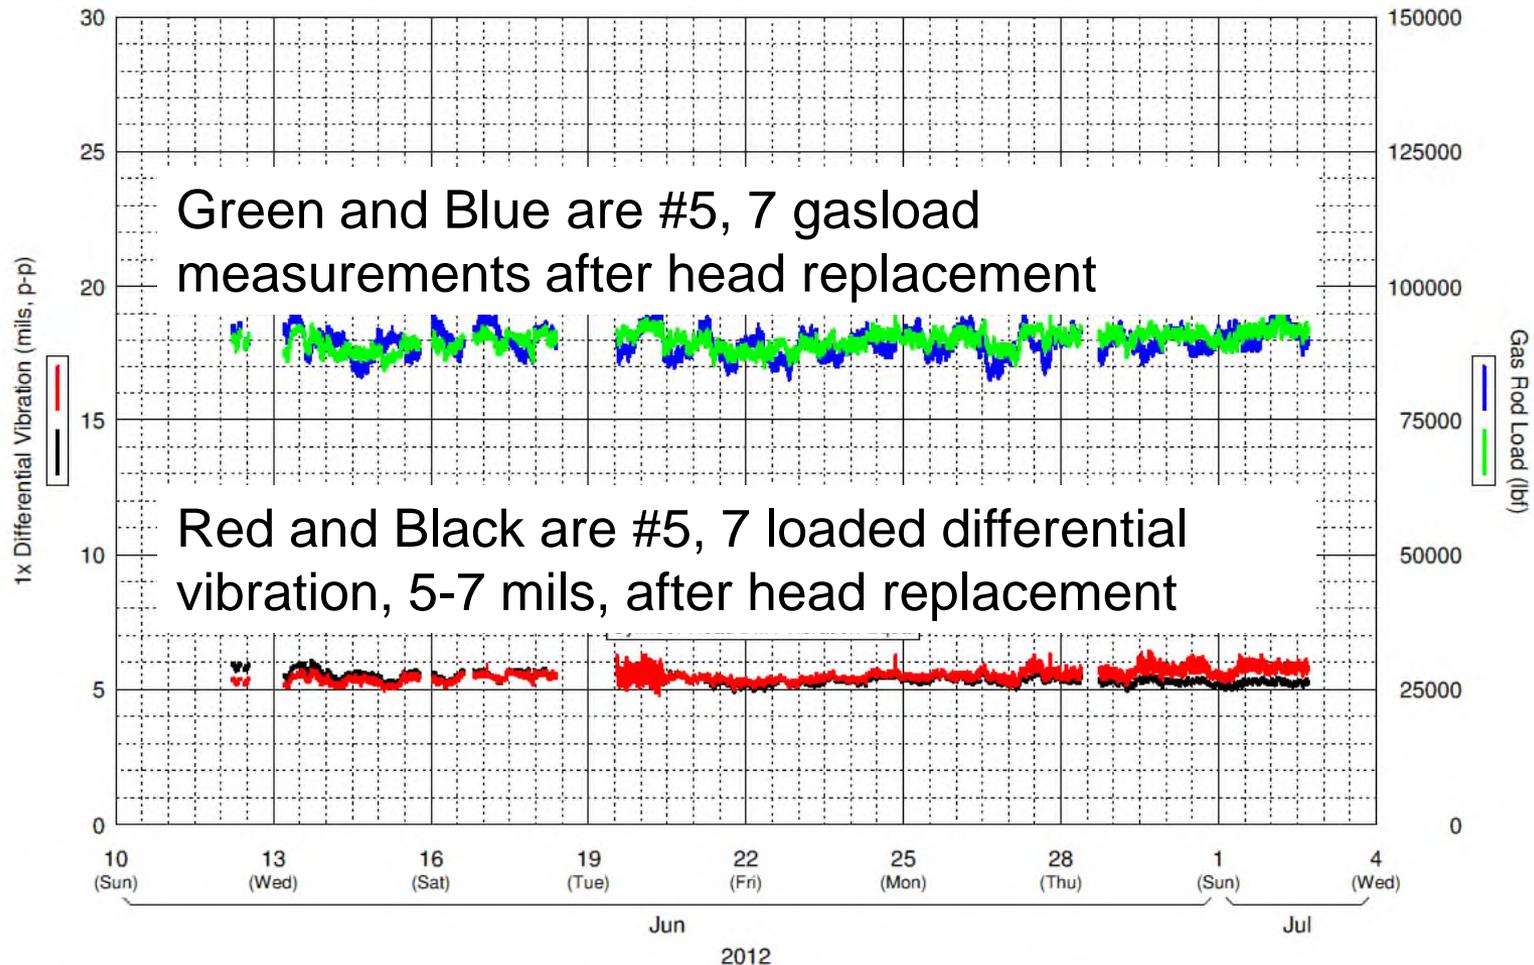
Gas Rodload and Differential Vibration After New Head Installed

- Based on this effort, operation with repaired heads require more extensive evaluation including RM&D and for short duration only
- RM&D technology, coupled with support from Operations, Maintenance, and Engineering staff, allowed for safe and confident, short term operation of a damaged head until a replacement could be sourced
- RM&D is an appropriate surveillance and analysis tool that can help to minimize assumptions while maximizing confidence in identified path forward
