**43rd Turbomachinery
30th Pump SYMPOSIA**

TWO POLE MOTOR VIBRATION DIAGNOSTICS, ANALYSIS AND SOLUTION

YU ZHAO – BHP BILLITON

NELSON BAXTER- ABM TECHNICAL SERVICES

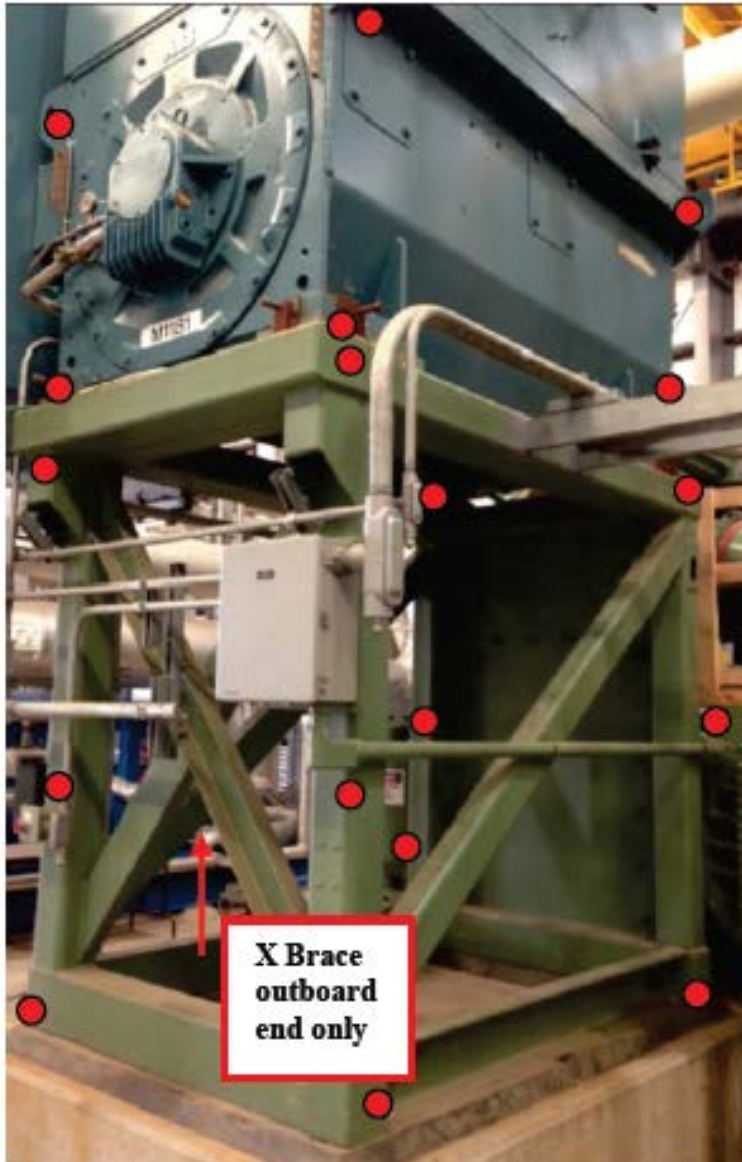
Field Measurement

- 1X dominant
- Found structural mode at 3000 rpm with cracked foundation
- Mode shape is mainly lateral vibration on the drive end, where the crack foundation is – at the anchor bolt location.
- Lose foot was foundation a year before and corrected, alignment done as well. Vibration amplitude unchanged.

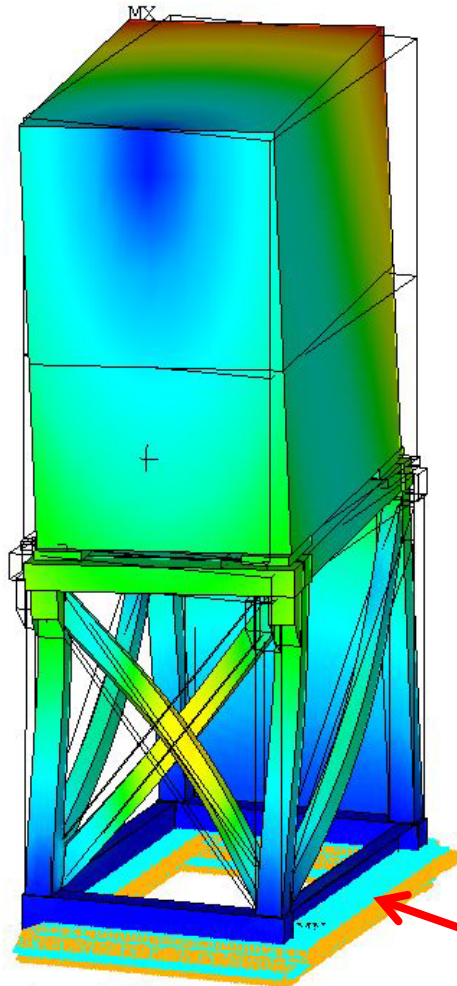
As-Design Condition

- The support has a natural frequency at 57.9 Hz, which is very close to the motor's running speed of 60 Hz
 - This resonance was likely the original cause of the foundation crack
 - Simply fixing the loose foot due to the damaged foundation did not and will not solve the resonance problem
 - This mode must be pushed away from the motor's synchronous excitation

All DOFs fixed on the bottom, no loose foot due to damaged foundation

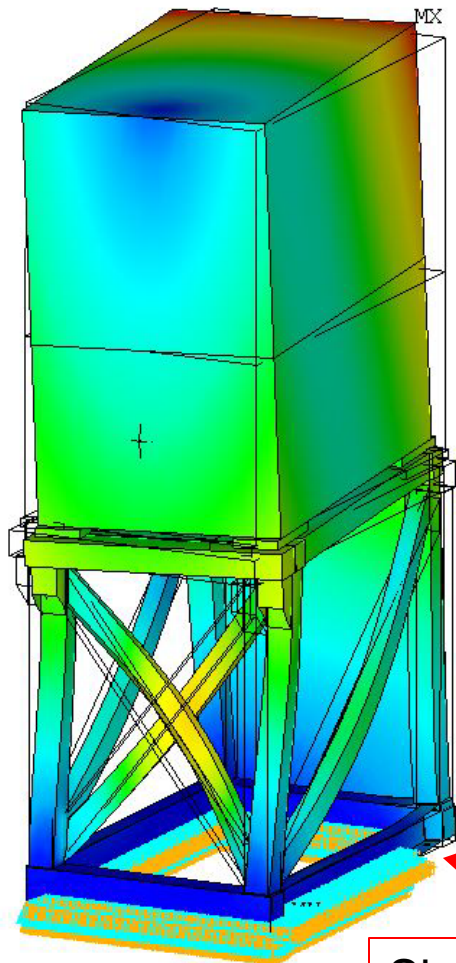
As-Found Condition

- The frequency of the problematic mode is reduce to 52.8 Hz
 - Both the frequency and the mode shape match the field measurements
 - This good correlation validates the FE model
 - Provides a good baseline to investigate solutions
 - The objective is to achieve 20% separation margin

Simulate the loose foot due to the damaged foundation by removing the constraints near the foot

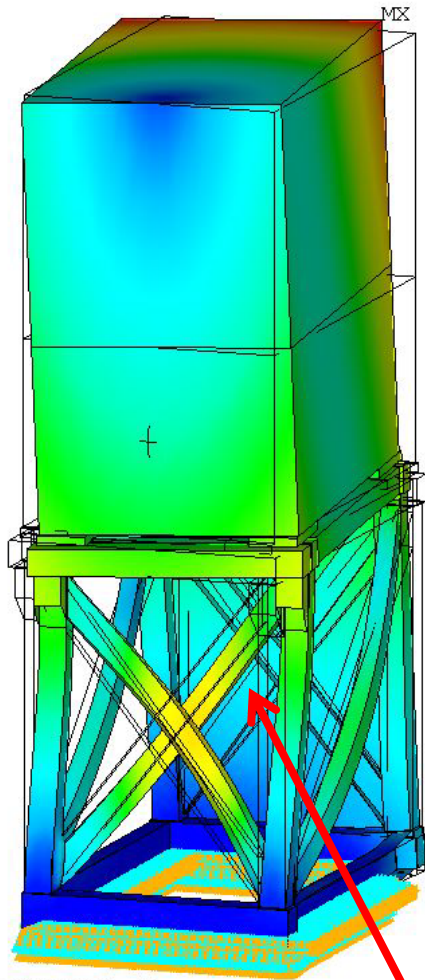
Initial Modification

- The frequency of the mode is increased to 53 Hz
 - Not a solution
 - Since the inboard end shows large displacement, it was intuitive to strengthen this end
 - However, this end is already very stiff due to the plate
 - Further stiffening is not effective
 - Strengthening device should be applied to the area showing the most twist, rather than the area showing the most displacement

X-brace added on the inboard end, loose foot

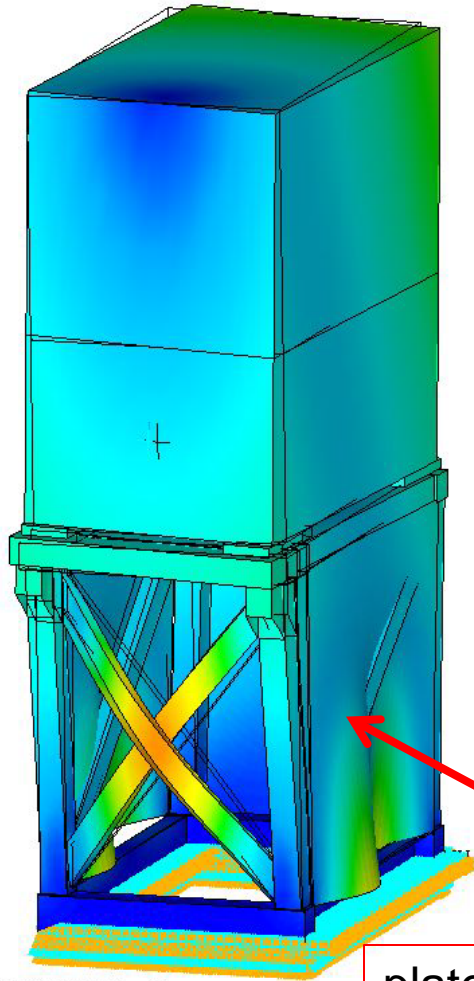
A Viable Modification

plate added to both sides

- Plates are added to the side surfaces
- The frequency of the problematic mode is increased to 72.8 Hz
 - 20% SM is achieved
- As a solution
 - Bottom of these plates should be welded as well
 - The plate should also be welded to the X-brace to reduce noise
