**43rd Turbomachinery
30th Pump SYMPOSIA**

Field Experience of Hydrophobic Membrane Filters for Corrosion Protection of Axial Compressor for Air Separation Plant

TOM DAVIDSON, P.E., LINDE LLC

Case Study: Air Separation Plant, Nitrogeno de Cantarell

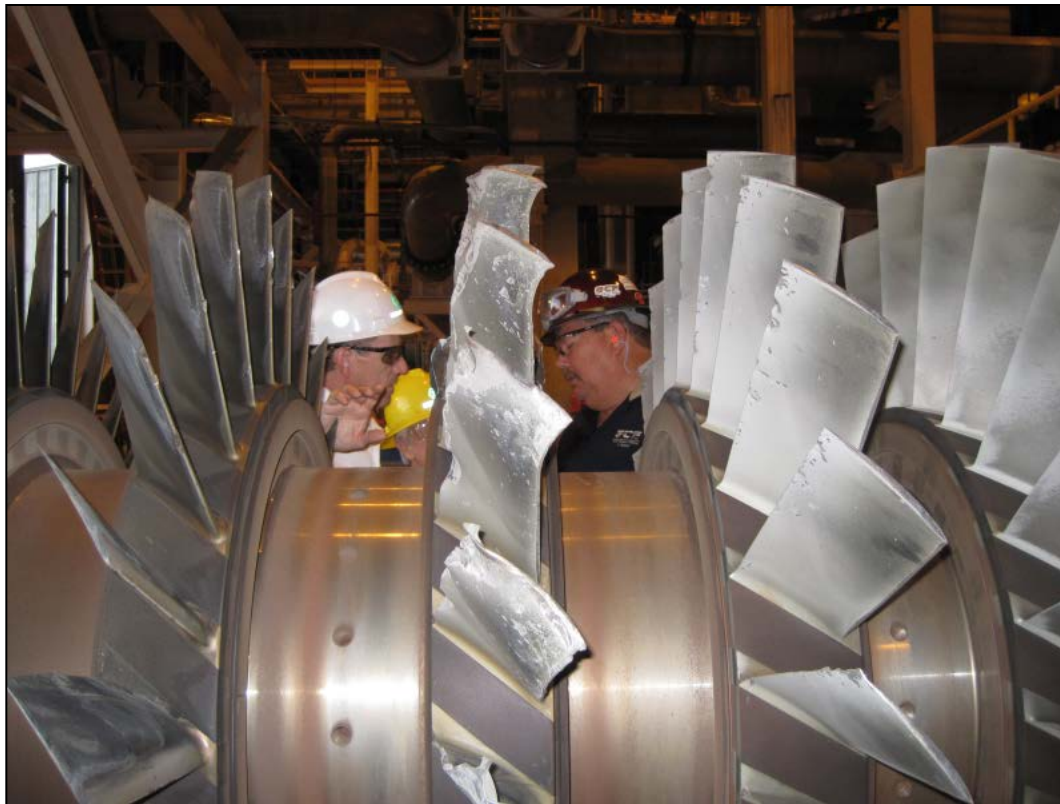
Damaged Compressor Blades

- Corrosion lead to blade cracking and resulted in several blade liberation events

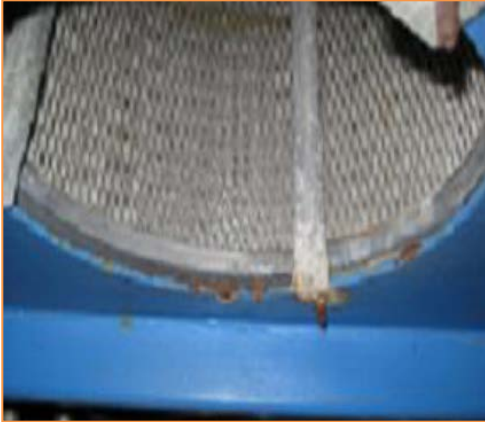
Clean side of filter contained corrosion and dirt particles.

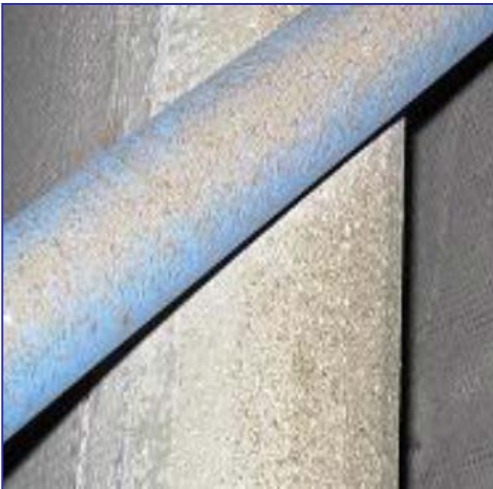
Buildup of dirt particles, chemicals, iron (rust) that eventually passed through the silencers to the compressors.

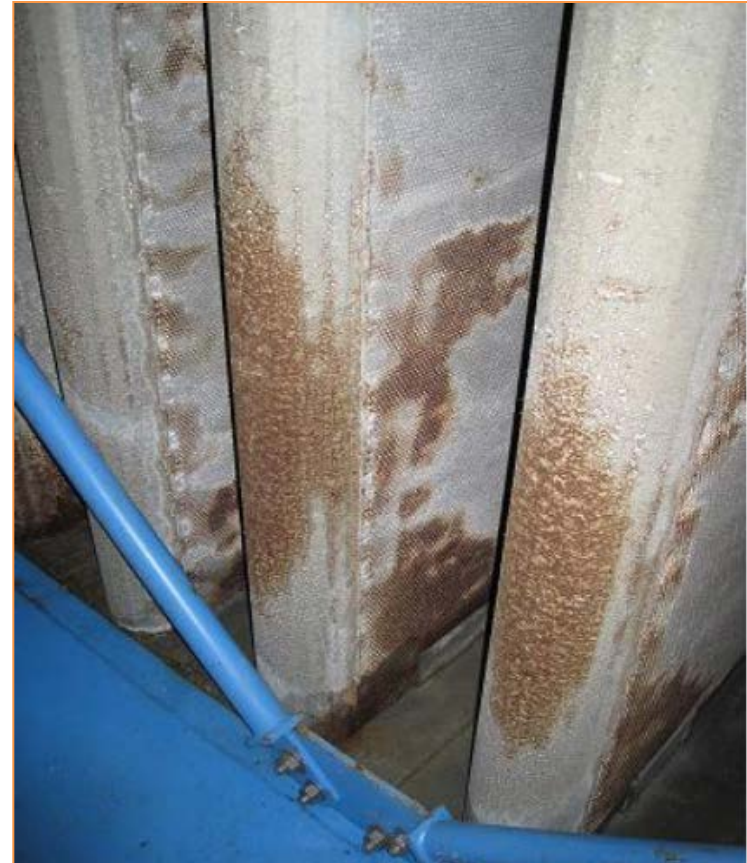
Deposits on silencers appeared to be salt, iron and dirt, all contributors to compressor fouling.

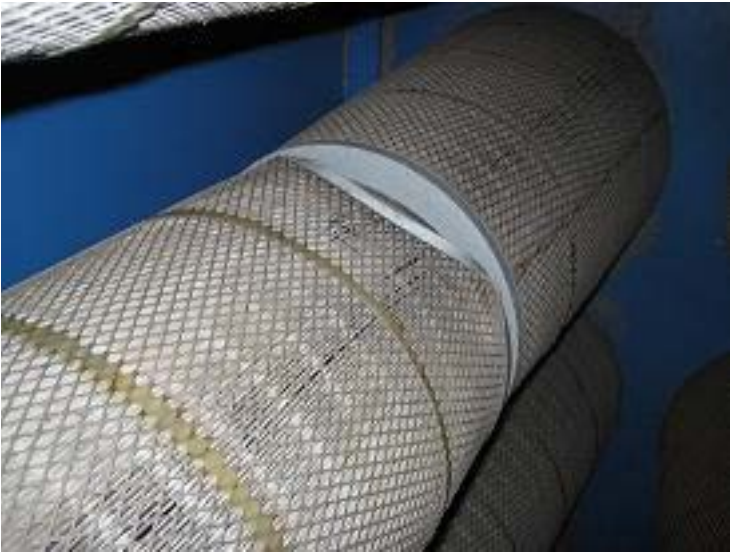
Damaged Filters

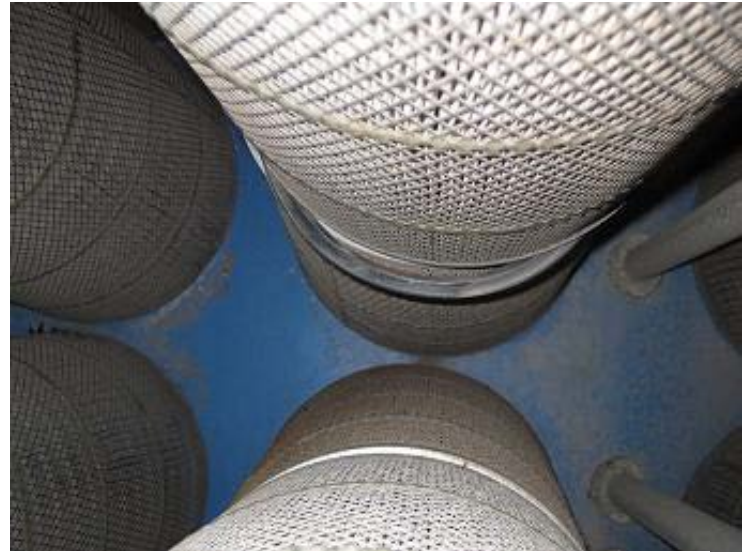
Misaligned Filters

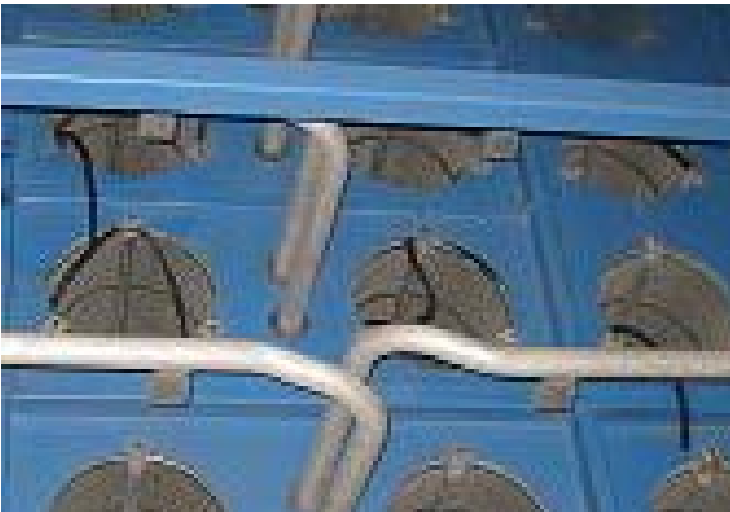
Gaskets not sealing on tubesheet
