# Compressor Failures due to CO<sub>2</sub> Corrosion

PETROBRAS

- To present failures that occurred with compressors in different production platforms offshore Brazil, due to the presence of CO<sub>2</sub> in process gas.
- To present the actions taken to recover the damages and minimize the corrosion effects.
- To present some references about CO<sub>2</sub> corrosion criteria.

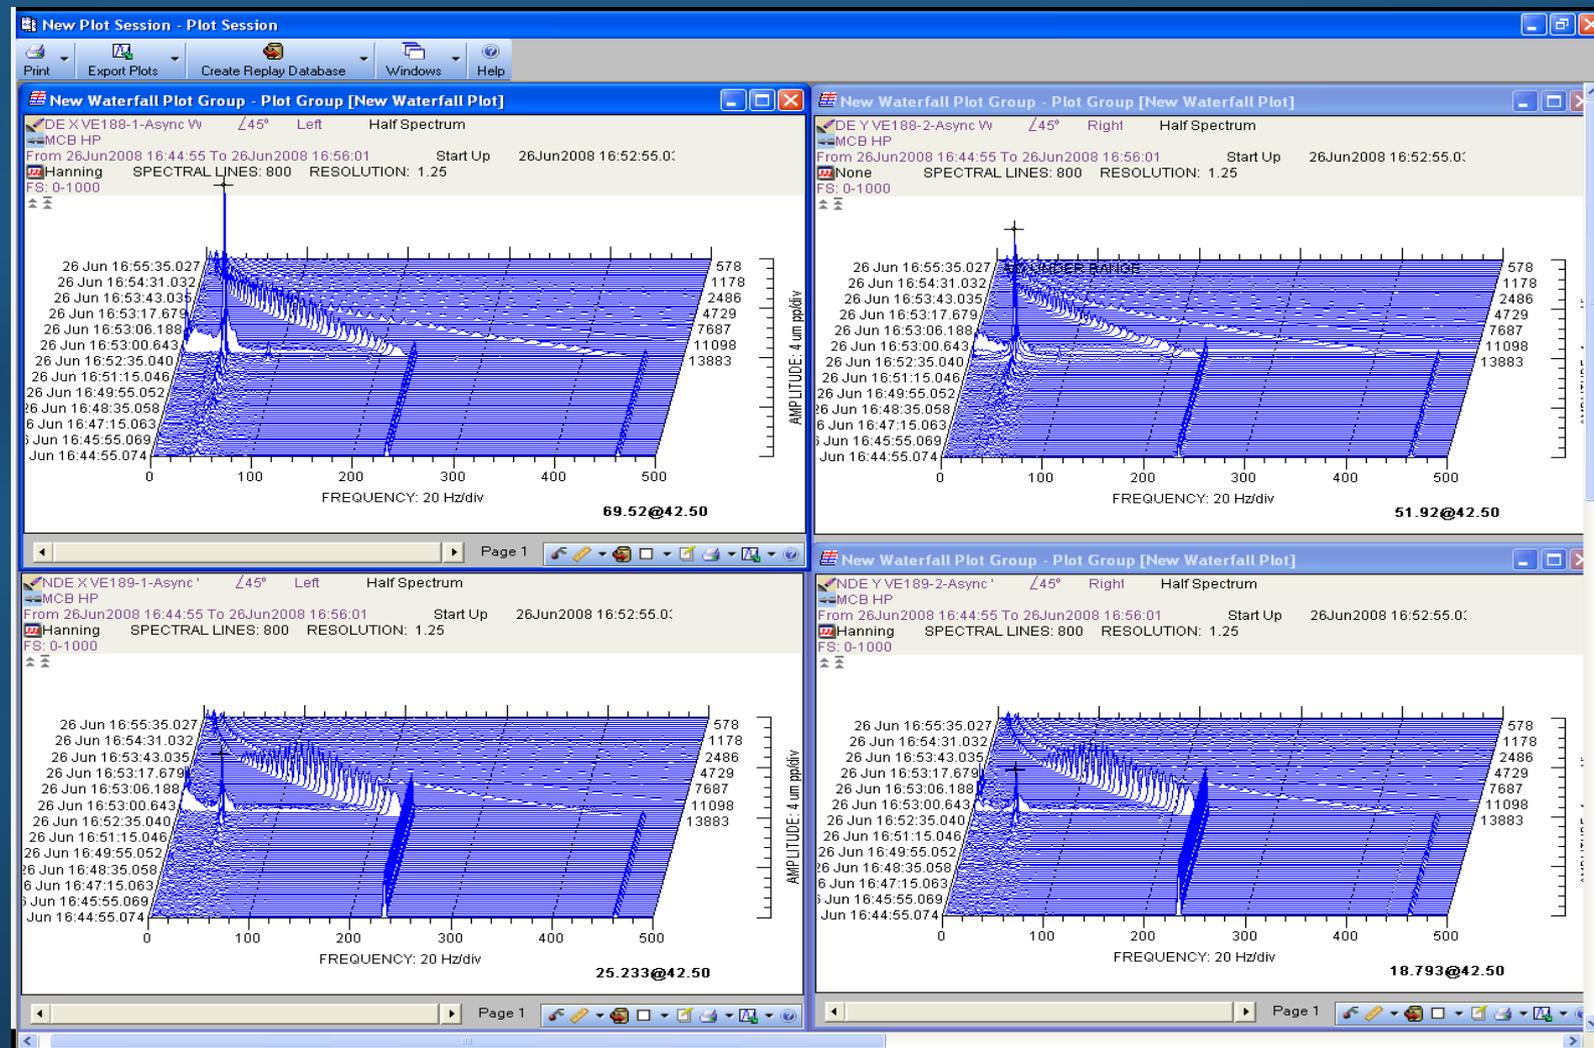
- Between March and July 2008, high pressure compressor C showed high vibration levels during start-ups.
- Further investigation of the event by the Technical Support team found an unstable, rapidly increasing, sub-synchronous vibration in the 40-45 Hz range.
- During this period, in which it failure, a performance monitoring routine was not yet implemented.
- The vibration was diagnosed as an aerodynamic instability.

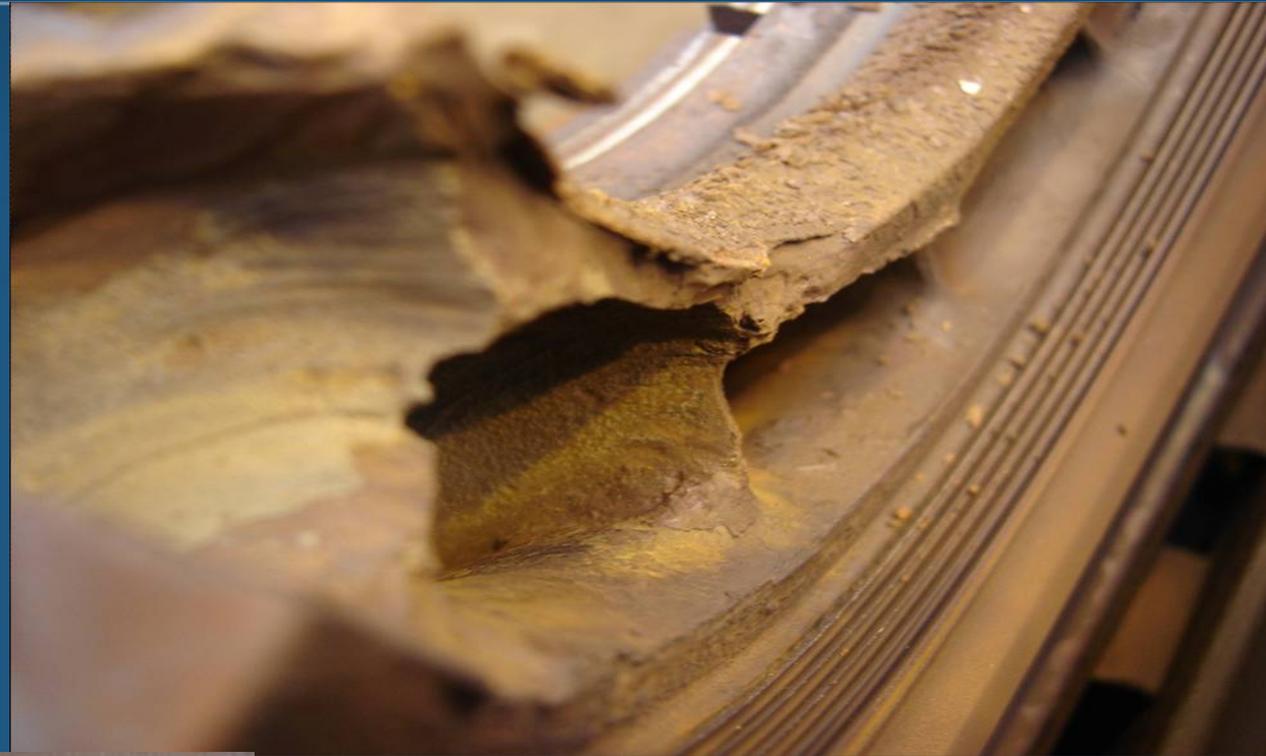
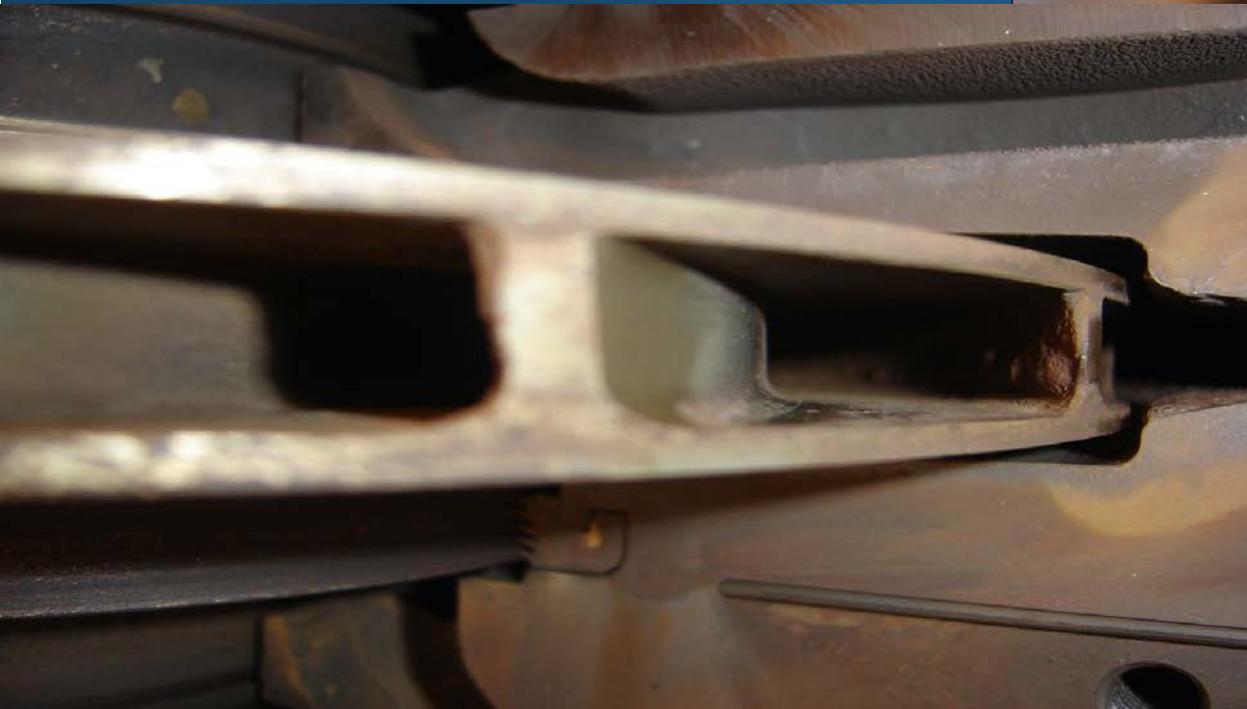
- The HP bundle was removed and sent to the turbomachinery workshop for inspection and posterior repair.
- When disassembled in the workshop, the cause of the aerodynamic instability was clear: severe material loss and deposits in both inlet and diffuser vanes of the first stage and impeller.

- Repair/replacement of the damaged bundle components took place at operator turbomachinery workshop.
- The inlet guide vanes were rebuilt, the inlet labyrinths and all other consumables were replaced.
- The bundle was reassembled in the compressor and returned to operation.

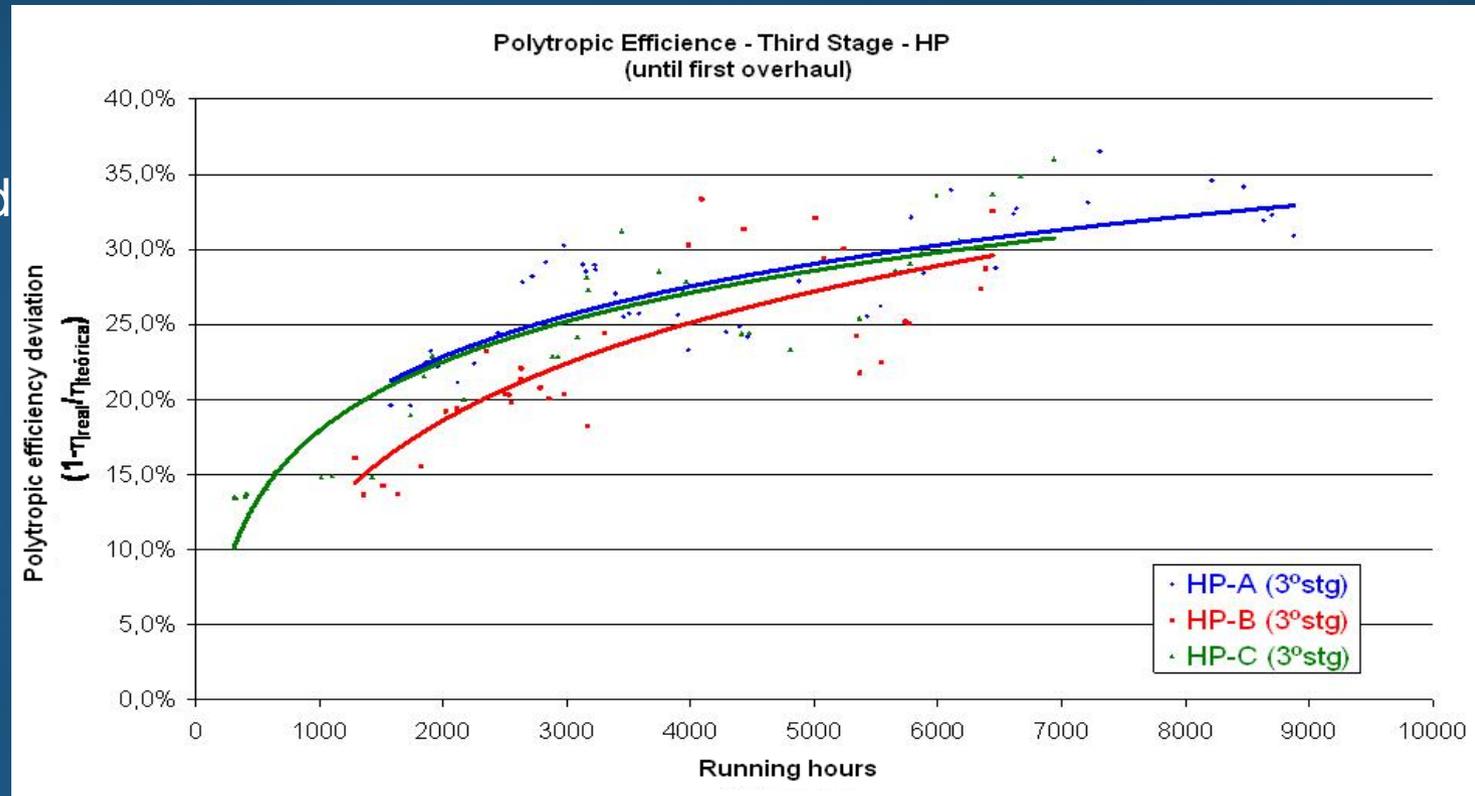
- After six month of compressor operation, it was observed a continuous and marked reduction in polytropic efficiency only in the high pressure compressor.

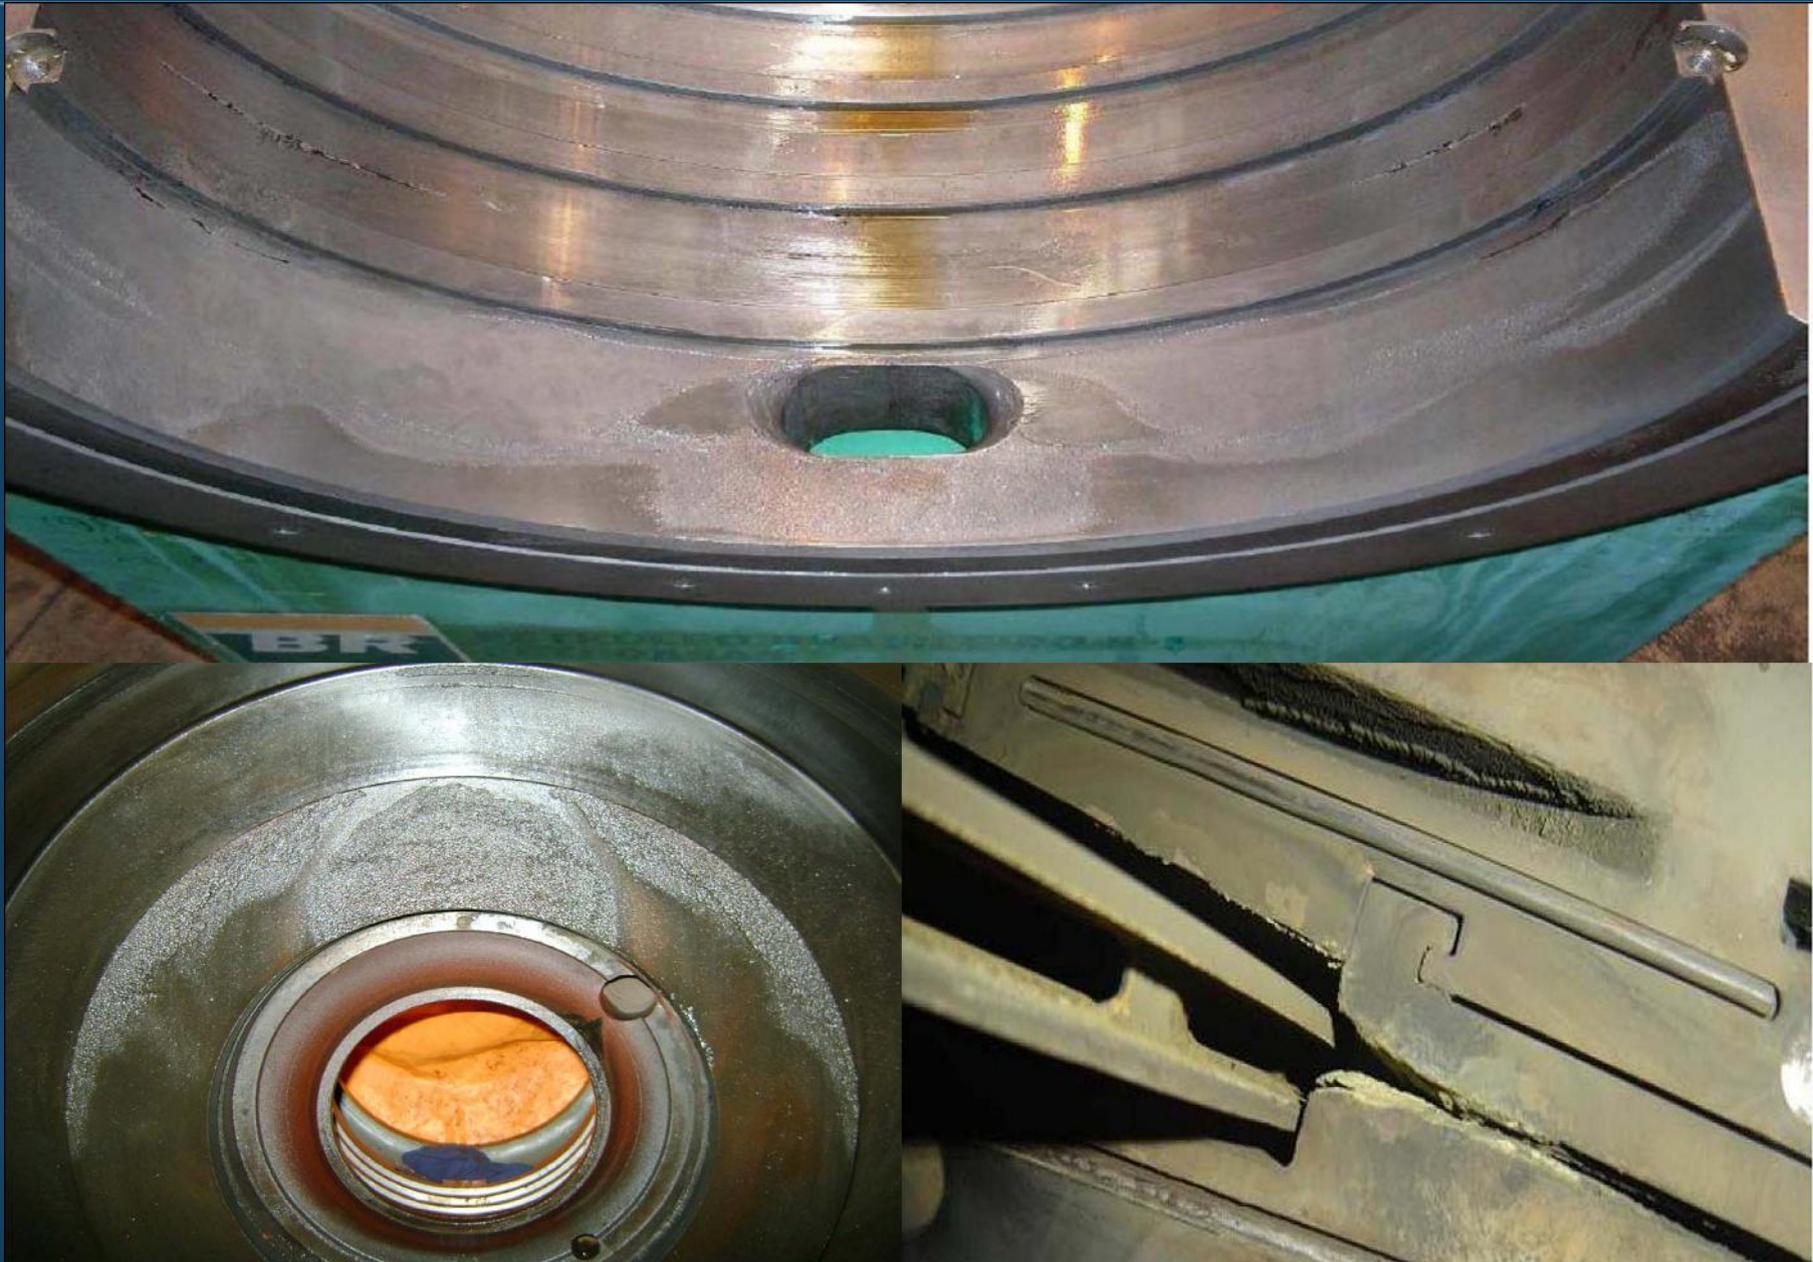
- No high vibration was observed
- In order to restore the design efficiency, HP bundles were disassembled and sent to turbomachinery workshop for inspection and repair.
- Corroded areas were found at both casing and bundle, and heavy deposits at first diffuser and impeller.
- The corrosion product was analyzed and confirmed that the corrosion was due to the presence of CO<sub>2</sub> ( Siderite – FeCO<sub>3</sub>).

Corrosion on casing and counter-casing and deposit on first impeller and diffuser

- Corrective and mitigation action were carried out to minimize the issue such as: completion of suction lines thermal insulation; review of the scrubbers design; and provision for a corrosion inhibitor system.
- The chosen action, in agreement with the manufacturer, was to implement an electroless nickel plating on the compressor (casing, counter-casing and first diaphragm) and to superheat the gas at stage suction.

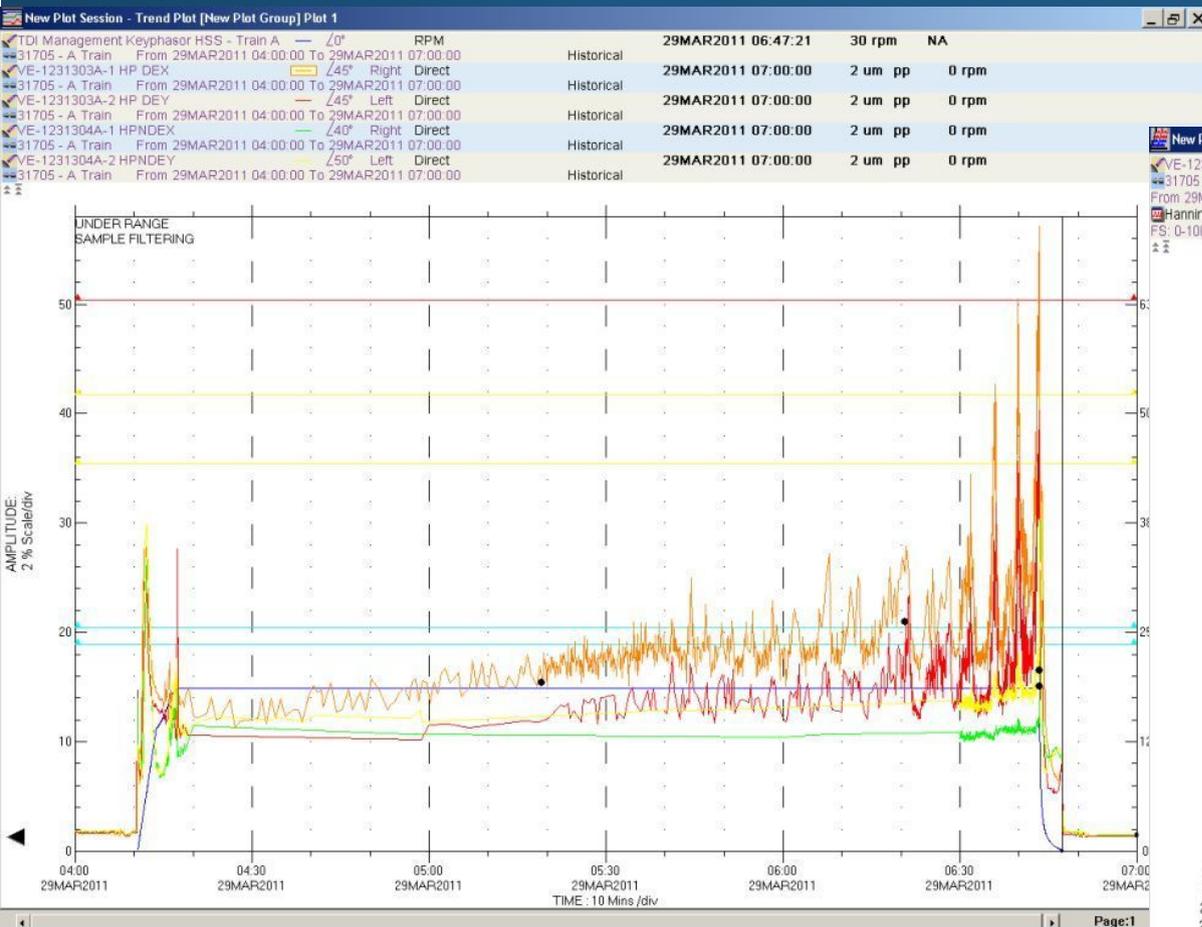
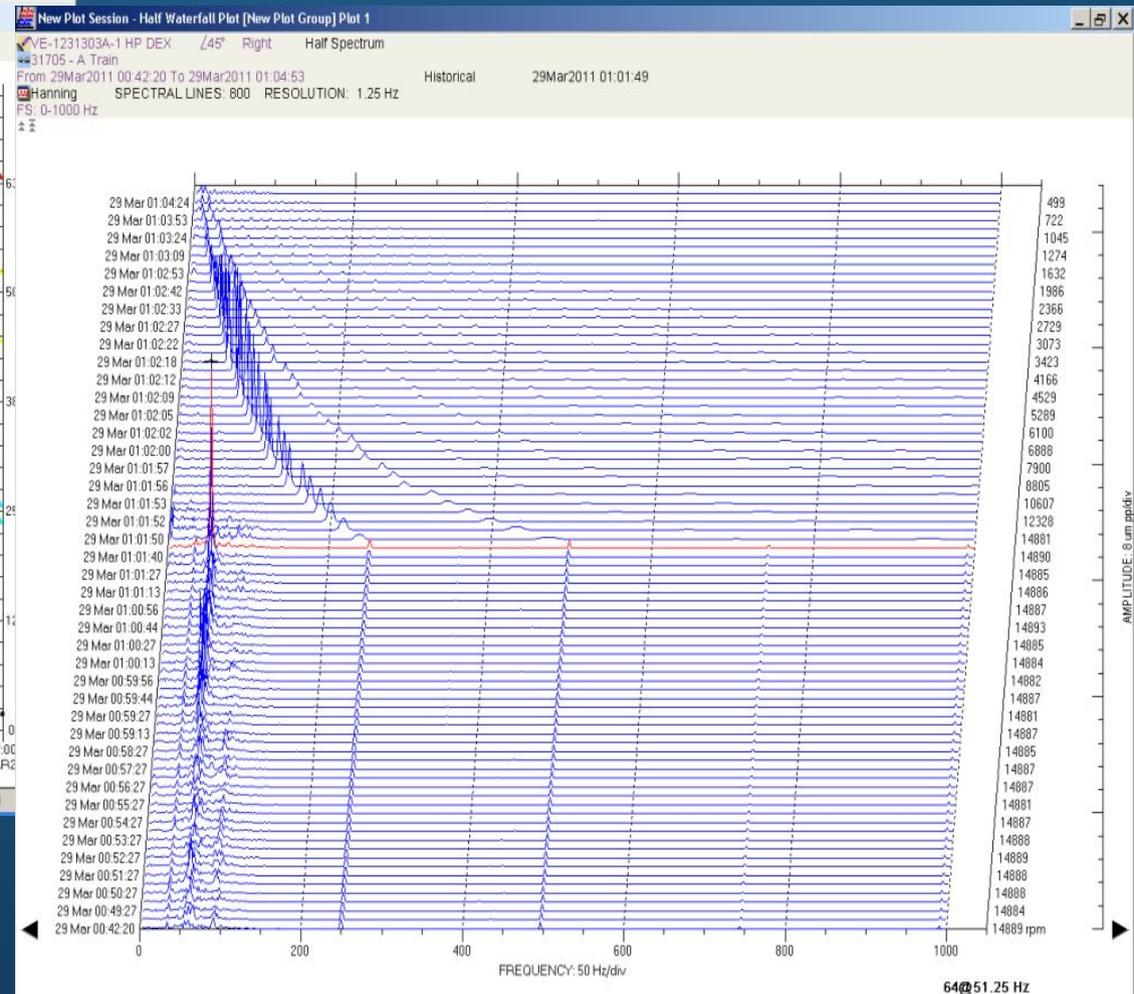
- At the beginning of 2011, HP compressor A faced several trips due to high vibration during normal operation.
- Further investigation of the event by the Technical Support team found an unstable, rapidly increasing, sub-synchronous vibration in the 45-50 Hz range.

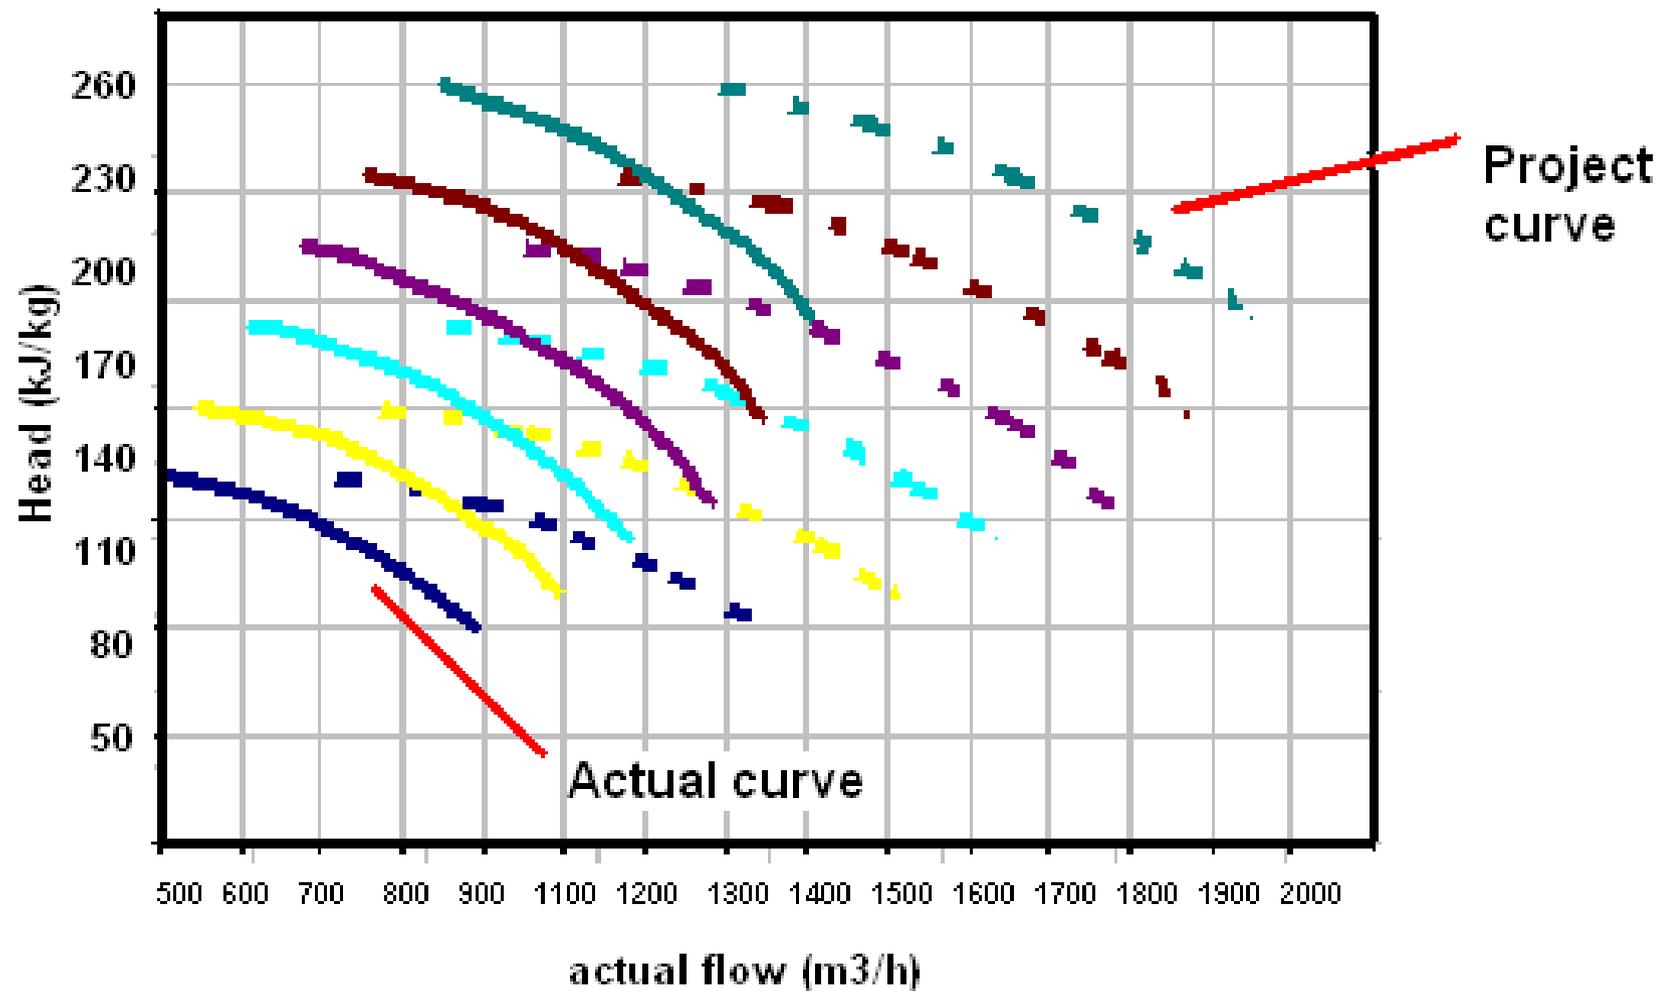
- It was also observed a reduction in both head and polytropic efficiency.

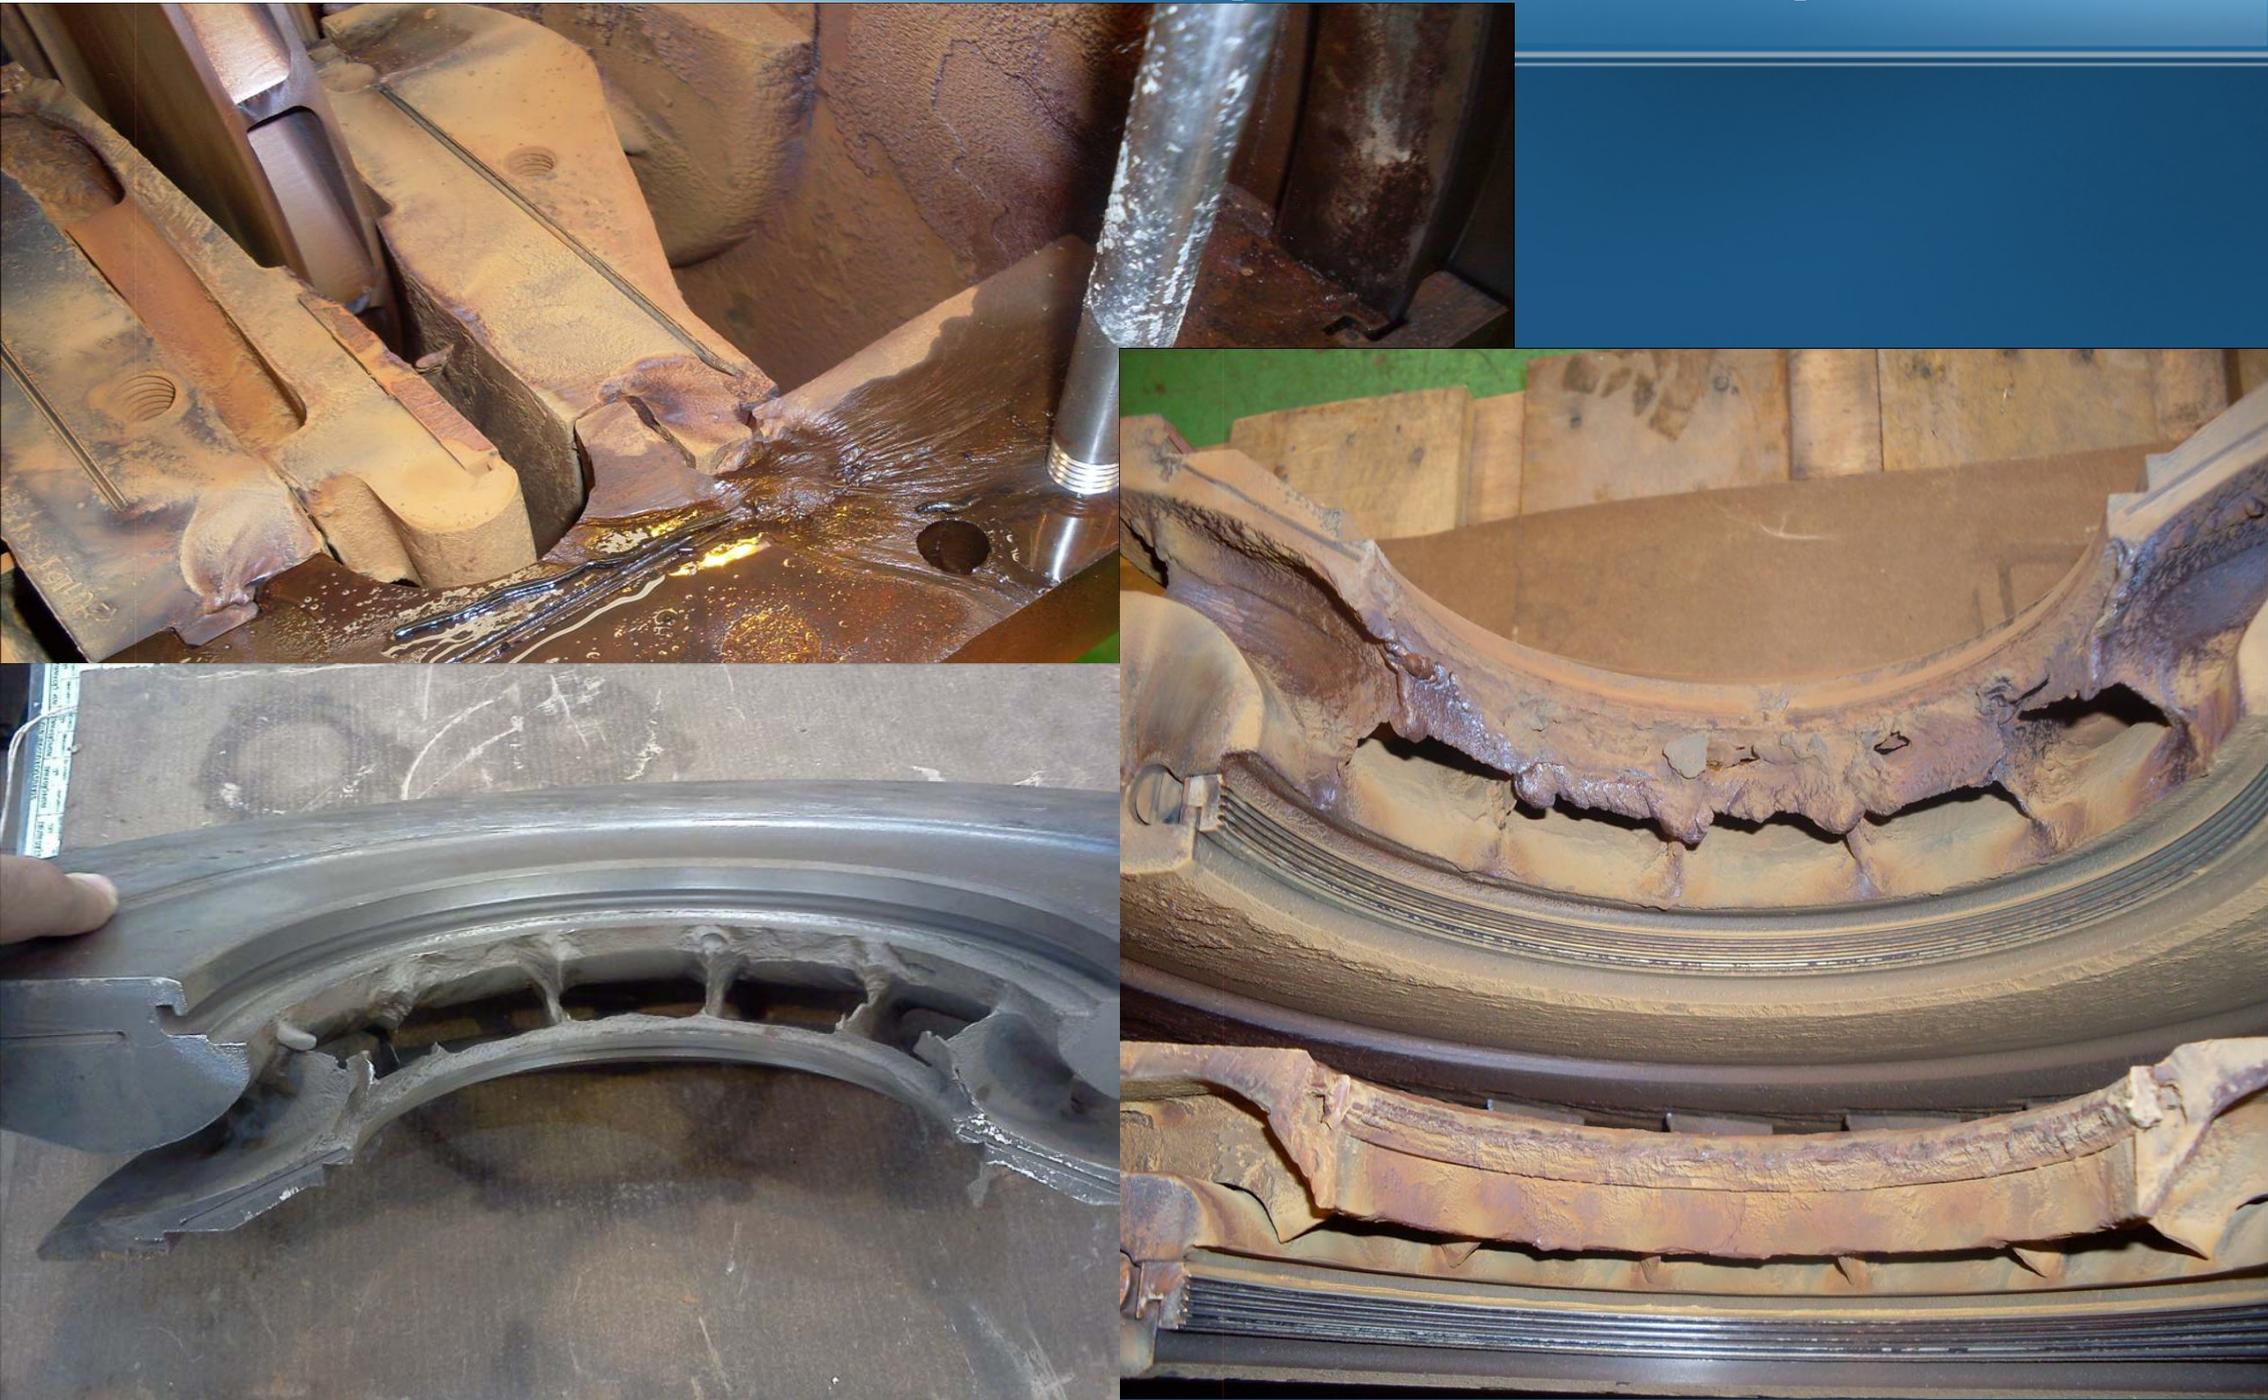
- In order to restore the design efficiency, HP bundle was disassembled and sent to turbomachinery workshop for inspection and repair.
- Corroded areas were found at both casing, IGV and diaphragm, and erosion at first, second and third diaphragm.
- The corrosion product was analyzed and confirmed that the corrosion was due to the presence of CO<sub>2</sub> (Siderite – FeCO<sub>3</sub>).

Corrosion and erosion on counter-casing as well as inlet wall

- Repair/replacement/cleaning of the bundle components took place at operator turbomachinery workshop.
- The first inlet guide vanes, labyrinths and consumables were replaced.
- Final solution is under analysis. Two possibilities are being considered: same coating solution used in P-51 or new components entirely manufactured in material resistant to CO<sub>2</sub> corrosion.
